## **UPGro Catalyst Grant Report (NE/L001969/1)**

# **A Hidden Crisis: strengthening the evidence base on the sustainability of rural groundwater supplies – results from a pilot study in Uganda**

**BGS report reference: OR/15/019**

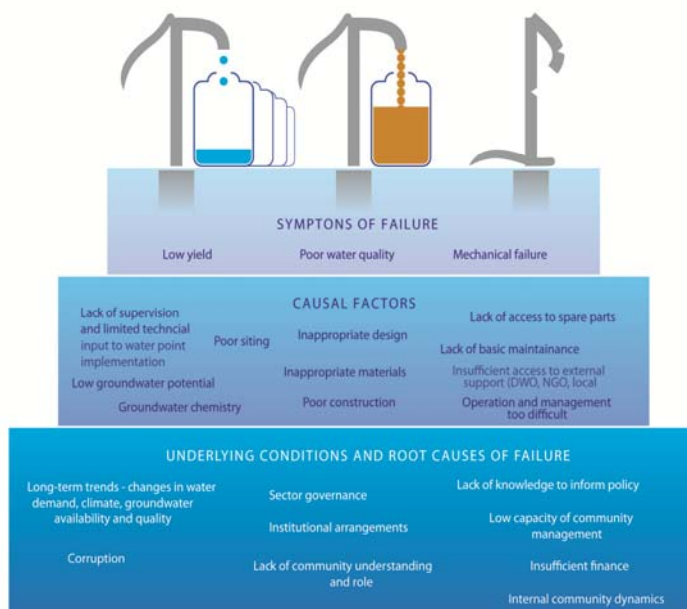
Figure 8: Hierarchy of symptoms, causal factors and underlying causes of water source failure

'insufficient yield' (a symptom of failure) can arise due to low groundwater resource potential; inappropriate design of the borehole in relation to the aquifer resource; or, inappropriate siting and borehole depth; or, high demand pressures. As another example, mechanical failure can arise from: poor installation of the pump and inappropriate construction materials; or the inability of the community to finance and facilitate repairs. These two sets of causal factors may be linked – the community may not be *willing* to raise the finance for repairs if the handpump construction is poor and repeatedly fails. The ability of a water user committee to repair the handpump is dependent on the underlying borehole construction and siting as well as access to spare parts and available finance.

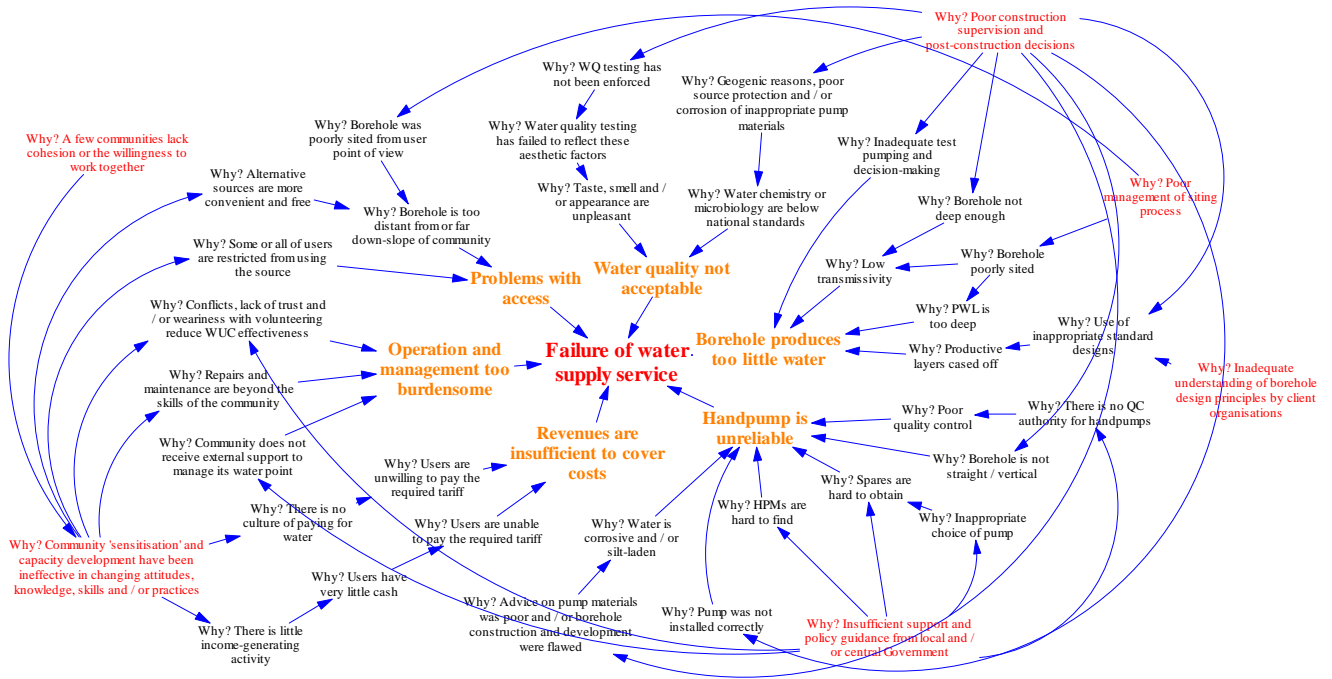
Figure 9 – A schematic causal link diagram of water point failure. Factors which can contribute to water point failure are shown in concentric rings around the failed water point in the centre. The arrows indicate linkages between different causal factors. Underlying conditions and root causes, which underpin these causal factors, and ultimately lead to the water point failure, are shown by the outer circle of red text.

A second RCA approach – **Causal Link Diagrams** – was then used to begin to examine how these different factors might interlink (Rooney and Vanden Heuvel 2004) – Figure 9. This was very useful in identifying the number and complexity of inter-linked factors, and to begin to frame water point failure as a system. One symptom of failure can arise from different causes. For example,

The factors underpinning failure of a water supply are, therefore, numerous and inter-related, and the causal link diagram (Figure 9) provides a useful diagnostic framework for visualising these layered and inter-linked sets of factors which can lead to failure. To investigate which linkages have led to supply failure at any one water point requires a systematic field methodology to collect comprehensive data on supply failure.

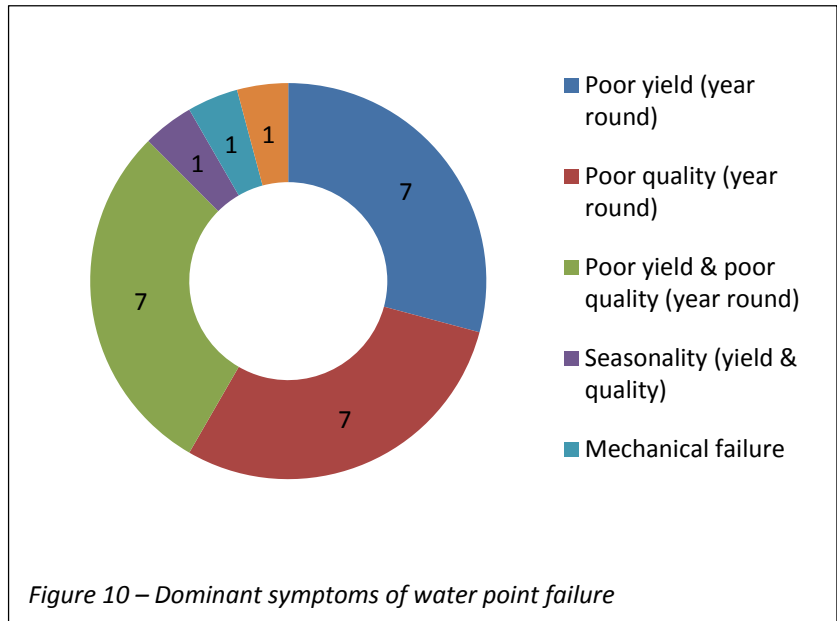
Figure 10 – Dominant symptoms of water point failure

According to the community discussions, many of the water points surveyed had quality and/or yield problems from the start, indicating an issue with siting or construction. Only three or four were functioning for one year or more before problems arose. Poor yield manifested itself in difficulties with pumping and/or having to rest the pump, whilst quality was primarily determined by sight (e.g. milky or rusty colour, presence of ‘worms’ or particles in the water), smell and/or taste. In five cases samples of the water had been taken away by local experts for testing at the time of the community complaints, but only one community had received feedback. There were few cases of seasonal failure (K12, A20) (see Figure 10).

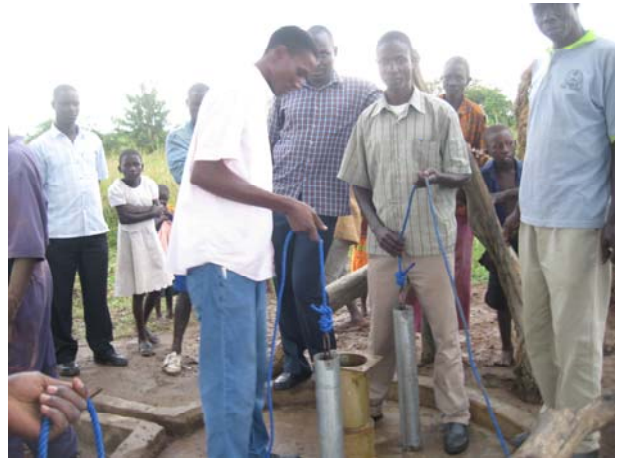
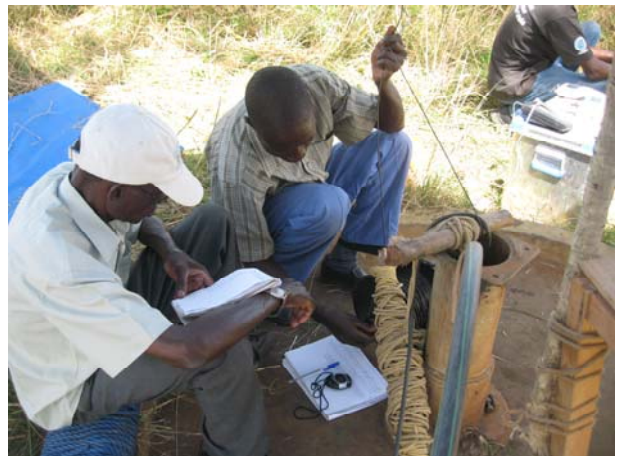
*Bailer (top) and pumping tests (bottom) being carried out in Amuria District.*

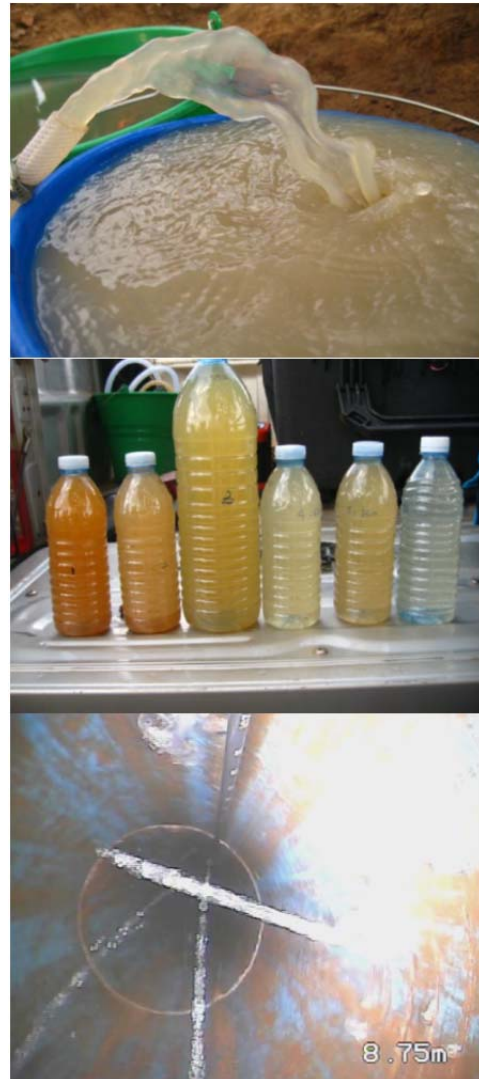
Laboratory analyses of the groundwater samples taken indicate relatively high organic carbon content (material derived from decaying vegetation, bacterial growth, and metabolic activities of living organisms or chemicals), with average NPOC (Non-Purgeable Organic Carbon – commonly referred to as total organic carbon (TOC)) measured as 0.8 mg/l (range 0.47 to 2.37 mg/l), and high dissolved iron (Fe) content – average total Fe 600 µg/l (over half of the samples had Fe in excess of 200 µg/l, with three >1000 µg/l). The high iron content in abstracted waters is supported by corrosion and staining of the pump components and by observation of significant orange staining at all the boreholes investigated in the CCTV surveys. This is most likely attributable to the high iron content of the waters, but may also be contributed to by ingress of soil particles into the boreholes which have screened intervals in the regolith (Figure 14). Elevated concentrations of zinc (five sites having Zn over 200 µg/l) are indicative of corrosion processes having taken place. Manganese concentrations were <200 µg/l in nearly all the waters. Full laboratory results are shown in Appendix 4.

Figure 14 – (Top) opaque, milky appearance of groundwaters; (Middle) groundwater quality improved in some boreholes with pumping; (Bottom) significant orange staining on borehole casing observed in all.

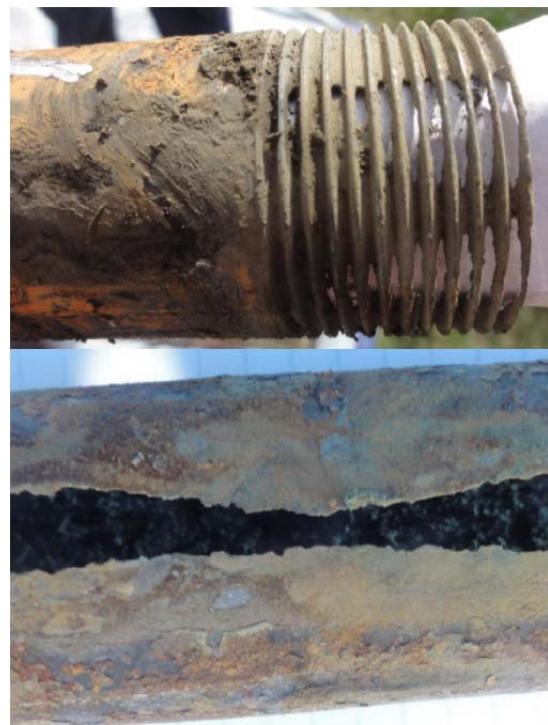
Figure 16 – (Top) corroded rising main thread; (Bottom) perforated rising main.

*Handpump repairs:* All of the water points are reported by the communities to have undergone some repair during their lifetime, the most common repairs being replacement of pipes, chains and the pump cylinder. Replacement of leaking or damaged rising main pipes had occurred at 9 of the 10 handpumps. In some cases this was reported to have been done by removal of the pipes – and thereby raising the pump cylinder by approximately 3 m for each pipe removed – or, by cutting out the corroded or damaged sections of the pipes and re-threading the remaining shorter pipes. On removal and inspection of the handpumps, there was evidence of either removal of the pipes, or shortening of pipes to remove damaged sections, rather than proper pipe replacement – Figure 17. Only one of out the 41 pumping rods examined in the nine study sites, conformed to India Mark II specifications – Figure 17.

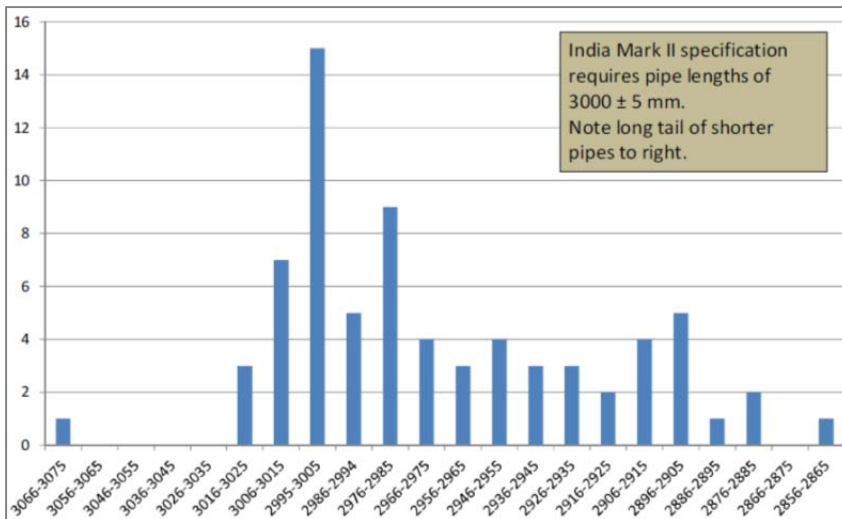
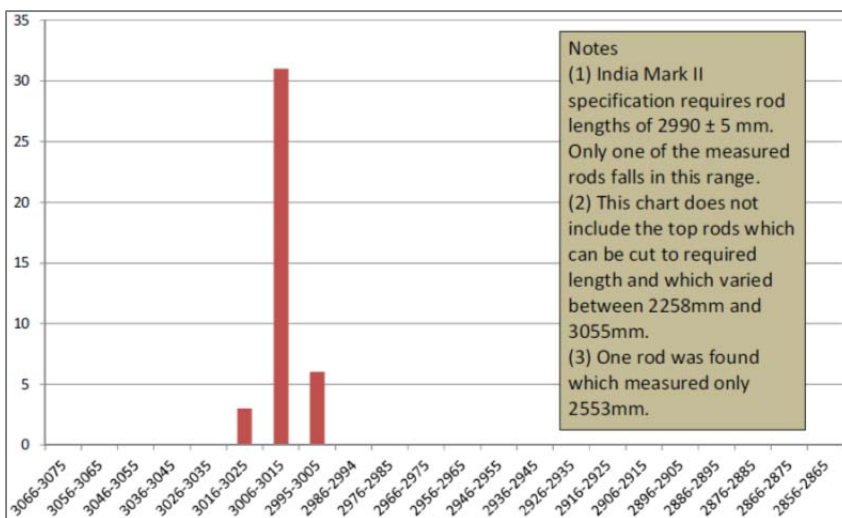
Figure 17(Top); frequency distribution of rising main lengths in mm (72 rising main lengths from 8 supplies examined); (Bottom) frequency distribution of pump rod lengths in mm (41 rods from 6 supplies examined).
