Stability monitoring of a rail slope using acoustic emission

The paper details the use of acoustic emission generated by active waveguide subsurface instrumentation to monitor the stability of a rail soil cutting slope failure. Operation of the active waveguide, unitary battery-operated acoustic emission sensor and warning communication system are described. Previous field trials reported by the authors demonstrate that acoustic emission rates generated by active waveguides are proportional to the velocity of slope movement, and can therefore be used to detect changes in rates of movement in response to destabilising and stabilising effects, such as rainfall and remediation, respectively. The paper presents a field trial of the acoustic emission monitoring system at a reactivated rail-cutting slope failure at Players Crescent, Totton, Southampton, UK. The results of the monitoring are compared with both periodic and continuous deformation measurements. The study demonstrated that acoustic emission monitoring can provide continuous information on displacement rates, with high temporal resolution. The ability of the monitoring system to detect slope movements and disseminate warning

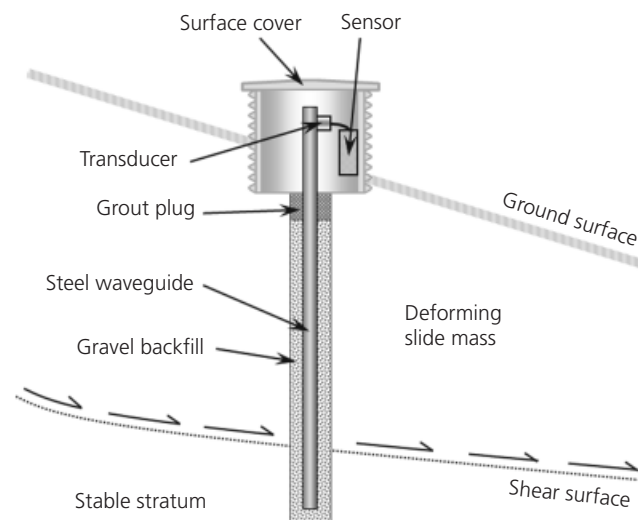
Figure 1. An active waveguide installed through a slope deforming on a shear surface, with an AE monitoring sensor attached to the top of the waveguide and protected by a cover (after Dixon *et al.* (2012a))

Deformation within soil generates interparticle friction and AE. Particle–particle interactions (e.g. sliding and rolling friction) and rearrangement of the particle-contact network (e.g. release of contact stress and stress redistribution as interlock is overcome and regained) are mechanisms that generate AE within soil (Lord and Koerner, 1974; Michlmayr *et al.*, 2012a, 2012b, 2013). Research has shown that soil-generated AE is detectable and measurable. The characteristics of the AE generated are governed by the properties of the soil (e.g. AE from fine-grained soils is highly influenced by moisture content and plasticity, and AE events of greater magnitude are produced in granular soil with large angular particles), and AE events with greater magnitude are generated by deforming soil with high interparticle contact stresses (Garga and Chichibu, 1990; Koerner *et al.*, 1981; Michlmayr *et al.*, 2013; Mitchell and Romeril, 1984; Shiotani and Ohtsu, 1999).

backfill (i.e. to generate relatively high-energy AE as the slope deforms, which can propagate along the waveguide). As the slope displaces, the gravel backfill is deformed, generating the AE.

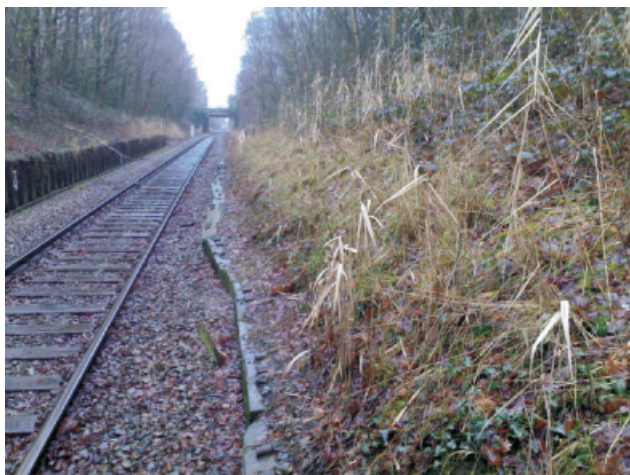
Figure 4. The toe of the slope, showing the distorted concrete cable trough and toe bulging

The reactivated slide mass was interpreted as moving along a defined shear surface that was at, or close to, residual strength (and therefore little or no further brittle loss of strength could take place), which was expected to result in small, low-velocity movements in response to seasonal pore-water pressure fluctuations inducing oscillations in shear strength along the shear surface (Hutchinson, 1988; Leroueil, 2001). Therefore, rapid and catastrophic failure was not anticipated; however, bulging at the toe of the slope was a concern, due to interaction with the adjacent rail infrastructure (i.e. serviceability limit state). A concrete cable trough at the toe of the slope had been deformed, indicating continued movement (Figure 4).

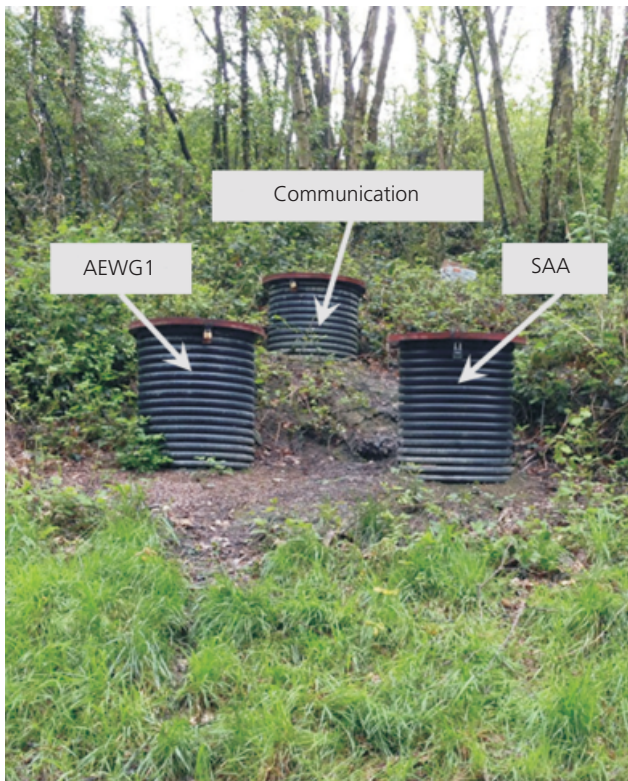
Figure 6. Photograph from the bottom of the slope, showing the surface covers protecting AEWG1, the SAA and the communication node

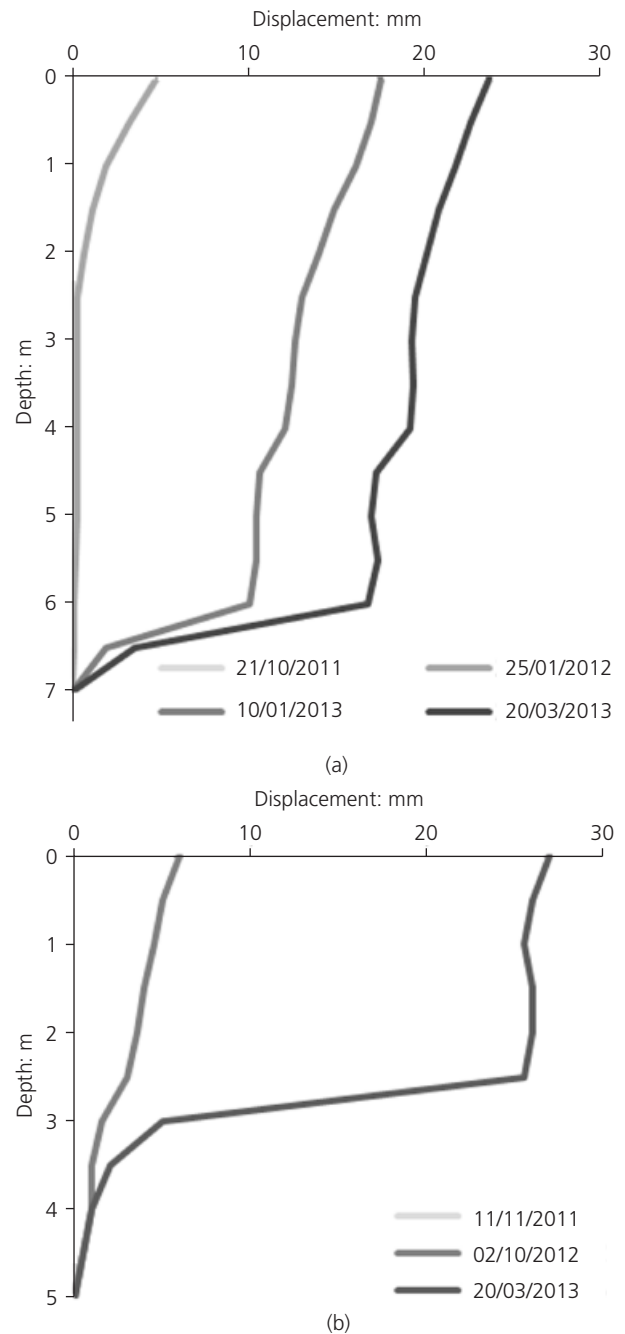
Figure 7. (a) Selected inclinometer survey data (0, initial reading on 21 October 2011) showing the main shear surface at a depth of approximately 6.5 m in the upper part of the slope, and (b) selected SAA survey data (0, initial reading on 11 November 2011) showing the main shear surface at a depth of approximately 3 m in the lower part of the slope. Note that the deformations increased progressively with time

Figure 7(a) presents survey data from the inclinometer casing and Figure 7(b) survey data from the SAA. The data show a shear surface depth at the location of the inclinometer of approximately 6.5 m (agreeing with the location of the soft to firm horizon found in the site investigation, as described in Section 3.2) and a shear surface depth of approximately 3 m at the location of the SAA. This information was used to produce the cross-section of the slope shown in Figure 8 (section A–A' in Figure 5) and the interpretation of the location and geometry of the shear surface, which was assumed to intersect the rear scarp and the toe.

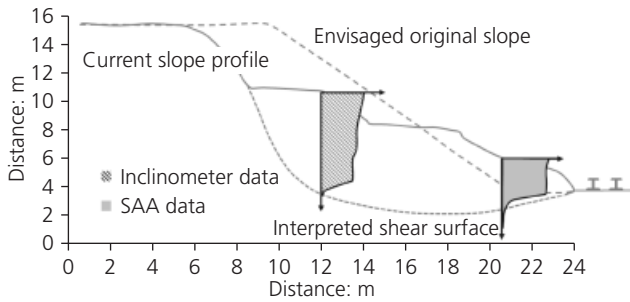
Figure 8. Cross-section A-A' (see Figure 5) showing the envisaged original slope profile, the current slope profile and the interpreted shear surface (with exaggerated inclinometer and SAA data)

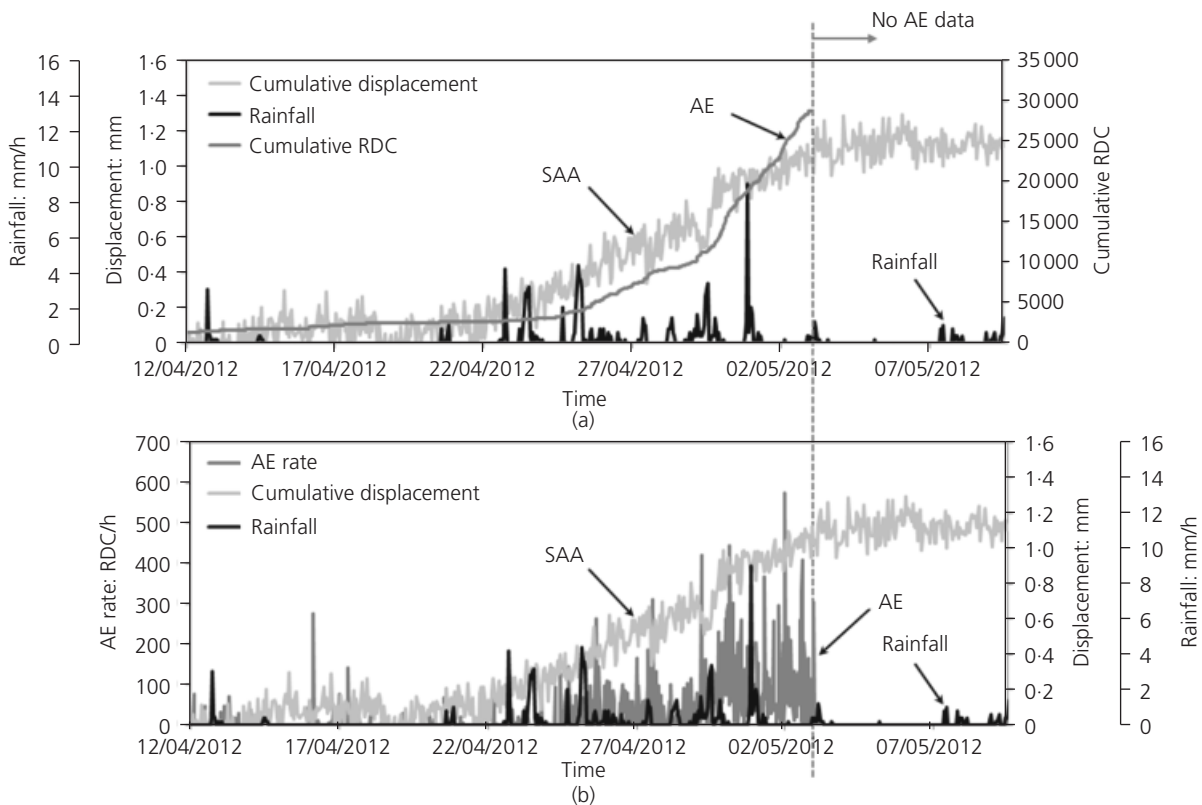
Figure 9. (a) Cumulative RDC, displacement and hourly rainfall against time for a small-magnitude, low velocity reactivated deformation event (data from the SAA and AEWG1), and

(b) AE rate (RDC/h), displacement and hourly rainfall against time (data from the SAA and AEWG1)

Figure 9(a) shows cumulative RDC, deformation and hourly rainfall over time for a period of slope movement that occurred between 19 April and 5 May 2012. The continuous deformation information was recorded by the SAA installed down-slope (i.e. near the toe). Deformation data were taken from the MEMS sensor immediately above the shear surface depth, and the measurements shown are the resultant from both *x*- and *y*-directions (i.e. resultant horizontal displacement). The AE data were recorded by the adjacent active waveguide and sensor node (AEWG1). Figure 9(b) shows the AE rate time series superimposed on top of the same deformation event. Approximately 1.2 mm of slope movement occurred during this 16 day period.

The active waveguide and sensor node also detected this small, low-velocity slope movement event. Of particular interest is the dramatic continual increase in AE rates as the slope movement initiated, and this continued throughout the 'very slow' deformation event. A surge of accelerated movement between 29 April and 30 April occurred in response to a preceding period of intensive rainfall. This period of accelerated movement was detected by the AE system, as evidenced by the increased AE rates (Figure 9b) throughout this period, and the increased gradient of the cumulative RDC record (Figure 9a).

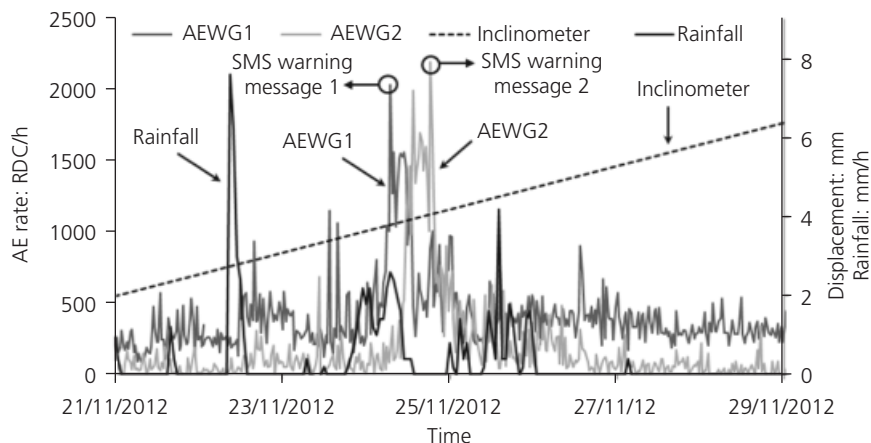
Figure 10. AE rate (RDC/h), inclinometer displacement interpreted for the measurement interval 15 November 2012 to 10 January 2013 and hourly rainfall against time for a period of slope

movement in response to intensive rainfall (data from AEWG1, AEWG2 and the inclinometer), the timing of the SMS warning messages (Figure 11) are superimposed

Predefined trigger levels were set on the sensors related to displacement rates. If the measured RDC in any given monitoring period exceeded one of the trigger levels, a SMS message was generated. The communication system sent a SMS alarm status on 24 November 2012 at 7:00 p.m., which stated that AEWG1 had detected 'very slow' movement as the AE rate exceeded 2000 RDC/h (Figures 10 and 11). Another SMS was sent on 25 November 2012 at 6:30 a.m., which stated that AEWG2 had also detected 'very slow' movement (both messages were received by the authors' mobile phones, one of whom was in Peru at the time) (Figure 11). Only one text message was generated at each of the two instrument locations during this period of movement because the AE rates subsequently decreased beneath the lowest trigger threshold in the successive measurement intervals. These warnings were generated by the peaks in the bell-shaped AE rate-time curves shown in Figure 10, which are characteristic of deformation events (as described in Section 2.3). Figure 10 shows the AE rate, inclinometer displacement and hourly rainfall over time for the period in which the deformation events and alarm SMS messages were triggered. The 11.5 h that separated the warning messages indicated that movement had been detected in the lower part of the slope prior to being detected in the upper section of the slope. Subsequent interrogation of the data shown in Figure 10 confirmed that the toe of the slope indeed moved before the head (i.e. AEWG1 generated a bell-shaped AE rate curve prior to AEWG2). An extended period of intense rainfall occurred at the location of the site prior to, and during, the deformation events. This rainfall provided for a build-up of pore-water pressures in the vicinity of the shear surface that was sufficient to reduce the effective stress and induce movement. This was followed by a deceleration of movements as pore-water pressures dissipated and due to mobilisa-

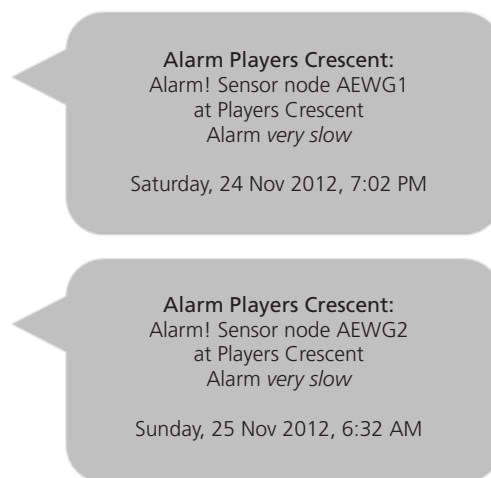
Figure 11. SMS warning messages AEWG1 (lower waveguide) and AEWG2 (upper waveguide) (Figure 10) showing the information contained (e.g. the time stamps and the alarm status)
