# Low Cycle Fatigue Behavior of Elbows with Local Wall Thinning

**Abstract:** There have been a number of studies concerning the integrity of high-strength carbon steel pipe elbows weakened by local pipe wall thinning, the latter can be typically caused by flow accelerated erosion/corrosion. In particular, the focus of several recent studies was on low cycle fatigue behavior of damaged elbows, mainly, in relation to strength and integrity of piping systems of nuclear power plants subjected to extreme loading conditions, such as earthquake or shutdown. The current paper largely adopts the existing methodology, which was previously developed, and extends it to copper-nickel elbows, which are widely utilized in civil infrastructure in seismically active regions. FE (finite element) studies along with a full-scale testing program were conducted and the outcomes are summarized in this article. The overall conclusion is that the tested elbows with various severity of local wall thinning, which were artificially introduced at different locations, demonstrate a strong resistance against low cycle fatigue loading. In addition, elbows with wall thinning defects possess a significant safety

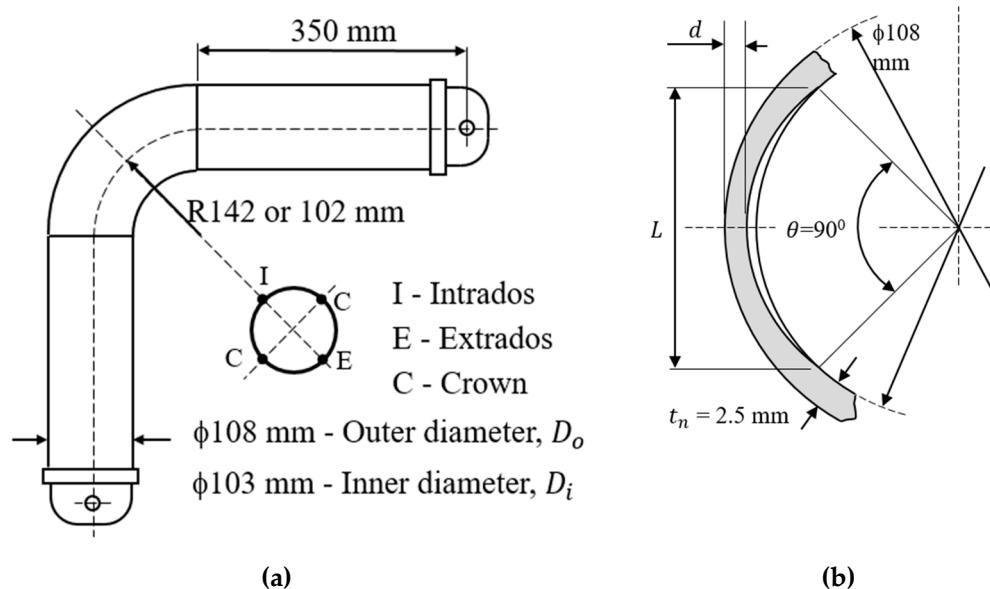
**Figure 1.** (a) Test specimen and main dimensions; (b) Wall thinning defect sizes.

The short and long bend elbows of OD = 108 mm and nominal thickness,  $t_n = 2.5$  mm, as shown in Figure 1a were fabricated by die casting. The elbows were made of C70600 Copper Nickel 90/10 (90%

The wall-thinning defects were artificially introduced on the inner side of the elbow wall. These defects were machined at the intrados, crown or extrados center regions, as shown in Figure 1b (one defect for each elbow specimen). The circumferential and axial shapes of the defects had circular geometry. Then, the defect geometry can be specified by the following parameters:  $L$  is the equivalent thinning length,  $\theta$  is the circumferential angle of the defect, which was kept at  $90^\circ$  in the present study and eroded ratio,  $d/t_n$ .

$M_E = P_E l$  is the moment amplitude corresponding to the maximum displacement of 20 mm, which can be obtained from the fictitious force amplitudes,  $P_E$ , corresponding to the first  $\frac{1}{4}$  cycle as illustrated in Figure 5 and  $l$  is the moment arm, which can be evaluated from Figure 1 for short and long radius elbows.

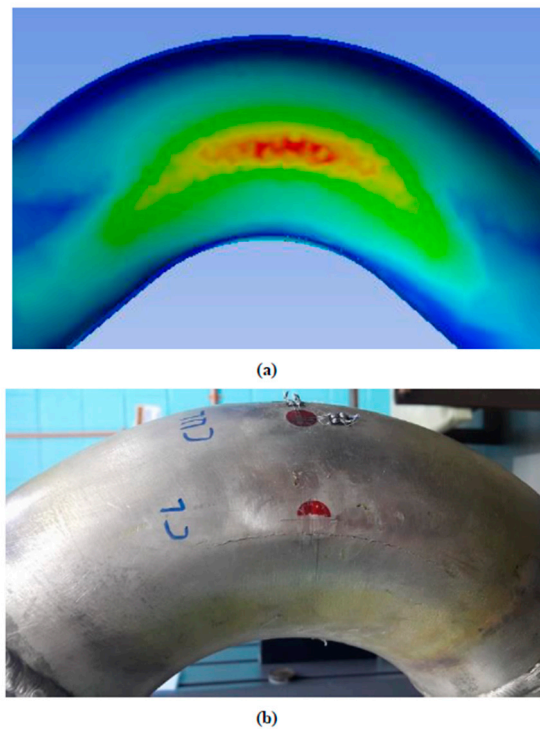
**Figure 2.** Distribution of effective stresses under in-plane bending (red area—at crown location shows the highest stress intensity), adapted from [19] with permission from wiley.com, 2019. (a) The FEA three-dimension failure illustration; (b) fatigue failure captured on the elbow after cyclic loading experiment.

It is well-known from the classical elastic stress analysis of thin-walled donut shells (or membrane shell theory) that the hoop stress largely remains constant, and the magnitude of the hoop stress is similar to the hoop stress in circular pipes loaded by inner pressure. The maximum circumferential stress takes place at the intrados, the minimum stress appears at the extrados region of elbows, while the crown is subjected to an intermediate stress level. However, from our present elasto-plastic FE results, see Figure 2, as well as from previous studies [19], it follows that the crown region can be subjected to the highest stress under closing-mode in-plane bending (in the absence of the inner pressure). Therefore, these results as well as the previous studies justify the consideration of various locations of wall thinning defects as the inner pressure and in-plane bending loading can change the critical locations with the highest stress and strain.

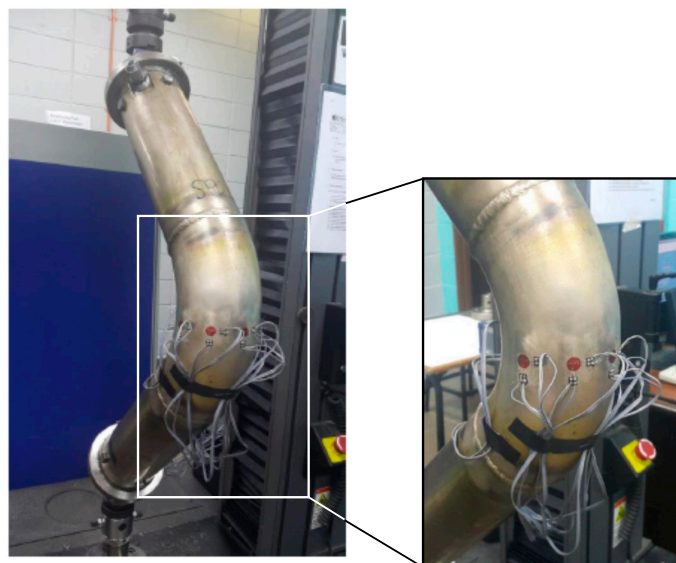
**Figure 3.** Test specimen equipped with strain gauge rosettes.

The testing apparatus used in this study included INSTRON 5982 universal testing machine, the pressurization system, and the data acquisition system. Elbow specimens were equipped with strain gauge rosettes at three critical locations on the outer surface to monitor deformations at intrados, extrados and crown regions during the displacement-controlled loading with and without inner pressure, see Figure 3.

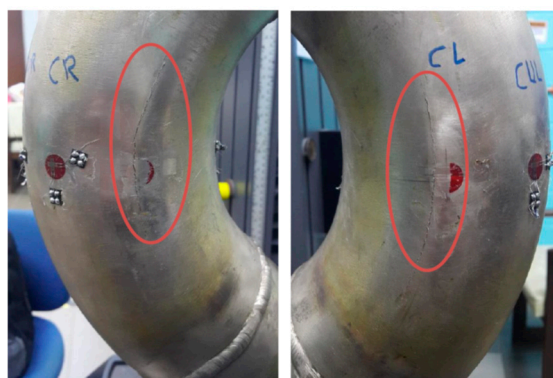
**Figure 4.** Fracture (crack penetration) at crown of sound elbow.

In all cases for sound elbows failure was observed at crown locations in the circumferential direction as shown in Figure 4. Cracks were not observed at intrados and extrados regions. The failure was identified when the reaction load was decreased or when a crack penetration was observed at the outer surface region of the crown, after that the fatigue test was terminated. These results were used as a benchmark for analysis of damaged elbows.

In almost all elbow specimens with local wall thinning at intrados or extradados, fatigue crack initiated at crown region and normally propagated in the axial directions as it was observed for sound elbows, see Figure 4. It is noted that in many cases, the crack initiated at crown, even for quite severe

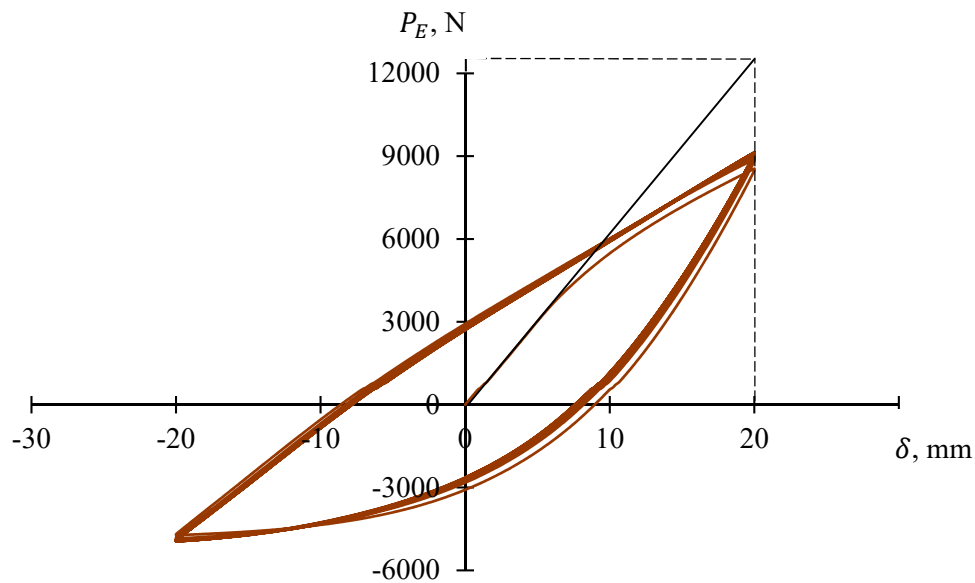
Figure 5. Typical load-displacement diagram.
