Investigation into the process of cured-in-place pipe sewer rehabilitation

Abstract

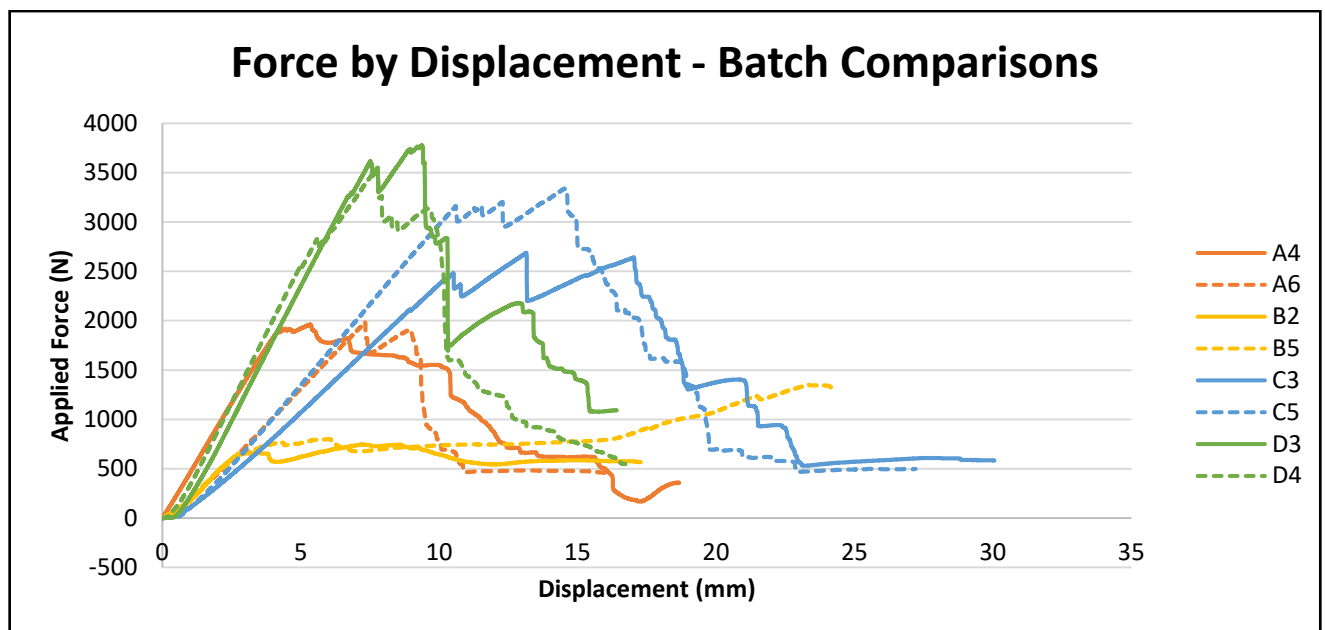
Figure 6 shows a range of 2 samples from each batch of testing completed and the associated displacement displayed. This has been created to quickly compare different batches of testing without cluttering the graph. Full graphs for each batch can be found in appendix 3.

Figure 6: Force by displacement - batch comparison

model which would be expected in a composite matrix, carrier material (shown in figure 6). Whereas it is difficult to see the actual failure point of batch B due to the ductility of the failure (see figure 6 and appendix figure 3B). The maximum displacement also ranged dramatically throughout the varying samples, appearing to level out at roughly 12, 20, 25 and 16mm for batches A, B, C and D respectively. Which shows a considerable range, once again batch B showed variation from the other samples and even at 20mm deflection the sample hadn't reached its maximum, showing it could potentially keep deflecting under heavier loading.

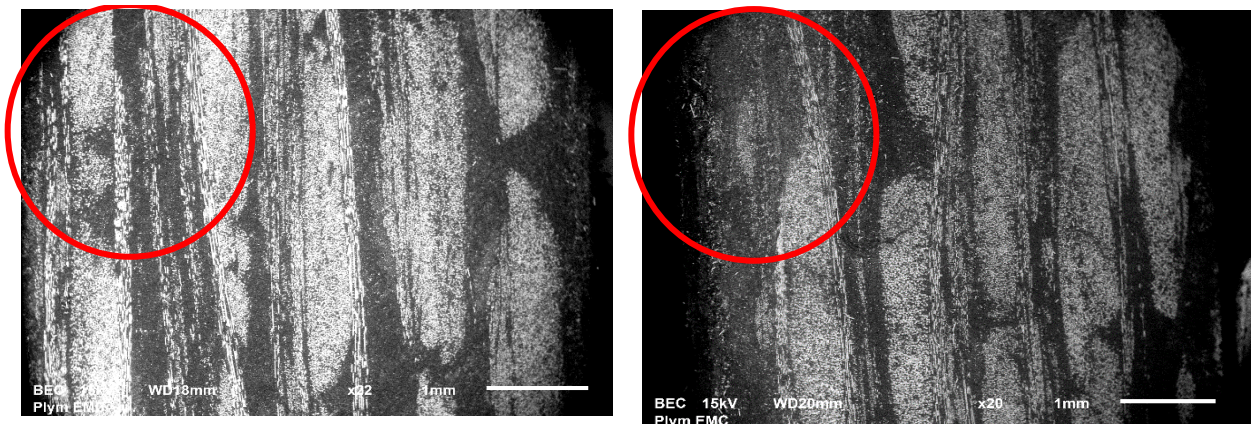
Figure 12 & 13: Sample C - whole thickness (L), Sample D – whole thickness (R)

some voids present throughout sample C, but overall the sample indicated a good spread of fibres, reaching to the edges of the sample. Sample D, shown in figure 13
