Senior Project – Corrosion Prevention

Project Title: Corrosion Prevention

Project Sponsor: Pete Schwartz, Cal Poly Physics

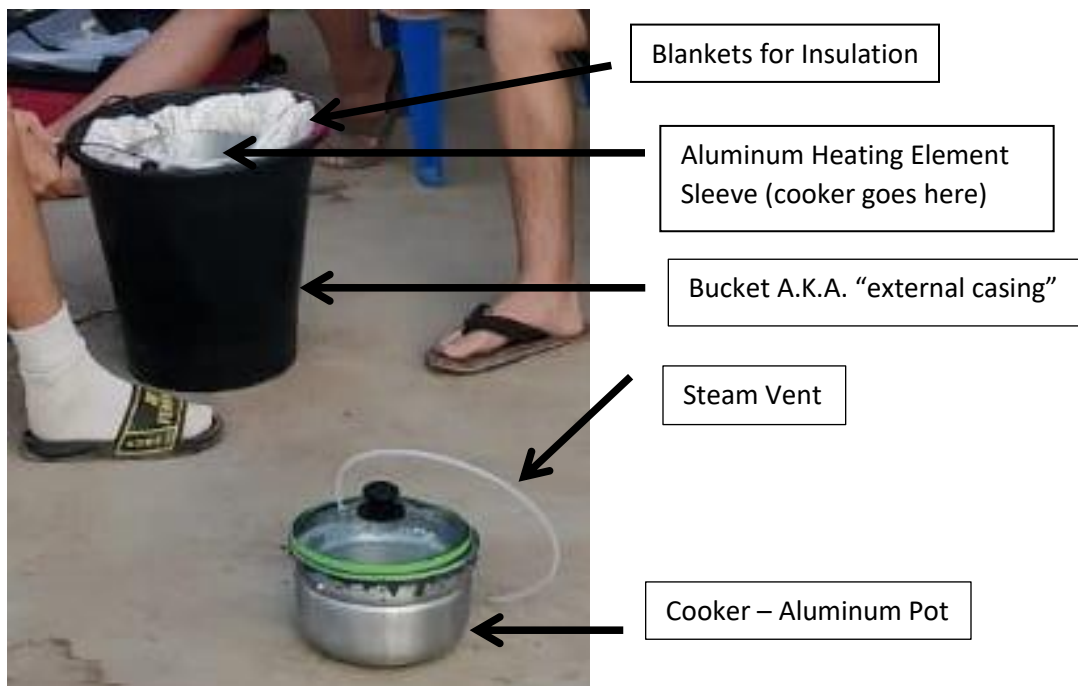
In Insulated Solar Electric Cooking (ISEC), heating is done by passing current through a chain of diodes directly connected to a solar panel (Gius et al, 2019). It is crucially important that the wires remain conducting, but not conduct to any metal surface that might short the heating circuit. Corrosion of any wires will cause a loosening of the mechanical (twisted) wire connection and could result in a loss of electrical connection completely, or undesired increased resistance.

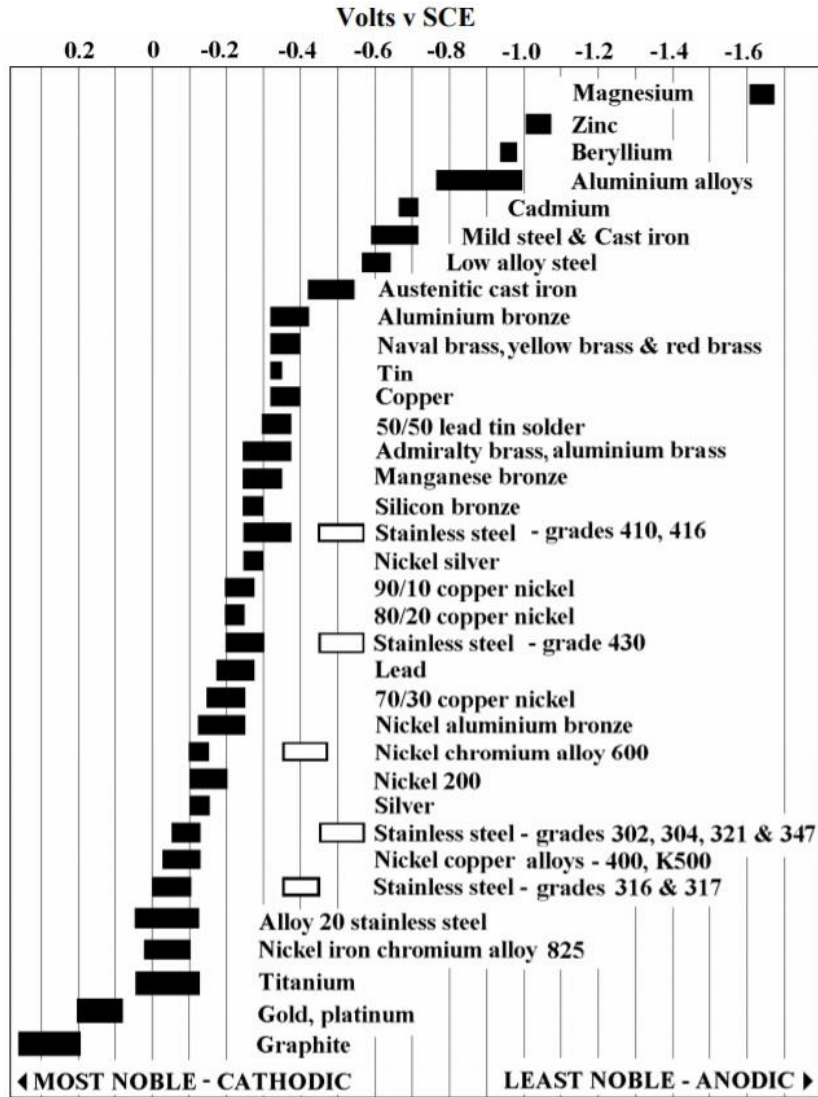
Source: <https://www.corrosionpedia.com/an-introduction-to-the-galvanic-series-galvanic-compatibility-and-corrosion/2/1403>

For our cooker, it is possible to use a different PCM than erythritol, but none of them are dielectric. Therefore, we must use metals that are as noble and close together on the galvanic scale as possible. For example, tin and copper connections will take longer to corrode than nickel and copper. Nickel plated wire and nickel chromium alloys (nichrome wire) would be better still. The only metals that matter are the ones exposed and/or in contact. When using nickel plated copper wire and nichrome wire connections, the nickel and nichrome are the only two metals in question.

Galvanic corrosion (and nearly all types of corrosion) happens **when two dissimilar metals are in direct physical contact or connected by a wire, and connected by an electrolyte**. It is known to occur faster with heat. One metal becomes the anode, is oxidized (loses an electron and a metal ion), and the other metal becomes the cathode, and is reduced (gains an electron). The anode is the metal which will corrode the fastest. The cathode will corrode much slower. In the case of our cooker, diode lead wires are composed of single stranded tin coated copper and the lead wires are pure single stranded copper. Copper becomes the cathode and tin the anode. They are both in contact with the erythritol which is electrolytic. The metal that is more noble on the galvanic scale (A.K.A. galvanic series) always becomes the cathode. The anode (tin) will shed an electron and a tin ion. Therefore, tin will visibly disappear and deposit elsewhere, causing loosened connections. See the galvanic scale and diagram on the next page.

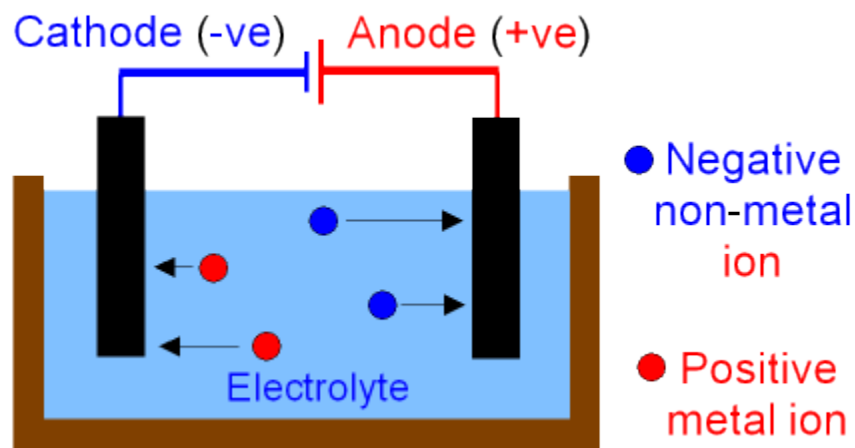
Source: <https://www.gcsescience.com/ex3.htm>

Electrolysis is considered a form of corrosion and occurs when two metals connected by a wire are placed in an electrolytic solution and a voltage is applied. These two metals need not be different metals. The voltage source forces a non-spontaneous reaction to occur. The anode is whichever metal is connected to the positive lead from the power source. The anode will shed ions and electrons and deposit those ions elsewhere. If copper were the anode, it would shed copper ions. Those ions would react with other ions present in the electrolyte to become more stable, and they would appear a green color. The green colored copper ions could deposit onto the same piece of metal they came from, or they could deposit elsewhere. See the diagram below. To prevent electrolysis, see steps below:

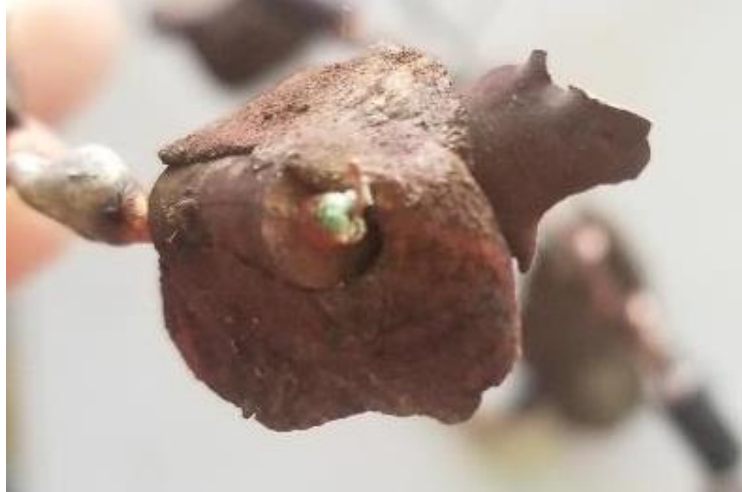
Figure 1. Corroded diode lead of a cooker constructed by twisting all connections. Surrounding the diode is erythritol and JB weld. During construction, diode bodies were glued to the pot using JB weld, but leads were left uncoated.

- Twisted connections between tin coated copper diode leads and copper lead wires, as well as diode lead to diode lead connections submersed in erythritol. These cookers usually stopped allowing current to flow within a few months of use. After being dissected, evidence of what is believed to be electrolysis was found. Figure 1 shows the notorious green color of corroded copper on the diode's lead wire. The corrosion progressed through the tin coating and nearly to the center of the lead wire. The confusing issue is that sometimes this green color is found on the most positive lead, and sometimes on the negative lead. Generally, we would expect the green color to be found on only one lead. Another cooker constructed in this way allowed current to flow for only 1 day. Then next morning it mysteriously did not work, after working perfectly the night before.

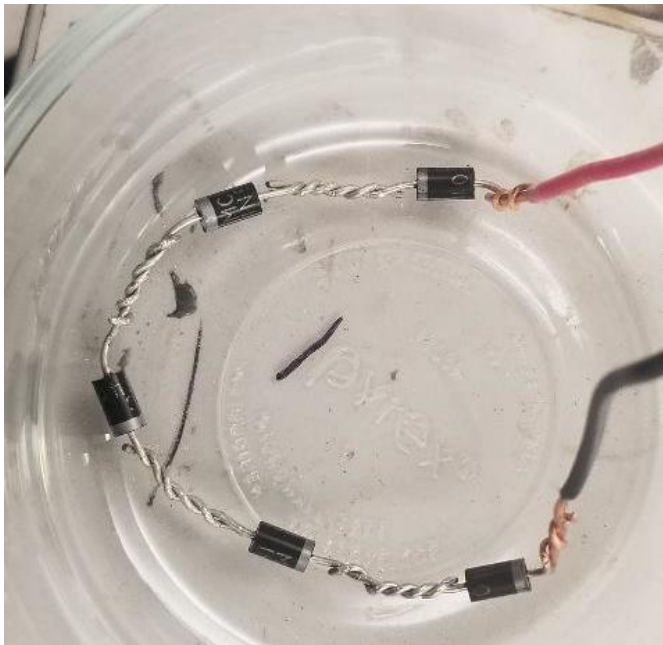
Figure 2: Bath 1 before adding erythritol.

Erythritol Bath 1 (see Figure 2): Applied current of 6A. Diode chain composed of single stranded copper leads connection to sanded copper diode leads on each end, then 5 tin (nonsanded) diodes for the middle of the chain. **We suspected corrosion to occur here, but suspected it might not cause a loss of electrical connection.**

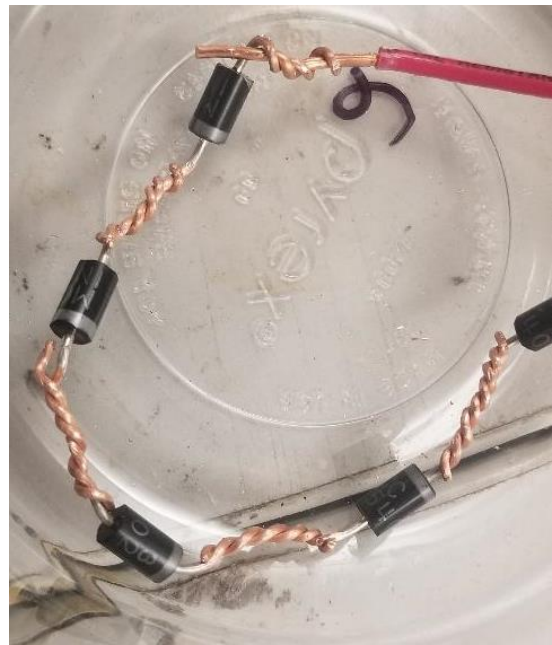
Figure 3. Bath 2 before adding erythritol

Erythritol Bath 2 (see Figure 3): Applied current of 6A. Single stranded copper leads, 5 diodes with sanded copper leads. **We suspected no corrosion to occur here.**

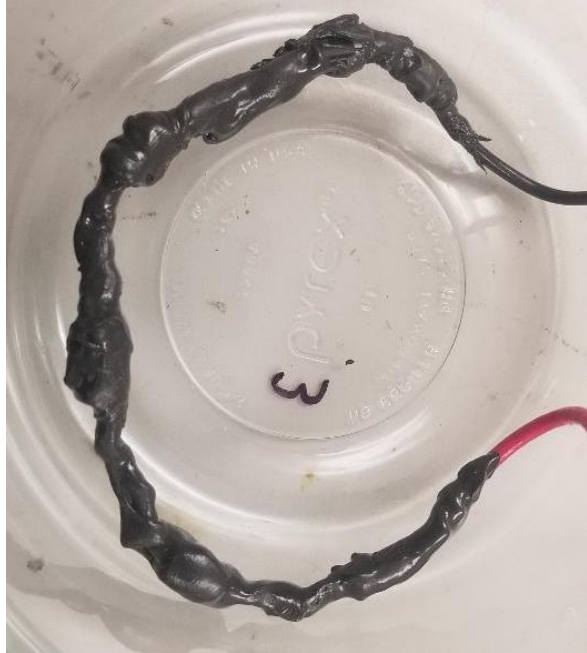
Figure 4. Bath 3 before adding erythritol.

Erythritol Bath 3 (see Figure 4): Applied current of 6A. Single stranded copper leads, tin diode leads, with the whole chain coated in JBweld. **We suspected no corrosion to occur here.**

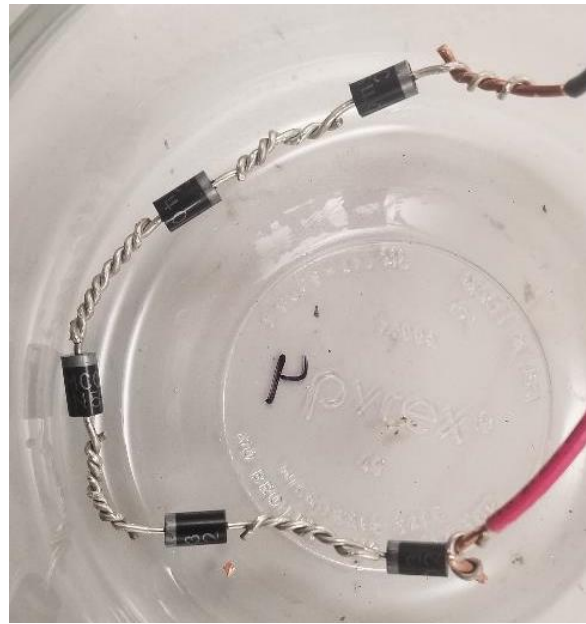
Figure 5. Bath 4 before adding erythritol.

Erythritol Bath 4 (see Figure 5): Applied current of 6A. Single stranded copper leads, tin diode leads, no JBweld coating. **We suspected corrosion to occur quickly here.**

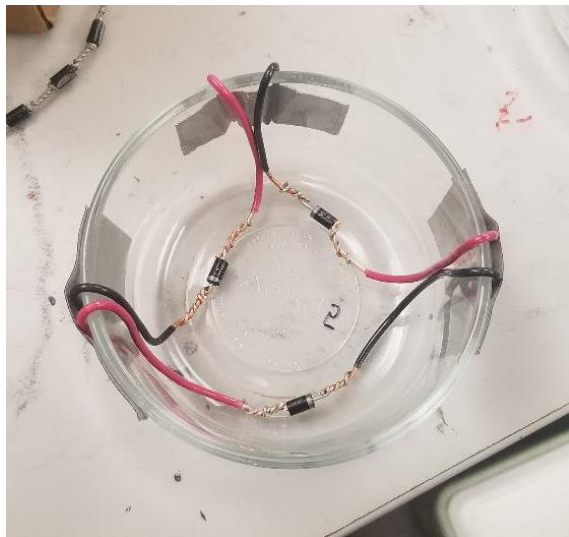
Figure 6. Bath 5 before adding erythritol.

Erythritol Bath 5 (see Figure 6): There was no voltage or current applied. 3 items were placed in this bath: A single stranded copper wire and tin diode lead twisted directly together, a single stranded copper wire and sanded copper diode lead twisted directly together, a single stranded copper wire and tin diode lead twisted directly together and coated with JB weld. These three items never physically touched but were in the same bath of erythritol. **We suspected corrosion to occur on copper and tin twisted together without JBweld.**

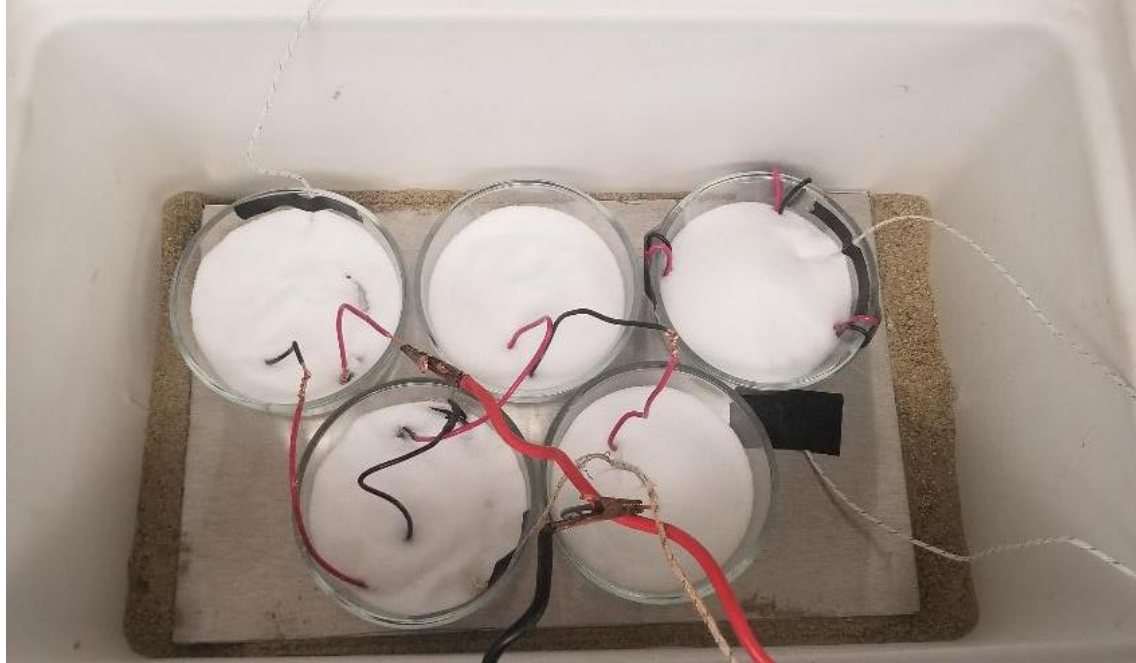
Figure 7. The cooler consisting of all baths filled with erythritol.

Bath 5 was placed inside of the styrofoam cooler containing baths 1-4 and it heat at nearly the same rate. All bath temperatures were monitored by placing a thermocouple in the erythritol. They melted at nearly the same rate (all within half an hour of each other, bath 5 melting last) and reached nearly the same temperature (bath 5 about 10°C cooler than the rest). A thermal switch was glued onto a single aluminum plate that was underneath of all baths. Sand filled the bottom of the cooler to prevent fires.

- After running the above experiment for about 2 hours, the circuit opened. As shown in Figure 7, the erythritol was in powder form. When it melts for the first time it will drop to the bottom of the bath and leave a cavity of un-melted erythritol around the diodes, insulating them. A few diodes were damaged, so I rebuilt all 4 chains and refilled each bath with 250g of erythritol before restarting the experiment. When I did restart it, I agitated the erythritol by hand, so it was always in contact with the diodes.

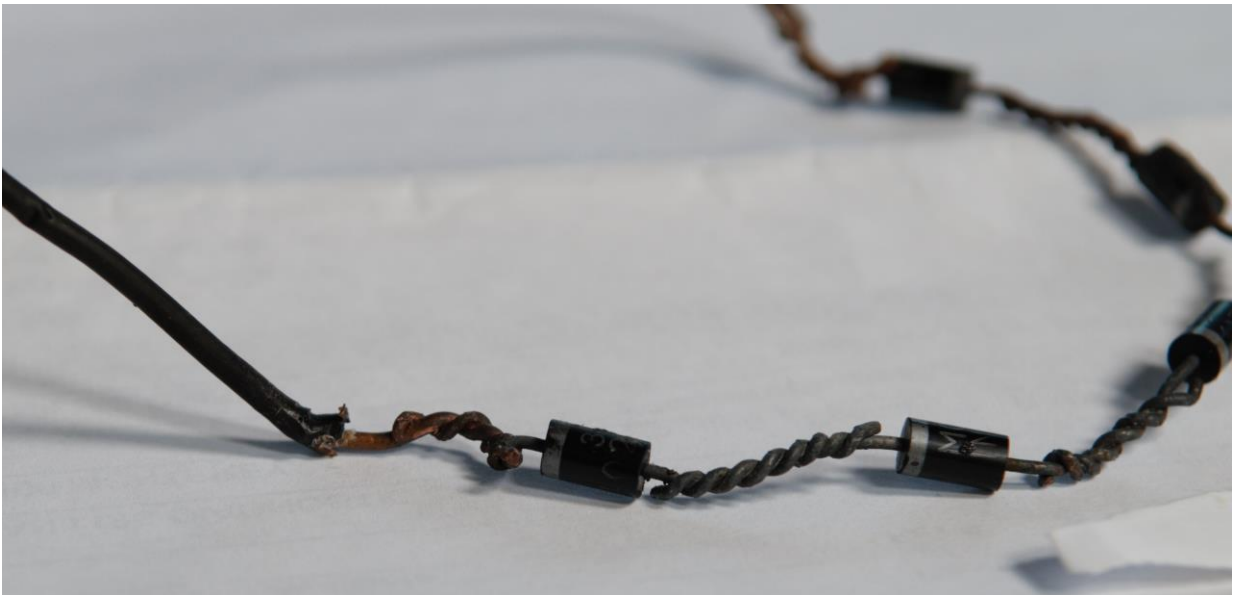
Figure 8: Negative end of chain from bath 1. This chain had been sanded at only the most positive and negative connections between the diodes and lead wires.

- Bath 1 (Figures 8-10): The chain with sanded copper leads on the most positive and negative connections only (not sanded, tin diode to diode connections) from bath 1 has a visible black coating which is thicker on the negative half of the chain (first 3 connections) than the positive half (last 3 connections). It allows current to pass, but as previously stated, needs to be held in a certain position from time to time, and has loose connections. It was also taken apart, cleaned with sandpaper, and put back together twice during the experiment. When preparing this chain, the tin was sanded by hand and there was still a small amount of tin near the diode body on the most positive and negative diode to lead connections (as well as tin covering each diode to diode connection). This small amount of tin near the diode body is still visible on the most negative diode to lead connection (Figure 8) but has corroded away on the most positive diode to lead connection (Figure 10). The tin is completely corroded away from the most positive diode to diode connection (Figure 10) and is completely intact on the most negative diode to diode connection (Figure 8). Both connections in between have some tin left but not all (Figure 9). This confirms our mental model of electrolysis as the anode (positive lead) has corroded away while the cathode (negative lead) has stayed intact.

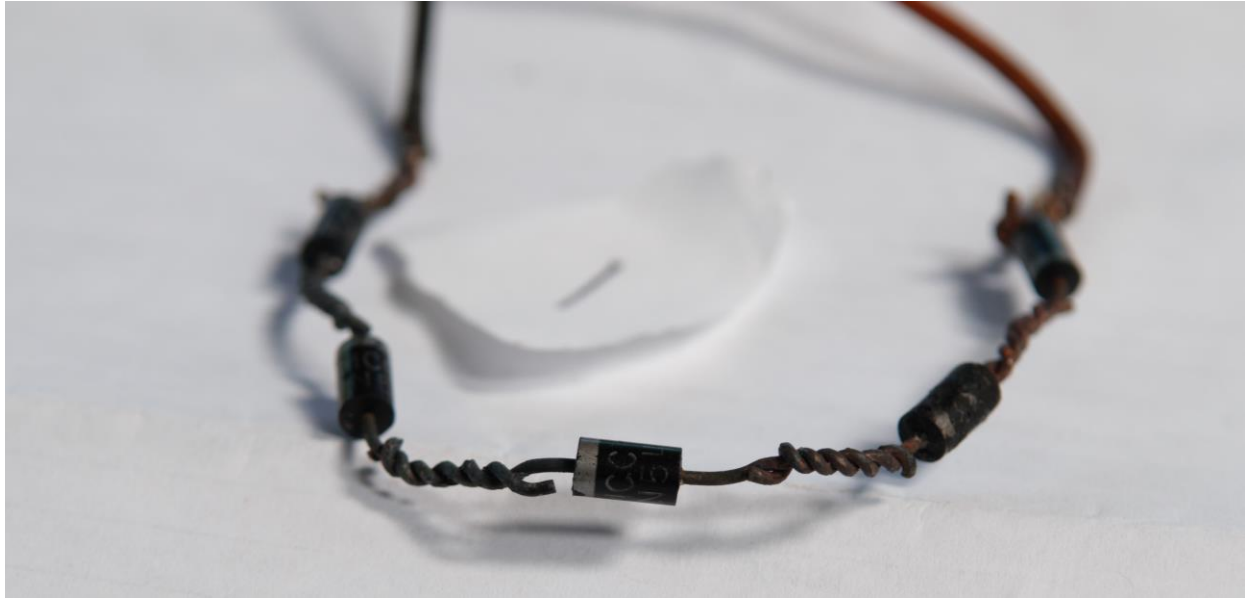
Figure 9: Middle of chain from bath 1.

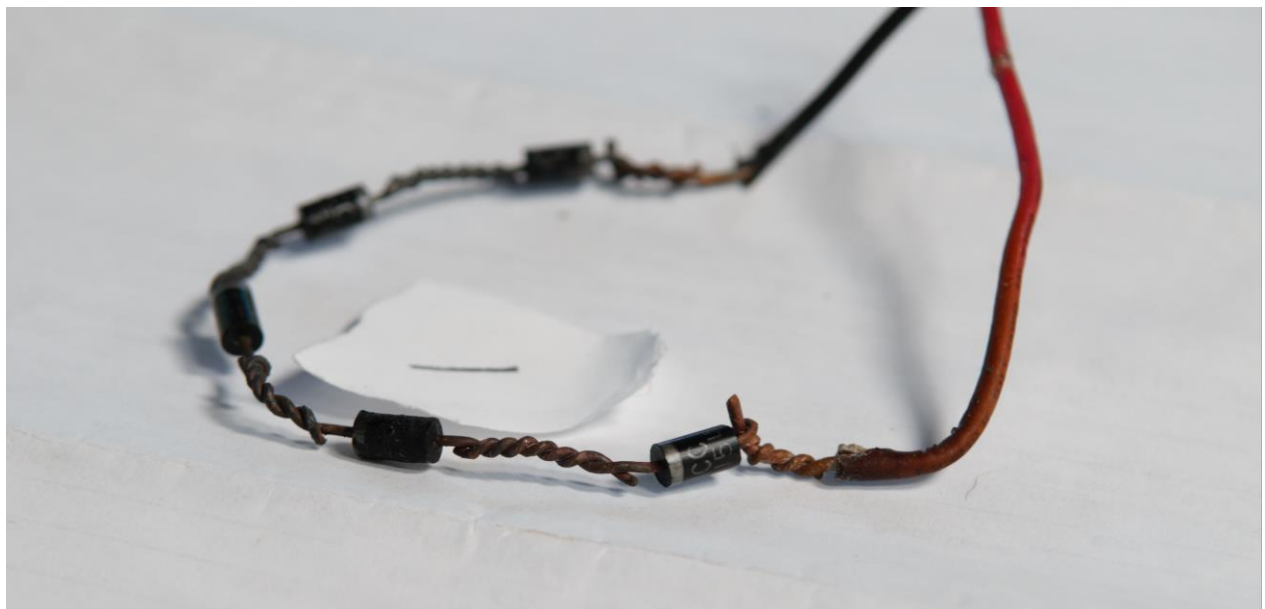
Figure 10: Positive end of chain from bath 1.

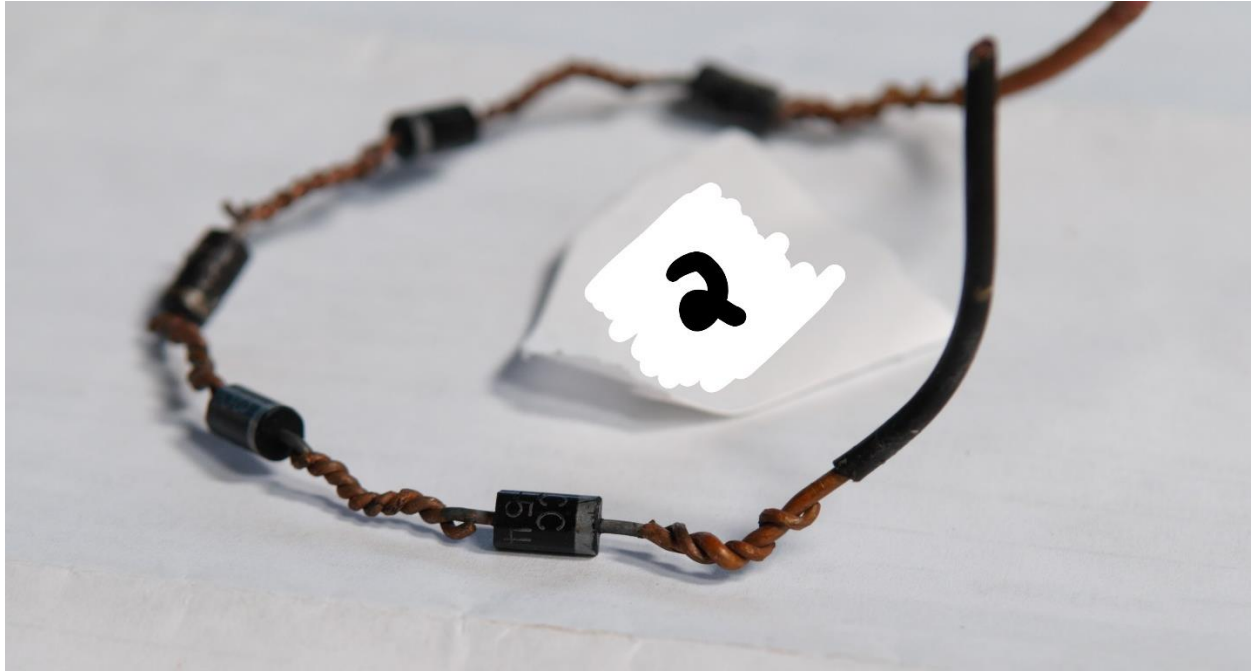
Figure 11. Negative end of chain from bath 2. This chain had all connections sanded to remove tin.

- Bath 2 (Figures 11-13): The chain with all leads sanded from bath 2 experienced a medium amount of corrosion. There is a black coating on portions of the leads between diodes. It is not a heavy layer. This black coating is assumed to be tin deposition and is attributed to the tin that is left behind when sanding by hand is not done perfectly. The connections are not loose.

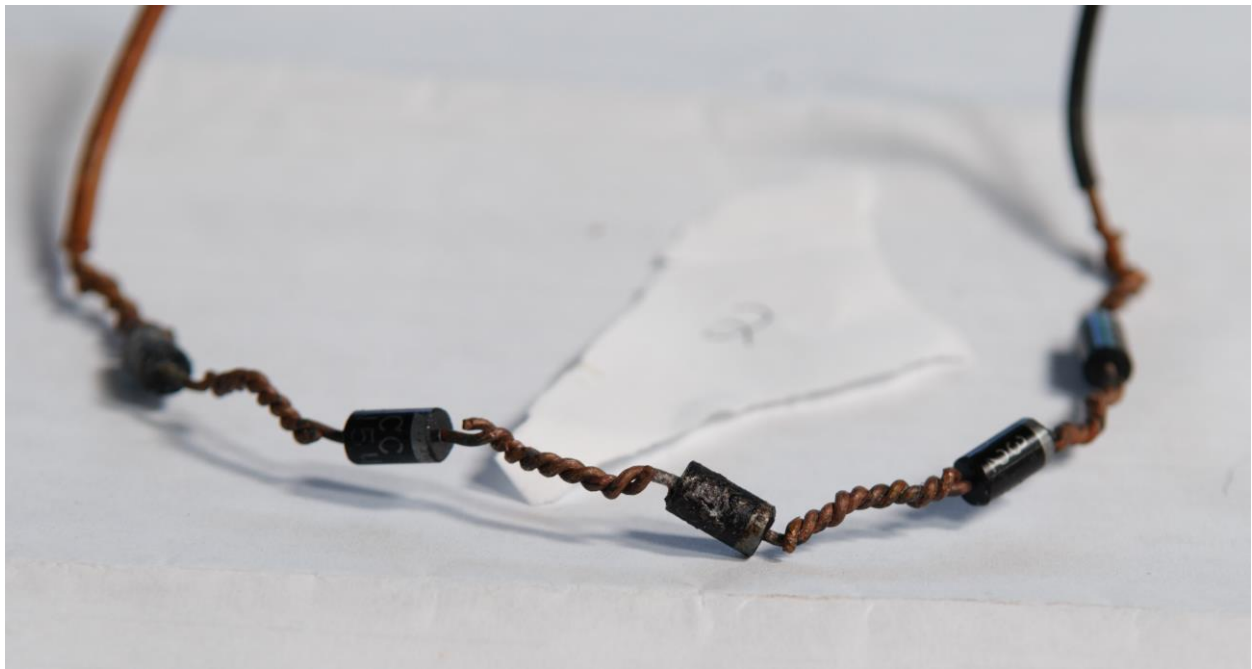
Figure 12: Middle of chain from bath 2.

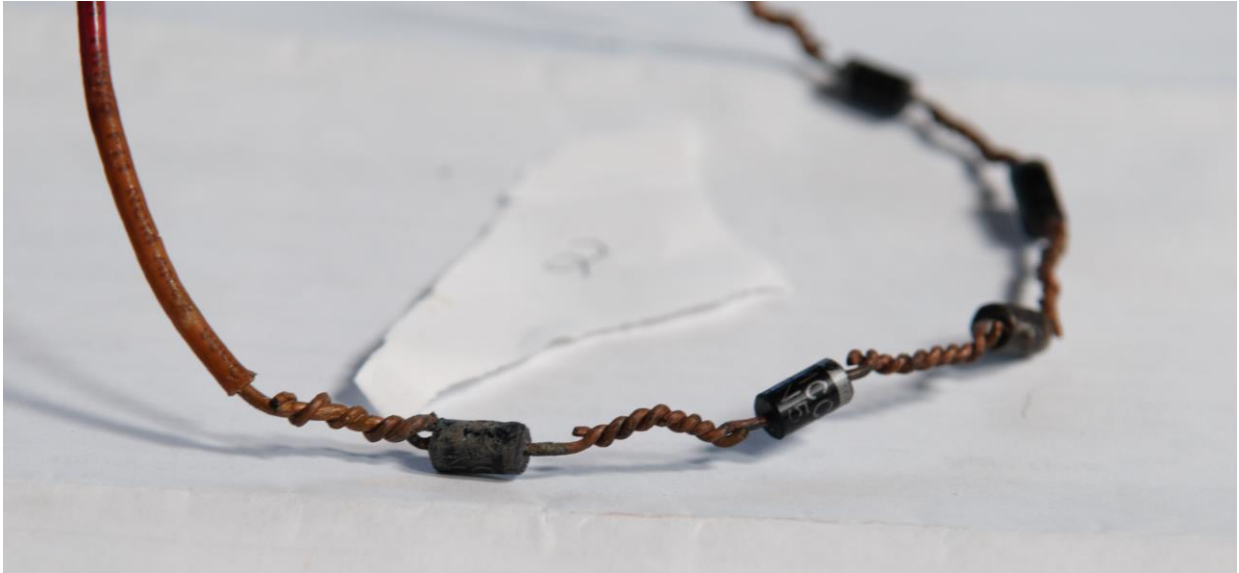
Figure 13: Positive end of chain from bath 2.

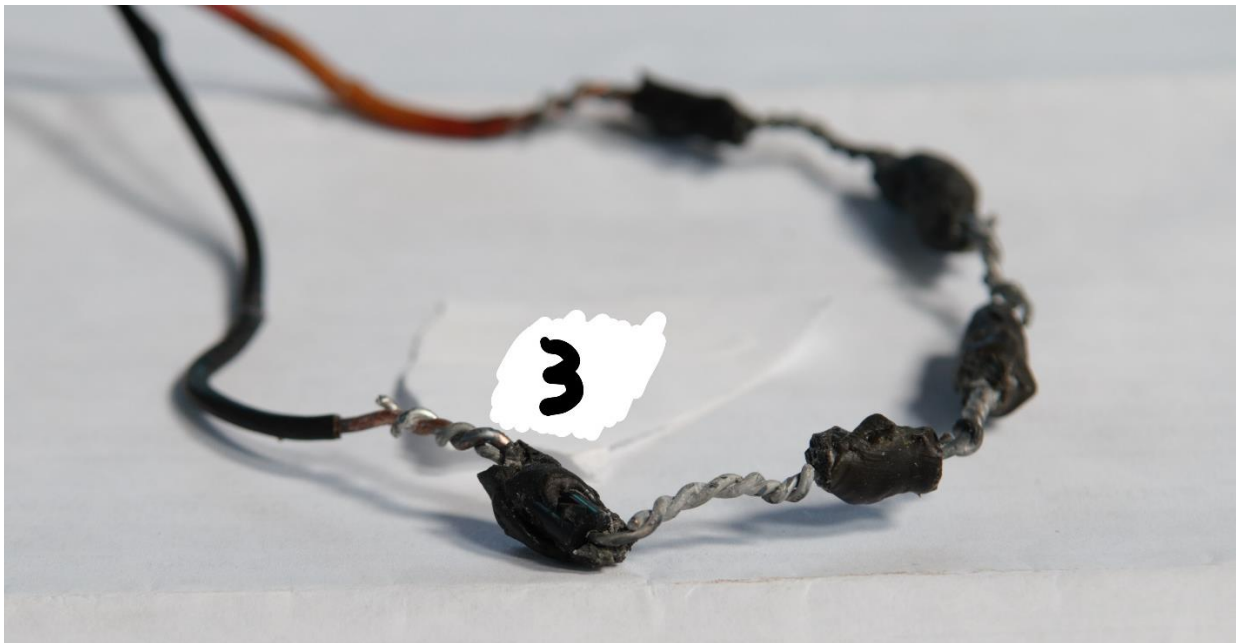
Figure 14: Negative end of chain from bath 3. This chain was coated fully in JB weld and no connections were sanded.

- Bath 3 (Figures 14-16): The JB weld coated chain from bath 3 experienced no visible corrosion and still allows current to pass through normally.
- Bath 4 (Figures 17-18) The chain from bath 4 with unmodified diode leads experienced little corrosion and looks much like it did before the experiment. There is a small amount of black coating on some of the diode leads, and it appears that some of the tin deposited on the most negative connection of that chain, where the diode lead connects to the copper lead. The positive copper lead wire is still copper colored while the negative copper lead wire is tin colored and will not come clean from a light sanding which usually cleans the black coating. The connections are not loose. NOTE: The broken diode in the middle of the chain did not break during the experiment. After the experiment was over, all baths were placed in an oven to melt

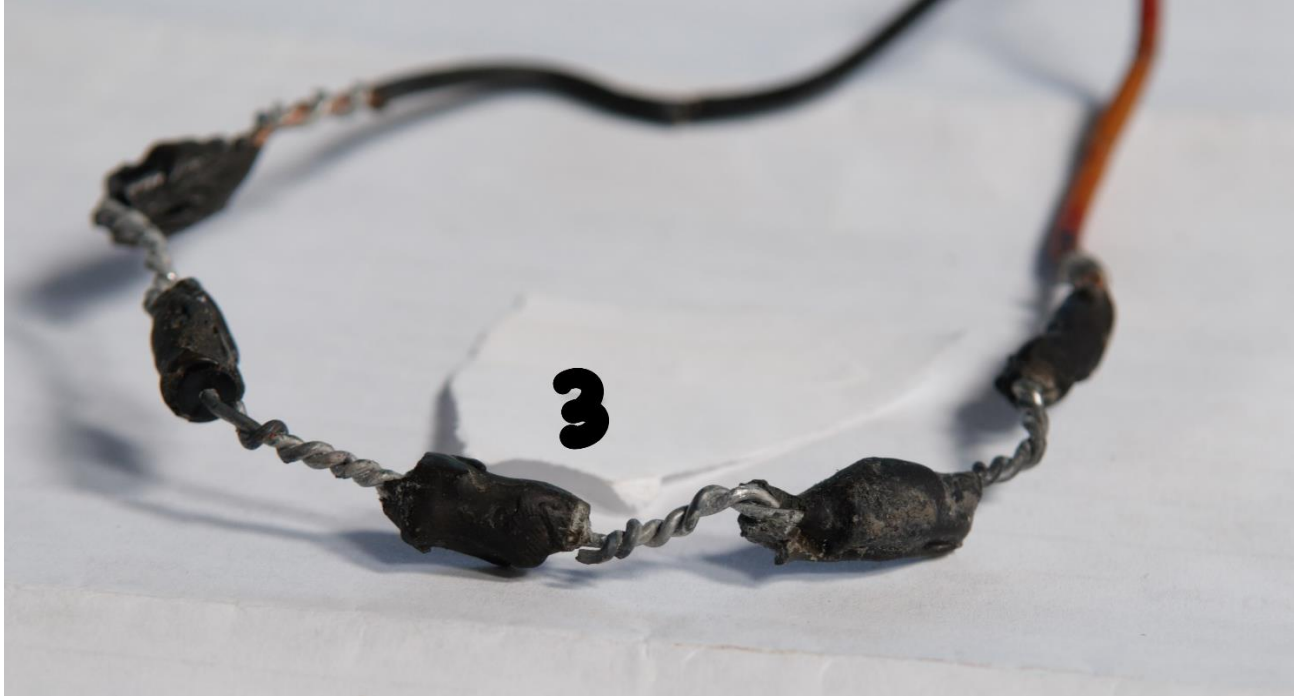
Figure 15: Middle of chain from bath 3.

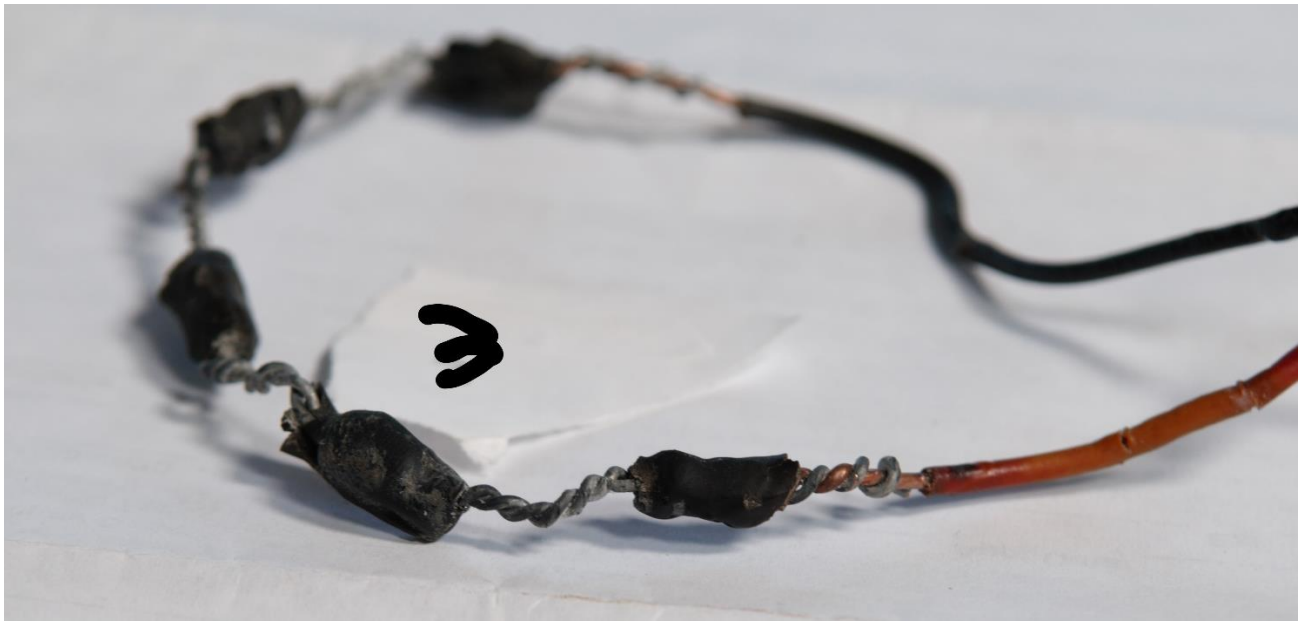
Figure 16: Positive end of chain from bath 3.

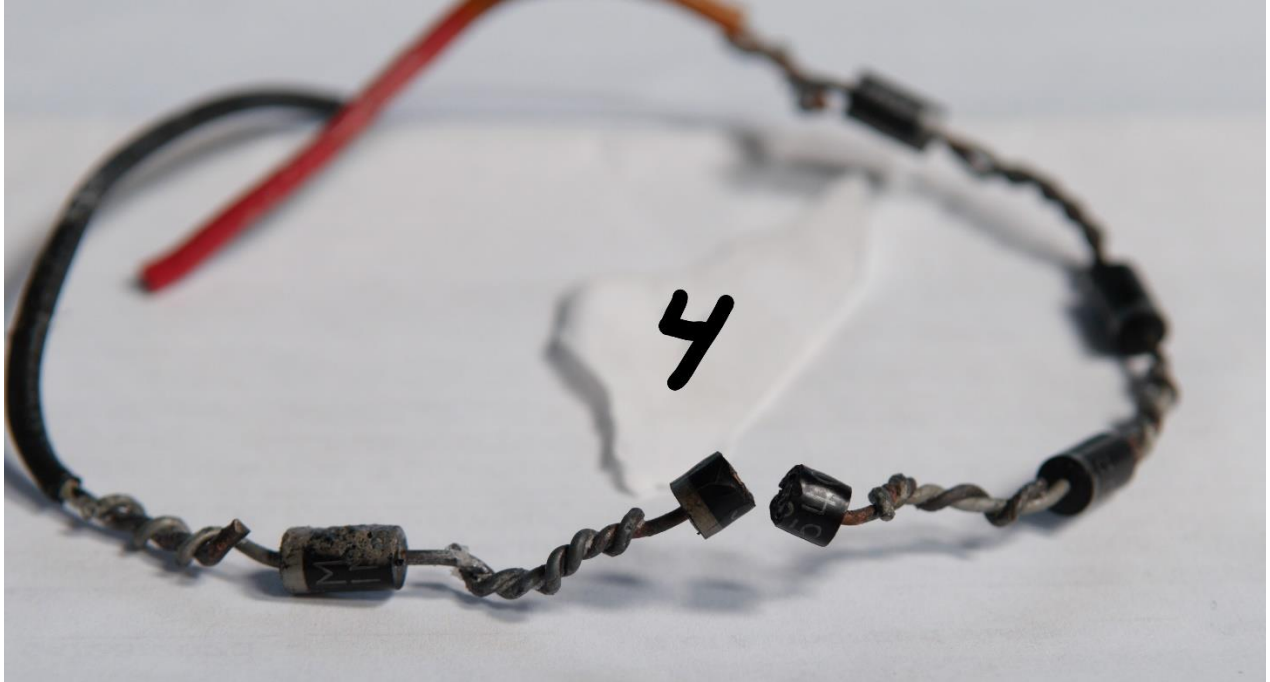
Figure 17: Negative end and middle of chain from bath 4. This chain was made with regular (not sanded) tin coated diode leads and copper lead wires.

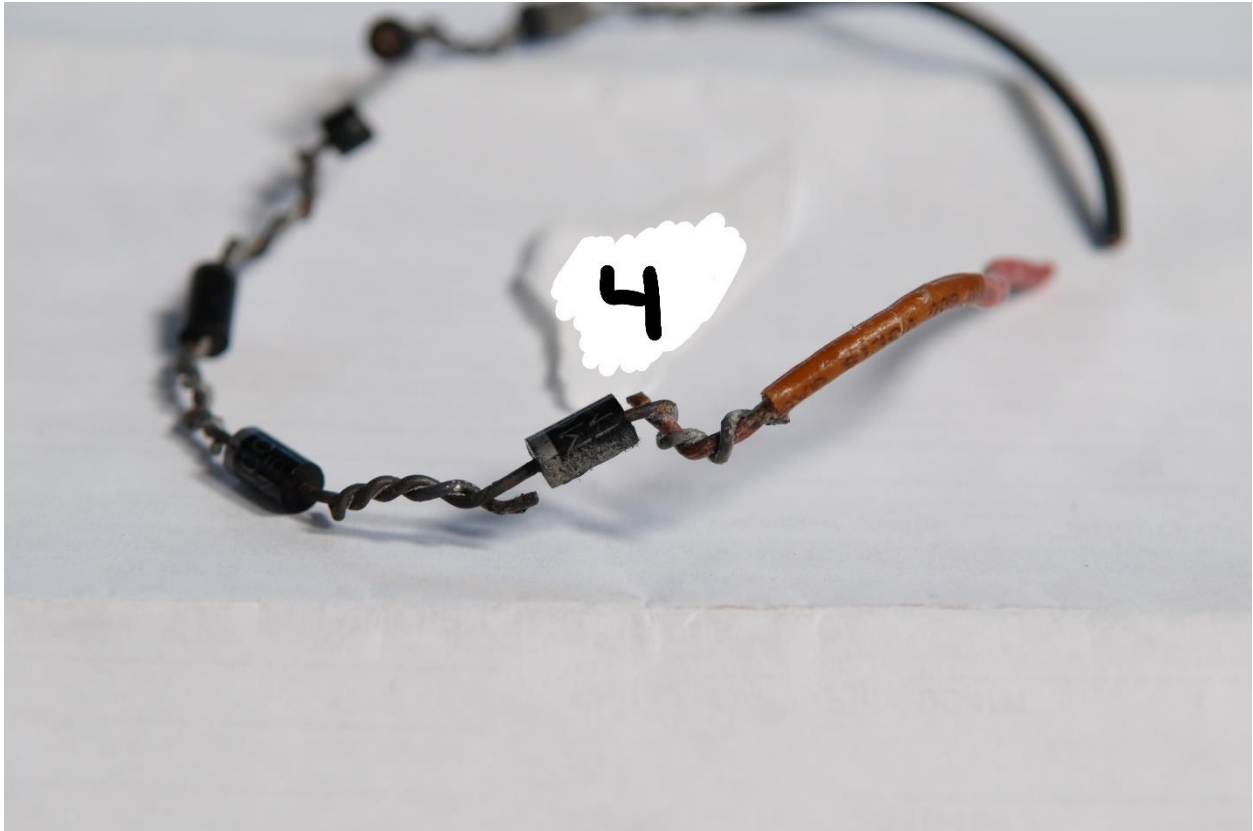
Figure 18: Positive end of chain from bath 4.

the erythritol to remove the chains from their baths. Baths 4 and 5 were left in the oven the longest, potentially reaching 240 °C but not reaching a temperature high enough to have broken the diodes. The diode broke upon removing it from its bath with great force, because it had been taped to the bottom of the bath with gorilla tape.

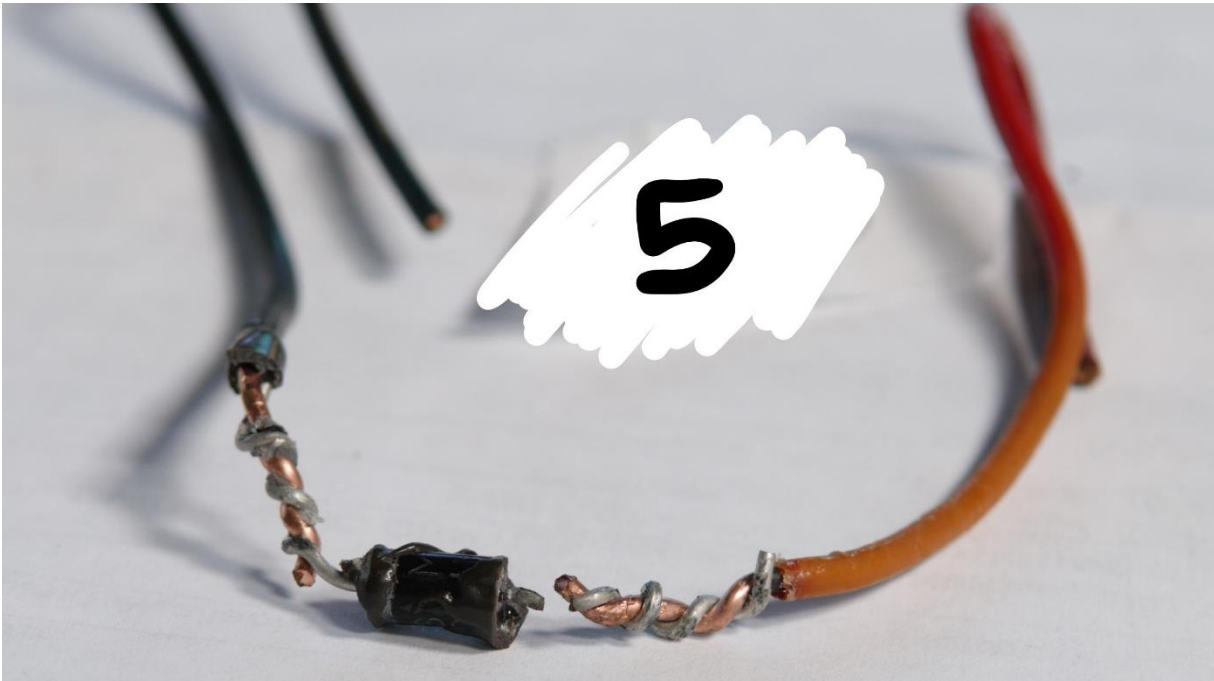
Figure 19: JB weld coated diode from bath 5. Diode lead was broken **after** the experiment.

- Bath 5 (Figures 19-21) the sanded and un-sanded diode (Figures 20 and 21, respectively) both have the same very small amount of black coating on portions of the leads. The JB weld coated diode (Figure 19) experienced no corrosion and looks pristine. NOTE: The broken lead in Figure 19 did not break during the experiment. After the experiment was over, all baths were placed in an oven to melt the erythritol to remove the chains from their baths. Baths 4 and 5 were left in the oven the longest, potentially reaching 240 °C but not reaching a temperature high enough to have broken the wires. The lead broke upon removing it from its bath with great force, because it had been taped to the side of the bath with gorilla tape.

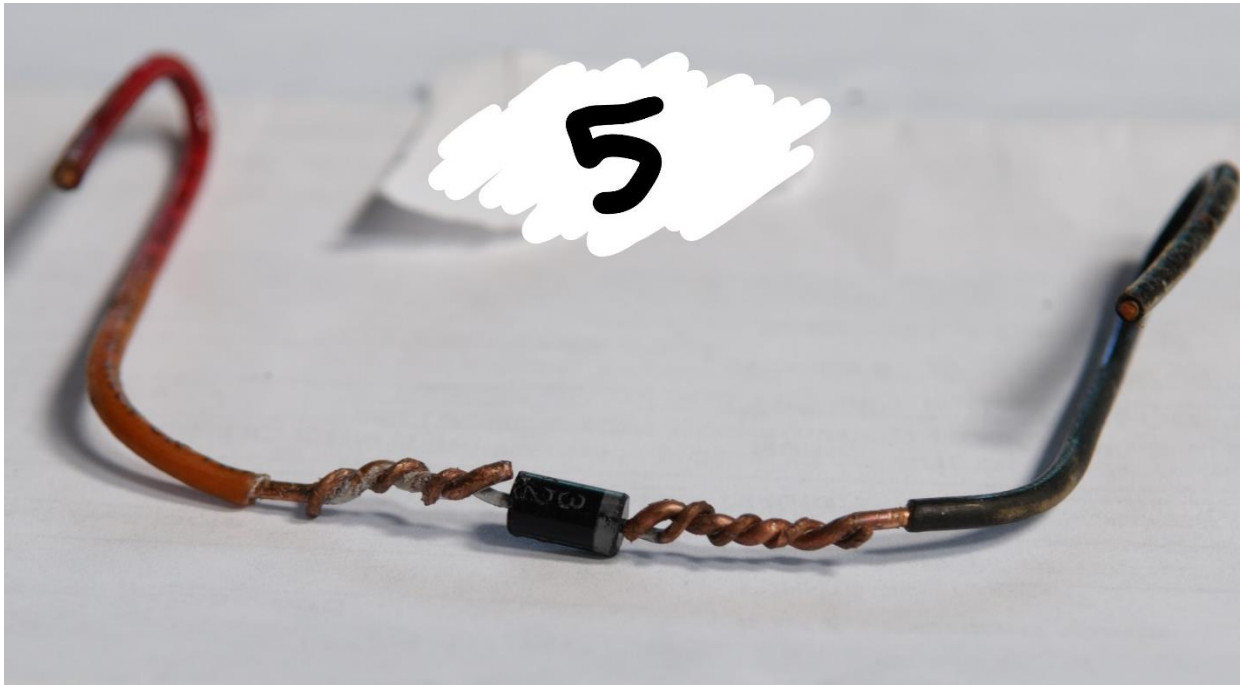
Figure 20: Diode with sanded leads from bath 5.

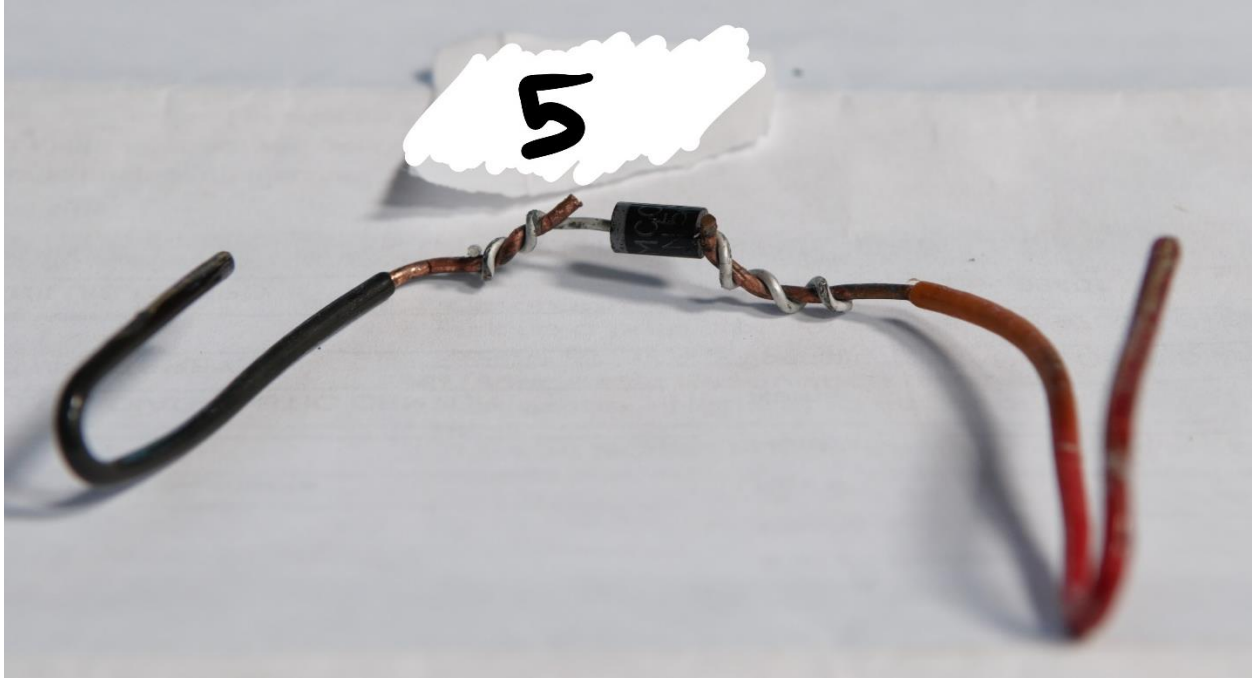
Figure 21: Diode with leads left not sanded (tin coated) from bath 5.
