# Cultural Heritage of a Three Centuries Old Wooden Church

*Patricia Săsăran, Ancuța Țenter and Lorelay-Diana Jianu*

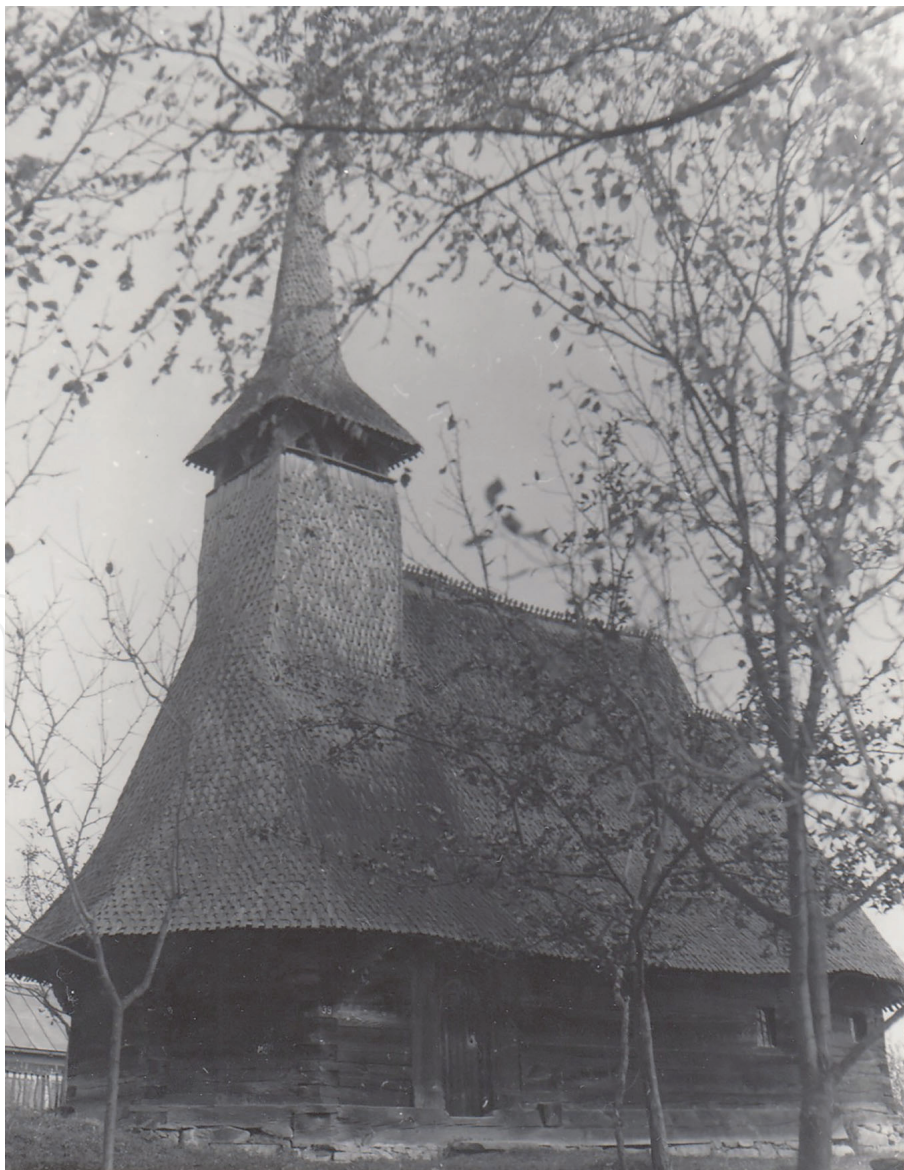
**Figure 1.**  
*Holy Archangels Church, Drăghia.*

The village is remarked by the presence of a wooden church (**Figure 1**) built in 1706, as testified to this day by the Latin inscription found left of the entrance: *Anno 1706 D. 14 obrys*. It is under the patronage of the Holy Archangels Michael and Gabriel, and today, it is part of the Lăpuș Deanery, belonging to the Orthodox Episcopate of Maramureș and Sătmar. It is made of oak wood, harvested from the oak forest found higher up from the church, and was paid for using donations from the villagers.

The church is 12.40 m long, 4.45 m wide, 7.50 m high at the ridge and 15.50 m high at the tower's spire. The base and the walls are all made of oak beams placed on a dry-laid stone foundation [6].

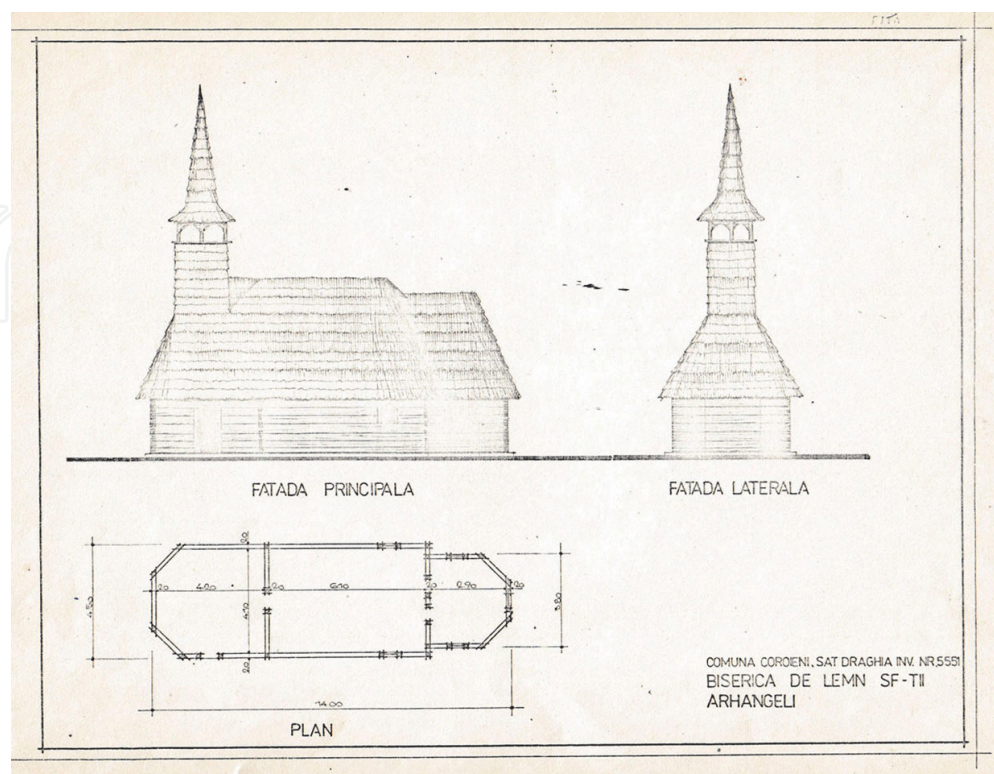
**Figure 2.**  
*The building plan of the Holy Archangels Church, Drăghia.*

The building plan (**Figure 2**) [7] is found throughout the area, the church being divided into a narthex, nave and altar. The narthex has a polygonal shape, covered with a straight ceiling, above which the bell tower is situated. The ceiling is painted with cherubs, and the walls are painted with images of the Myrrhbearers and of wise and foolish virgins from the Gospel of Mathew. The narthex was where the women would attend the mass [8].

The nave is rectangular, with a dome, and is separated from the narthex by a wall with an opening and a door. The door is painted with two saints and, in the lower part, the tree of life in a pot. The door frame is engraved with symbols such as

the six-petaled rosette, honeycomb and wolf's teeth. The opening is fitted with small turned columns of various forms that were painted white [9]. Between the nave and the altar is the iconostasis. The altar is in a domed polygonal apse.

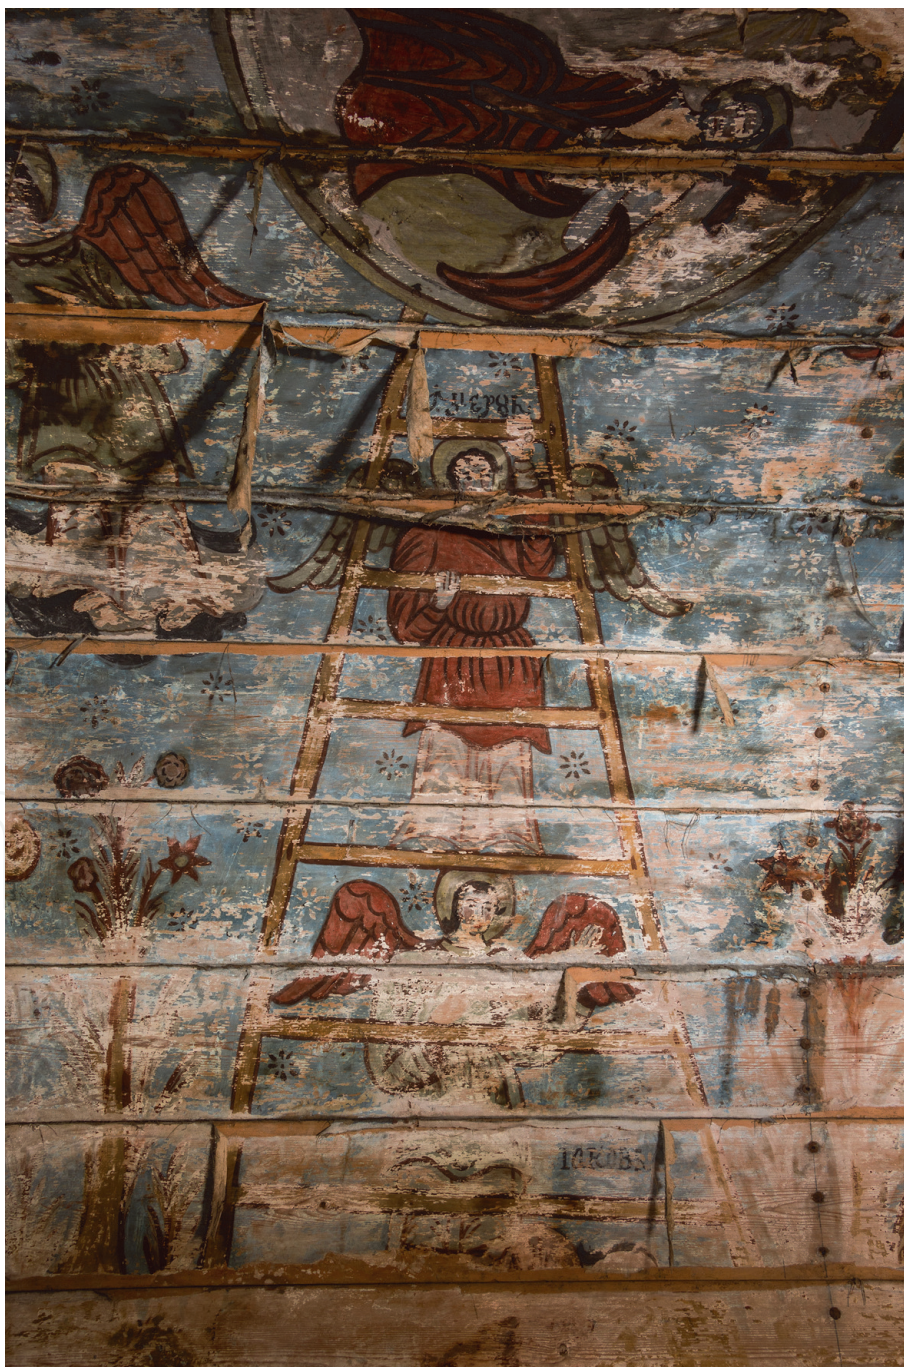
**Figure 3.**  
*Painting of angels climbing Jacob's ladder.*

The painting is tempera on canvas and wood and covers the entirety of the church interior. In order to make a continuous painting medium, the painters applied bands of hemp canvas stuck with animal glue to the gaps between the beams and planks. In the altar there is a part of the wall that is entirely covered with canvas, not just the gaps.

The painting in the nave is badly damaged, many scenes being unrecognisable, with only some spots of colour left. Among the visible images, there are Jacob's ladder (Figure 3), the Holy Trinity, Elijah riding to the heavens in his fire chariot

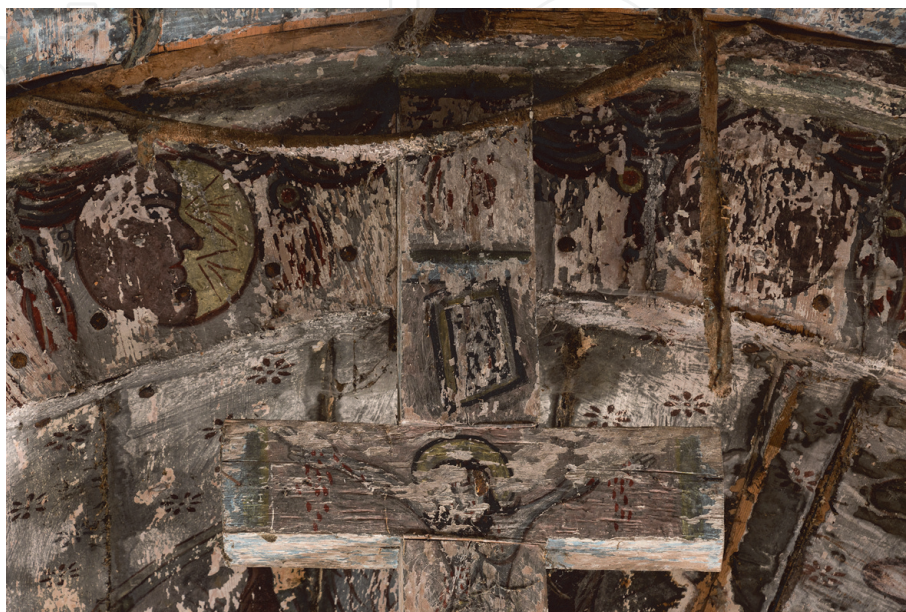
**Figure 4.**  
*Detached canvas strips.*

The partial detachment of the canvas strips (**Figure 4**), stuck to cover the gaps between the planks, led to the exfoliation and loss of the paint layer found on them. Numerous bands detached completely of the support and led to the permanent loss of the paint layer. Furthermore, there are hints of a moderate xylophagous attack that affected the support and led to small losses of paint layers. In some places one can see flight holes caused by xylophagous insects.

and the four Evangelists. The paintings on the iconostasis, being sheltered, are entirely recognisable. The Twelve Apostles are depicted with Jesus as a High Priest in their middle, and at the top of the iconostasis, there is a wooden cross painted with Jesus crucified. Above the iconostasis there is a semicircular opening on the frame, of which there are painted portraits of the six prophets from the Old Testament, while on the other side of the cross, the sun and the moon are painted (**Figure 4**).

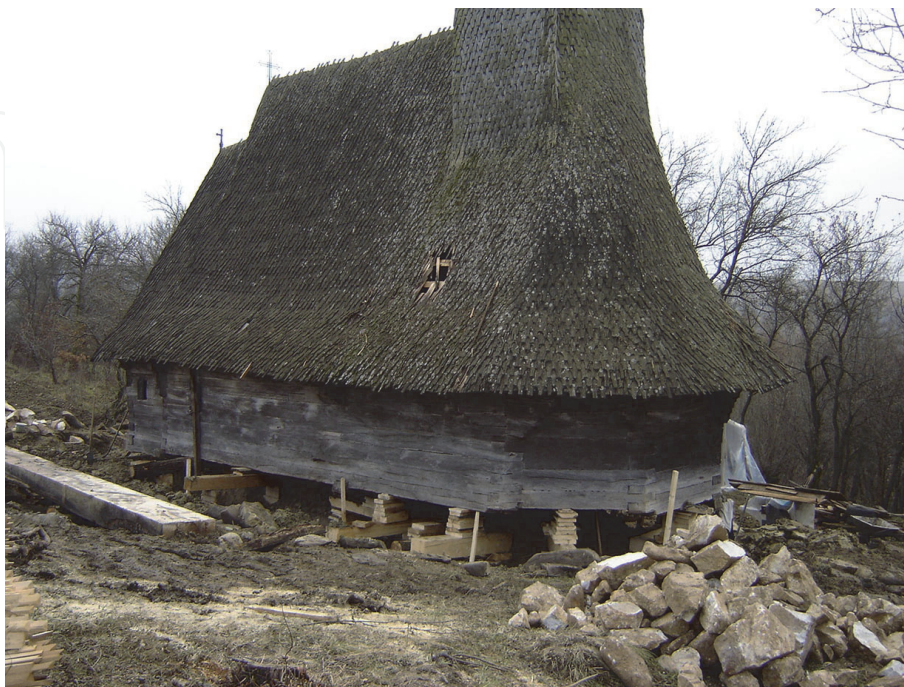
**Figure 5.**  
*The lifting of the church.*

The restoration and consolidation work required numerous interventions. Since the church interior was painted, a protective tent was needed to protect it during the works. The entire roof framework was removed, since it was badly damaged, leaving only the frame of the tower. Then, the entire church was lifted (**Figure 5**), using a jack and wedges, to a height that permitted the foundation work to be carried out.

Once lifted, the existing stone foundation was dismantled, and a new foundation made of reinforced concrete was poured on the entire base of the church, as well as two crossbeams that would sustain the dividing walls between the three rooms. The stone foundation was rebuilt over the concrete one, keeping the old architecture. The wooden base was replaced with oak beams that were treated to protect them from rot and fire. Some of the beams were dismantled and either restored or replaced. The building was placed on the new base and the new foundation, and then the new roof framework was built. A scaffold was built in order for the workers and materials to easily reach the roof. The old wooden shingle covering was badly damaged by the weather and had many holes made by green woodpeckers, so it had to be replaced, and the birds' access to the tower was hindered using fine-mesh netting. The cross from the tip of the tower was restored as well and placed back in its place. The finishing work was also performed, on the floors and woodwork. The work ended with the installation of the lightning rod.

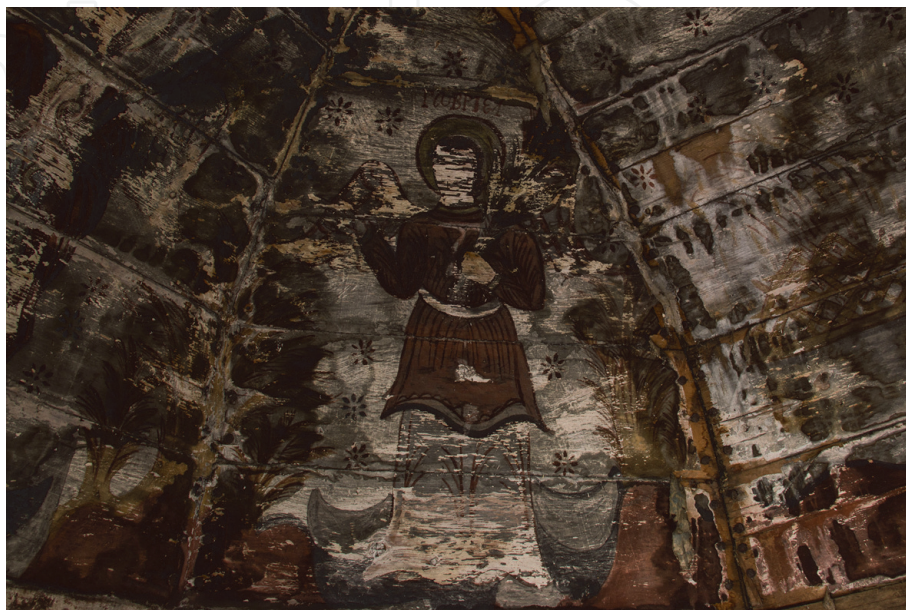
**Figure 6.**  
*The sequence in the ceiling.*

Unfortunately the funds were exhausted; the mural painting had no chance to be restored. The age of the church and the current climatic conditions lead to an advanced degradation of the painting from the interior of the wooden church (**Figures 6 and 7**).

consequence of rainwater seeping in, the wood and the painting on it were badly damaged. Another cause of damage were the temperature fluctuations between night and day, which led to volumetric changes of the wooden structure that resulted in the chipping and fissure of the paint layer, leading to a complete loss of painting in some large areas. This phenomenon is particularly intense on the southern side of the church, which receives more sunlight during the day than the other sides.

Following the degradation of the binder and the volumetric changes suffered by the wooden support under moisture gain and loss, the paint layer lost its adhesion to the wood, leading to chipping. Significant losses of paint layer are ascertained, even all the way to the wooden support, caused by dusting or involuntary rubbing and hitting on the surface. For example, the areas that were protected by the pews of the cantors hold more paint than those next to them. Still, these areas and the iconostasis have more damage caused by the metal nails driven in the wood.
