Bailey, D.A. (2005) The effect of damage on the energy absorption potential of composite structures. PhD thesis, University of Nottingham.

*The Effect of Damage on the Energy Absorption
Potential of Composite Structures*

Thesis submitted to the University of Nottingham
for the degree of Doctor of Philosophy
June 2005

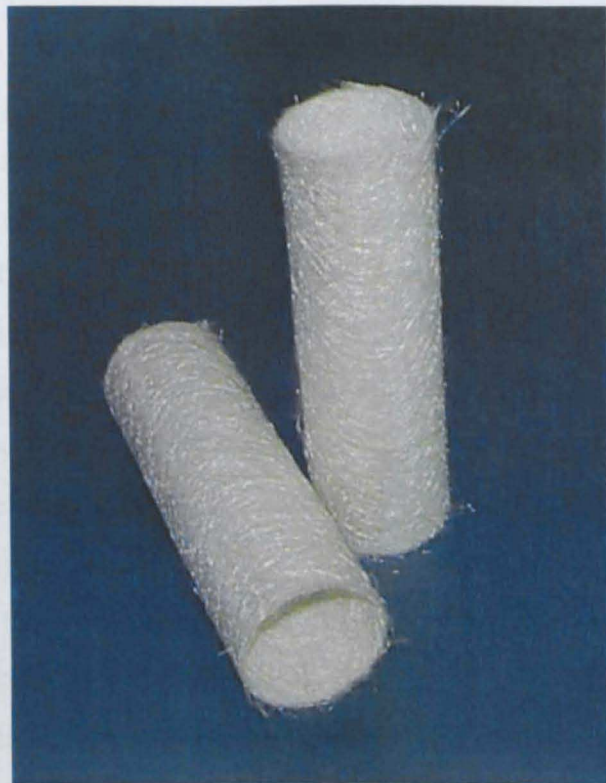
Figure 3-4 – Preforms (from Duckett [5])

The preforming process followed a pressurised roller technique developed by Corden [1]. The mat was cut into 300mm tapes ready to be preformed. These pieces were initially taped to an aluminium mandrel, which was supported in a Pultrex filament-winding machine. Attached to the machine was a pressurised roller and this compacted the fibres as they were rolled. A hot air gun was used during rolling and this melted the binder, allowing the layers to bond together as they were rolled. After six layers had been rolled onto the mandrel the preform was slid off ready for moulding. Preforms were then trimmed to 250mm in length, removing the starter tape. Figure 3-3 shows the filament winding machine, mandrel and roller and a completed preform is shown in Figure 3-4.

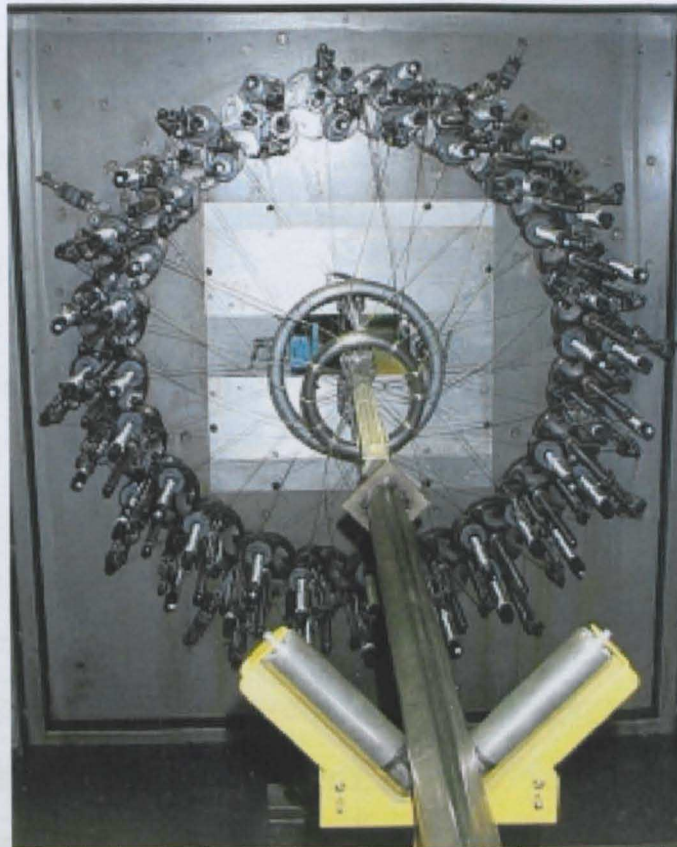
Figure 3-6 – The braiding of the 38.1mm diameter small braided tubes

The braiding took place directly on the inner mandrel of the small tube mould, after coating with Chemlease PMR-90 mould release. The braiding machine had 48 bobbins loaded with the glass tows and the mandrel attached to it. A $\pm 45^\circ$ braid was used and 6 layers were applied to the mandrel. Figure 3-6 shows the braiding machine with the mandrel attached during the process.

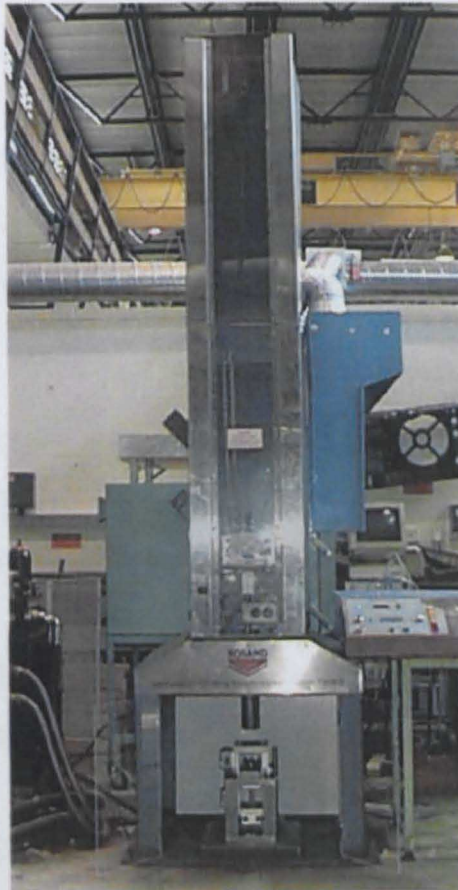
Figure 3-16 - Rosand falling weight impact test machine

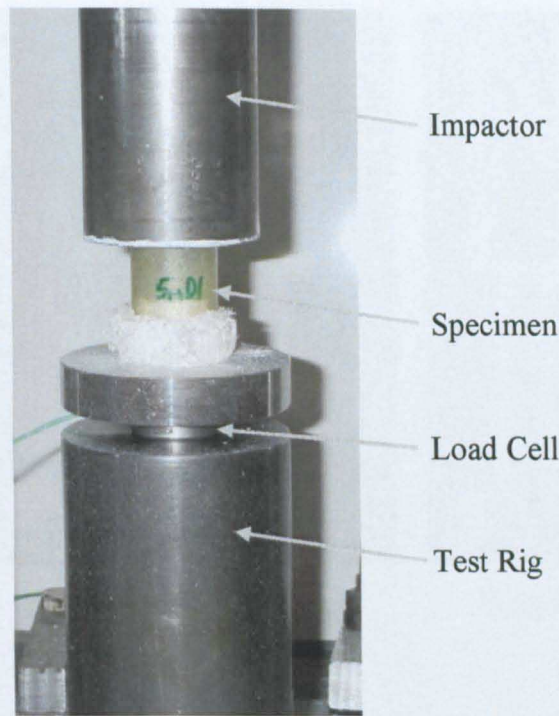
Figure 3-17 – Dynamic tube test rig

Dynamic tests were carried out on a Rosand IFW5 falling weight impact test machine (see Figure 3-16). The effective impactor mass was 44.65kg (without a specimen). Samples were bonded directly onto the impactor using cyanoacrylate. The fixture used for these tube tests is shown in Figure 3-17. The load data were acquired using a Kistler 9051A piezoelectric load cell with a measuring range of 0-120kN. The load cell was connected to a PC via a PCI based instruNET 100 and iNET 200 data acquisition system at a sample rate of 40000 samples/sec. A nominal test speed of 5m/s was used and three samples of each damage type were crushed using specimens 80mm in length with 45° chamfers as triggers.

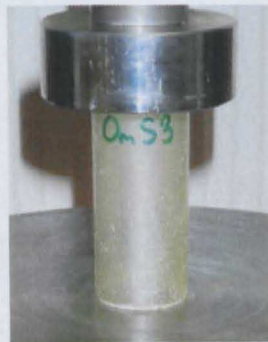
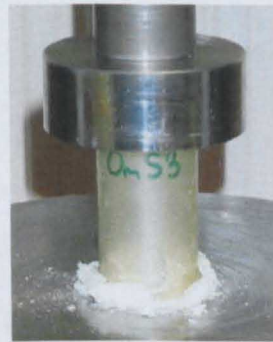
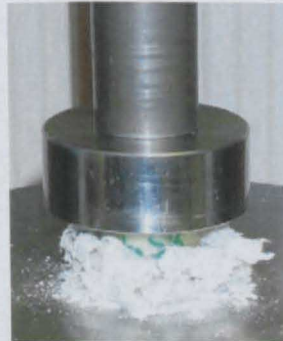
Figure 4-1 – Load-displacement curve of an undamaged small, 38.1mm diameter, 2mm wall thickness, CoFRM tube (sample 3) and images taken during testing at 5mm/min. An example of the stable failure mode (progressive crush).

Tubes failed by two main mechanisms, *stable* or *unstable* crushing. During stable crushing, tubes failed progressively and a steady crush load was reached and maintained throughout the test. In this case the splaying failure was observed as described in Chapter 2 [1]. Figure 4-1 shows an undamaged tube during crush and respective load-displacement trace and is an example of a stable crush. During the initial part of the crush, up to point 1 in the figure, the crush zone is being formed. At point 1 a debris wedge has been created and opens an axial crack in the wall of the tube. At point 2 a steady crush has been achieved and the geometry of the crush zone will remain unchanged throughout the test.

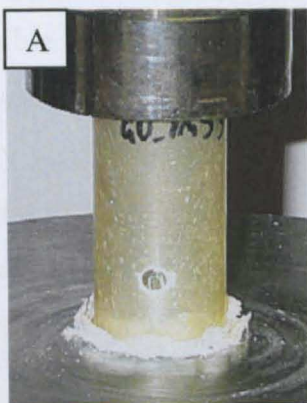
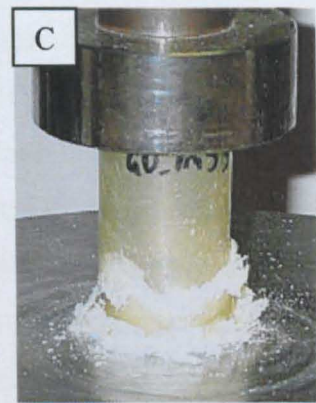
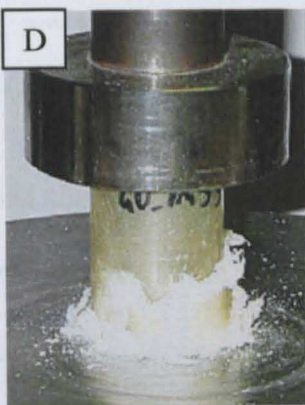
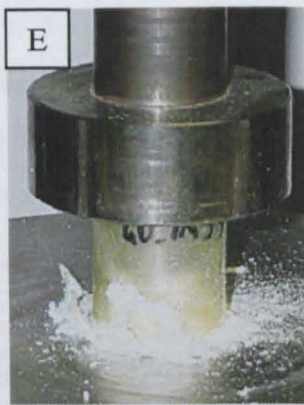
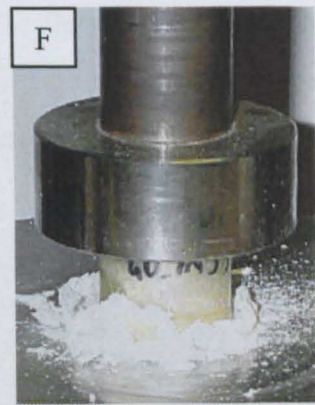
Figure 4-2 – Load-displacement curve of a Small, 38.1mm, 2mm wall thickness, CoFRM tube containing a 7.5mm hole centred at 30mm from the chamfer (sample 3) and images taken during testing at 5mm/min. An example of the unstable crush mode

Unstable crushing was seen in some of the damaged samples where the zone of damage caused a circumferential, through thickness fracture to form. Figure 4-2 shows a small CoFRM tube containing a 7.5mm hole during crush and respective load-displacement trace and is an example of an unstable crush. These fractures cause a reduction in energy absorption due to a reduction in crush load, but many samples recovered to a progressive crush after the damage zones had been passed. Figure 4-3 shows an image taken from a low magnification microscope of a part-tested small CoFRM tube containing a 10mm hole through section 2 (see section 3.6.4). This shows a cross-section of a tube that failed unstably with a crack developing around the tube. The crack can clearly be seen as a shear failure through the wall thickness of the tube. This failure reduces the load carried by the tube as only friction between the two sides of the crack is supporting the structure once it has developed. The failure mode, either stable or unstable, were identified for each test and shown in the results tables throughout this chapter.

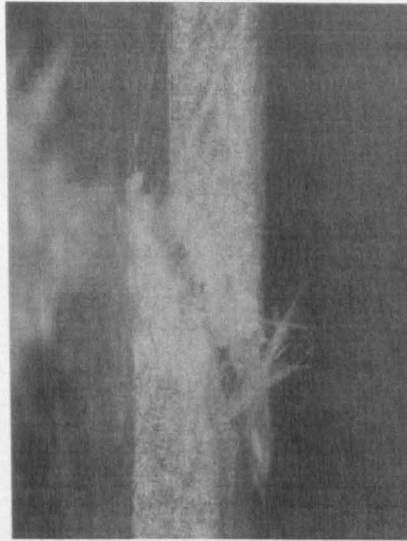
Figure 4-3 – Microscope images of a small CoFRM tube at section 2 through a part-tested specimen containing a 10mm hole (6 times magnification)

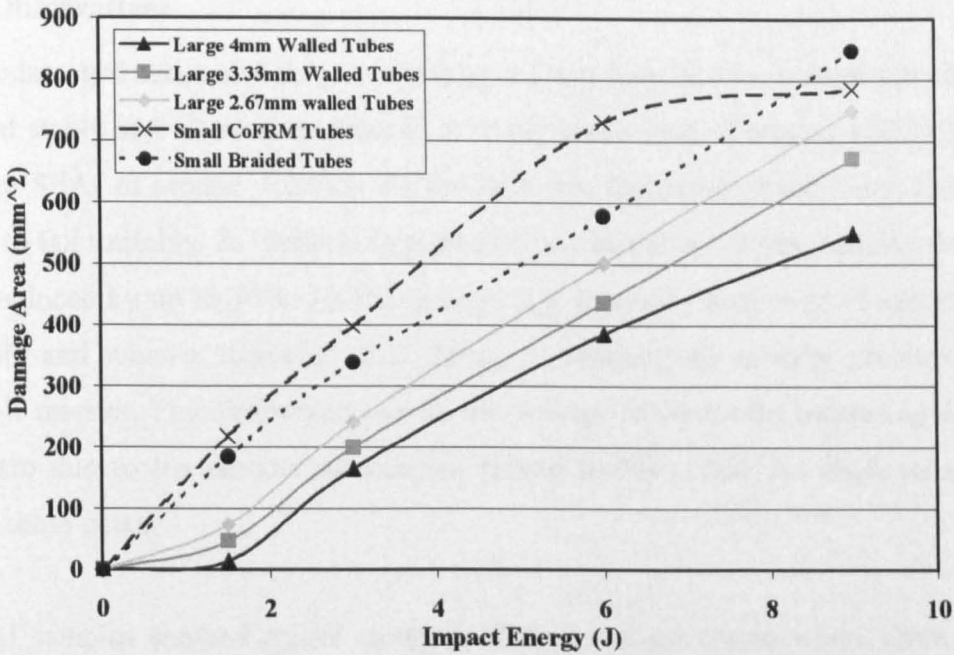
Figure 4-4 – Impact energy versus damage area for large and small tubes

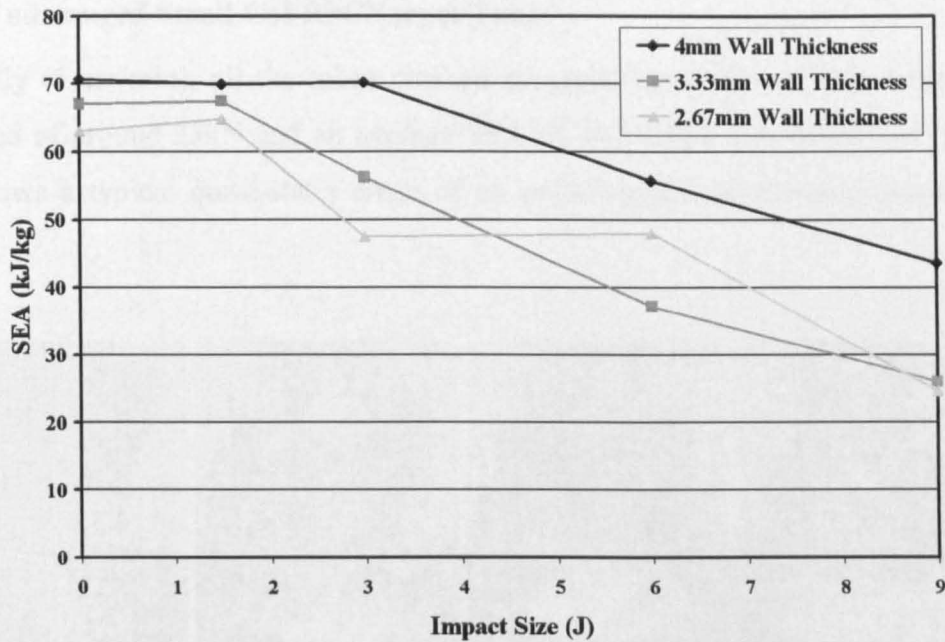
Figure 4-8 - Average SEAs for each impact size tested in the CoFRM/Norpol large (89.1mm diameter) tubes of varying wall thickness

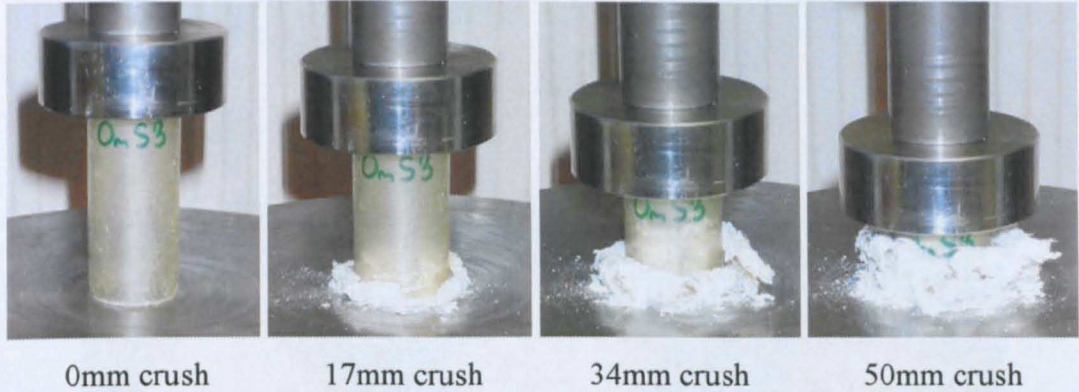
Figure 4-9 – Quasi-static crush of an undamaged, 38.1mm diameter CoFRM/Norpol tube (sample 3)

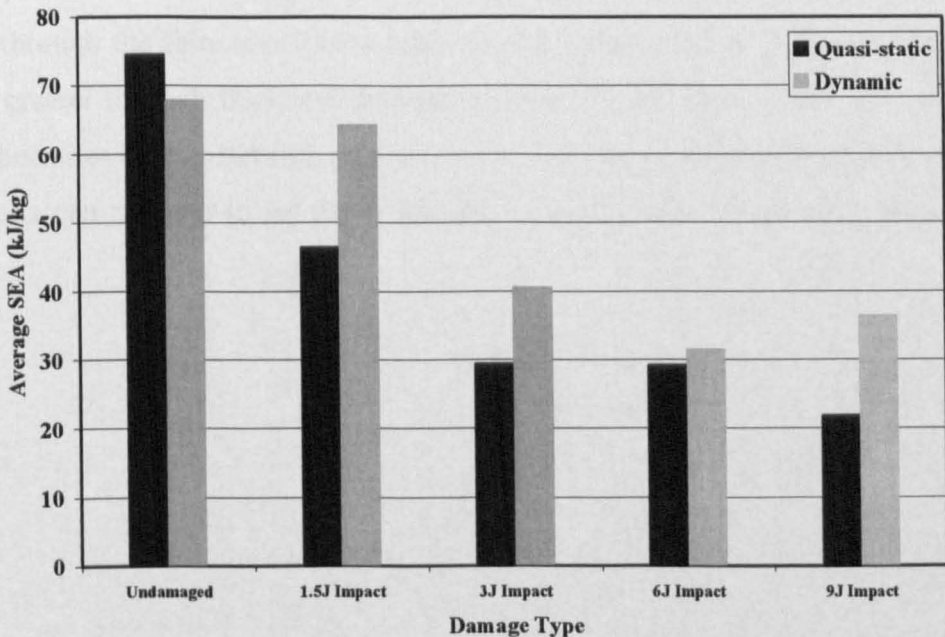
Figure 4-14 – Bar chart showing average SEAs for the quasi-static and dynamic tests of the small CoFRM tubes containing impact damage

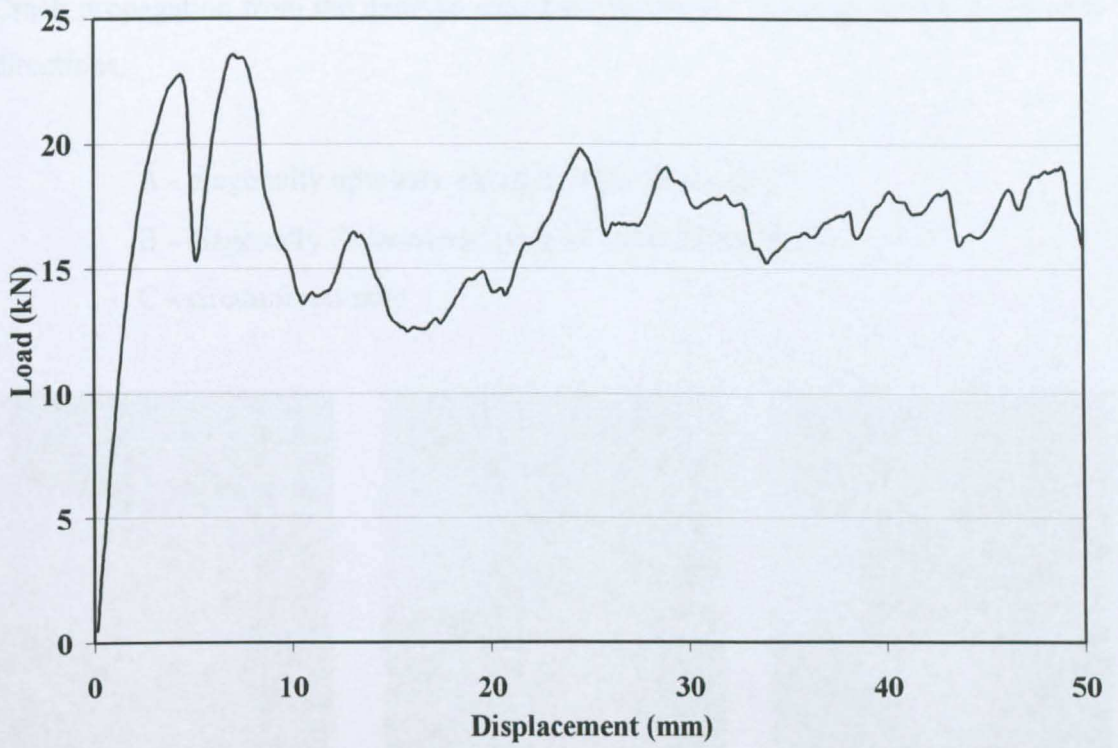
Figure 4-16– Load-displacement curve and images through crush for an undamaged braided small, 38.1mm diameter, tube tested at 5mm/min

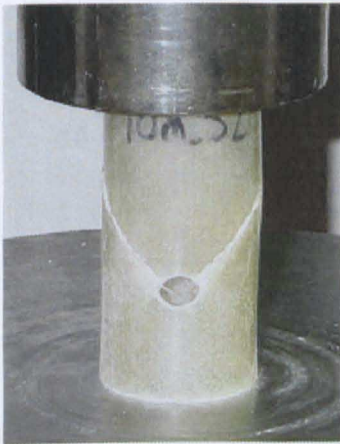
Two type A fractures

Figure 4-17 – Crack propagation types in the 38.1mm diameter braided tubes containing simulated damage

Crack propagation from the damage zone (see Figure 4-17) was generally in one of 3 directions:

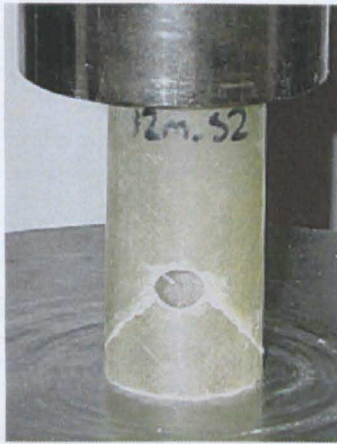
B - diagonally downwards, parallel to the fibres at 45°

Two type B fractures

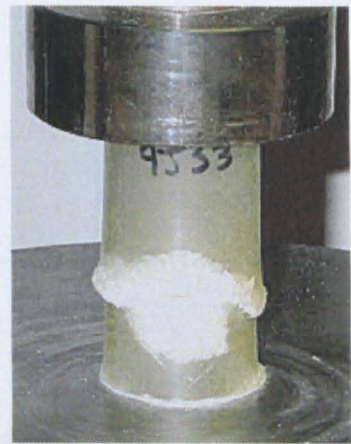
C - circumferentially

Two type C fractures

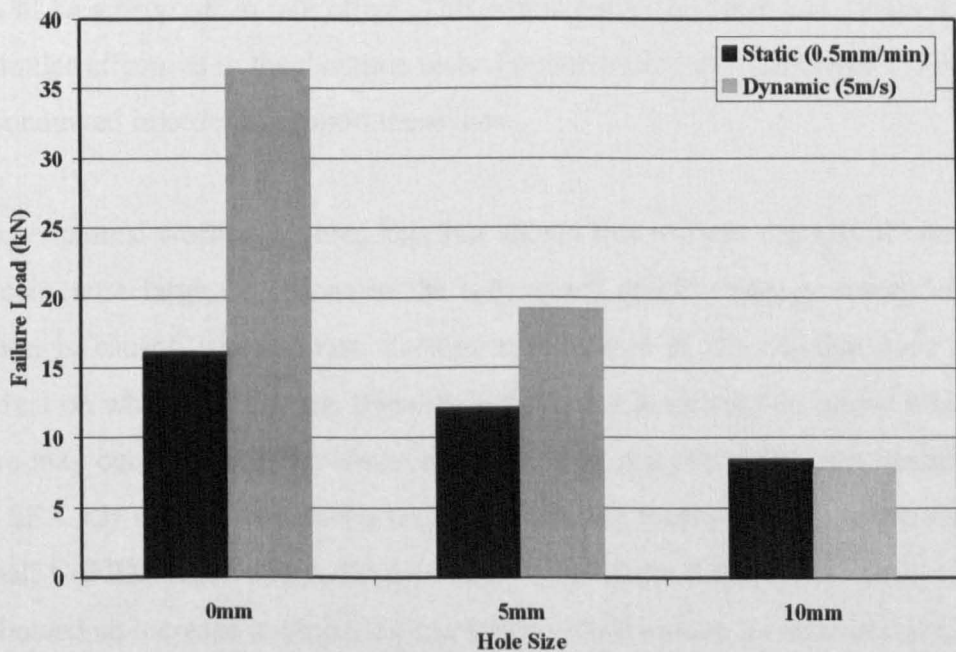
Figure 4-24– Bar chart showing the average failure loads of the quasi-static and dynamic tensile tests containing holes

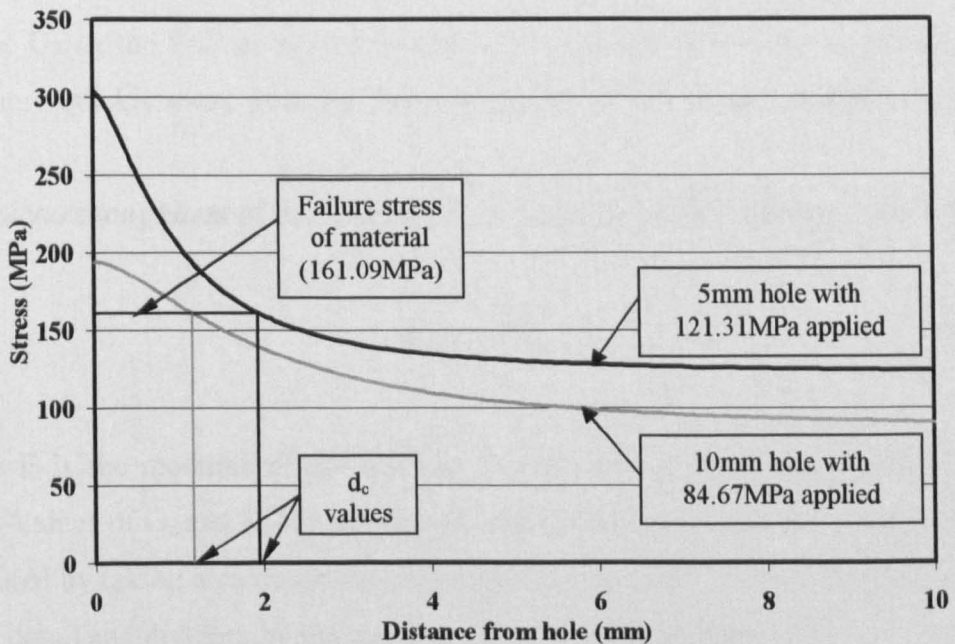
Figure 5-6 – Stress vs. distance from edge of hole for a CoFRM/polyester coupons containing holes, under tension
