Innovative Water-reduced Injection Grouts For The Stabilisation Of Wall Paintings In The Hadi Rani Mahal, Nagaur, India: Design, Testing and Implementation

1.2 The Loggia of the Hadi Rani Mahal, Ahhichatragarh fort and palace complex of Nagaur, India

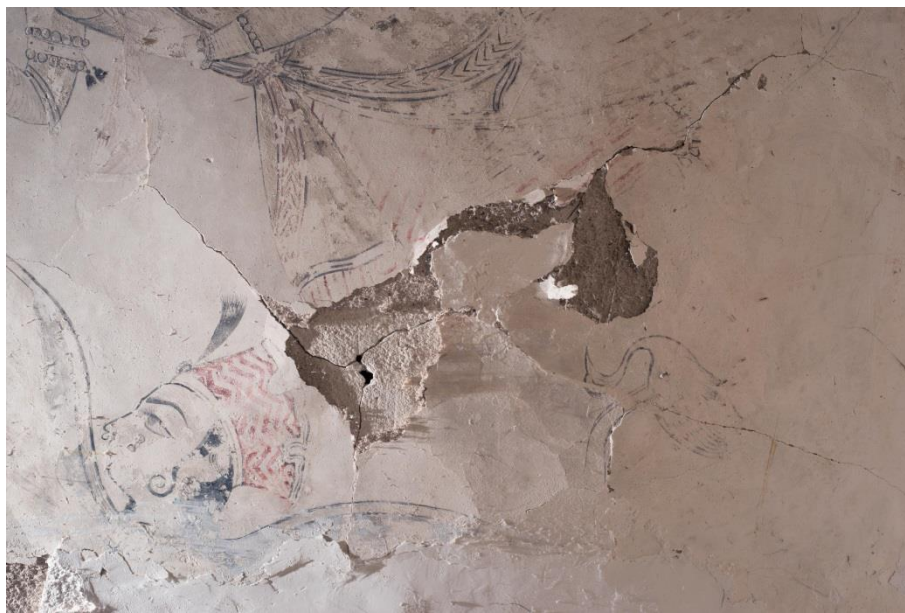
Fig.1: Unstable deformed delamination on the ceiling of the Loggia of the Hadi Rani Mahal (Ahhichatragarh fort and palace complex of Nagaur, India); raking light (©The Courtauld Institute of Art, 2015)

The fort has a complex physical history [7:59], including historic water infiltration, widespread and unstable plaster delamination and past conservation interventions (Fig.1). The Loggia underwent replacement of ceiling panels² due to their collapse, and filling of losses with a gypsum-based material. The secondary support presents severe salt crystallisation problems, especially where water infiltration had been extensive. The Loggia is exposed to highly fluctuating and uncontrollable environmental parameters, which exacerbate cycles of salt crystallisation and deliquescence.

Condition assessment of the Loggia revealed extensive areas of unstable delamination occurring at different locations within the plaster stratigraphy with salt efflorescence both on the surface and inside the delamination, and salt-forming ions throughout the stratigraphy. Two types of delamination were identified:

1. thick and deformed (up to 50 mm), typically between the stone support and the coarse plaster;
2. thin (up to 5 mm), typically between the coarse and the *araish* plaster.

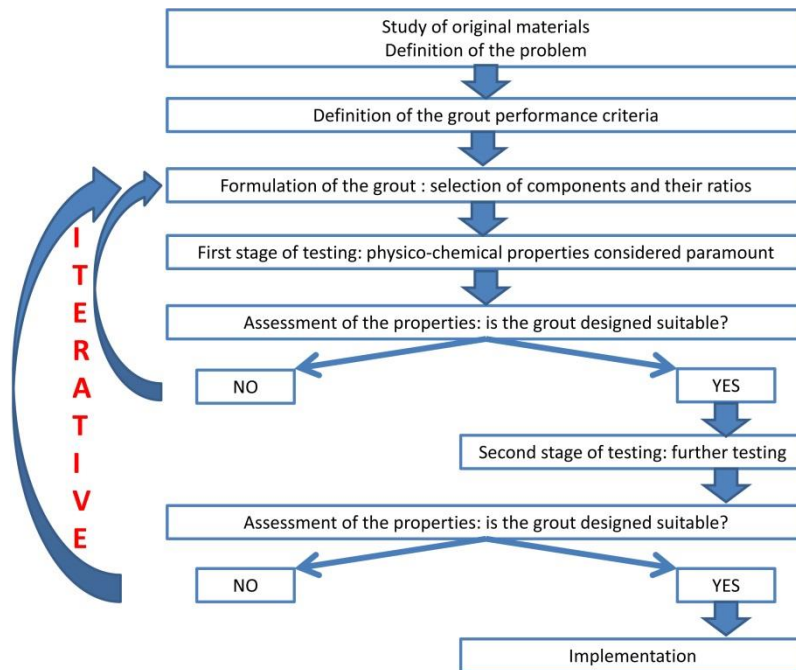
Fig.2: Methodology for grout development and testing

developed, starting with properties which are paramount for the grout to fulfil and faster to assess, reducing the number of possible grout mixtures for properties requiring more complex testing methodologies. If necessary, the formulation needs to be modified and tested again until suitable, following an iterative process (Fig.2).

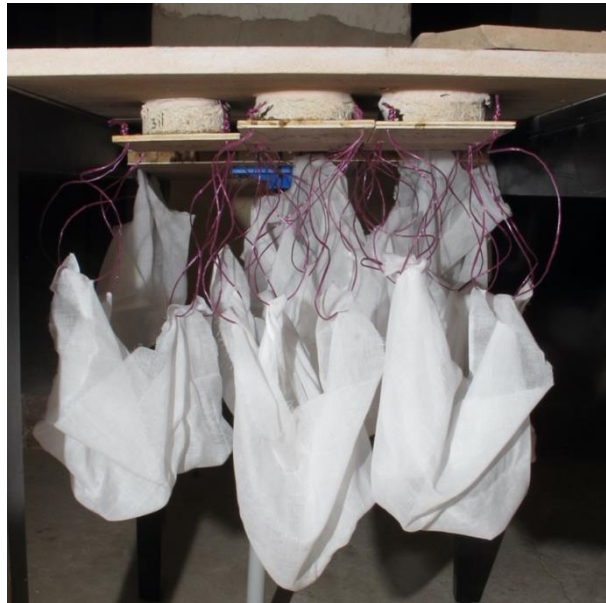
Fig.3: 'Sandwich' test for grouts G (stone-coarse plaster delamination)
(©The Courtauld Institute of Art, 2016)

A 'sandwich' test was developed to test adhesion of the grout set between porous layers. This test is the *ad hoc* field version of **the laboratory 'sandwich' test [17]**. Plaster discs (100 mm diameter) were prepared simulating coarse (height 20 mm) and *araish* (height 5 mm) plasters. The discs were glued onto plywood squares, on which a canvas bag was attached **to incrementally add weight to the system**. Grout G was injected on coarse plaster discs, the system was attached to the underside of a sandstone slab placed horizontally (to simulate a horizontal delamination) and let set for 21 days (Fig.3). Grout MG was injected on *araish* plaster discs (Fig.4), and the system was attached to coarse plaster discs. After the grout had set (21 days), the system was placed **in a position which simulated a horizontal delamination**. Weights of 100 g

were incrementally added to the canvas bag until the system failed. The rupture was qualitatively evaluated: failure at the interface between materials gives information about actual *adhesion*; failure in the middle of the grout thickness indicates grout *cohesion*. The bond or cohesive strength were then calculated with $\sigma = F/A$ (where σ is the tension, F the applied force and A the area where the rupture occurs). A rupture in the middle of the grout is preferable, as it indicates that the grout-stone/grout-plaster bond strength is higher than the grout cohesion, and that the grout cohesion is lower than that of the 'original' materials.

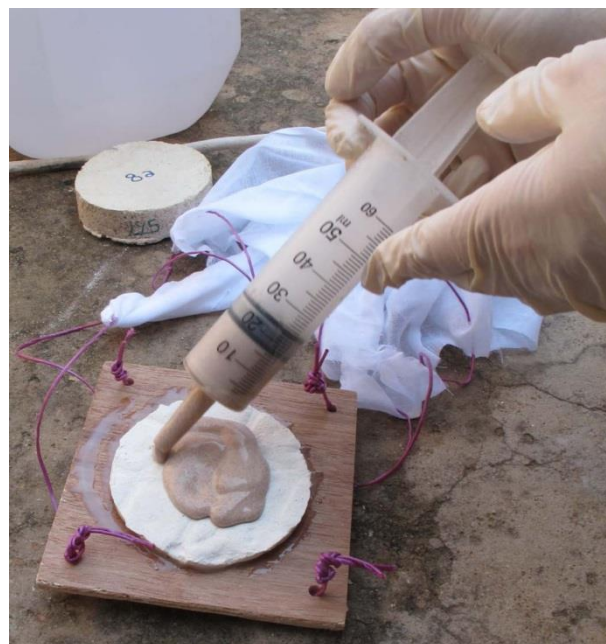
Fig.4: 'Sandwich' test preparation for grouts MG (coarse-araish plaster delamination)
(©The Courtauld Institute of Art, 2016)

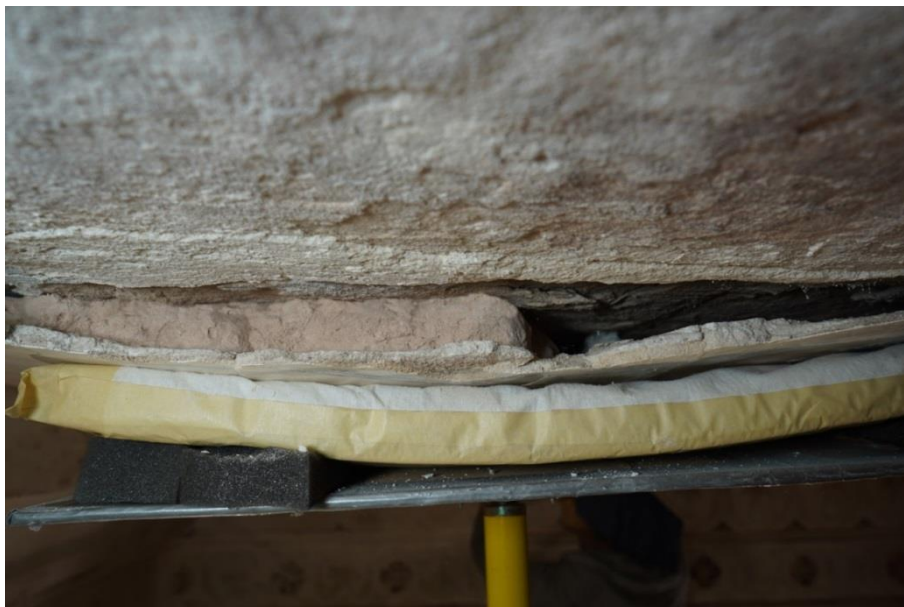
Fig.5: Delaminated area partially filled with grout G, showing good adhesion, with multi-layer absorbent press (©The Courtauld Institute of Art, 2016)

Grouts prepared with 100% water and 50% water-50% ethanol, with aluminium powder and without adhesives performed well, including in the 'sandwich' test; the system always failed in the middle of the grout when adhesives were not present (i.e. the adhesion was higher than the grout cohesion; cohesion was higher than adhesion when adhesives were present). The water-ethanol grout, however, had a slightly higher density (because of a higher amount of quartz sand required to counteract shrinkage) and a delayed and more limited expansion compared to the water-based grout. An area of a painted ceiling in the Loggia, with imminent risk of loss due to unstable and deformed delamination, was selected for initial implementation and evaluation. Low dry density was deemed paramount due to **gravity** and anticipated amount of grout required to re-establish adhesion. Therefore, water-based grout G, with a faster and higher expansion, good bulking properties and lower density compared to the water-ethanol one, was considered safer to implement in this particular area (Fig.5). **Efflorescence was removed from the surface in the unstable area to grout, and efflorescence and plaster microcores were taken from a close stable area. They were analysed with ion test strips. In both areas, sulphates, chlorides and potassium were detected at the surface; in the stable area, such ions were detected also close to the surface (up to 6 mm in depth). Within the stratigraphy (up to 18 mm in depth) primarily sulphates and some nitrates were identified. Salt recrystallisation on the surface was reduced through the use of a multi-layer clay⁸-based absorbent press system, also securing the painting [18:213]. The ion content in the clay was verified with ion test strips after the intervention, after having removed the press; sulphates, nitrates, chlorides and potassium were identified, as in the plaster. The area was monitored for 14 days after the intervention and no efflorescence appeared on the surface.**
