Moisture in walls before and after internal wall insulation: a long-term in-situ dataset

Abstract. This work addresses the need for long-term, high-resolution, in-situ datasets by providing in-wall humidity and temperature data from three walls of in-use office buildings over three to four years, two of which were insulated during this period. Temperature and humidity sensors were inserted diagonally into three locations within the thick brick walls, and the holes were carefully packed with dry brick dust. Surface, ambient and interstitial measurements were also recorded, as were additional climatic data during 18 months at one wall, and in-wall moisture content using resistance pins for 18 months in another. This dataset is unique due to the combination of temporal length and resolution, spatial detail, as well as the availability of control data from both before and after insulation and the use of real climatic conditions on both sides of the walls. The experiment was designed to produce data to facilitate parameter estimation by inverse analysis. By using these estimated parameters, or by taking material property measurements, it would also be useful for validating and calibrat

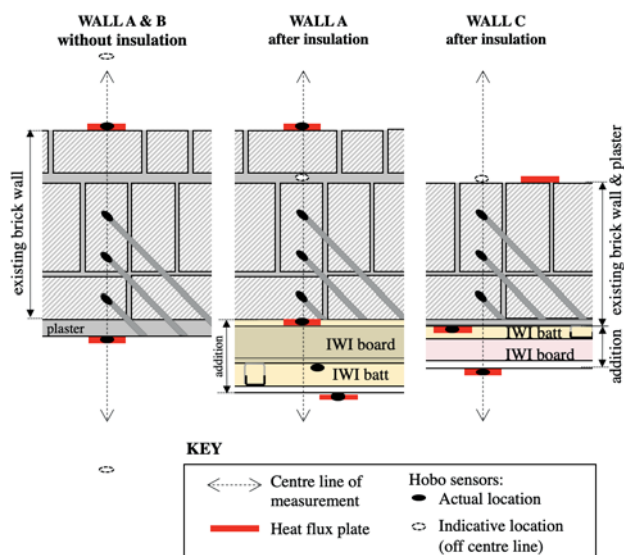
Figure 1 shows horizontal sections through walls A, B and C. Walls A and C are shown with insulation (middle and right), further detail about the insulation build ups are given in section 2.4. The hobo sensors were inserted into three holes drilled diagonally, at a 45° angle into all three walls, in order to limit damage or disruption to the material in the assumed direct moisture transport path, normal to the wall surface (centre line in figure 1). The perpendicular depths of the sensors from the inside brick surface were 50mm, 175mm and 245mm, in all cases ± 5 mm. To avoid advective moisture or heat transfer through air gaps the holes around sensors were packed in with brick dust. The sensors are still able to detect humidity levels in this condition [10].

Fig. 1. Horizontal sections of the three walls showing sensor locations.

From Nov 2015 to the end of 2016 both walls A and B were uninsulated and there is comparable data for both, from sensors placed as shown in figure 1. For wall A, there are 420 days of data from at least six sensors, with 6

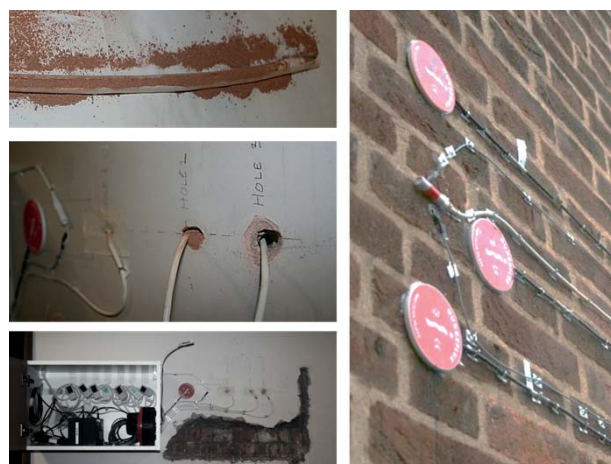
Images of the sensor installation process are shown in Figure 2. The sensors were inserted via a half plastic tube filled with brick dust and then gradually topped up with more brick dust, this process took at least two hours to ensure the deepest holes were completely filled. Inserting wet clay or mortar may have been quicker, but the sensors would need to be protected from the initial moisture content, and any additional sheathing would add uncertainty to the measurement. The holes were then capped with mortar. To avoid the heat flux plate interfering with the assumed perpendicular flow of heat and moisture through the centre line, three heat flux plates were mounted centrally on bricks adjacent to the centre line, to monitor the same configuration of materials through the wall and to compare the difference between locations. The plaster on part of the inside face of the wall was stripped back in order to locate the brick and mortar joints and a position in the centre of a brick was chosen as the central line of measurement.

Fig. 2. Installation of the hobo sensors in the wall. Anti-clockwise from top left: hobo sensor in half tube filled with brick dust, packing brick dust into diagonal holes in wall, measurement equipment on internal surface with some plaster removed, measurement equipment on external surface.

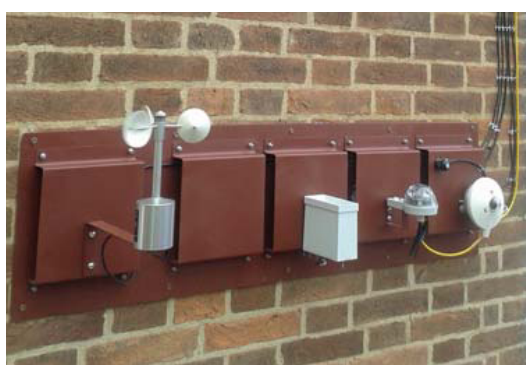
Climate monitoring equipment was installed on wall B in Summer 2018 as shown in figure 3. On the left, a *Vector A100R* anemometer measures wind velocity. The three-cup rotor turns a magnetic actuator, and the pulse per

revolution is transmitted to a wireless datalogger. The Anemometer operates at a maximum speed of $> 75\text{ms}^{-1}$, with an accuracy of 1% for readings between 10 and 55ms^{-1} , and 2% for readings $> 55\text{ms}^{-1}$ [16].

The *Rain-o-Matic* small rain gauge, is a tipping bucket held in place by a hard ferrite magnet, which breaks a circuit and allows the measuring bucket to empty in one quick movement (less than 300 ms) and then return to its normal position [17]. The device is simple but can be blocked by debris. The *Hydreon RG-11* is an optical rain gauge, which logs interruptions on a light source on the lens cover caused by rain drops. The *Hydreon RG-11* is a useful qualitative sensor, but no accuracy specification has been derived by the manufacturers due to difficulties in finding a clear correlation with tipping bucket measurements. The sensor will frequently record quantities close to the tipping bucket, but outlier events deviate much further [18].

The *Kipp and Zonen CMP3* pyranometer measures global short-wave radiation in the spectral range of 300 to 2800nm and has a total daily uncertainty of $< 10\%$ [19]. The *Apogee SP110* silicon-cell pyranometer only measures a portion of the solar spectrum (350-1100nm) and is calibrated to estimate the global shortwave radiation from this [20].

Fig. 3. Climate monitoring equipment. L to R: Vector A100R anemometer, Pronamic Rain-o-Matic tipping bucket rain gauge; Hydreon RG-11 optical rain gauge; Apogee SP110 silicon-cell pyranometer; Kipp and Zonen CMP3 pyranometer.

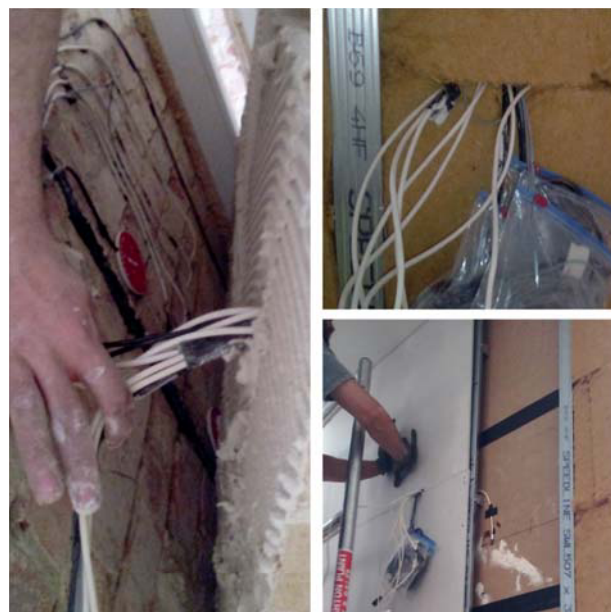
Figure 4 shows the process of installing the internal wall insulation on wall A, which comprised one 100mm layer of woodfibre board, fully adhered to the existing brick surface, 50mm of woodfibre batt between aluminium brackets and a plasterboard finish. The sensor cables were routed away from the line of measurement and through the woodfibre board, woodfibre batt and plasterboard, along with the cables from the external monitoring equipment, which were also further away from the line of measurement. Interstitial sensors were fixed to the brick face and between the woodfibre board and woodfibre batt.

Fig. 4. Installing the IWI on Wall A. Clockwise from top left: surface sensors on brick surface after plaster removed, with cables arranged through the adhesive fixed IWI board away from centre line of measurement; sensor cables fed through IWI batt between aluminium battens; sensor cables fed through fermacell board on metal battens on board (and showing IWI board surface sensor); sensors fixed to new wall surface and cables through to new cupboard, off the centre line of measurement.

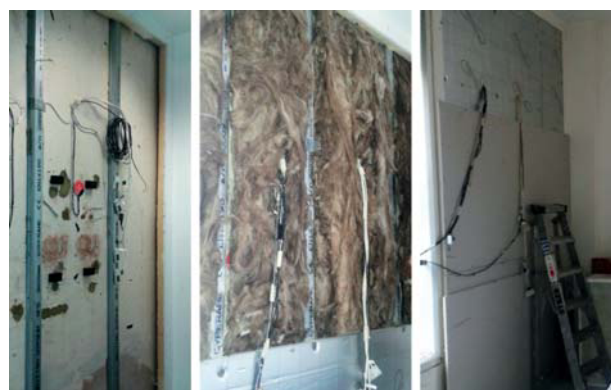
Wall C is a similar structure to A and B, but without the outer layer of brick. The same process was followed, and the sensor depths were the same in the brick wall, but in this case the insulation system was plasterboard on 50mm polyurethane mounted on 25mm battens (see

figure 1), and the voids packed with mineral wool. The installation process is shown in figure 5. The existing plaster was not removed on wall C.

Fig. 5. Installing IWI on Wall C. Left to right: sensors on existing wall; mineral wool fitting between aluminium battens; phenolic insulation board being fixed to battens.

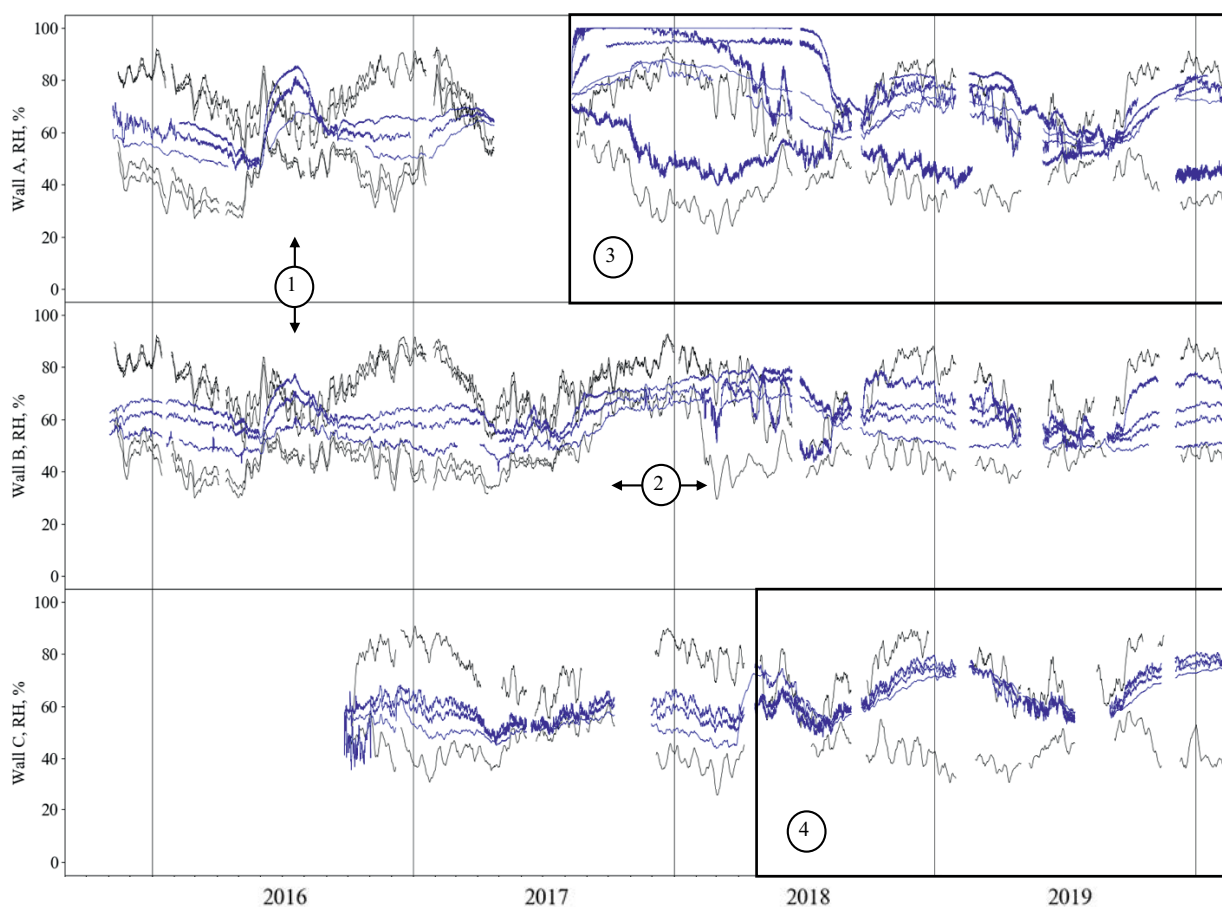
Figure 6 shows the relative humidity data for the three walls. The conditions indicated by the numbers are explored in this paper: 1) walls A and B uninsulated over one year, 2) wall B uninsulated over four years including a winter without heating or windows, 3) Wall A insulated and wetting event occurred, 4) wall C insulated and hygrotrac sensors installed. The most complete and highest resolution dataset was captured in the first 18-24 months for walls A and B, when five minute data was measured by seven sensors in walls A and B; there are few gaps. From mid-end 2017 the ambient sensors were moved to another in-wall position for walls A and B, corresponding with the time that wall A was insulated. The heating was switched off in zone A in January 2017, and zone B was unheated for winter 2017/2018 until the beginning of February 2018.

Fig. 6. Relative humidity data for three walls between November 2015 and February 2020. Black shows ambient and surface measurements (seven day rolling average), blue shows in-wall measurements (24hr rolling average). The thick outlines indicate when walls A and C were insulated.

small gaps in the data representing 1% of the period; the longest gap is 66 hours. For wall B there are 425 days of data from at least six sensors, with 3 gaps in the data, representing 2% of the period, the longest gap is 6.4 days. There are 420 days of concurrent data from both walls, from 12-14 sensors with six gaps in the data representing 2% of the period, the longest gap being 6.4 days. These periods also include surface and ambient data as shown in figure 6.

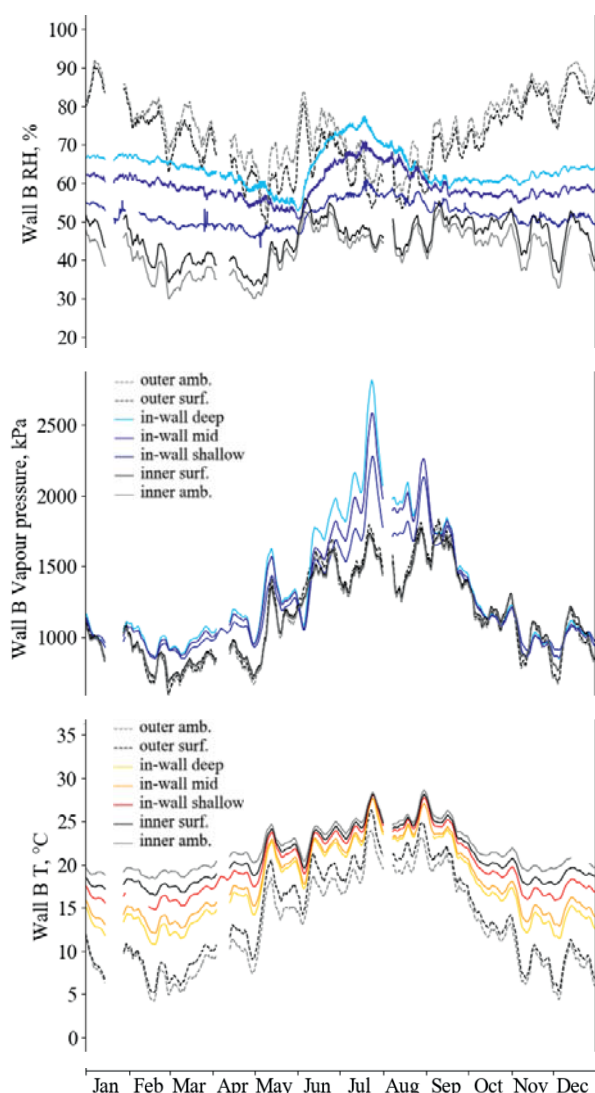
Figure 7 shows the RH, vapour pressure and temperature measurements from the 7 sensors across wall B in 2016. The 5-minutely data is presented as one hour rolling averages for the in-wall RH data, and seven day rolling averages for the surface and ambient RH data, the temperature and vapour pressure data are all presented as seven day rolling averages. This shows the low frequency trends more clearly but also leads to over-representation of gaps in data in the plots.

During 2016 there is a peak in RH during the summer measured by the in-wall sensors, which does not appear in any other year of data measured, except where walls were insulated mid-year. This may have been caused by the high rainfall during June 2016. The removal of plaster from the inside wall surface (approximately 200mm away from the line of measurement) may also have had an impact, although a sensitivity analysis based on this wall suggests that a reduction in vapour resistance of the plaster and finishes would have the opposite effect [21].

Fig. 7. Measurements of RH (top) vapour pressure (middle) and temperature (bottom) across wall B. Colours available online.

For both walls the difference between ambient and surface RH is greater at the inside compared to the outside in winter, and greater at the outside compared to the inside in summer as shown in figure 8, which is the opposite for the temperature, as shown in figure 7. This data is useful for studying the heat transfer and vapour diffusion

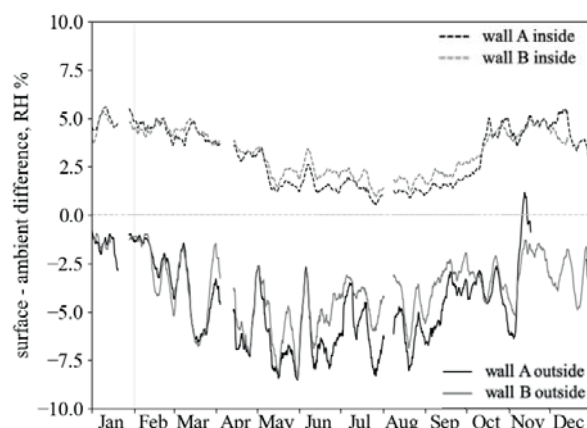
Fig. 8. Difference between surface and ambient RH during 2016.

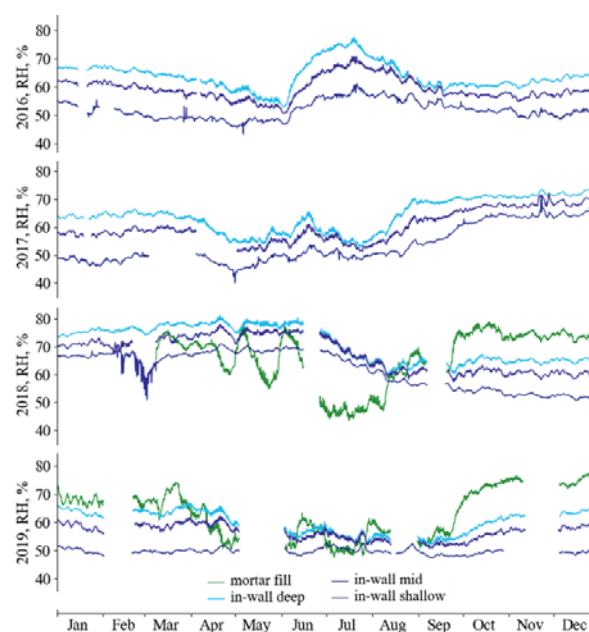
Wall B was uninsulated for the duration of the measurements, as a control wall, and the contained space was unheated for the winter 2017/2018 until the beginning of February 2018. The windows were also removed and replaced during this period and the difference between internal and external conditions was reduced to less than 5°C in Jan 2018, compared to approximately 15°C in zone A. Figure 9 shows RH from the in-wall sensors over the four years. Figure 10 shows moisture gradients across wall B on July 15th at 12pm for the four different years, including the surface sensors on both sides of the wall, after 2017 the ambient sensors were removed, and sensors were added to the mortar fill layer. Error bars show equipment accuracy ($\pm 2.5\%$) and dimensional uncertainty ($\pm 7\text{mm}$).

Fig. 9. RH across wall B 2016 - 2019 (top to bottom).

In 2016 there is a RH peak in summer that is not seen in the other years, and the relative humidity levels are significantly higher in the outer wall (B5, +245mm). This reduces during the following summer by at least 20% RH. The external RH is approximately 10% RH less at the same day and time. During summer 2017, following the winter with no heating and windows, the RH through the whole wall is above 65% RH but drops to approximately 50% by the following summer. The external surface RH is 40-50% for all four years. The in-wall RH difference between 2016 and 2019 is notable and may be caused by a combination of the plaster repair, windows being replaced, and differences in external RH.

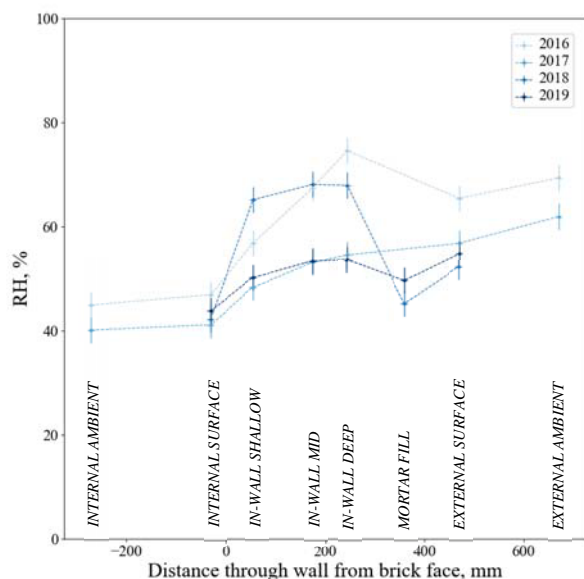
Fig. 10. Moisture gradients through wall B in 2016, 2017, 2018 and 2019 at 12pm on 15th July.

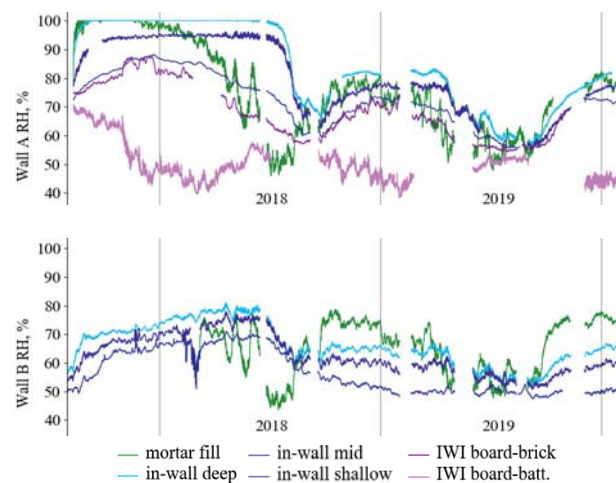
Figure 11 shows the RH measured by the in-wall sensors in wall A and wall B from Aug 2017 to February 2020, after wall A was insulated. Figure 12 shows moisture gradients across both walls including the surface sensors on both sides of the wall in winter 2018/2019 and in summer 2019. Unfortunately, the external surface RH sensor was damaged on wall A after the insulation works, so the measurement at wall B is used as a proxy. The wall was washed after the IWI was installed which raised the in-wall RH at location A5 (+245mm) to 100% from Aug 2017 until June 2018, when this reduced to less than 70% RH within a few weeks. During this period the RH measured in the organic insulation layers did not rise above 80% for any significant period of time. By winter 2018/19 the difference between in-wall RH for the sensors in the brick had dropped to approximately 20%, and 10% by summer 2019.

Fig. 11 shows the RH levels are higher in the wall at ‘in-wall deep’ location (+245mm). compared to the ‘mortar fill’ location (+360mm) for most of period until September 2019, for the insulated wall, whereas for the control wall (wall B) the in-brick sensors measure lower RH levels than the mortar fill for all of winter 2018/2019

and some of the summer 2019. There is likely to be some air movement in the mortar fill layer, so the conditions follow that of the external environment more closely.

Fig. 11. RH across insulated wall A (top) and uninsulated wall B (bottom) from Aug 2017 to Feb 2020.

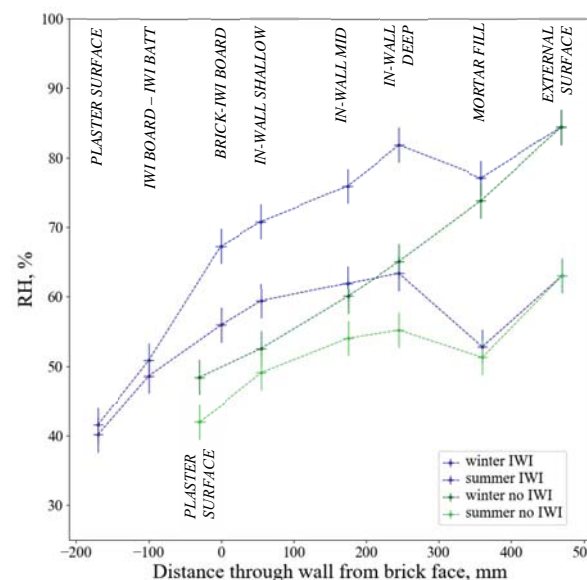
Fig. 12. Moisture gradients through walls A (blues) and B (greens) on 10th Dec 2018 and 10th June 2019 at 12pm.

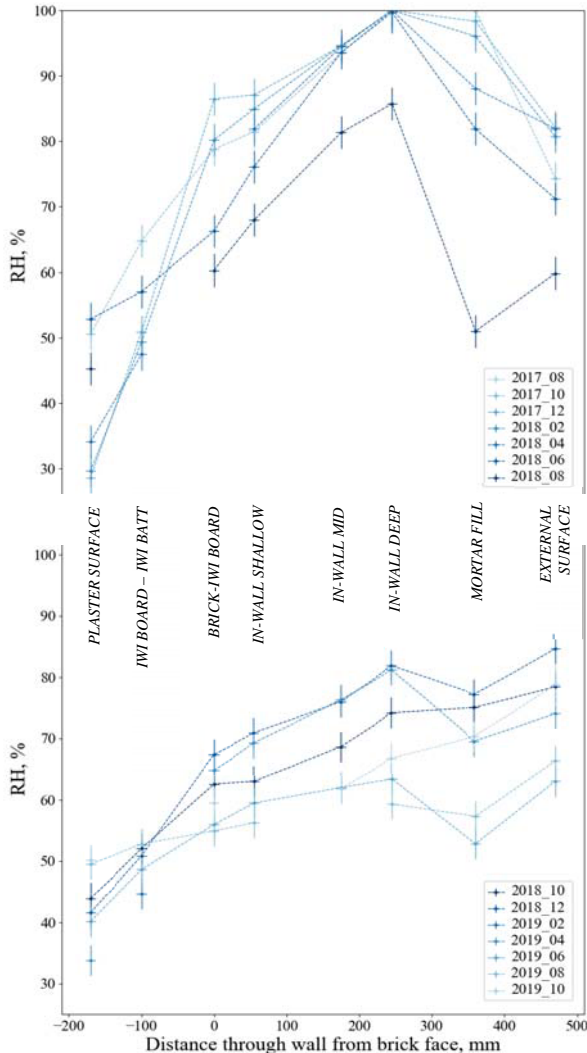
Figure 13 shows bi-monthly RH gradients through wall A from the time of the wall being insulated and the external bricks being washed, to the end of 2019, by which time the RH had returned to lower levels. Following wetting, outer locations of the wall reached 100% RH within a few weeks (although it should be noted that sensor measurement uncertainty increases to $\pm 3.5\%$ over 95% RH). The RH measured in the mortar fill layer then falls over the next 6 months, with the gradient increasing gradually, before the measurements become more closely linked to external conditions. The RH levels in the middle brick change by less than 2% over at least 7 months and drop suddenly during summer 2018.

Fig. 13. Bi-monthly moisture gradients through wall A for the year after the ‘wetting event’ (from Aug 2017 to Aug 2018, top) and the following year (Oct 2018 to Oct 2019, bottom).

This data provides the opportunity to investigate the wall recovery from a significant wetting event across different materials at different locations in the wall, to compare estimated parameters for wet and dry conditions

and to use these, or measured material properties, to compare the data to a hygrothermal model of the same wall. It is also possible to draw some conclusions about anticipated drying times of the system used but it is impossible to separate the effects of adding moisture and insulating the wall as the exact quantity of liquid added is not known.

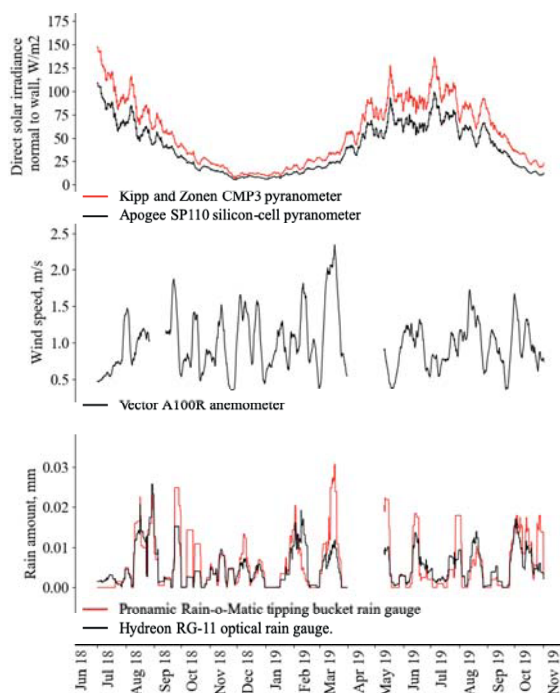
Figure 15 shows the climate data collected at the external face of Wall B for 18 months, from June 2018 to

December 2019. This data offers the opportunity to assess the wall's response to external conditions in more detail during this period, and through comparison to local weather data can offer an insight into local sheltering. It also allows comparison of two different pyranometers and two different rain sensors. The collection method does not include a wind driven rain collection plate [23], but horizontal rainfall immediately adjacent to the surface may be a useful comparison to WDR calculations using local weather data available [21].

Fig. 15. Climate data from June 2018 to Dec 2019. Top to bottom: Solar irradiance; wind velocity; rain amount.
