## Improvement in hot corrosion resistance of dissimilar alloy 825 and AISI 321 CO<sub>2</sub>-laser weldment by HVOF coating in aggressive salt environment at 900°C

### Abstract

This study investigated the hot corrosion performance of a dissimilar weldment of Ni-based superalloy and stainless steel joined by CO<sub>2</sub> laser welding and improved by high-velocity oxy-fuel (HVOF) coating in a Na<sub>2</sub>SO<sub>4</sub>–60wt%V<sub>2</sub>O<sub>5</sub> atmosphere at 900°C. A dissimilar butt joint of AISI 321 and alloy 825 was fabricated by CO<sub>2</sub> laser welding with low heat input after obtaining the optimum welding parameters by bead-on-plate trials. The metallurgical and mechanical properties of the laser weldment were evaluated. The tensile test results indicated the occurrence of fracture in the base metal AISI 321 side. The HVOF process was employed to coat Ni–20wt%Cr on the weldment. To evaluate the surface morphology of the corrosion products formed on the uncoated and HVOF-coated weldments, scanning electron microscopy (SEM) analysis was performed. Energy-dispersive spectroscopy (EDS) was used to determine the different elements present on the surface scales. Th

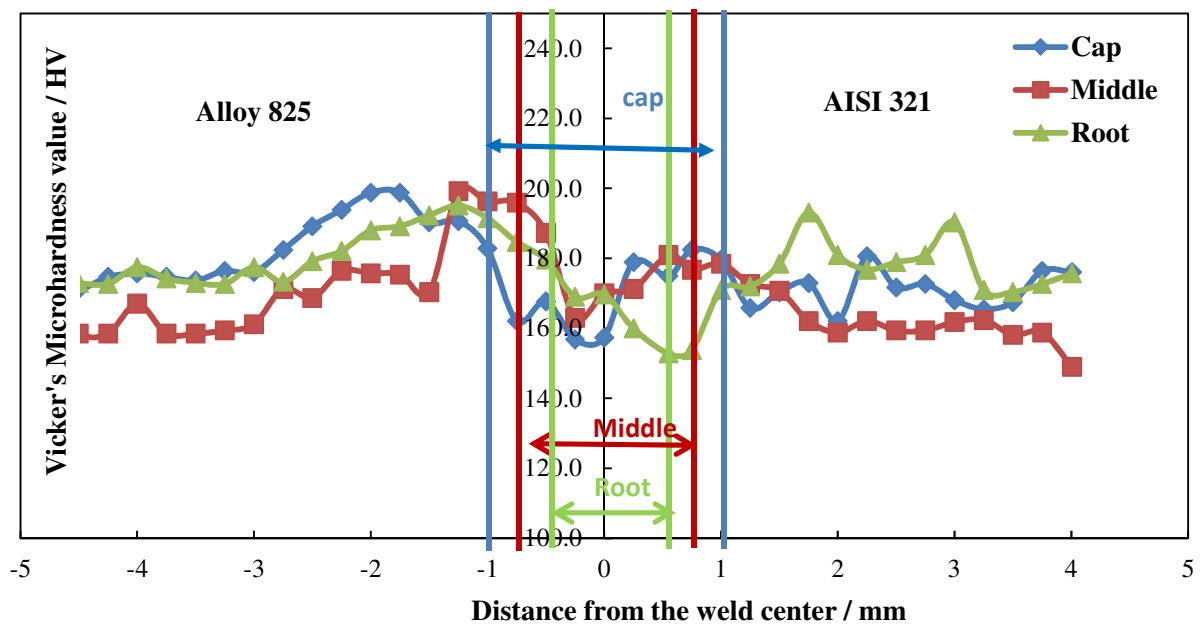
Fig. 3. Microhardness profile of 825-321 dissimilar CO<sub>2</sub> laser weldments.

Fig. 3 illustrates the microhardness profile of 825–321 dissimilar laser weldments. The hardness dropped comparatively while progressing toward the weld interface from the alloy 825 regions. The average hardness values of the alloy 825, weld zone, and AISI 321 were HV 170.8, HV 177.9, and HV 166.2, respectively. The microhardness profile shows that all the regions presented similar hardness values.

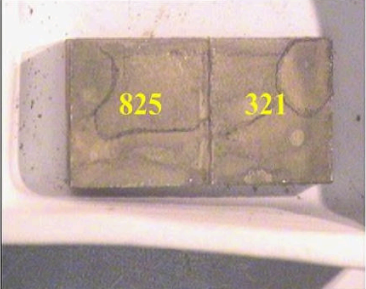
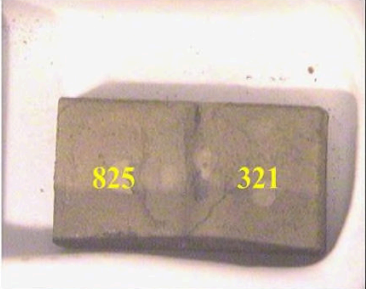
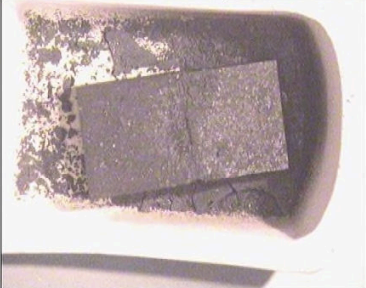
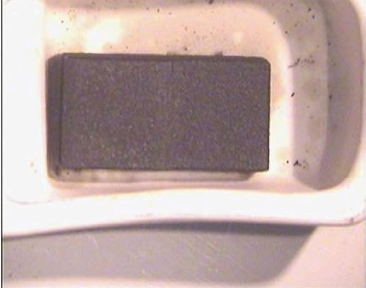
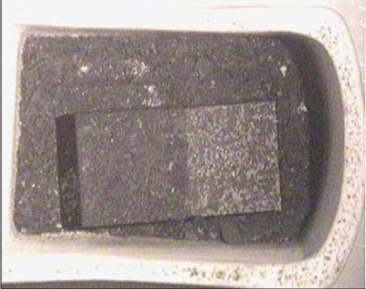
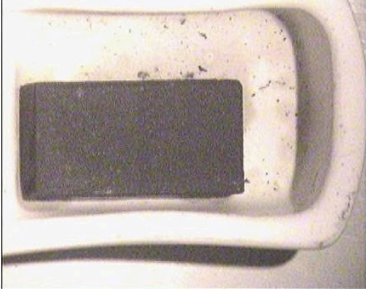
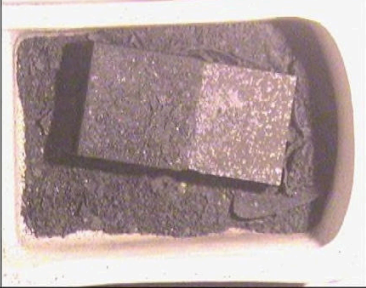
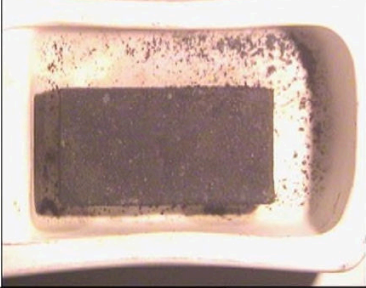
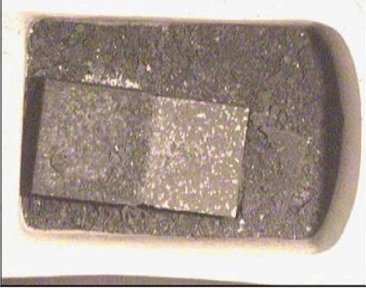
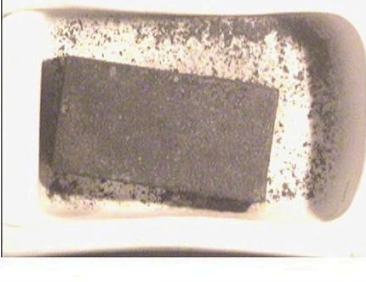
The uncoated specimen is heavily corroded, with a dark, porous layer of corrosion products covering most of its surface.

The uncoated specimen is almost completely covered by a thick, dark, porous layer of corrosion products.

The HVOF-coated specimen shows a dark, uniform layer of corrosion products, with the underlying metal surface still visible.

**Fig. 7.** Macro-images of uncoated and HVOF-coated hot-corroded weldments during exposure to molten salt at 900°C.

Macro-images of the uncoated and coated weldments during exposure to the salt environment are depicted in Fig. 7. The macro-images show the presence of oxide scales on the surface, spallation, and sputtering. In the uncoated weldment, from the initial stage onward, the scales started to spall on both the weld and base metal regions. This could be attributed to the extensive corrosion at the AISI 321 region and the weld zone caused by the development of the  $\text{Fe}_2\text{O}_3$  scale. The spalling rate of scales increased with an increase in exposure time, as shown in Fig. 7. A minor oxide scale spallation was observed in the coated specimen.

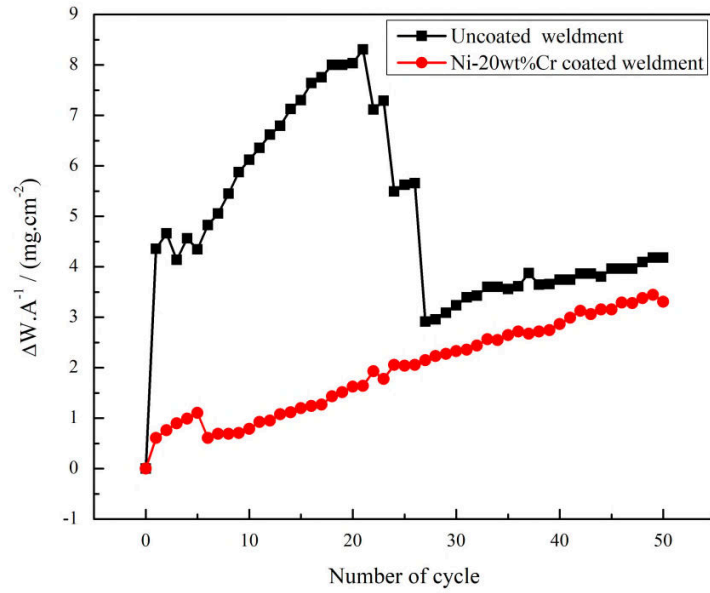
**Fig. 8.** Thermogravimetric analyses of uncoated and HVOF-coated weldments after subjection to hot corrosion in  $\text{Na}_2\text{SO}_4\text{-60wt\%V}_2\text{O}_5$  molten salt environment at  $900^\circ\text{C}$ .

The weight gain plots of the uncoated and coated weldments are depicted in Fig. 8, where  $\Delta W$  is the weight gain, and  $A$  is surface area. The uncoated weldment showed a higher corrosion rate compared with the HVOF-coated weldment. During the initial stage of the hot corrosion study, high weight gain could be found in both specimens, which was due to the development of new oxide scales on weldments [17]. The uncoated weldment exhibited a high weight gain of  $8.307 \text{ mg}\cdot\text{cm}^{-2}$  at the 21<sup>st</sup> cycle, after which the weight started to decrease; this decrease was attributed to the spalling of oxide scales outside the crucible. Thus, calculating the corrosion rate for the uncoated specimens is difficult. A similar result has been reported by Muthu *et al.* [16]. The HVOF coating showed less weight gain ( $3.305 \text{ mg}\cdot\text{cm}^{-2}$ ) and also provided better resistance to corrosion. This indicates that the coating surface was protected due to the presence of NiO and  $\text{Cr}_2\text{O}_3$  oxide scales.

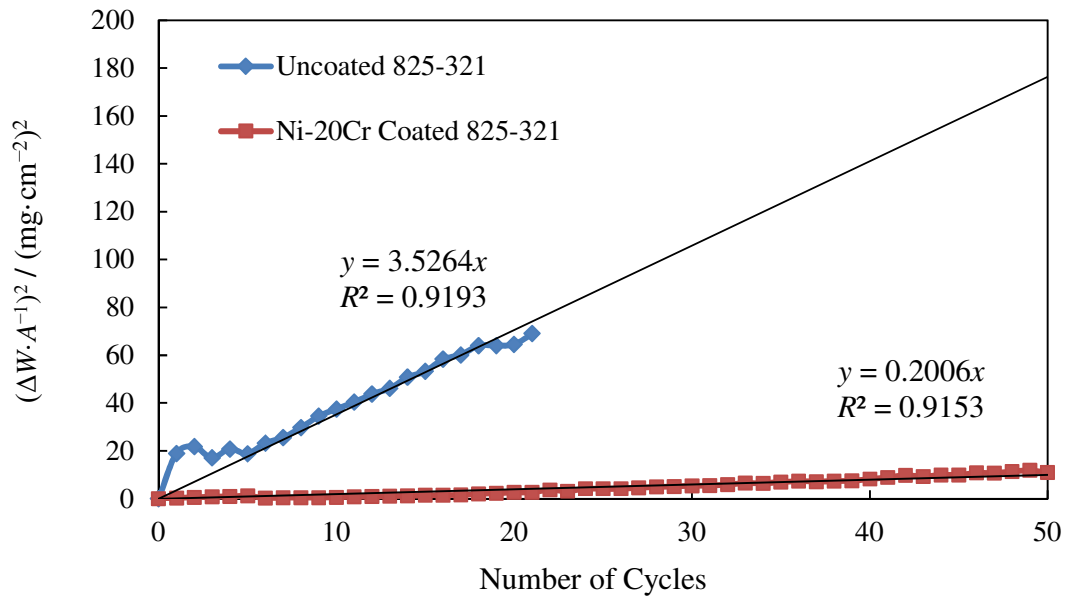
Fig. 9. Plots of  $(\Delta W \cdot A^{-1})^2$  vs. number of cycles for uncoated and HVOF-coated weldments after hot corrosion at 900°C.

Fig. 9 shows that the relationship of  $(\Delta W \cdot A^{-1})^2$  versus the number of cycles for the coated specimen follows the parabolic law, while that for the uncoated weldment follows the parabolic law till the 21<sup>st</sup> cycle, after which it deviates. The corrosion rate of the weldments can be calculated by  $(\Delta W \cdot A^{-1})^2 = K_p \times t$ , where  $K_p$  represents a parabolic constant,  $t$  is exposure time in s. The weight gains and parabolic rate constants ( $K_p$ ) of the coated and uncoated samples are presented in Table 4. The parabolic rate constant ( $K_p$ ) was obtained from the slope of the linear regression fitted line for  $(\Delta W \cdot A^{-1})^2$  versus the number of cycles. The nature of fit depends on the square of the weight gain  $(\Delta W \cdot A^{-1})^2$  for the specimen and is directly related to the weight loss and weight gain pattern of the sample. This suggests that if the material has good hot corrosion resistance, the fit will be a straight line and follow the parabolic rate law.

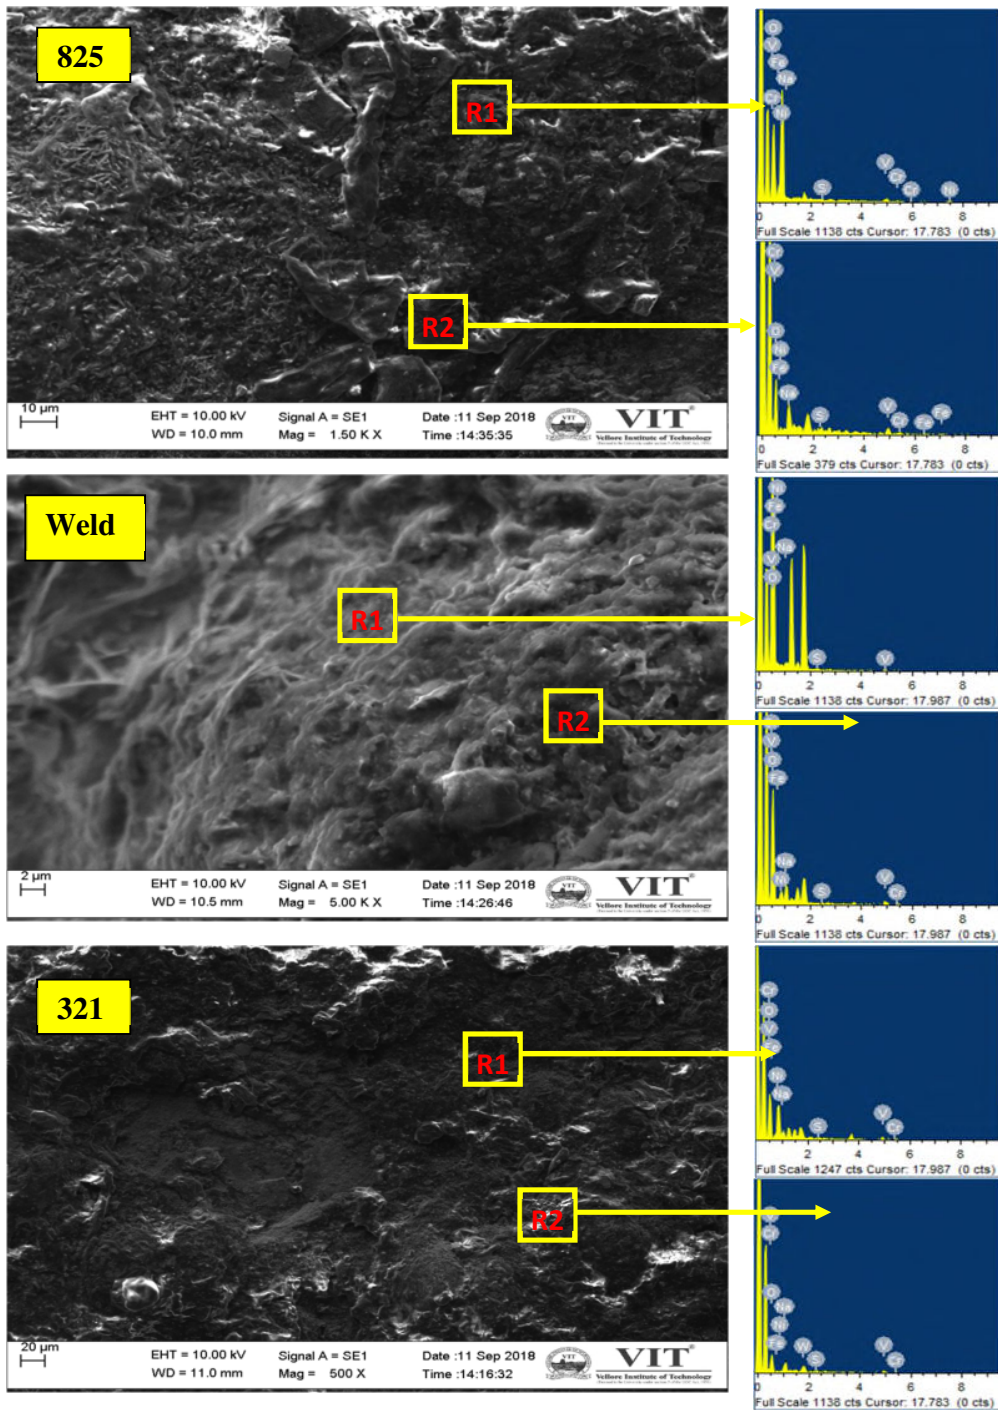
Fig. 11. SEM/EDS analysis of the HVOF-sprayed Ni-20%Cr-coated 825-321 CO<sub>2</sub> laser weldments after hot corrosion in Na<sub>2</sub>SO<sub>4</sub>-60wt%V<sub>2</sub>O<sub>5</sub> environment at 900°C for 50 cycles (R1 and R2 correspond to Region 1 and Region 2, respectively).

The SEM microstructures of the hot-corroded uncoated and HVOF-sprayed 825–321 dissimilar laser weldments are described in Figs. 10 and 11, respectively. The SEM morphology of the uncoated weldment (Fig. 10) shows the existence of cracks in the oxide scales and the spalled region. The alloy 825 region featured an uneven surface due to oxide scale spallation, and cracks were also observed. The EDS analysis results reveal the presence of high contents of Fe, O, and Ni, with a moderate amount of Cr. This suggests the existence of NiO, Cr<sub>2</sub>O<sub>3</sub>, and Fe<sub>2</sub>O<sub>3</sub> scales. In the weld region, a particle-shaped microstructure, as well as a spalled region, was observed. The EDS analysis of the particle-shaped structure shows the formation of Fe<sub>2</sub>O<sub>3</sub>, Cr<sub>2</sub>O<sub>3</sub>, and NiO scales. The AISI 321 region mainly consisted of O and Fe, with a small amount of Ti, Ni, and Cr. Corrosive elements Na, S, and V were found in all the regions of the weldment. Considering the Ni–20wt%Cr-coated weldment, the SEM microstructure (Fig. 11) (weld and base metal region) exhibited a rough surface, and cracks were observed on the surfaces. Higher amounts of oxygen, nickel, and chromium with minor amounts of Fe, Na, V, and S were observed in the oxide scales of the coated weldment.

Table 6. Elements present in the HVOF-coated 825–321 dissimilar weldments after hot corrosion in Fig. 11

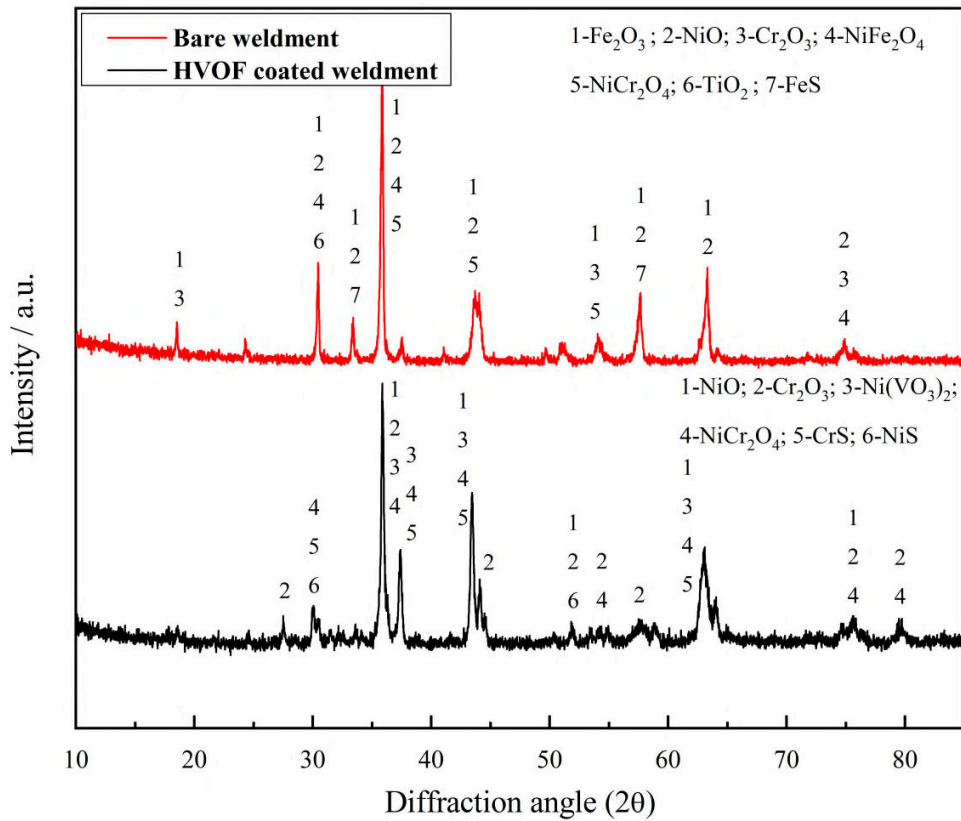
Fig. 12. XRD analysis of the uncoated and HVOF-coated weldments after hot corrosion at 900°C.

The XRD analysis result (Fig. 12) indicates the occurrence of a major phase of  $\text{Fe}_2\text{O}_3$  in the uncoated sample, suggesting that the sample had undergone severe corrosion. Such phase was not prevalent in the case of the HVOF-coated sample; rather, phases such as  $\text{NiO}$ ,  $\text{FeS}$ ,  $\text{TiO}_2$ ,  $\text{NiCr}_2\text{O}_4$ ,  $\text{FeCr}_2\text{O}_4$ , and  $\text{Cr}_2\text{O}_3$  were observed in minor amounts. The XRD result of the Ni–20%Cr-coated weldment shows the presence of the following reaction compounds in the scales:  $\text{NiO}$ ,  $\text{Cr}_2\text{O}_3$ ,  $\text{NiS}$ ,  $\text{CrS}$ ,  $\text{Ni}(\text{VO}_3)_2$ , and spinel oxides such as  $\text{NiCr}_2\text{O}_4$ .

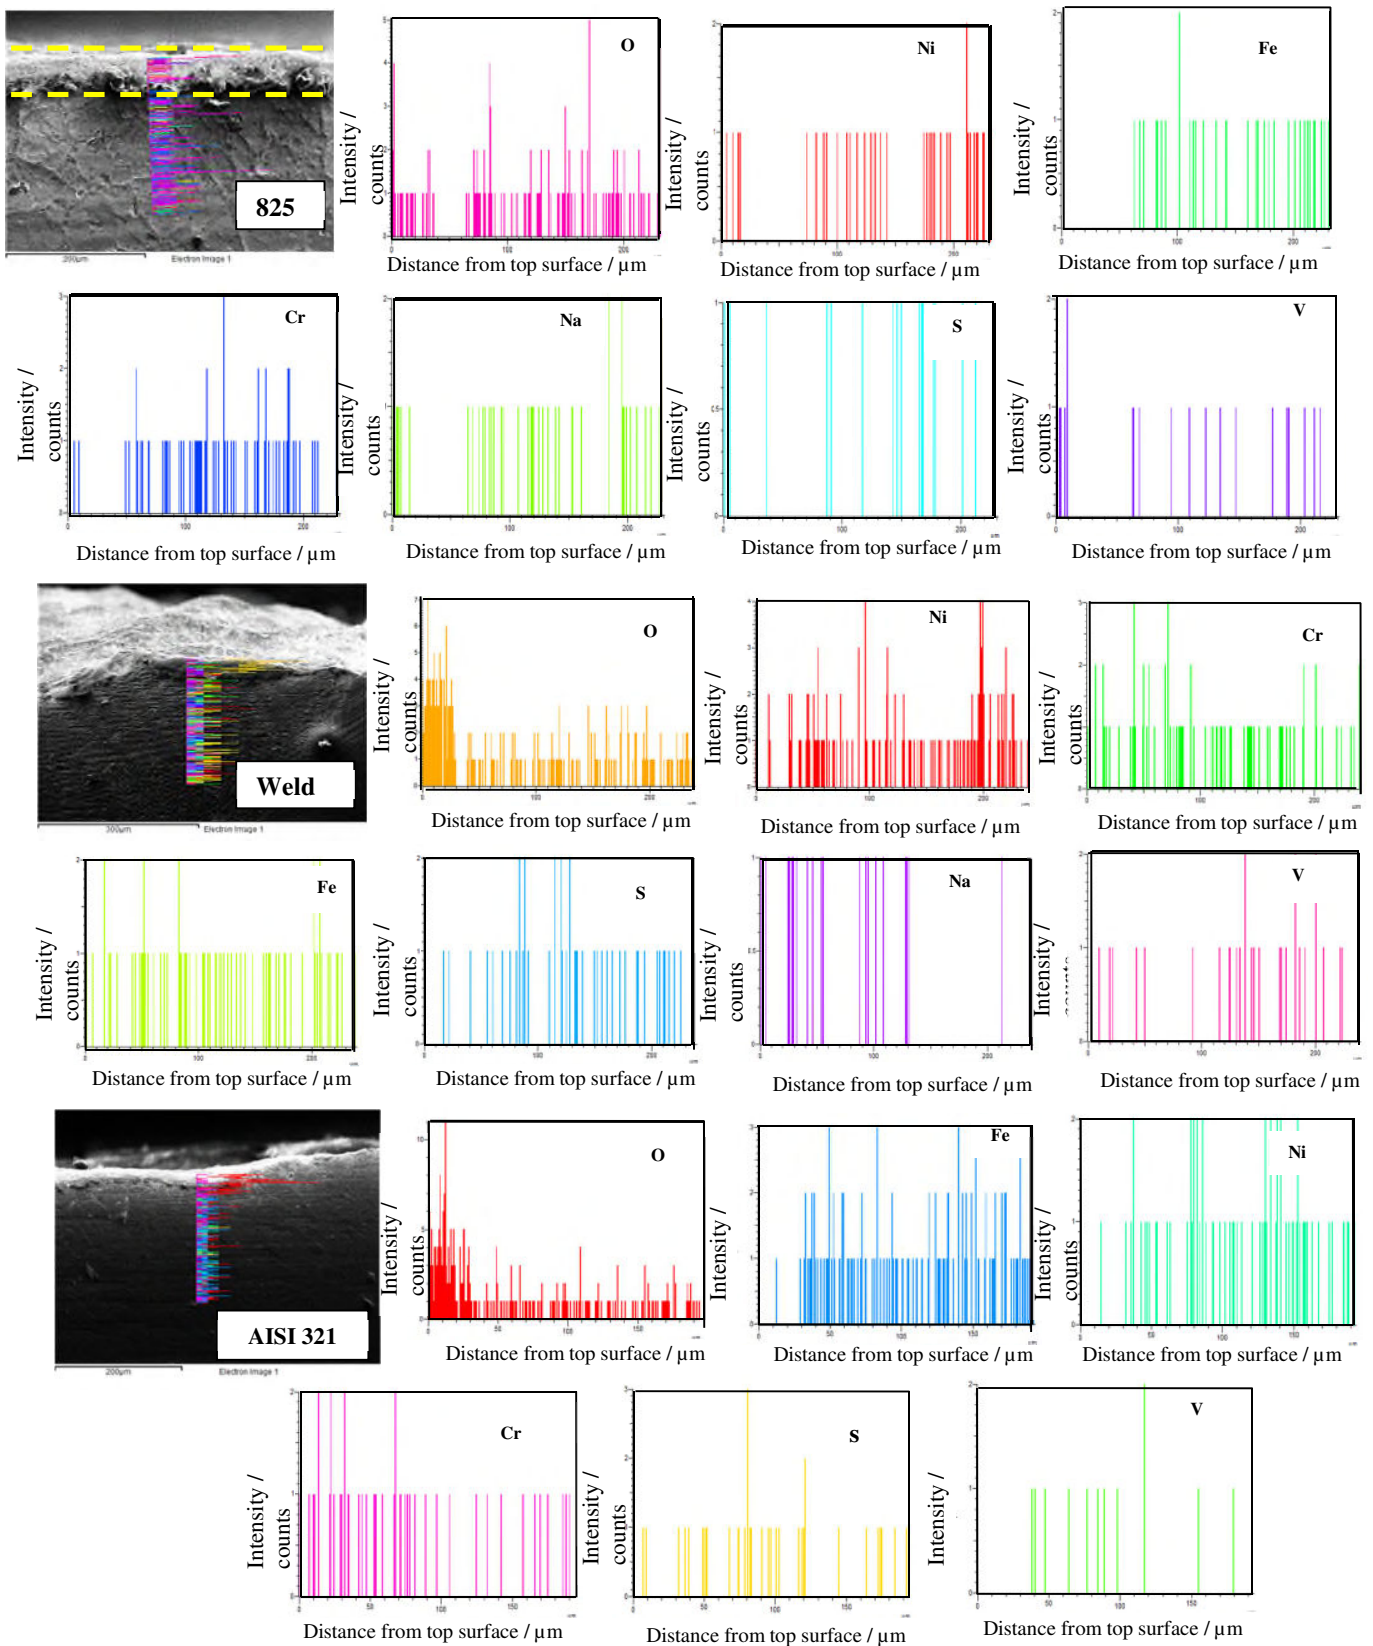
Fig. 13. SEM/EDS line mapping analysis on the uncoated dissimilar 825-321 weldments at cross section after hot corrosion at 900°C in Na<sub>2</sub>SO<sub>4</sub>-60 wt%V<sub>2</sub>O<sub>5</sub> environment.

To analyze the distribution of elements, EDS line mapping analysis was performed on three regions at cross sections: alloy 825, weld, and AISI 321. Fig. 13 shows the result of EDS line mapping cross-sectional analysis of the uncoated dissimilar 825–321 CO<sub>2</sub> laser weldment after hot corrosion at 900°C in an Na<sub>2</sub>SO<sub>4</sub>–60wt%V<sub>2</sub>O<sub>5</sub> environment. From the EDS line mapping analysis result, it can be inferred that the oxygen concentration was higher at the top surface of all the regions, which suggested higher oxidation. Other elements such as Ni and Cr were present in moderate amounts, while Fe was fully present on the regions of alloy 825, weld, and AISI 321; other corrosive elements such as S, V, and Na were also present in the top region. The SEM analysis of the cross section showed the presence of oxide scales on the alloy 825 region in the range of 45–50 μm, and very thin oxide scales were found in the weld and 321 regions due to more oxide scale spallation. High oxide scales spallation could be observed in the region of the AISI 321 region due to the rapid cyclic growth of Fe<sub>2</sub>O<sub>3</sub> oxide scales.

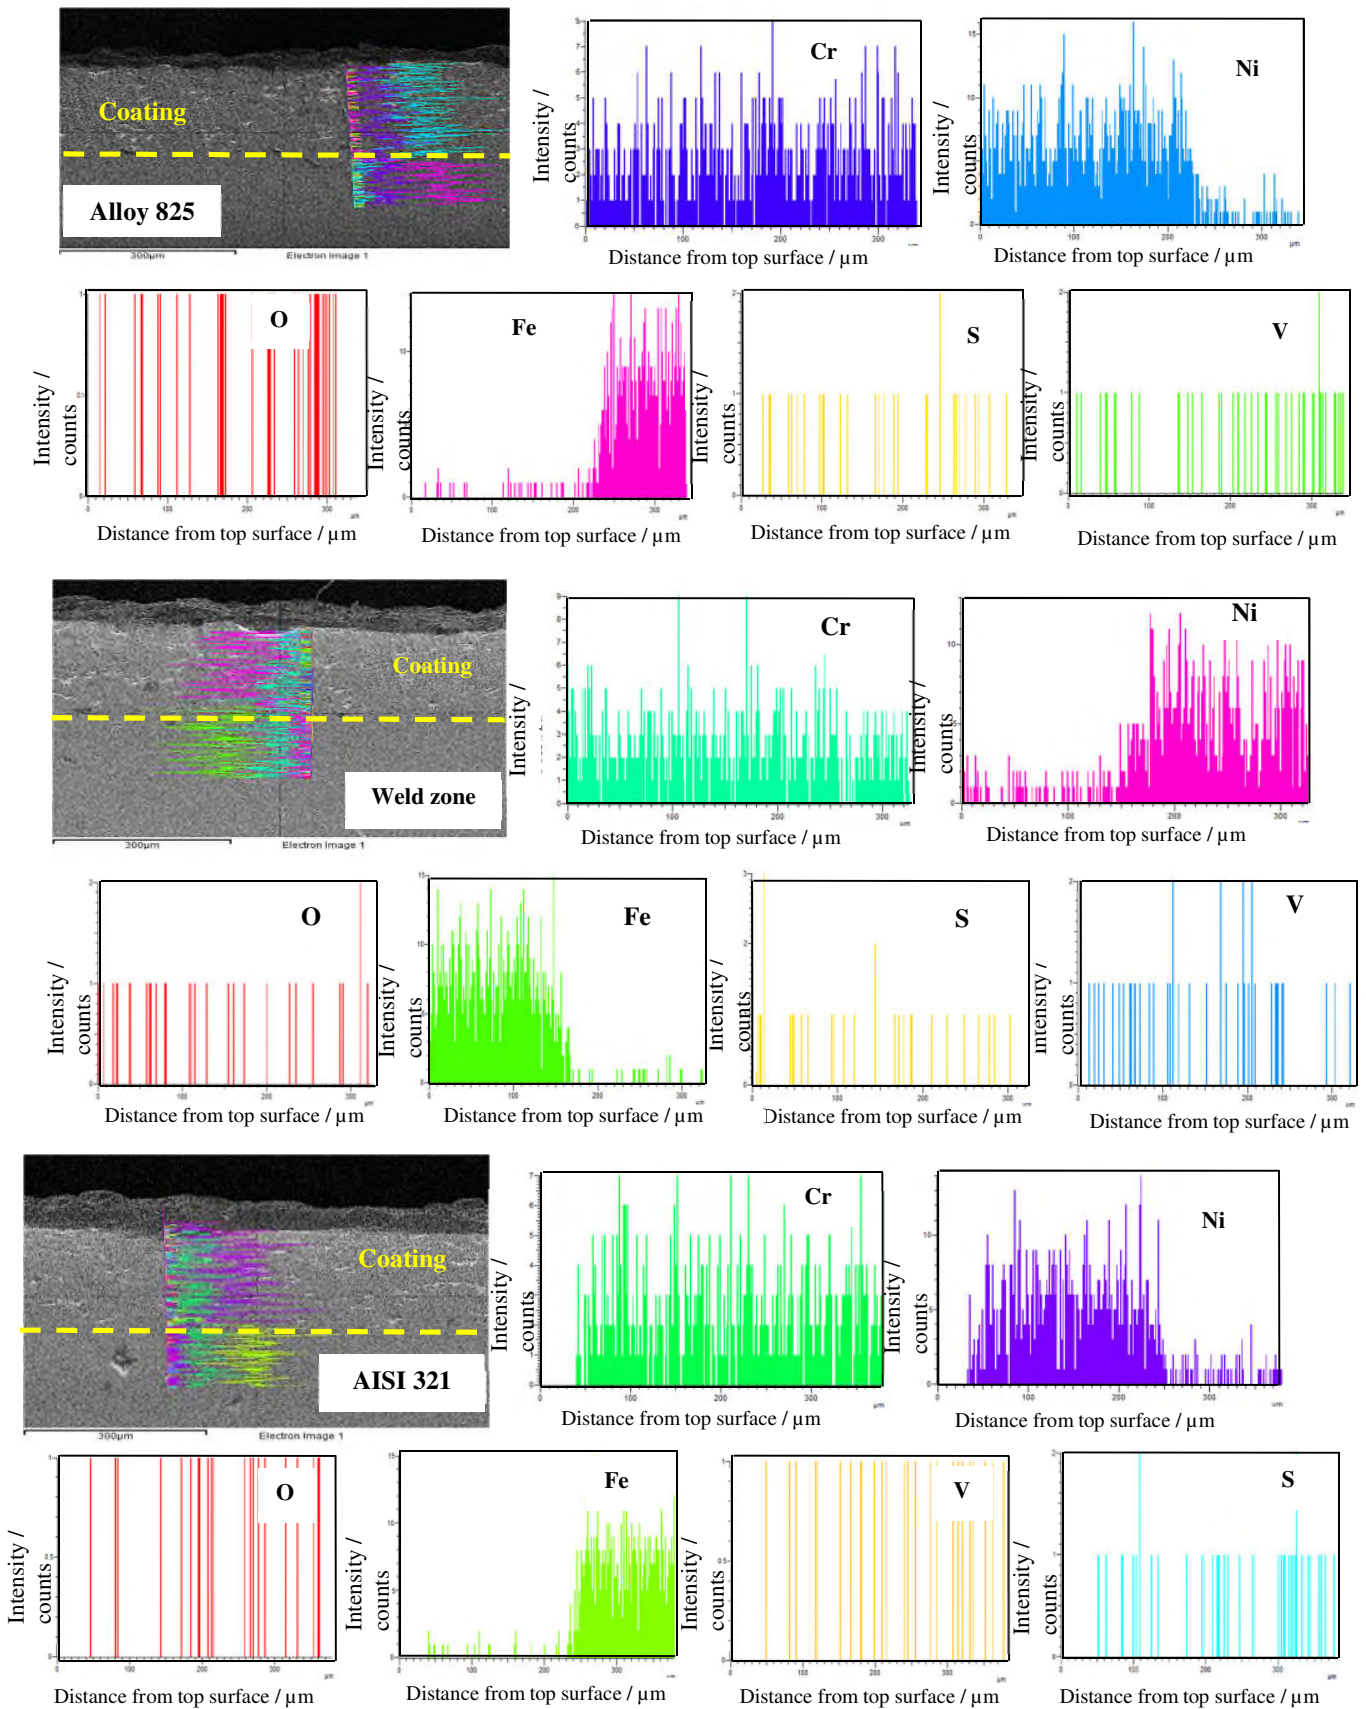
Fig. 14. SEM/EDS line mapping analysis on the HVOF-sprayed dissimilar 825-321 weldments at cross section after hot corrosion at 900°C in  $\text{Na}_2\text{SO}_4$ -60 wt%  $\text{V}_2\text{O}_5$  environment.

The cross-sectional SEM and EDS line mapping analysis results of the HVOF coating performed on the weldment after hot corrosion are depicted in Fig. 14. The SEM analysis result clearly describes that the coating showed good bonding to the weldment, and also no more cracks were found in the coating interface. The results indicate that the top surface of the coating mainly consisted of O, Ni, and Cr, which suggested the formation of NiO and Cr<sub>2</sub>O<sub>3</sub> scales. A minor amount of Fe was found in the coating region near the interface, which indicated the diffusion of Fe from the substrate [19].
