Citation: Borri, Antonio, Corradi, Marco and De Maria, Alessandro (2020) The Failure of Masonry Walls by Disaggregation and the Masonry Quality Index. *Heritage*, 3 (4). pp. 1162-1198. ISSN 2571-9408

# The Failure of Masonry Walls by Disaggregation and the Masonry Quality Index

**Abstract:** The visual method for assessment of the structural behaviour of historic masonry walls, known by the acronym MQI (Masonry Quality Index) was introduced in 2002 by a team of researchers from the University of Perugia, Italy. This is based on a visual survey of the faces and the cross section of a wall panel, and it aims at verifying if a wall complies with the “rules of the art”. Based on this analysis, it is possible to calculate a numerical index: numerous tests, carried out on site by the authors to validate the method, have demonstrated that the index is able to provide useful information about the mechanical characteristics and structural response, in general, of the analysed wall panel. The failure mode of a wall panel under the action of an earthquake is a critical aspect. In general, the failure modes can be categorized in two classes: masonry disaggregation and the development of a lo

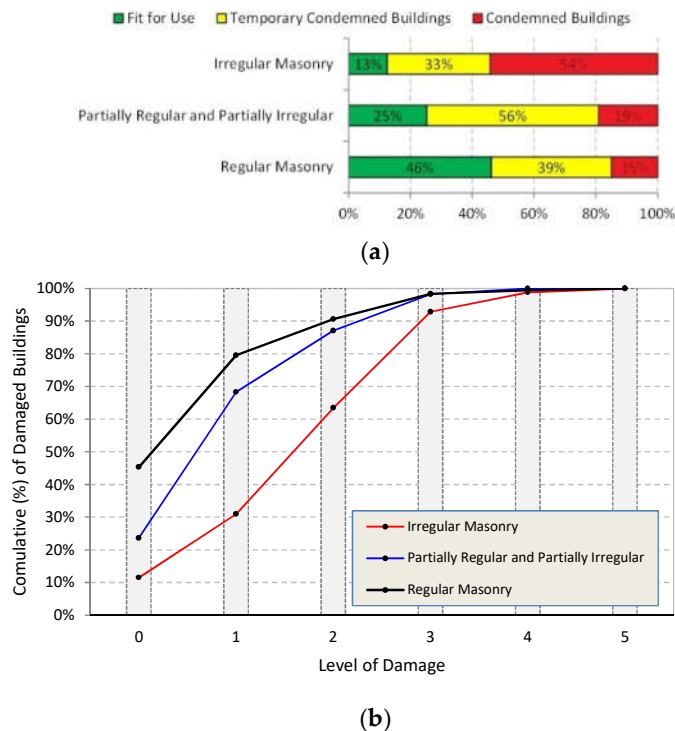
**Figure 1.** Results of the post-earthquake assessment of the existing building stock of Norcia, Italy (city centre): (a) classification in terms of masonry typology and (b) cumulative percentage of damaged/collapsed buildings in terms of level of damage (0 = no damage; 5 = building collapse).

Unfortunately, the situation we face is more complex: it is difficult to be placed inside well-defined relationships and we cannot say that the only reason for these collapses was the masonry low quality. For example, in addition to the low masonry quality, ineffective wall-to-wall connections, presence of horizontal out-of-plane static forces (for example, due to arched or vaulted structures), and other seismic vulnerabilities were often noted in collapsed buildings. However, a statistical analysis based on a large number of buildings and using the reports of the damage suffered by masonry buildings after the 2016 central Italy earthquake clearly demonstrated that the influence of the masonry quality is critical (Figure 1).

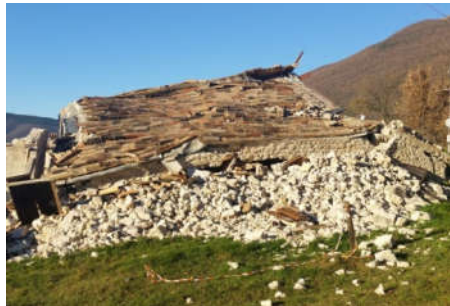
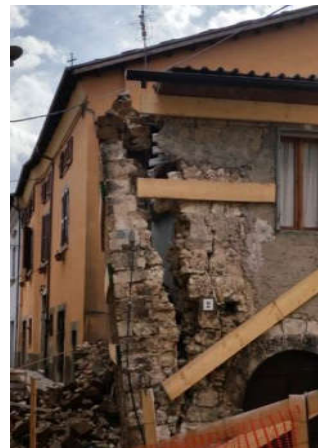
**Figure 2.** (a) Example of masonry disaggregation of a low-quality masonry in Campi Basso (Perugia, Italy), Italy, after the 2016 Central Italy earthquake and (b) an out-of-plane mechanism of a wall panel of a building in Norcia (Perugia, Italy), Italy (2016 Central Italy Earthquake).

the building and the presence of weakening elements, like openings in the walls, sections where the walls are narrow, and cracks caused by previous earthquakes. In particular, collapse mechanisms may develop from weak areas in the masonry (openings, preexisting cracks, recesses of walls, grafts of floors, etc.) (Figure 2b).

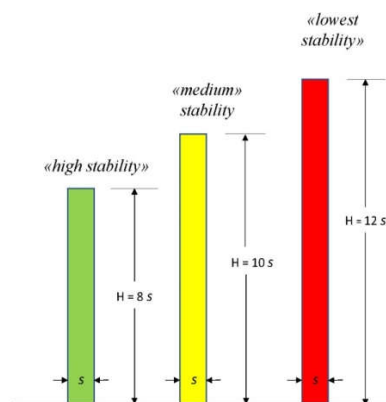
Figure 3. Stability of wall panels, according to Rondelet [27].

This collapse mechanism is mainly governed by the horizontal component of seismic acceleration. However, the vulnerability of the wall will considerably worsen if the earthquake is characterized by high vertical seismic acceleration [9,10]. This mechanism is well-known in the scientific community. This was studied by Giuffrè [22], Lagomarsino and Podestà [23], Lourenço et al. [24], and Borri et al. [25,26]. It is worth to cite here the conclusion drawn by Rondelet [27]: “overall stability is more important than acting forces for the analysis of the integrity of the buildings”. Rondelet states that the equilibrium of the wall panels of “all types of buildings” depends on their slenderness: “a wall panel will be highly stable if its thickness  $s$  is  $1/8$  of its height”, “the wall will exhibit a medium stability if its thickness is  $1/10$  of the height”, and “it will be almost unstable (lowest stability) if the wall thickness is  $1/12$  of its height” (Figure 3).

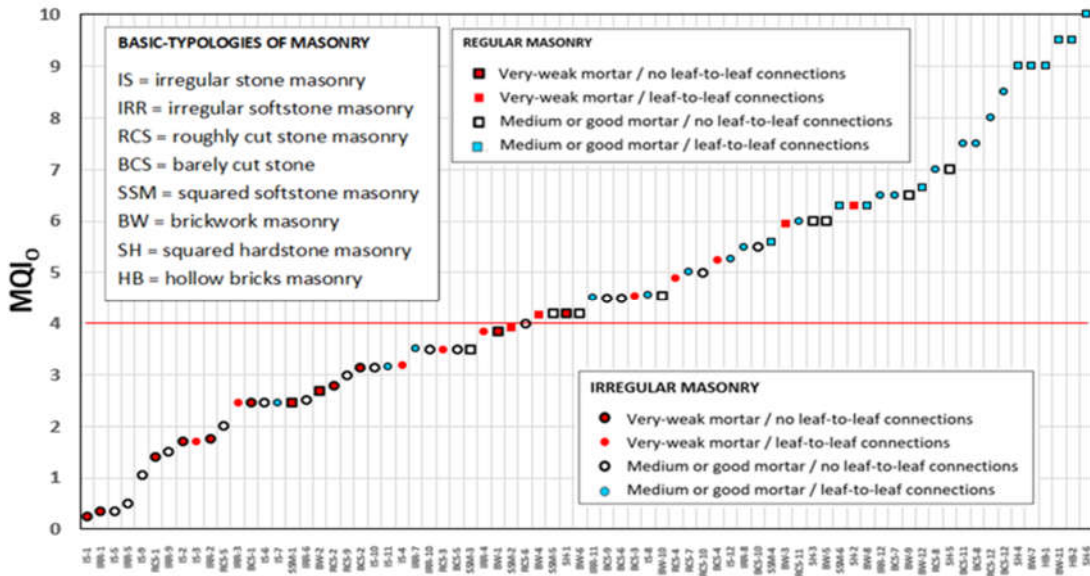
**Figure 7.** MQIo values for the masonry typologies suggested by the Italian Seismic Code: each masonry typology is identified by an abbreviation and by a number that corresponds to the description reported in Tables 4–10.

Figure 7 shows the MQI<sub>o</sub> values of the masonry typologies considered in the Italian Seismic Code. In addition to the MQI<sub>o</sub>, the figure specifies the quality of the mortar, the masonry arrangement (regular or irregular), and the level of connection between the wall leaves (for multi-leaf walls). A red line for a value of 4 of the MQI<sub>o</sub> divides the graph in two regions. It can be noted that the masonry typologies characterized by a very weak mortar, unconnected wall leaves, and an irregular arrangement are usually below this line. For these masonry typologies, we believe that it is likely to fail by disaggregation under the action of an earthquake. Oppositely, the MQI<sub>o</sub> values of masonry typologies, both regular and irregular, and characterized by a non-weak mortar and connected wall leaves is typically higher than 4 (Figure 7).

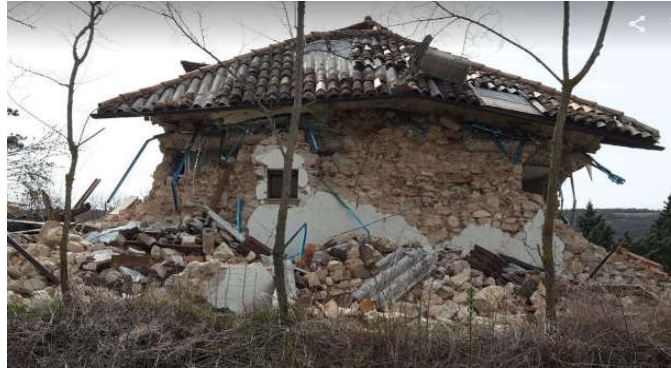
**Figure 8.** A collapsed building in Campi Basso, Norcia, Italy: The masonry (combination No. 1 of Table 4) of this building disaggregated during the earthquake.

This is the basic masonry typology where disaggregation is more frequent. Based on our database, it is rare that entire buildings or wall members made of this basic masonry typology can crack when subjected to the seismic action without disaggregating. This happened only when the quality of the mortar was not too weak and there were horizontal mortar bed joints and headers (combination No. 8 in Table 4) or when the mortar was good and there were some headers (combination No. 11 and 12 in Table 4). Table 4 shows the combination of 3 different critical parameters (quality of the mortar (possible outcomes: very weak, medium, and good), horizontality of the bed joints (yes or no), and level of connection between wall leaves (yes or no)), resulting in 12 masonry types. Figures 8 and 9 show two different masonry typologies where masonry disaggregation was noted (Figure 8) and did not occur (Figure 9) during recent seismic events in Italy.

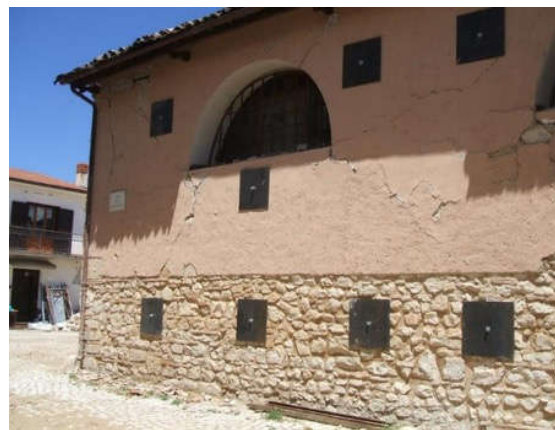
**Figure 9.** Stonework building in Onna, near L'Aquila in Italy: the arrangement of the stonework is uniform, and the masonry texture is well-organized (homogeneity of the stones and random presence of bricks to improve the overall wall's stability) (combination No. 12, Table 4). It can be noted that this wall was consolidated using a deep repointing the mortar joints. The medium dimensions of some stones suggest a good connection between wall leaves. The masonry material of this building did not disaggregate during the 2009 Aquila earthquake. It should be also highlighted here that most historic masonry buildings of Onna, typically made of a masonry of lower quality, disaggregated during the 2009 earthquake [28].

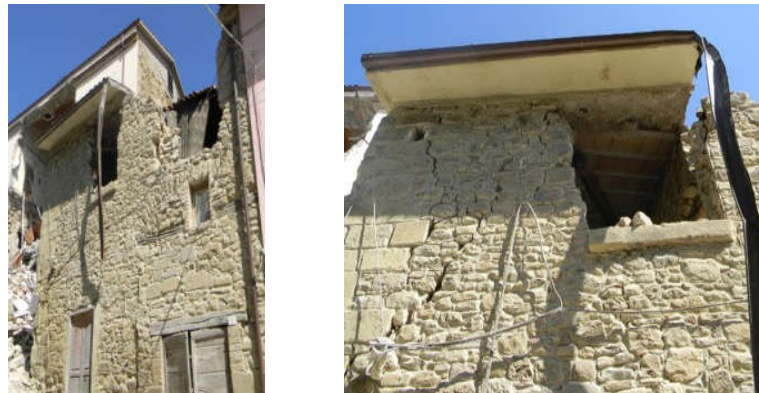
**Figure 10.** A building in Accumoli, near Rieti, in Italy: a large number of large cut stones was used here. This highly increased the level of connection between the wall leaves (combination No. 7, Table 5: cut stone masonry, medium-quality mortar, and effective connection between wall's leaves). For the upper part of this building, the quality of the masonry is lower and the wall leaves seem unconnected (combination No. 5, Table 5: cut stone masonry, medium-quality mortar, and non-effective connection between wall's leaves). The masonry of the upper part of this building disaggregated during the 2016 Central Italy earthquake.

This basic masonry typology (made of roughly cut stones, *conci sbozzati* in Italian) is very common in Italy, and a large number of slightly different types of masonry can be categorized here (Figure 10). Under the action of an earthquake, the failure modes can be both by disaggregation or in-plane cracking. The most important parameter, governing the failure mode, is the quality of the mortar. Masonry made with very-low quality mortar typically failed by disaggregation, with the only exception of walls with horizontal bed joints and headers (Table 5).

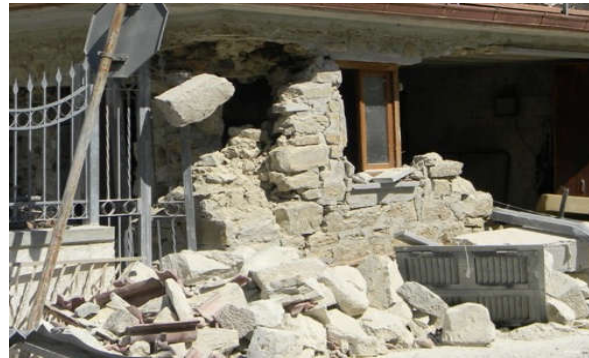
**Figure 11.** Pescara del Tronto, near Ascoli Piceno, in Italy. This is an example of cut-stone masonry, very weak mortar, unconnected wall's leaves (Combination No.2, Table 6). The building failed due to masonry disaggregation.

It is worth noting that “barely cut stones” (*pietre a spacco* in Italian) are mechanically worked stones (Figure 11). These stone blocks are more regular than roughly cut stones (described in Section 6.1.2). Walls made with barely cut stones exhibited a satisfactory structural response when struck by seismic action. Only when the used mortar was very weak and there were no headers in the walls was masonry disaggregation noted (Table 6).

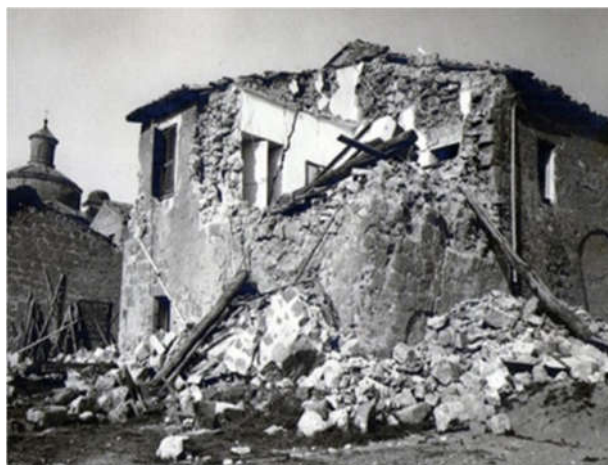
**Figure 12.** Tuff stone building in Tuscany, Italy, after the 1971 earthquake: the masonry typology can be classified in combination No. 1 of Table 7: irregular stones, non-horizontal bed joints, unconnected wall leaves, and very weak mortar. The failure mode is by disaggregation.

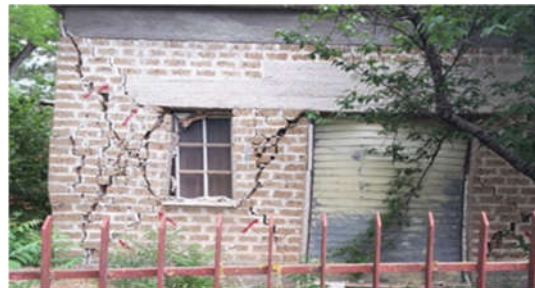
**Figure 13.** Tuff block masonry of a building in Norcia, Italy: the quality of the mortar is good (combination No. 6, Table 8). The 2016 earthquake caused the shown failure mode: it can be noted that cracks diffusively opened in the tuff blocks, while this is very rare if the mortar quality is weak. Masonry disaggregation usually does not occur for this masonry typology.

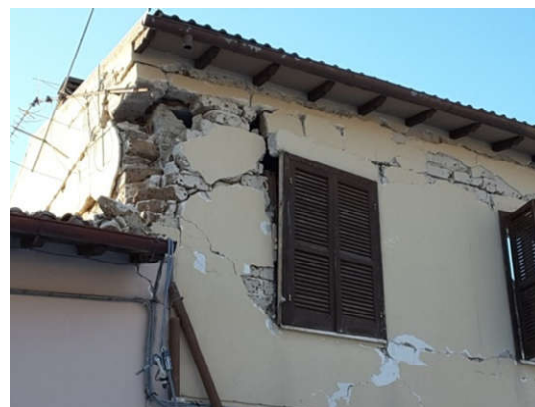
**Figure 14.** A tuff masonry building in San Pellegrino (Norcia, Italy): the masonry was made of squared tuff blocks and a very weak mortar (combination No. 2, Table 8). Cracking mainly occurred in the bed joints. The 2016 Central Italy earthquake caused a failure mode by horizontal sliding of the upper part of the building, likely activated by significant vertical component of the seismic action. The phenomenon of masonry disaggregation can be noted at the corner.

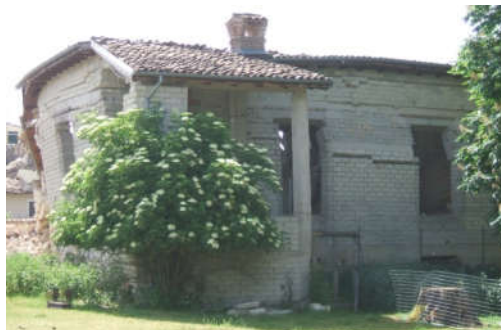
**Figure 16.** A building made of concrete block and irregular stones in Onna, Italy.

Particular situations are not rare, and these are not considered by the Italian Seismic Code. As an example, Figure 16 shows a building in Onna, Italy, where the load-bearing walls were made of two different types of masonry: some walls were made of irregular stone masonry (pebbles, and erratic and irregular stones) (combination No. 1, Table 4). For other walls of the same building, solid concrete blocks were used. During the 2009 Aquila earthquake, the irregular stone walls disaggregated while the concrete block wall diffusively cracked, without falling apart. The MQIo index of the stone walls is very low (0.35), while it reaches the value of 9 for the concrete block ones.

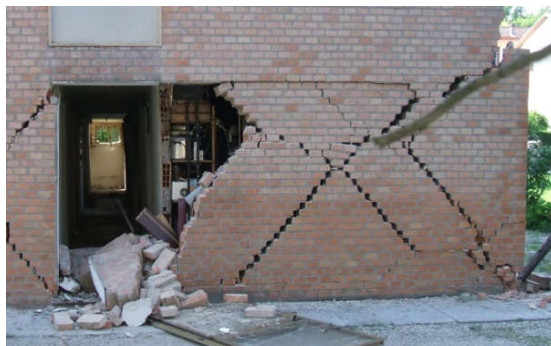
**Figure 17.** Failure mode of a building made of bricks and cement mortar (San Possidonio, Italy).

Another interesting case study is shown in Figure 17. Again, the masonry typology cannot be assigned to one of the types suggested by the Italian Seismic Code. This is a brickwork building located in San Possidonio, in Emilia Romagna. The mortar is made of cement, and the type of bond is heading bonding pattern. The 2012 earthquake caused in-plane shear cracking without masonry disaggregation phenomena. The MQIo is 8.5.

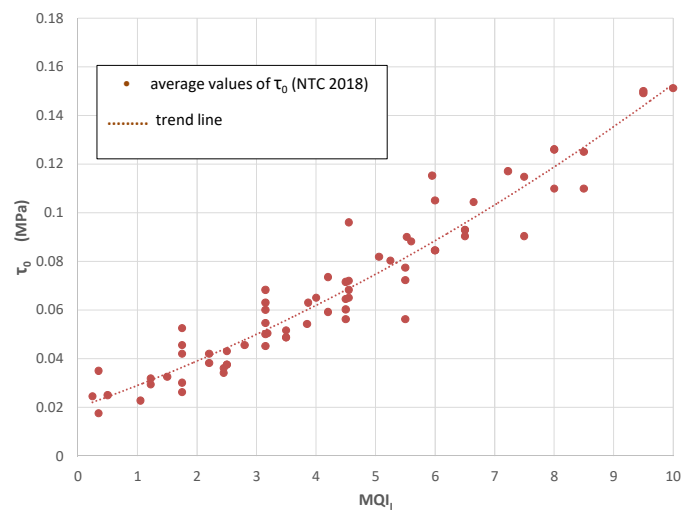
**Figure A3.** Masonry shear strength  $\tau_0$  vs.  $\text{MQI}_i$  (NTC 2018, Italian Seismic Code, 2018).

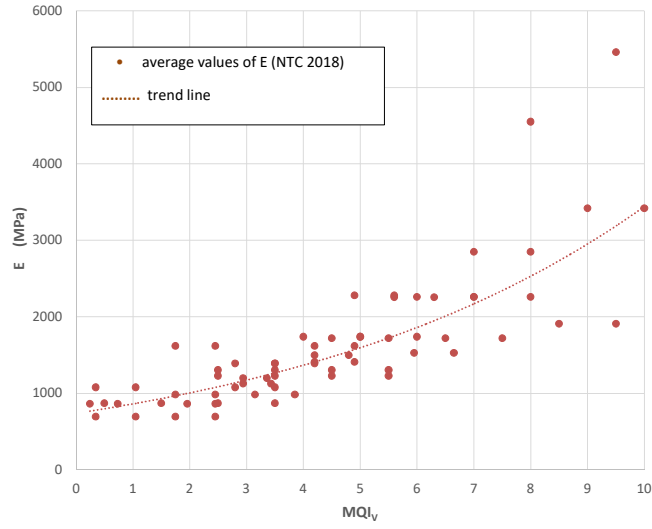
Figure A4. Masonry Young's modulus  $E$  vs.  $MQI_v$ .

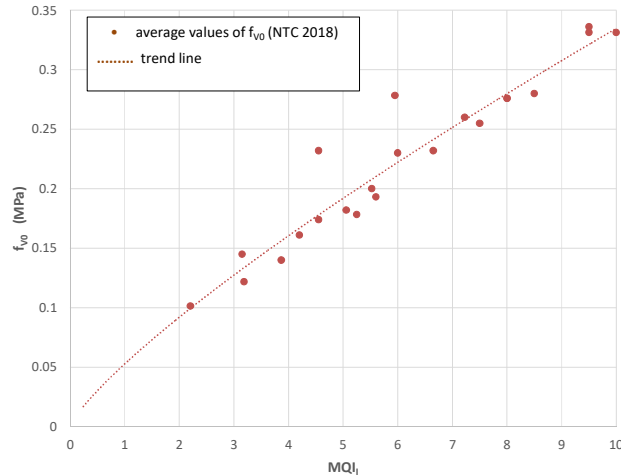
**Figure A7.** Masonry shear strength  $f_{v0}$  vs.  $MQI_I$ .

$$f_{v0 \text{ mean}} = 0.0475 \text{MQI}_i^{0.854} \quad R^2 = 0.928$$

$$f_{v0 \text{ max}} = 0.0654 \text{MQI}_i^{0.822} \quad R^2 = 0.918$$

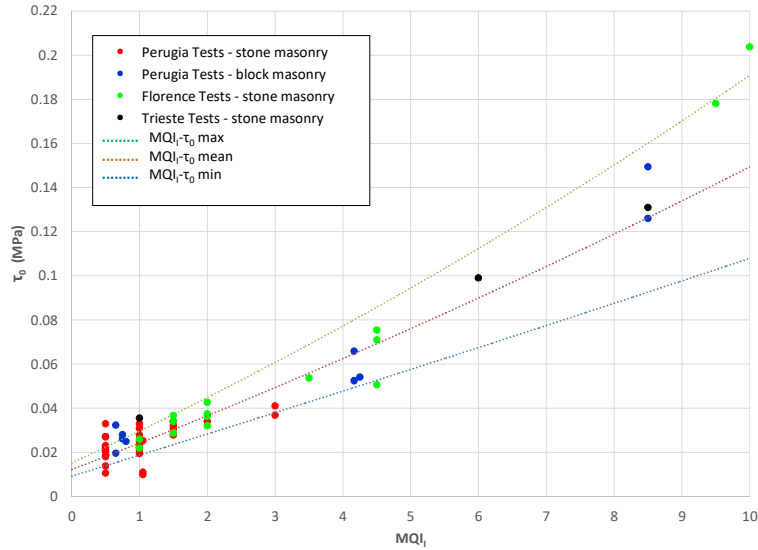
**Figure A8.** MQI<sub>r</sub> vs. shear strength  $\tau_0$ : experimental results are compared with suggested relationships.

Sixty experimental results of diagonal tension tests have been used for calibration purposes. These tests (55 conducted on-site and 5 in the laboratory) have been carried out on full-scale wall panels ( $1.2 \times 1.2$  m). Tests used for calibration were carried out at the University of Perugia, Florence and Trieste. On-site testing was performed in buildings located in Italy (Umbria, Abruzzi, Emilia Romagna, and Tuscany regions). In Figure A8, shear strength values  $\tau_0$  from on-site testing [31,32] are correlated with  $MQI_I$  values. It can be noted that the MQI method is able to provide an adequate estimation of the masonry shear strength: most experimental results fall in between the two upper and lower bound curves of the suggested  $\tau_0$  vs.  $MQI_I$  relationship.
