Descriptive Analysis of the Performance of a Vegetated Swale through Long-Term Hydrological Monitoring: A Case Study from Coventry, UK

Article

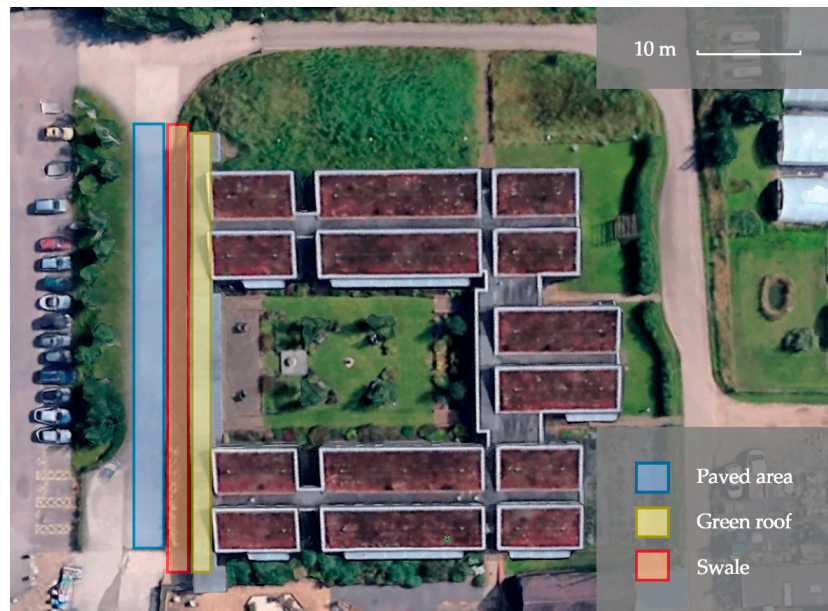
Figure 2. Drainage area and downspouts draining the runoff from the adjacent extensive green roof.

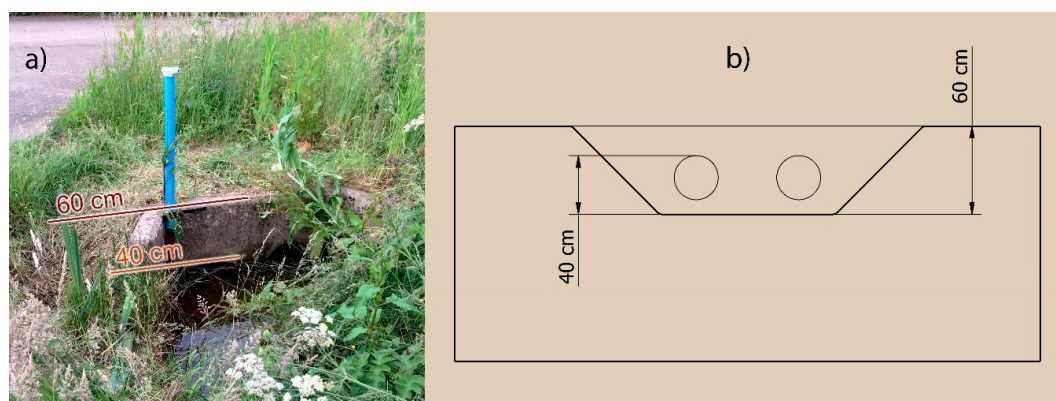
Water level monitoring allowed the authors to determine the performance of the swale from a hydrological perspective, by identifying the temporary ponding produced by different storm events over the 3 hydrological years. This temporary ponding enabled the detection of those rainfalls that produce sufficient runoff to exceed the hydraulic capacity of the system, and overflow. The water levels used to pinpoint the 2 levels of hydraulic failure were defined as the diameter of the pipes placed at the discharge point (0.40 m), whilst flooding issues were depicted as those values recorded over the maximum ponding depth (0.60 m) (Figure 3). Then, those water level records registered above these threshold values, would mean that the system failed to cope with the storm event under one of the two levels of security considered.

Figure 3. Water levels of hydraulic failure indicated at the discharge point (a) and its cross section (b).

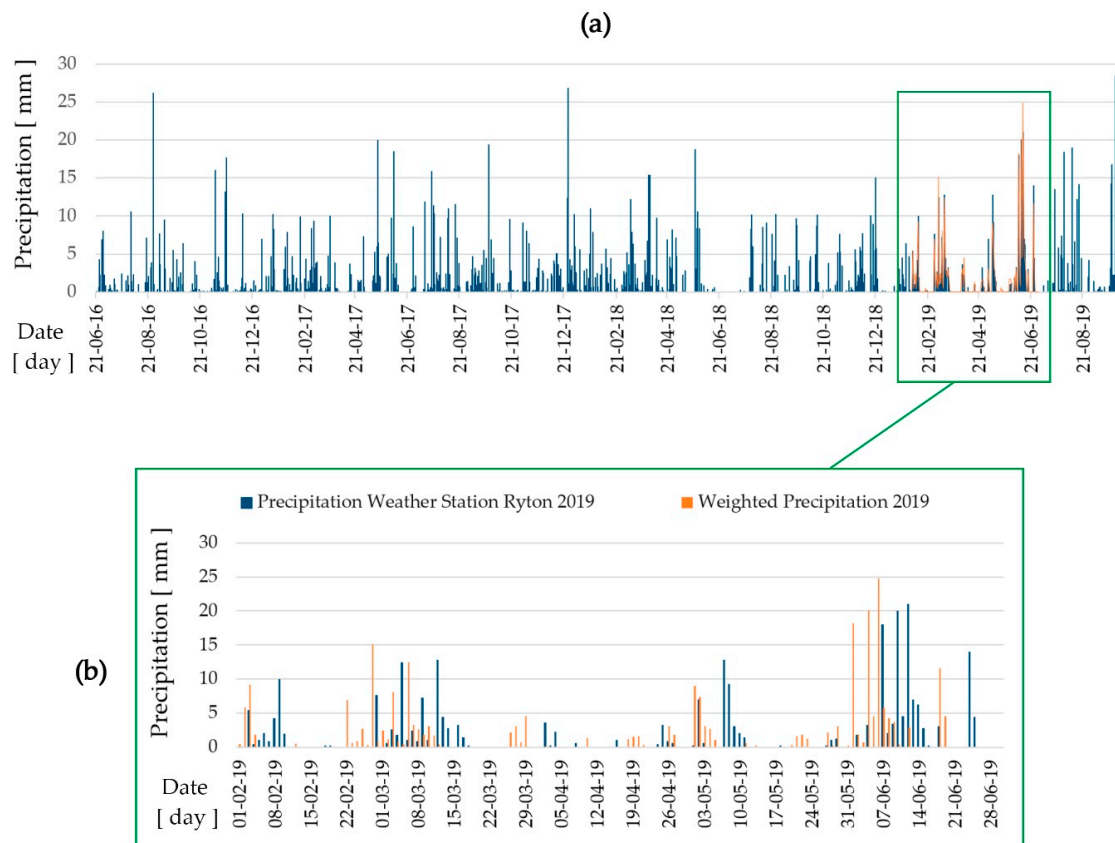
This methodology provided the following calibrated weather data for the whole period of monitoring where the first 31 months followed the method of calculation showed above and the last 6 months used the data from the weather station located on-site (Figure 4).

Figure 4. Weather data at the experimental site for (a) the entire monitoring period and (b) the 6 months of calibration.

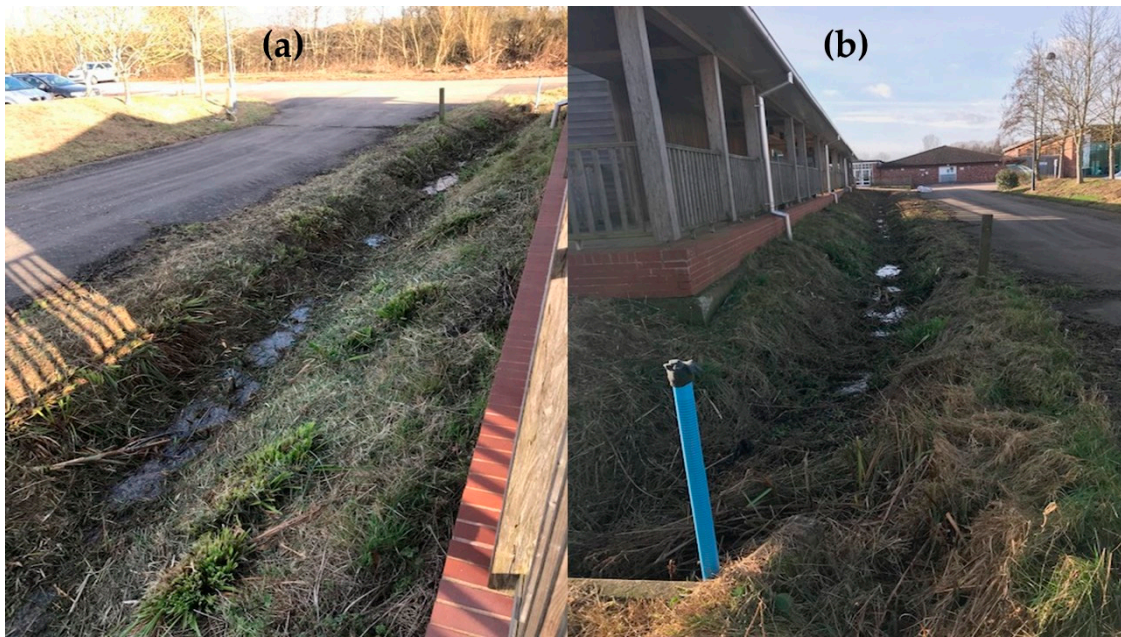
Between 2016 and 2019, the swale received only superficial reactive maintenance, consisting primarily of an autumnal cut of large vegetation such as the removal of weeds >300 mm in height and coppicing of saplings that had established in the swale. This reduced the visible growth in the winter periods, with an annual regrowth occurring the following spring. A change of ownership of the site occurred in early 2020, resulting in a clear cut and complete removal of vegetation on 3 February 2020 (see Figure 5).

Figure 5. Detail of the swale after complete removal of vegetation (February 2020): (a) South-west sight of the swale; (b) North-east view of the swale from the discharge point and the monitoring device.

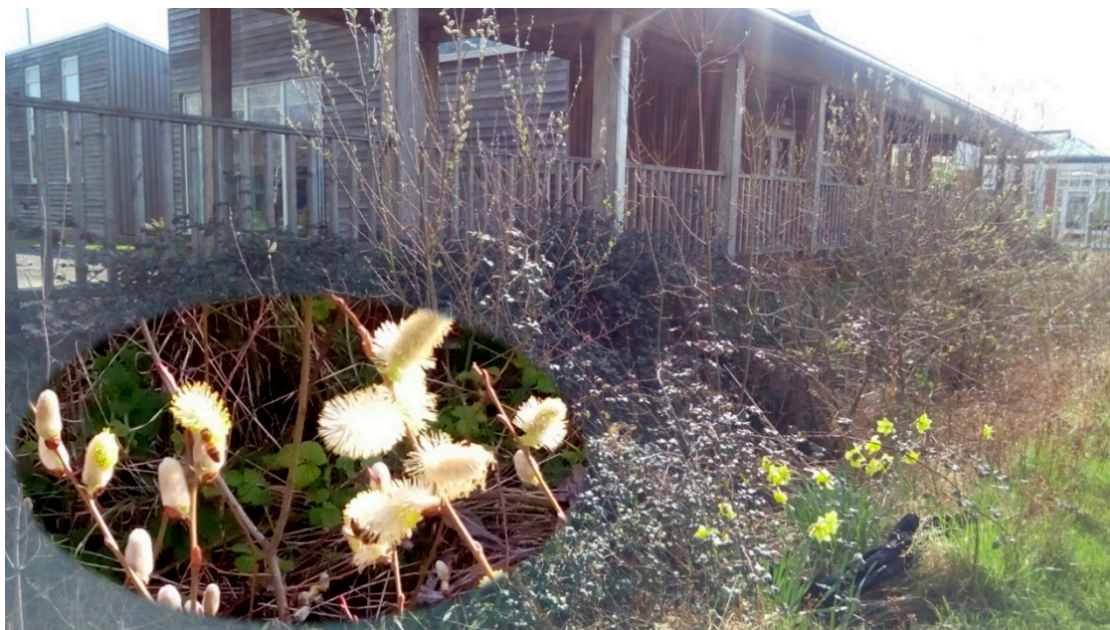
The maintenance schedule allowed the growth of vegetation (see Figure 6) which involved a certain degree of biological evolution, potentially transforming the ecosystem service provided by the system. The removal of large vegetation could prevent out-competition of beneficial plants, such as those that support pollinators, but could limit the hydraulic attenuation of the swale by reducing evapotranspiration and vegetative obstacles to flow.

Prior to the reactive maintenance, there was evidence that the swale had some biodiversity and ecosystem services value, with extensive bramble growth (*Rubus fruticosus*), goat willow (*Salix caprea*), bulrush (*Typha latifolia*), common nettle (*Urtica dioica*) and daffodil (*Narcissus*), as shown in Figure 5. Several species of grass were present, and the majority of the plants encountered were self-seeded, coming into the swale from vegetation adjacent to the swale. Authors noted several specimens of pollinating insect using the swale, including honeybees, bumble bees, hoverflies, butterflies and moths (Figure 6).

Figure 6. Detail of the swale before maintenance works. Picture taken looking from North-east to South-west from the mid-point of the swale's length in early Spring 2019.

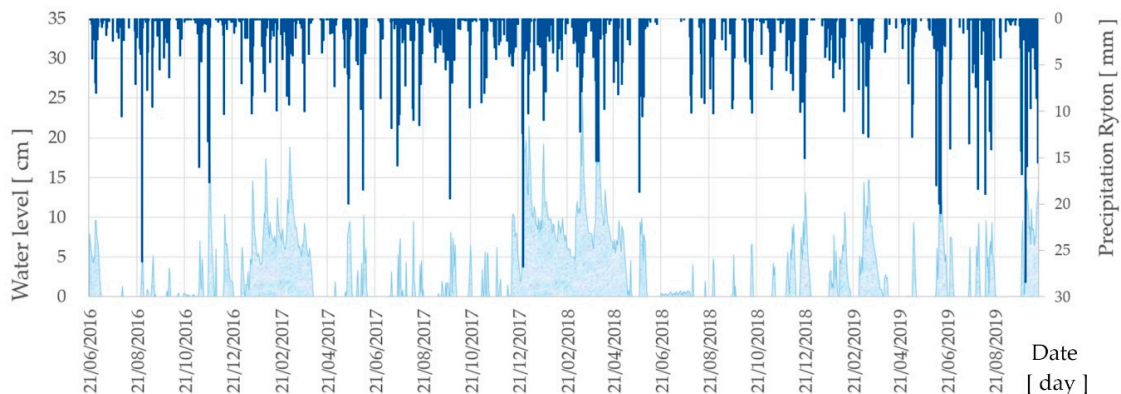
Three hydrological years were monitored for this study, showing varying storm events from low values to storm events with peaks over 25 mm. Figure 7 shows the direct impact of the storm events on the hydrology of the vegetated swale, by the increment in the water level at the discharge point.

It was possible to identify a repeated pattern in 2018 and 2019 for the water level in winter, especially between December and March where water levels ranged between 5 and 15 cm, with some peaks over 20 cm. However, the winter of 2019 shows an irregular performance with some valleys showing no detectable water level.

Figure 7. Water level and rainfall registered during this research.

Summers indicated lower water levels from 0 to 10 cm (Figure 7) and many consecutive days with no temporary water standing in the swale. This long-term descriptive analysis allows the identification of those periods where the vegetated swale varies from dry swale to wet swale, including the identification of maintenance operations marking changes between grassed swale functions and the provision of wet land services with relevant growing of vegetation which will be described in the operation and maintenance sub-section (3.3).

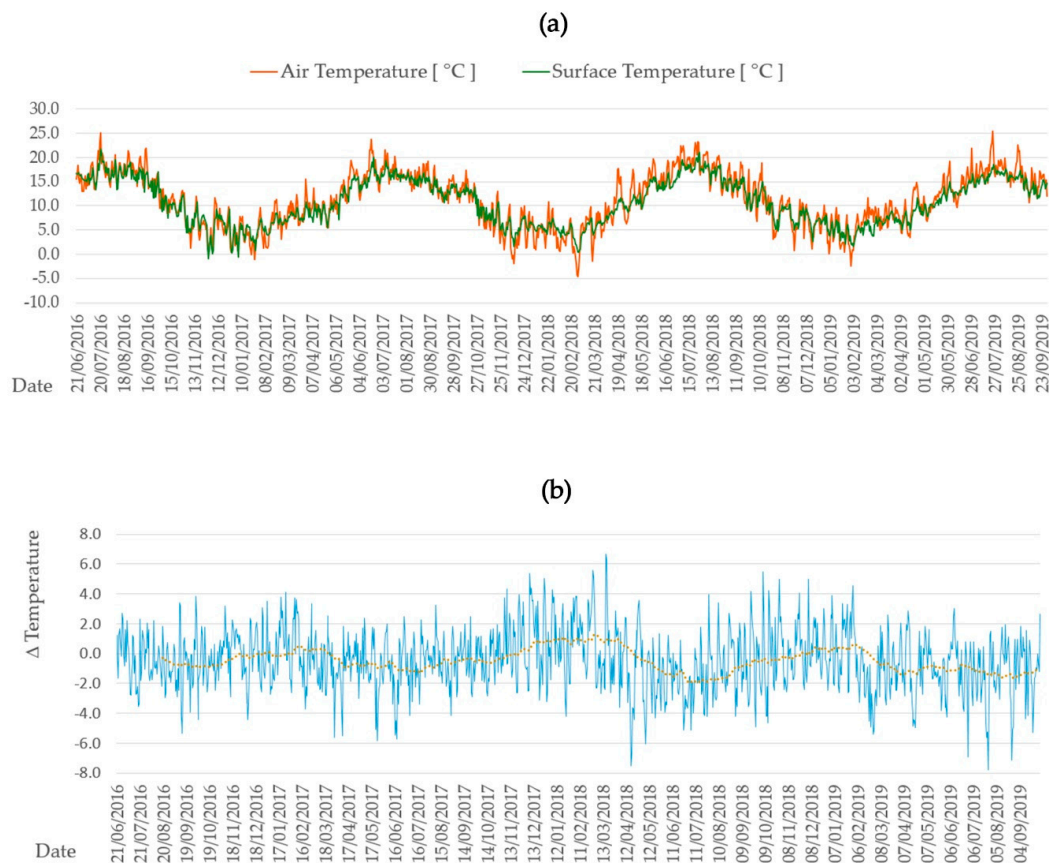
Seasonality effects were captured in the field monitoring, being especially clear in the descriptive analysis of the temperatures, recorded in the surface of the vegetated swale. Air temperature also followed the same trend, with peaks in summer and valleys in winter (Figure 8).

Figure 8 shows that the difference in temperature between the surface of the swale, and the air is pronounced, with much greater extremes in the air temperature. This difference reaches 4–6 °C with peaks up to 8 °C in the summer period. On the other hand, the variation is positive towards the surface in winters, reaching 1–2 °C of difference, being between 4 and 6 °C in the most favourable cases. This is another point of interest for researchers regarding the consistency of the temperature variation between the air and the swale, considering the climatic conditions for this study. In addition, this data could be of particular relevance to local authorities looking to reduce the urban heat island (UHI) effect in urban environments through the implementation of SuDS techniques. In the case of this swale, the temperature behaviour provided by the system was consistent and robust. No high extreme values were registered for the temperature of the swale surface despite the fact that the UK had some of its warmer summers during this monitoring period, as described in Section 2.1.

Figure 8. (a) Surface water temperature (°C) and air temperature (°C) registered during the monitoring period; (b) temperature variation between the surface and the air.

This temperature behaviour presented in Figure 8, reinforces the idea of the design of greener SuDS, such as devices housing GSHP technologies, reported by Charlesworth et al. [14]. Rey-Mahía et al. [15], in their laboratory simulation of the combination of swales and GSHP technologies, presented a range of temperature performance that can be compared to this field study in order to find out whether this laboratory study could be applied to the swale in Ryton, Coventry, UK. Figure 8 shows that even in the worst scenario, represented by air temperature falling below 0 °C several times over the 3 year period of the study (nearly −5 °C in early 2018 as the lowest temperature registered during the monitoring period), the surface temperature for the swale maintained consistent values above 0 °C, temperatures which would be expected to be even higher in the ground below the swale surface. Consequently, the GSHP system could work continuously. Following on from this potential application, the swale surface registered mean temperature values around 5 °C in winter and 17 °C in summer, providing future studies with valuable information to feed their simulations and modelling investigations.
