The Evolution of Corryong/Nariel Creek since European Settlement: Implications for On-going Management Prioritisation

Elisha A. Teo^{1,2}, Philip M. Marren¹

7ASM Full Paper

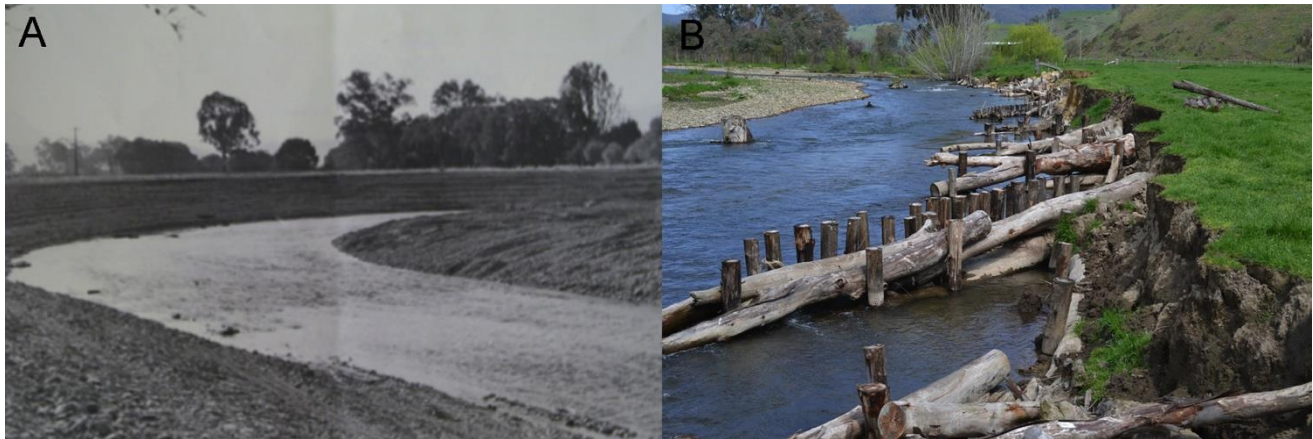
Figure 1. Different sections of the same reach in A) 1956 and B) 2012. Earlier river management works involved severe channel straightening and realignment. It is presumed that these works have caused the channel instability issues still currently faced, leading to more stabilising works being implemented since.

The entire length of the river has been subject to stream management works of some manner (Water Victoria, 1989). Initial river engineering in the 1960s and 1970s involved major channel straightening and realignment that were meant to increase the rate of drainage (Figure 1). Unfortunately, channel instability increased and a large flood in 1972 led to avulsions through farmland. Farmers responded by fencing the channel and planting willows (Webster, 2006). Gravel was also excavated from banks to build roads during this period, leaving banks exposed and unstable (Webster, 2006). Since the establishment of the Shire's River Improvement Trust (now the North East Catchment Management Authority), attempts to radically modify channels have ceased. Projects now focus on regaining channel stability through rocking and tethered logs (Figure 1). A few reaches have also received artificial gravel deposition by NECMA to decrease stream power.

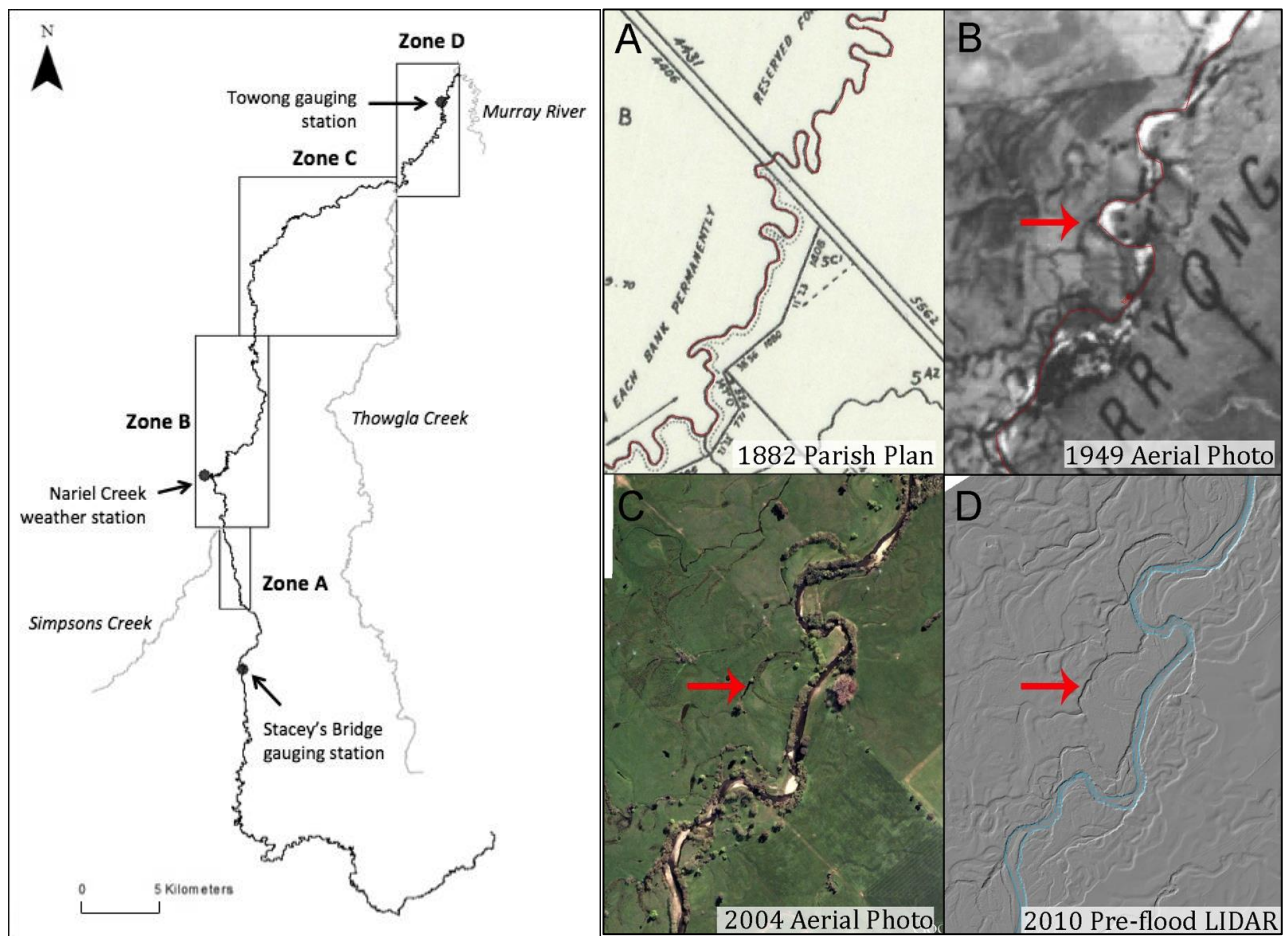
Figure 2. Map of Corryong Creek (left), depicting the separate Zones, the Nariel Creek weather station and Stacey's Bridge gauging station. Panels A to D show the same reach captured by different sources. The red arrows point out a meander that was once present but the scar of which still remains.

Measurements were made from the point alluvial channel began to the confluence with the Murray River (Figure 2). The study reach was divided into four zones (Zones A to D). Zone boundaries were defined at major confluences and at the margin between partially-confined and unconfined valley settings to account for the geomorphic effects of discharge volume and valley confinement. Zone A, which has a discontinuous floodplain, ends at the confluence of Corryong and Simpsons Creek. The end of Zone B marks the end of the discontinuous floodplain and the large widening of the valley downstream. Zone C continues just upstream of the confluence of Corryong and Thowgla Creek, from which Zone D extends to the River Murray. Using ArcGIS, 14 captures of channel form spanning 1883 to 2011 were digitised from parish plans, aerial photos, a geological map, and LiDAR (Figure 2). Due to the decreasing resolution of data with age, the planform centreline (and therefore sinuosity) was the only consistent channel parameter measured throughout this time series. Average channel widths and amount of sediment deposition for each reach (quantified using the surface area of exposed sediment) were only measurable for the 1985, 2004, 2010 and 2011 captures.

Changes in climate were determined using rainfall (1884 to 2013) and river flow records (1954 to 2013) obtained from Nariel Creek weather station and Stacey's Bridge gauging station (Figure 2). Post-1954, flood recurrence intervals were established using a Log Pearson III flood frequency analysis of instantaneous daily discharge data. When identifying periods of high flow, bushfire events were also noted since they have a hydrological effect of increasing discharge. Newspapers and DEPI photos confirmed major floods. The presence of cyclical flood regimes was tested by applying the statistical methods used by Riley (1981), Brooks & Brierley (2000) and Erskine & Townley-Jones (2009). A single factor analysis of variance (ANOVA) test determined significant differences between rainfalls of different climate regimes (Riley, 1981; Brierley et al., 2005). To identify and analyse temporal changes in rainfall unique to Corryong, an intervention analysis was performed using the cumulative sum technique (CUSUM). This was followed by a Wilcoxon Rank Sum test (Erskine & Townley-Jones, 2009). ENSO/IOD periods were defined using Meyers et al. (2007) and the Bureau of Meteorology. Rainfall and flow anomalies for each ENSO/IOD combination categories were gathered, as conducted by Ummenhofer et al. (2009), and tested statistically using ANOVAs.

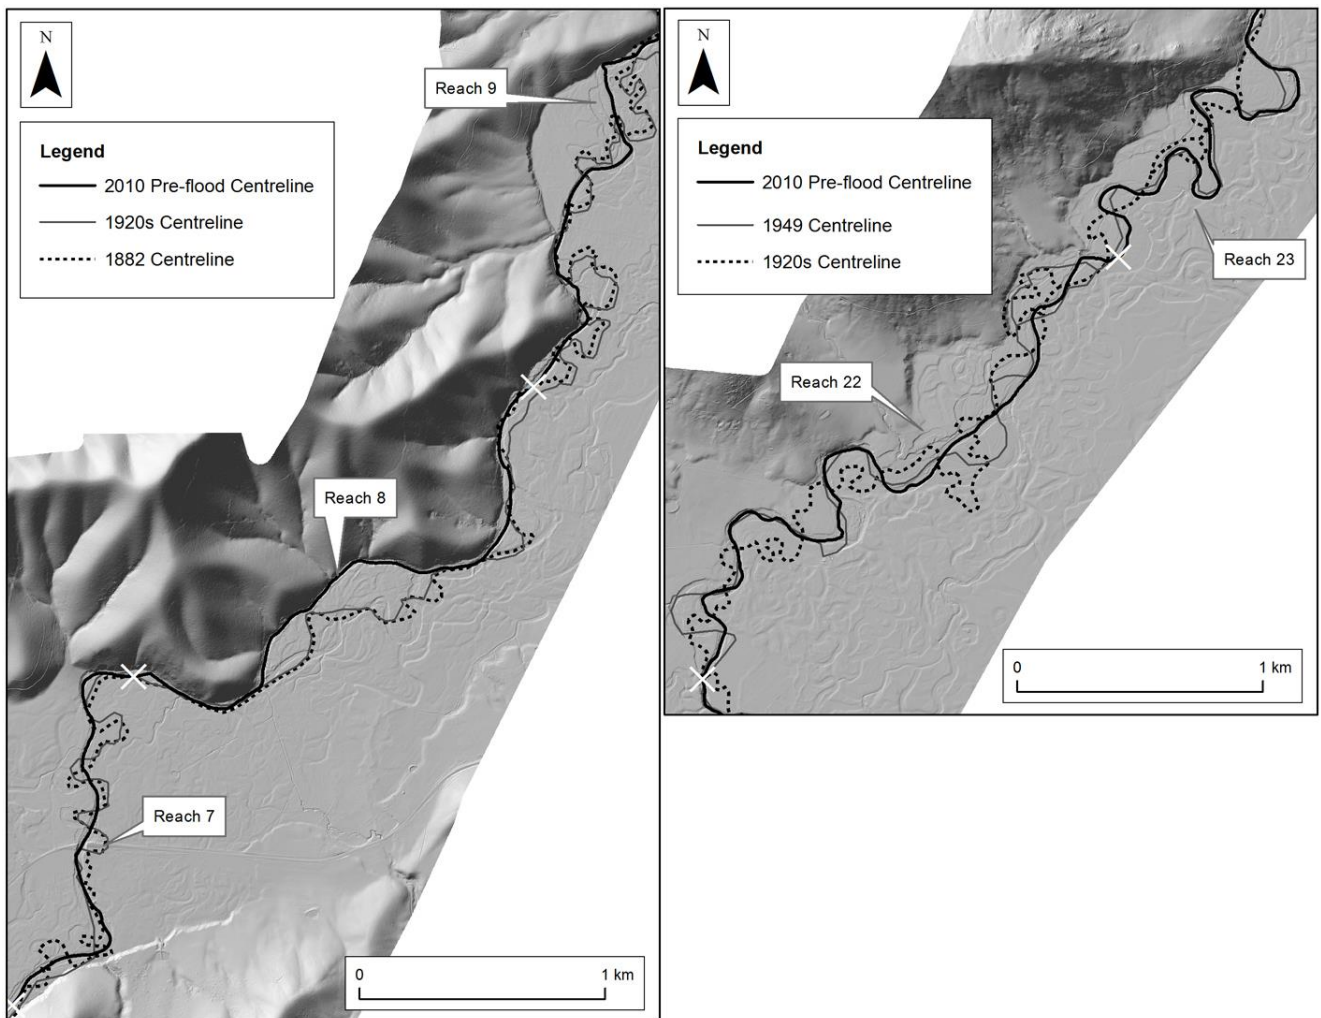
Figure 3. Examples of channel straightening. The planforms are superimposed over the LiDAR data captured in 2010.

Since the 1880s, Corryong Creek has become significantly straighter throughout its length (Figure 3). The overall average sinuosity of 1.47 in 2011 is 26% lower than the 2.01 in 1882. There are three general stages to sinuosity change observed (Figure 4). From the early to mid-20th century, there is a large decrease in sinuosity. From then to the mid-1990s, there is also a decrease in sinuosity, although at a lower rate. This is followed by a slight increase in sinuosity from the mid-1990s to the present. Measurements of channel width and sediment deposition fluctuate accordingly – when channels are wider there is a decrease in deposited sediment, when channels are narrower there is an increase in deposited sediment (Figure 4). Thus, there is a clear definition of the first periods of channel aggradation (mid 1980s to mid-2000s) and degradation (mid-2000s to 2010 pre-flood) using these parameters. From before and after the late 2010 floods, there is an overall increase in both channel width and exposed sediment.

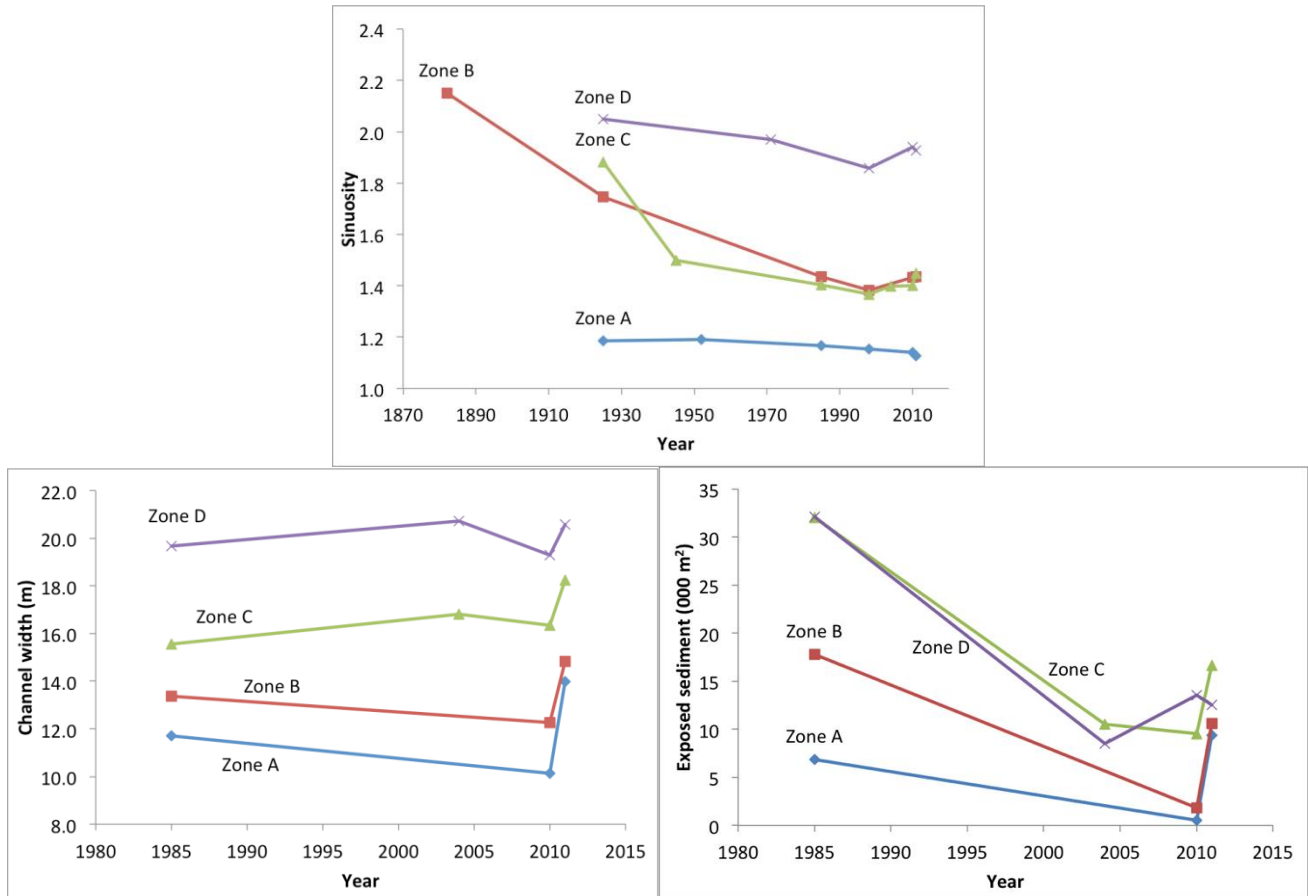
Figure 4. Sinuosity, channel width and sediment deposition measurements categorised by Zone.

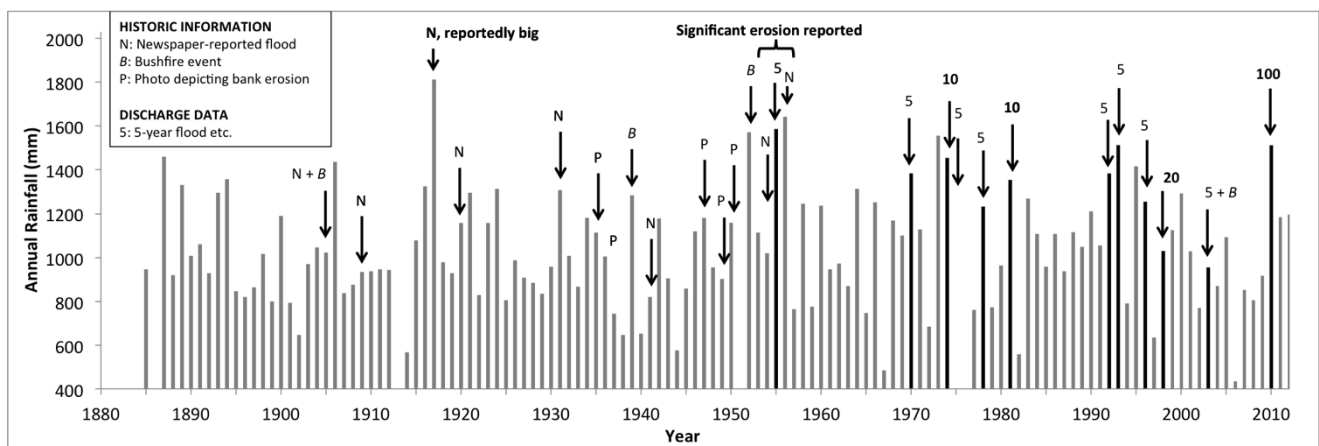
Figure 5. Average annual rainfall and major flood and fire events from 1885 to 2012.

The multidecadal flood regimes defined for other catchments in southeast Australia (Erskine & Townley-Jones, 2009) are not applicable to Corryong Creek (Figure 5) – an ANOVA test comparing the average annual rainfalls of each regime produced an insignificant p-value at a 95% confidence level. Repeating the methodology (CUSUM analysis) to determine a flood regime unique to Corryong’s rainfall still does not reveal multidecadal climate fluctuations. However, the influence of ENSO/IOD is statistically strong in the rainfall and flow data. Above average rainfalls and flow typically occur during years of La Nina and/or negative IOD; below average rainfalls and flow occur during years of El Nino and/or positive IOD (Figure 6).

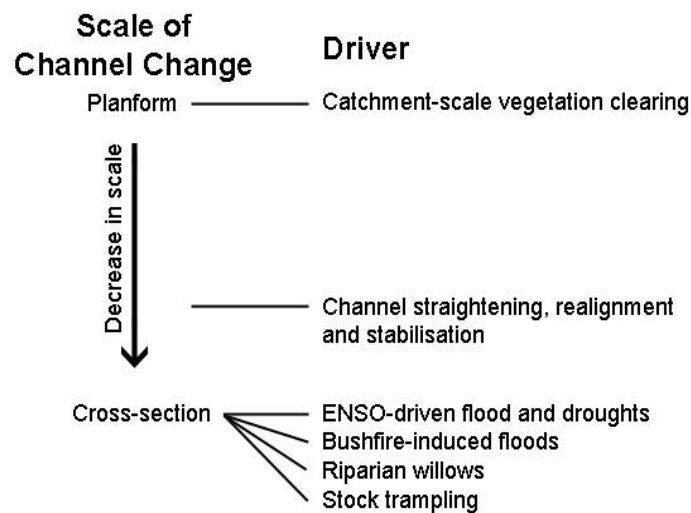
Figure 7. The type of channel change and its driving factors, as evidenced by Corryong Creek.

The recent data on channel width and sediment deposition show that channel degradation occurs during La Niña-dominated periods and channel aggradation during El Niño-dominated years. Since there is a strong ENSO signal in Corryong Creek's hydrology, it is possible for periods of less and more channel erosion to be discerned through ENSO fluctuations (longer-term flood regime cycles were not found). Flood events do not appear to affect sinuosity significantly – after the 100-year flood in 2010, the planform has remained almost exactly the same yet there was severe channel widening and release of sediment. Thus, different variables lead to different scales of channel change, which are summarised in Figure 7. This is likely to be due to the persistence and scale of these variables (Knighton, 1998). For instance, catchment clearing is expansive, usually not reversed, and able to alter catchment hydrology greatly (Siriwardena et al., 2006) – thus, it has the tenacity to affect planform. On the other hand, more periodic and spatially sporadic variables only have the potential to impact the cross-section.
