**Microstructural Alterations of Commercial Metallic Alloys by Friction  
Surfacing**

genehmigte Dissertation

Stefanie Hanke  
aus  
Karlsruhe

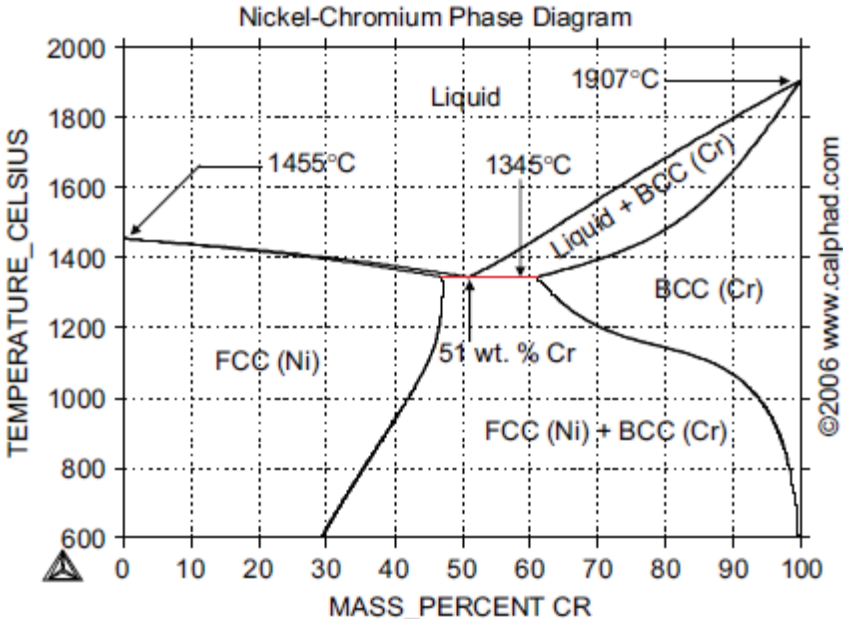
Figure 3: Phase diagram of Cr-Ni system [87].

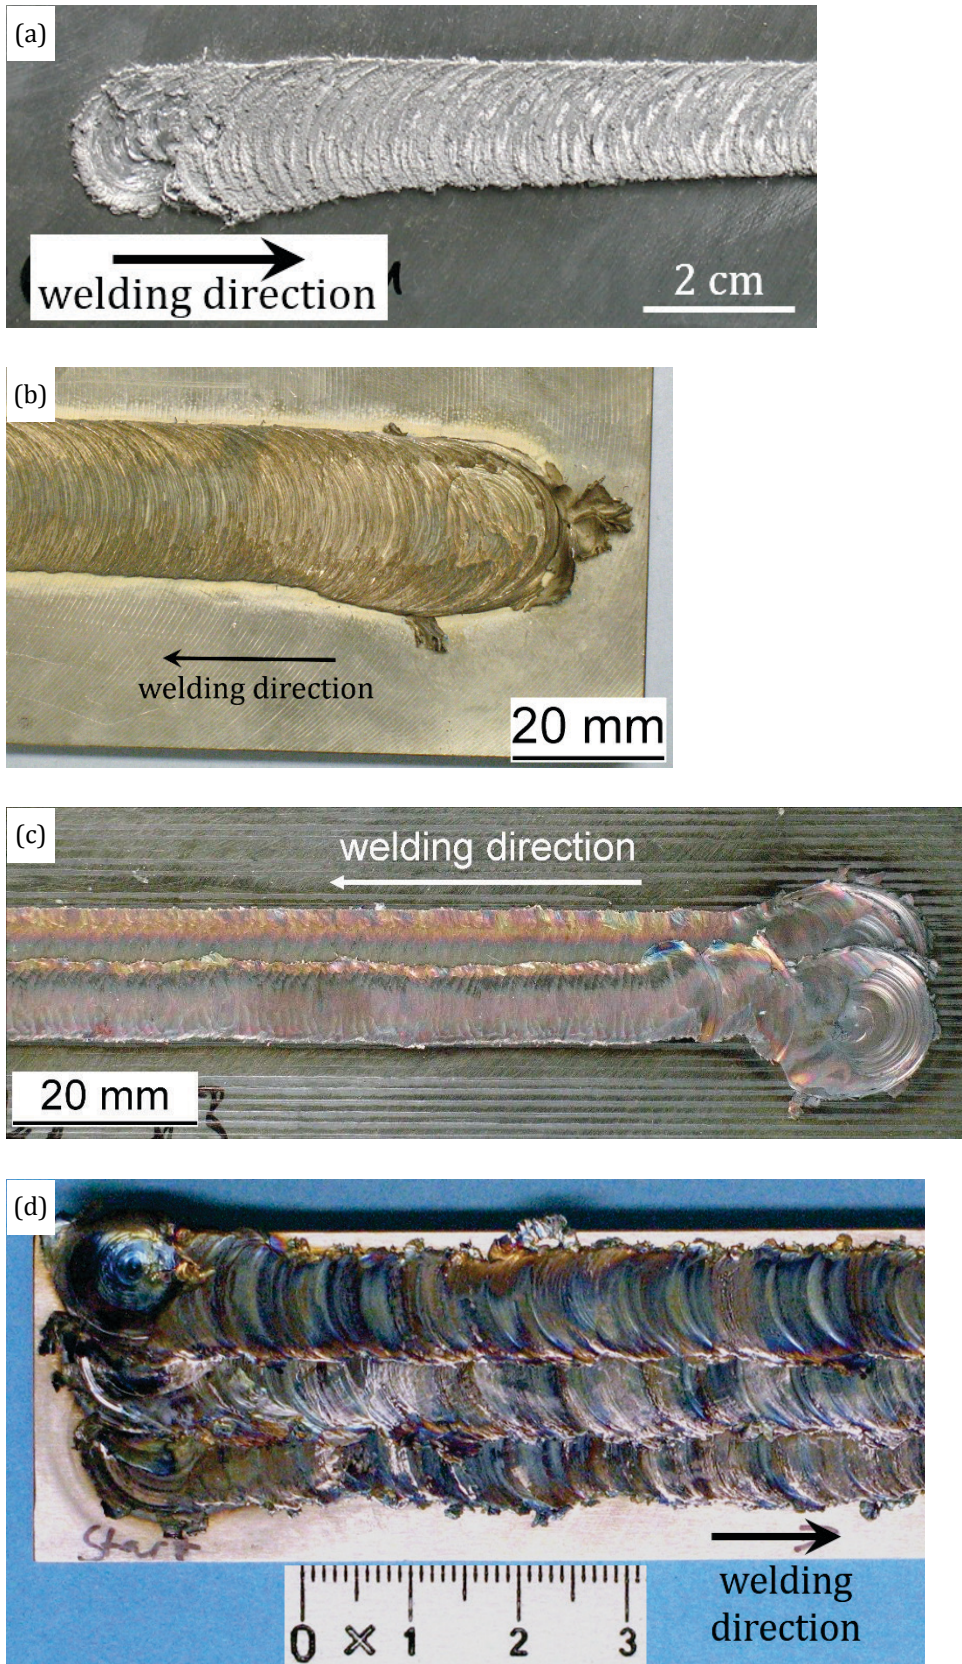
Figure 8: Macroscopic photographs of single layer coatings from aluminium (a) and NiAl-bronze (b), double-layer coating from CP4M steel (c) and triple layer from Cr60Ni40 alloy (d).

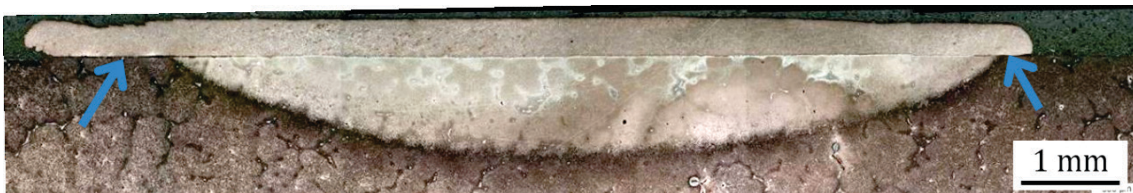
Figure 10: Cross section of a NiAl-bronze FS layer.

The cross section presented in Figure 10 shows a NiAl-bronze layer on self-mating substrate. Single layer coatings were found to have a thickness between 0.60 and 0.80 mm in the centre, depending on process parameters. The width of the layers is around 24 mm, with a bonded region of around 20 mm.

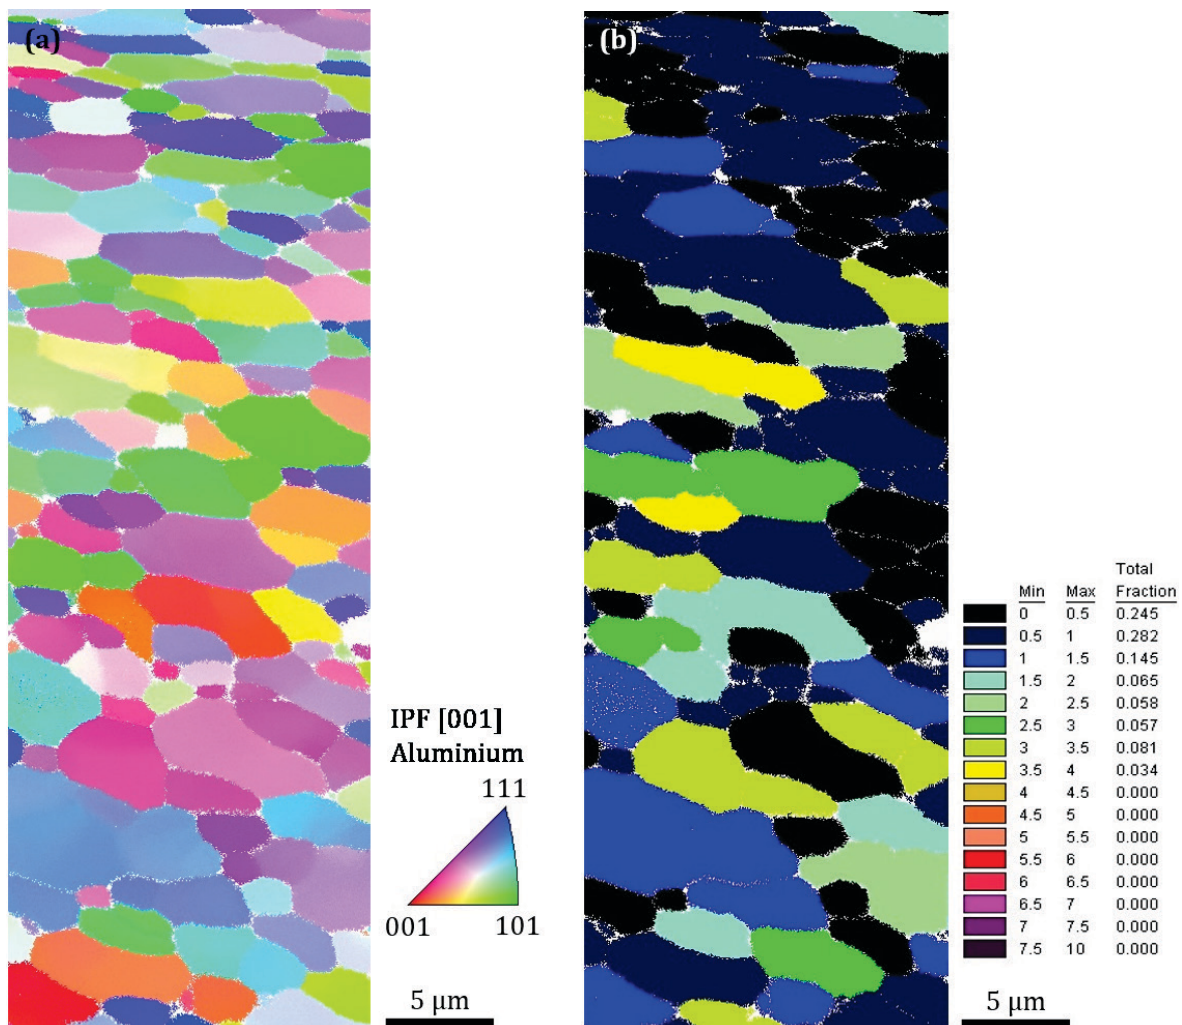
Figure 16: EBSD measurement of the microstructure of a 6082 FS coating. In the inverse pole figure (IPF) the colours represent the different orientations of the grains (a) and the grain orientation spread map (GOS) shows the standard deviation of the orientations measured on all points within each grain (b).

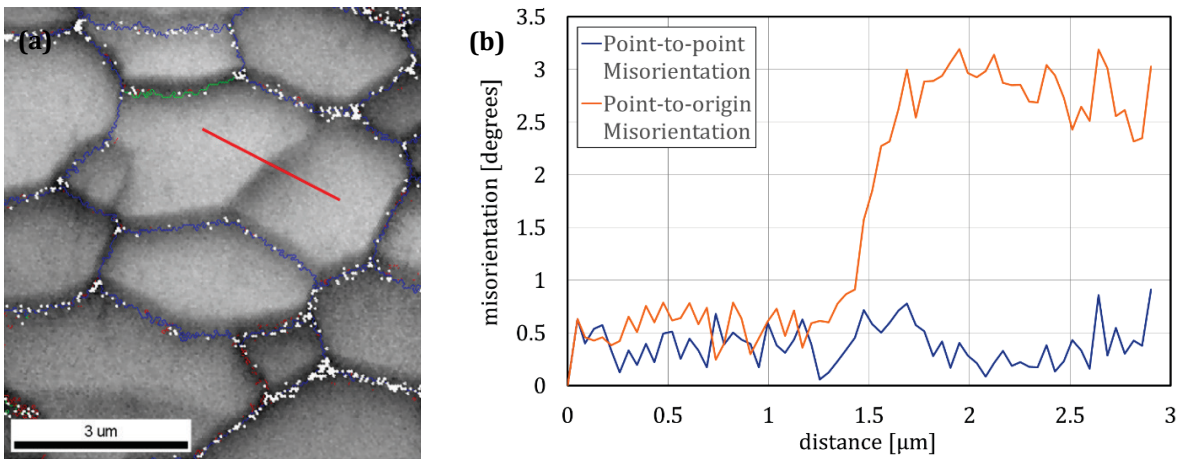
Figure 18: Detail of the EBSD measurement in Figure 17 (red box). In the image quality map grain boundaries are displayed in blue, if the rotation angle between neighbouring pixels is  $> 15^\circ$ , in green for  $5$  to  $15^\circ$  and below  $5^\circ$  in red (a). The straight red line indicates the path along which misorientation angles between single pixels are presented in (b).

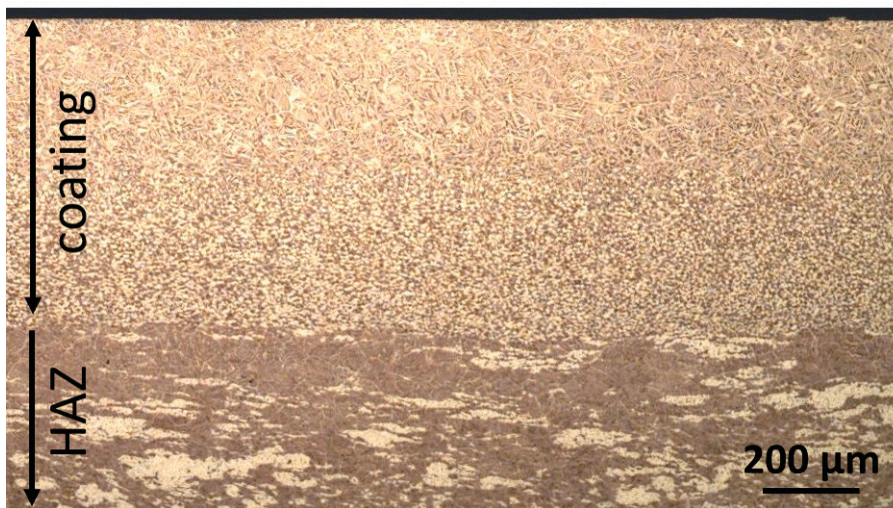
Figure 25: Detail from a cross section of a single layer NiAl-bronze FS coating showing also part of the heat affected zone (HAZ) in the substrate.

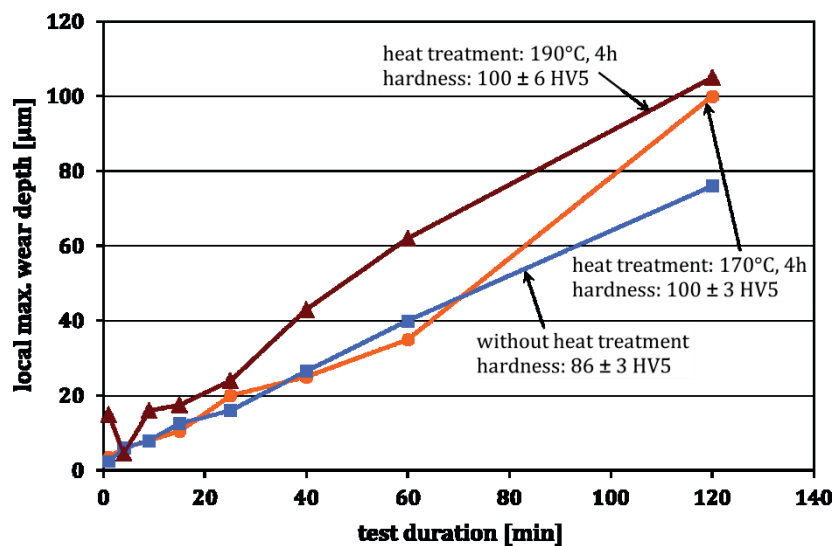
Figure 82: Localised maximum wear depth vs. test duration for 6082 FS coatings subjected to cavitation. The three curves show data for one coating in the original state, and two coatings heat treated at different temperatures.
