# **In-plane shear cyclic behavior of windowed masonry walls reinforced with Textile Reinforced Mortars**

## **ABSTRACT**

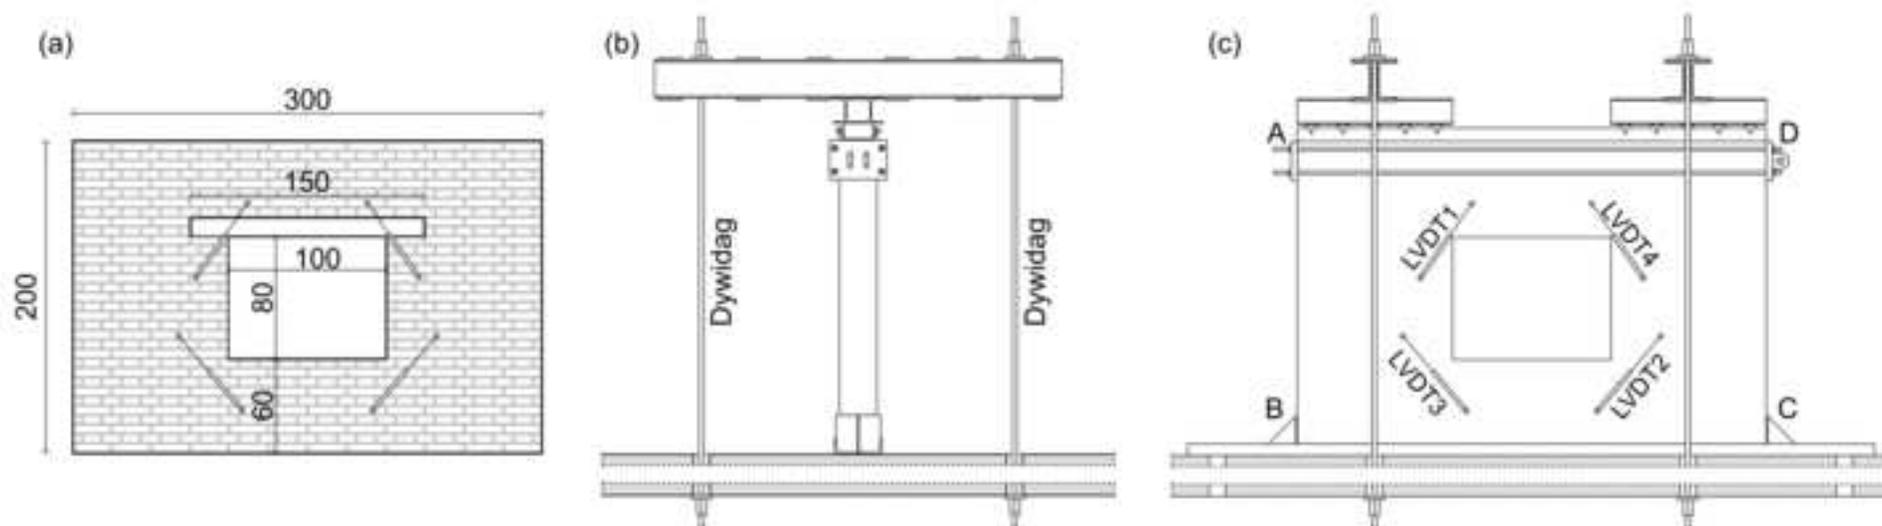
456 *Figure 1. (a) Geometry of masonry walls; Test characteristics (b) front elevation, (c)*  
457 *lateral view.*

117 the left and right sides of the wall, points A and D in Fig. 1(c), both of which were  
118 connected by four steel bars ( $\phi 20$ ). These bars did not work in push cycles, as the force

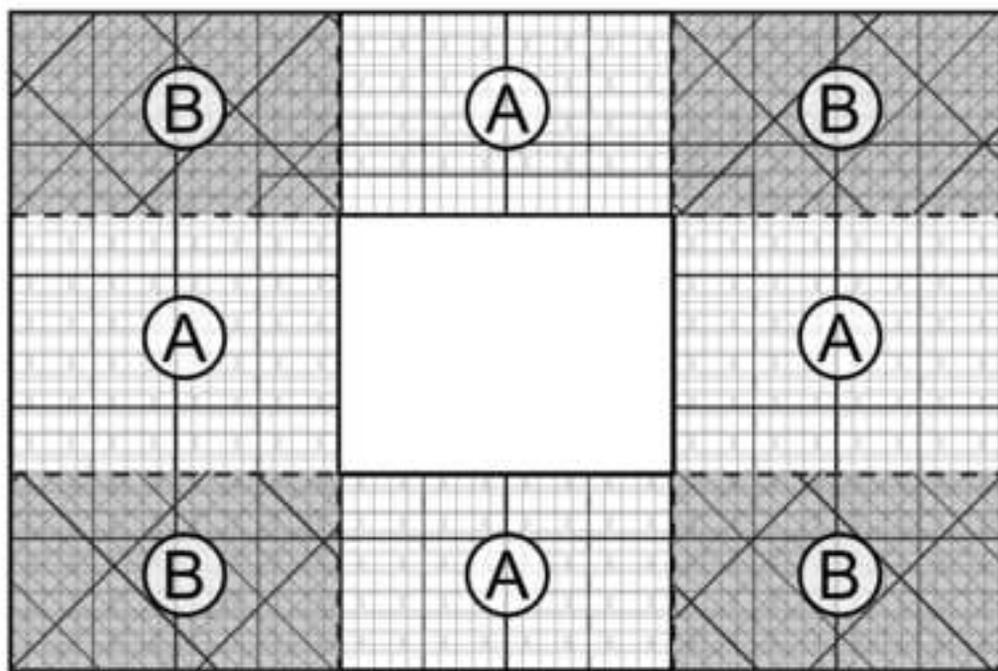
458 *Figure 2. TRM reinforcement distribution, G220 oriented in 0°-90° and ±45° directions.*

98 In order to improve the wall's behavior under cyclic loads a Textile Reinforced Mortar  
99 (TRM) layer was applied to both  $3 \times 2 \text{ m}^2$  surfaces. This TRM was made with a Glass  
100 Fiber Mesh (see main properties in Table 1) in a fiber reinforced mortar (56 days  
101 compressive strength of  $14.1 \text{ MPa} \pm 1.7\%$ ). Two orientations were combined in the  
102 reinforcement as defined in Fig. 2. The whole surface was reinforced with a continuous  
103 mesh oriented in the wall's main directions ( $0^\circ$ - $90^\circ$ ), while the four corners, where  
104 cracks were expected, counted with an additional mesh in the tensile stress principal  
105 direction ( $\pm 45^\circ$ ). 20 cm overlaps were considered between two meshes in the same  
106 orientation.

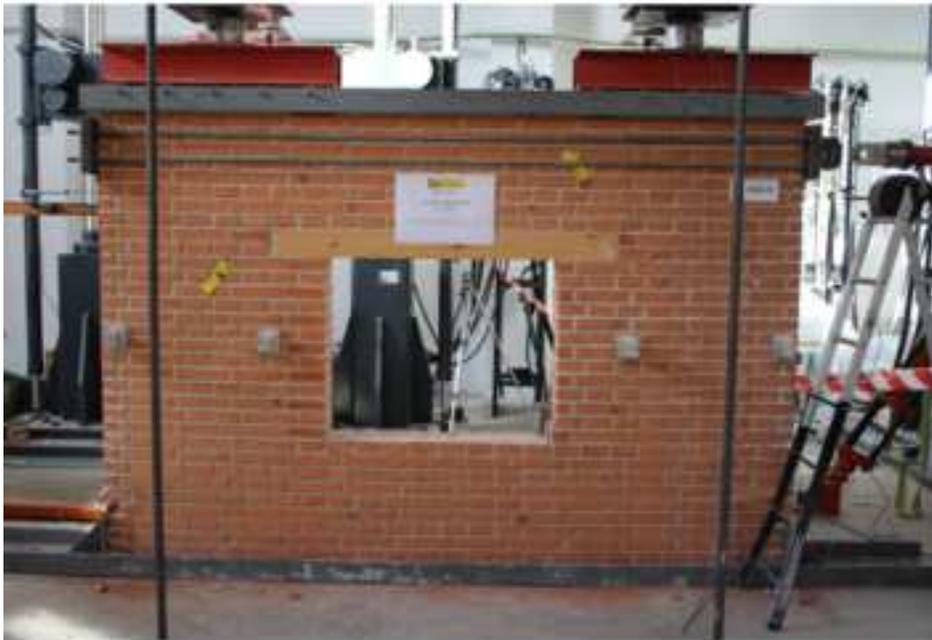
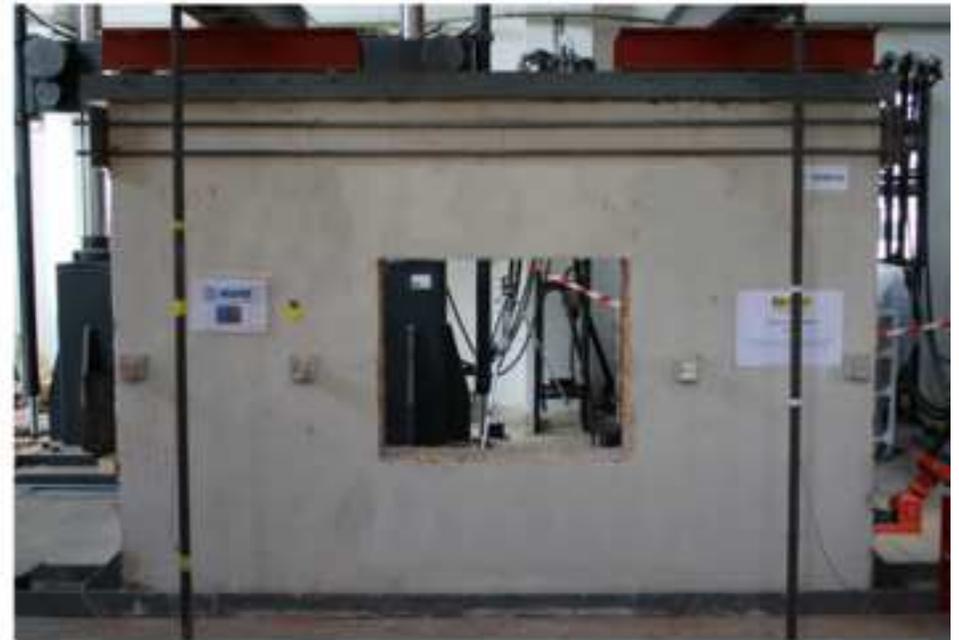
459 *Figure 3. Tested walls: (a) Unreinforced, (b). TRM reinforced sample.*

(a) Unreinforced wall, U-W

(b) TRM reinforced wall, TRM-W

107 Fig. 3 includes a general view of two tested specimens with all the auxiliary elements to  
108 apply the vertical preload and the lateral in-plane cyclic force. The experimental set up  
109 is shown in Fig. 1(b) and (c), in which horizontal loads were applied to point D using a  
110 hydraulic loading cell with a maximum capacity of 750 kN. A vertical load (150 kN)  
111 was applied using four Dywidag 32 before the beginning of the tests to simulate the  
112 weight of a three stories high building. Each Dywidag was monitored with a strain gage,  
113 in order to control the vertical preload of the test, and register the possible variability of  
114 the vertical load when lateral forces were applied. Different steel beams and cylinders  
115 were used to allow different displacements between the wall's drift and the upper  
116 loading devices. The shear force transmission was made with two steel plates located at

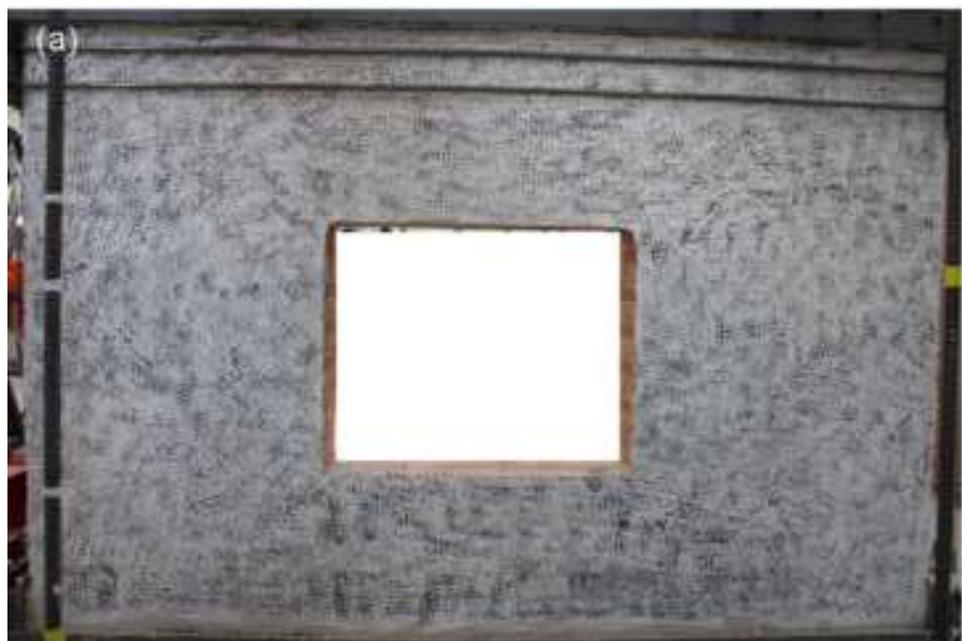
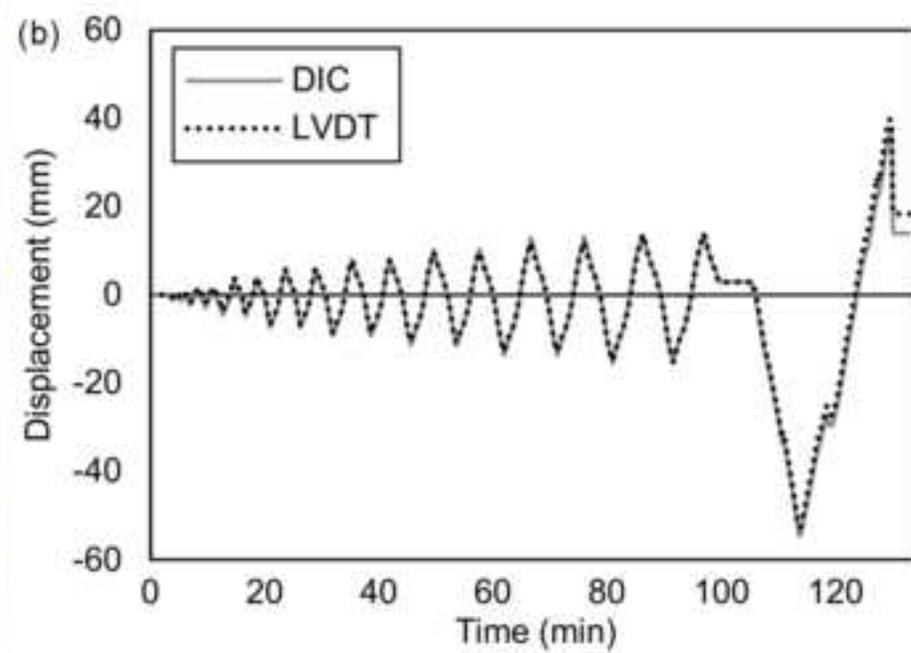
460 *Figure 4. (a) DIC speckle in the TRM-W. (b) Comparison between DIC and LVDT.*

143 because the out-of-plane displacement is considered negligible compared to the in-plane  
144 components. A crucial step is the creation of the stochastic pattern (Fig. 4.a). In order to  
145 optimize the analysis, the perfect contrast in the images was improved by painting in  
146 white the walls before applying the black speckle [24]. Fig. 4.b shows the good agreement  
147 between DIC and LVDT systems in this study.

276 Finally, cracks were monitored with LVDTs located on one side near the window's  
277 corners and an additional DIC system was used to monitor the other side (to collect data  
278 from the whole wall). A comparison between the measures of both techniques was  
279 presented above (see Fig. 4).

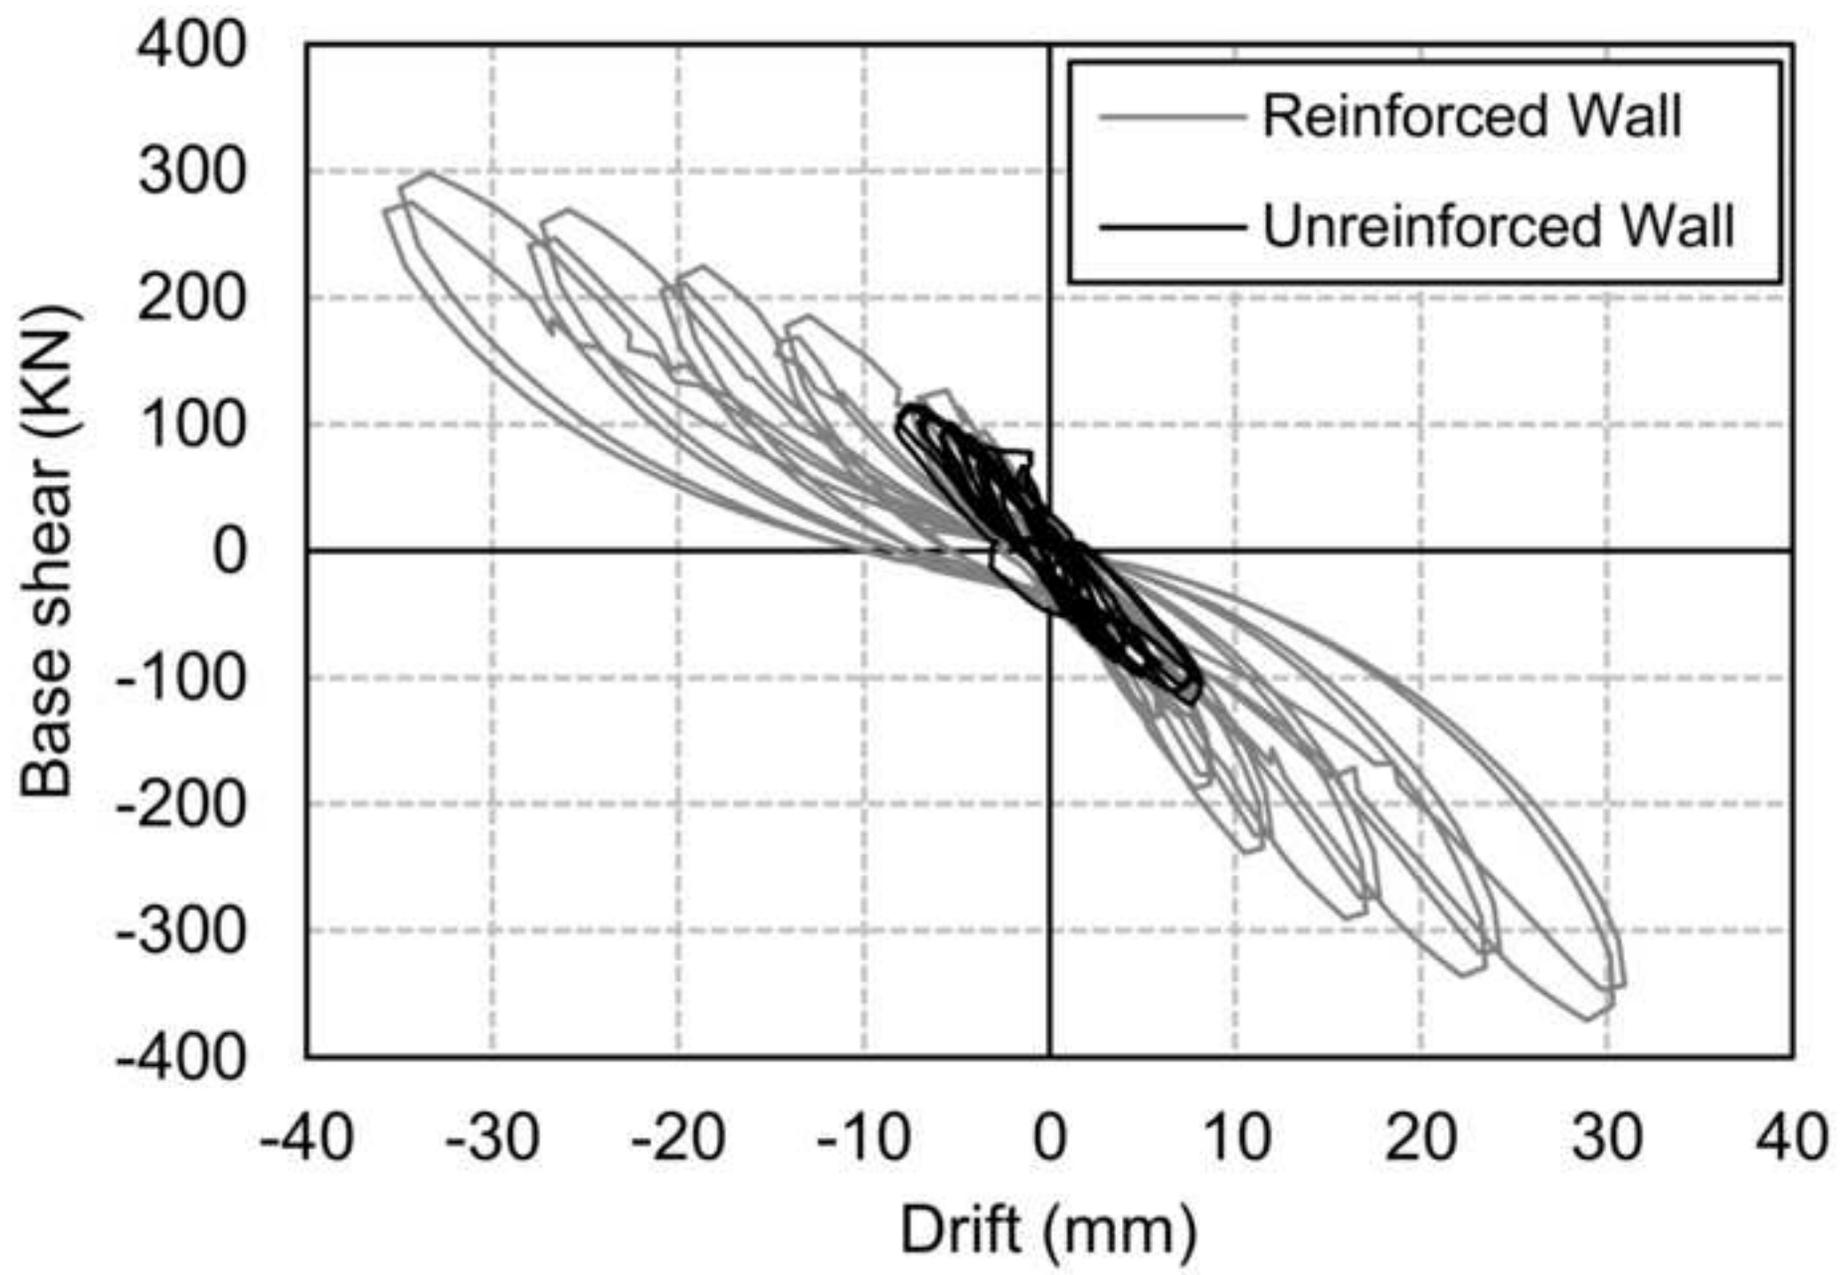
461 *Figure 5. Hysteretic load-drift curves.*

156 The mechanical behavior of the specimens was evaluated by the relationship between  
157 loads and the displacements of the upper part of the wall. In this case, displacements  
158 have been represented as the drift, i.e. the difference between the lateral movements of  
159 the upper and lower part of the wall. Figure 5 shows the hysteresis cycles for the  
160 specimens up to an interval displacement of -35 and 30 mm for a reinforced wall (TRM-  
161 W), and -9 and 9 mm for an unreinforced wall (U-W). The similarity and symmetry of  
162 the displacements in both directions should be pointed out here. The drift amplitudes in  
163 the unreinforced wall were lower. However, for a 9 mm drift the damage detected could  
164 compromise the overall stability. Hence, the incremental cycles were changed for  
165 pushover tests at the same constant displacement rate.

166 The initial response of both structures was similar, but the U-W rapidly degraded after  
167 cracks initiated. On the other hand, the TRM-W could still resist higher loads and  
168 displacements beyond the U-W failure. On average, the maximum loads reached by the  
169 TRM-W at the end of the test were 204% higher than their U-W counterparts (see Fig.  
170 5). In addition, the TRM seemed to increase the energy dissipation capacity, which  
171 could be seen as a greater ductility.

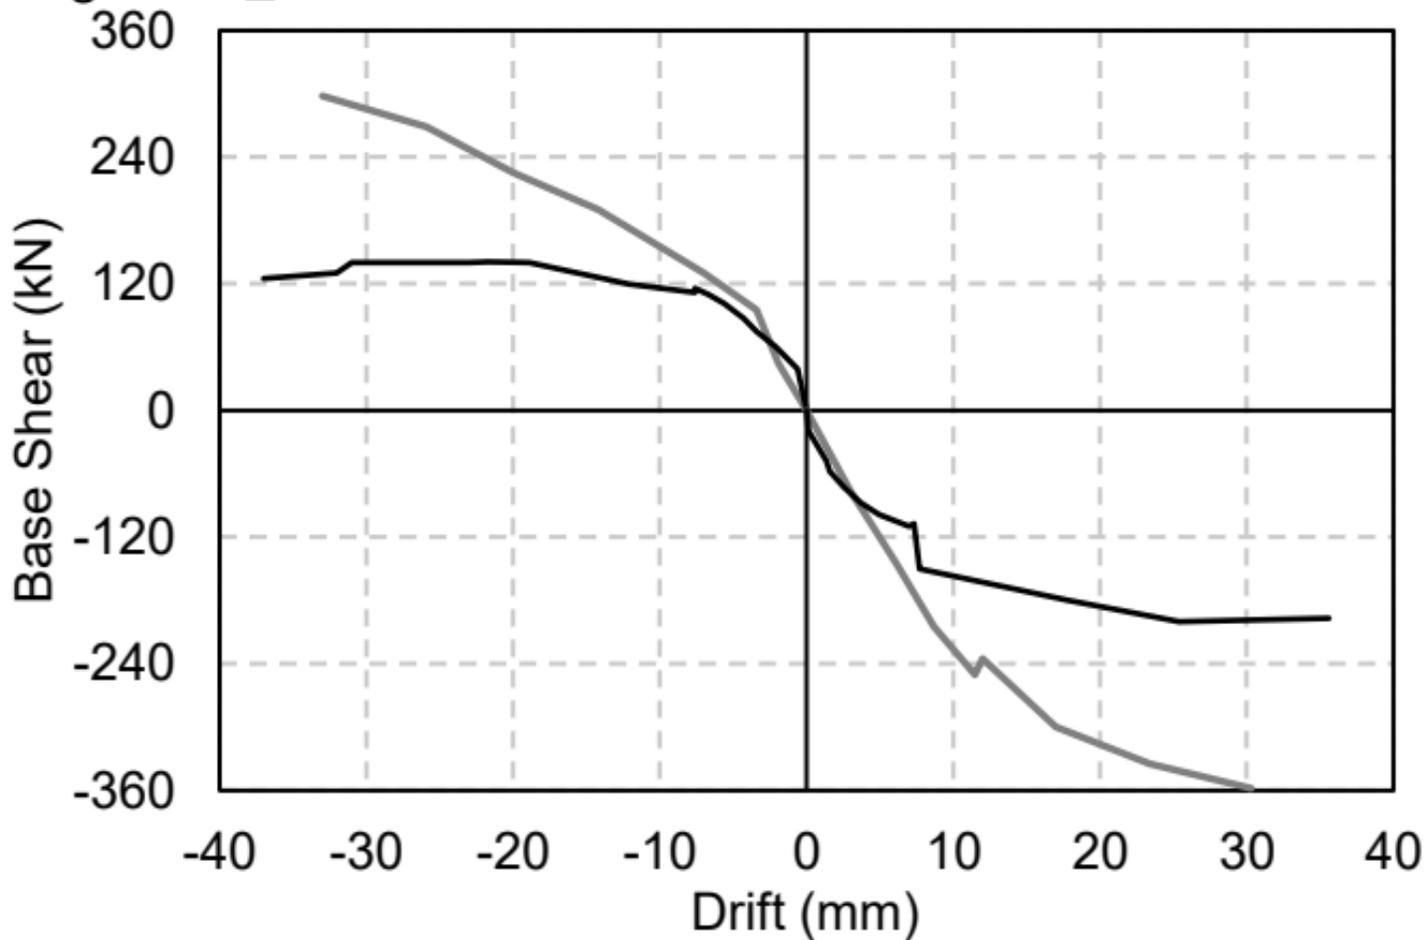
Figure 6 — revised Reinforced Wall Reinforced Wall

462 *Figure 6. Load-drift envelope curves.*

173 Fig. 6 shows the load vs drift envelope curves for both walls, considering the maximum  
174 response of each cycle. In this case, the change of the stiffness could be obtained as the  
175 load/drift ratio. Although U-W and TRM-W specimens had very different behavior,  
176 both specimens showed similar mechanical performance in both drift directions.

177 The unreinforced wall, U-W, could resist a maximum 120 kN load, and a -9 mm drift.  
178 Higher displacements produced a behavioral change. Specially, during the pushover  
179 cycles U-W specimen behaved as two independent structures because after a 9 mm push  
180 and pull a horizontal crack all along the wall's section had been generated. Therefore,  
181 both parts were detached, the upper mid wall continued moving, while the lower part  
182 remained still, hence the crack widened but the rest of the structure wasn't anymore  
183 damaged. For this reason, after a  $\pm 9$  mm drift, cycles were changed to pushover tests.

184 The U-W envelope curve in Fig, 6, after -9 mm, shows that the load remained relatively  
185 constant with only a small increase (133 kN, 9.7 % of the failure load that was 120 kN)  
186 as the imposed drift increased. It could be due to overcoming the friction between the two  
187 wall sub-structures, which could increase due to restrains imposed by vertical load to  
188 avoid the separation of both parts of the wall. Finally, the drift at the end of the test was  
189 around -35 mm. After this first pushover test, another one in the pull direction was made

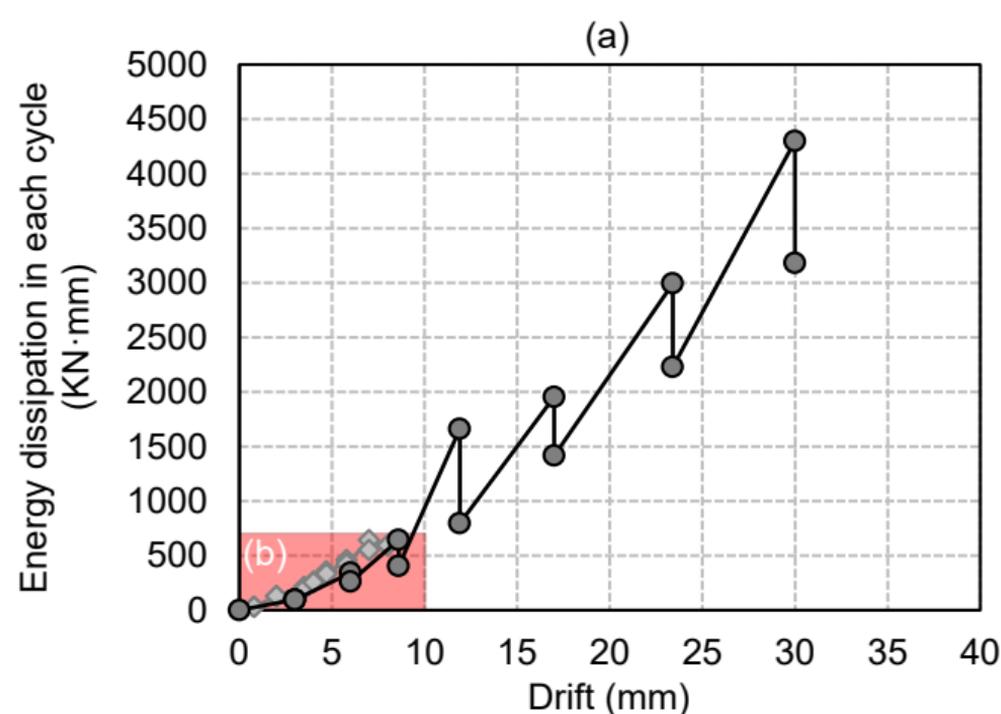
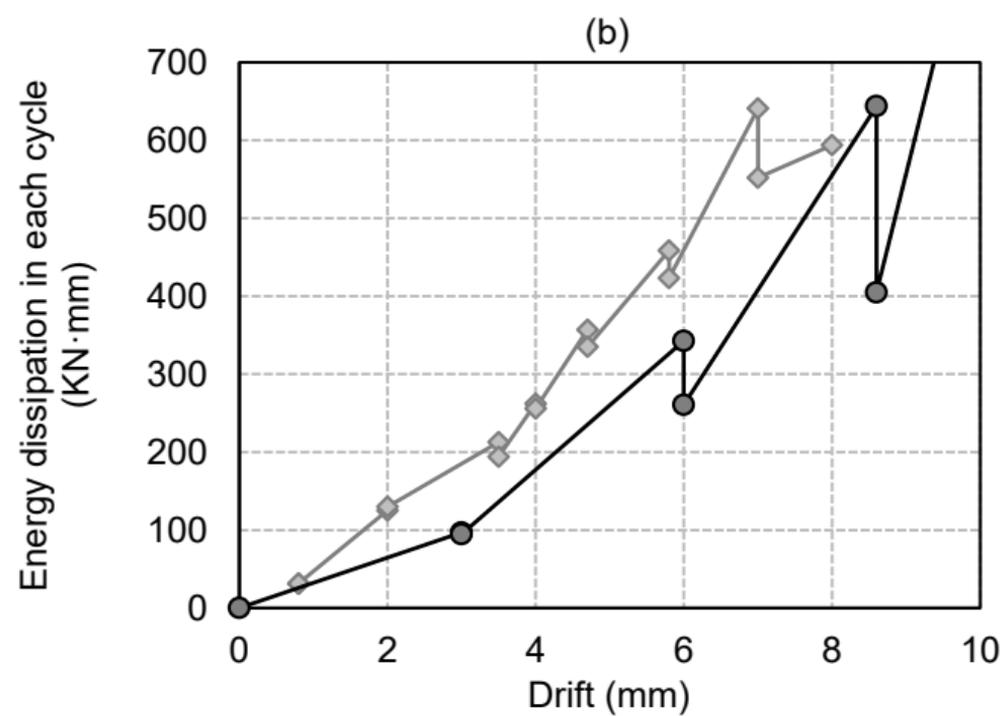
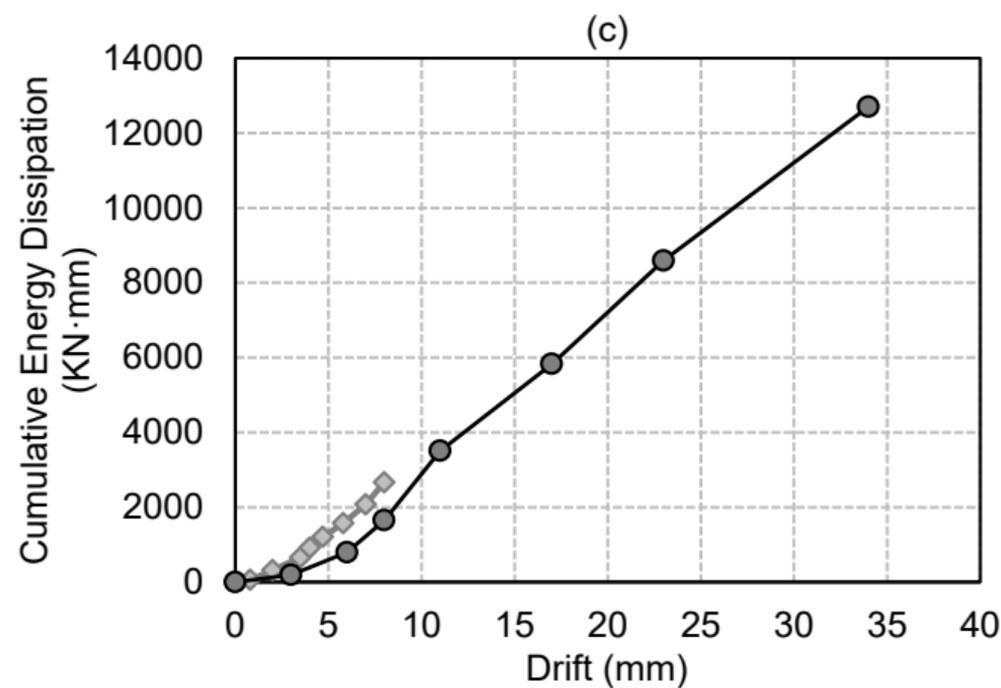
Figure 7 - revised

463 *Figure 7. Energy dissipation vs drift curves per cycle (a), magnification for*  
464 *displacement <1 cm (b), and cumulative energy dissipation (c).*

221 The energy dissipated in a single load cycle (i.e. for a certain drift) was obtained using  
222 the trapezoid rule to assess the area within the hysteretic load-drift curve (Fig. 5). This  
223 energy loss has been represented in Fig. 7 as the dissipation of each cycle (Fig. 7.a and  
224 7.b), or as the cumulative energy (Fig. 7.c).

225 In general, the cycles with the same drift did not dissipate equal energy. The second  
226 cycle dissipated less energy, as the main loss occurred when cracks appeared in the first  
227 cycle. In addition, the amount of energy was higher for wider cycle amplitudes (see Fig.  
228 7.a and 7.b). Nevertheless, the U-W presented a reduction of energy loss between 7 and  
229 8 mm drifts, see Fig. 7.b. This seemed to be a symptom of strength loss. Hence, the test  
230 was decided to be finished below this point.

231 As explained before, the unreinforced wall was damaged earlier. Therefore, for low  
232 levels of displacement, the U-W specimen was already cracked and dissipated more  
233 energy than the TRM-W. However, at the end of the test, considering the ductility of  
234 each sample, the TRM-W showed higher energy dissipation capacity, and the total  
235 energy loss was 529% with respect to the U-W (see Fig. 7.c). Thus, the TRM enhanced  
236 the behavior in terms of total energy dissipation and higher ductility, which could be  
237 observed as a delayed crack development, which may prove the TRM as a suitable

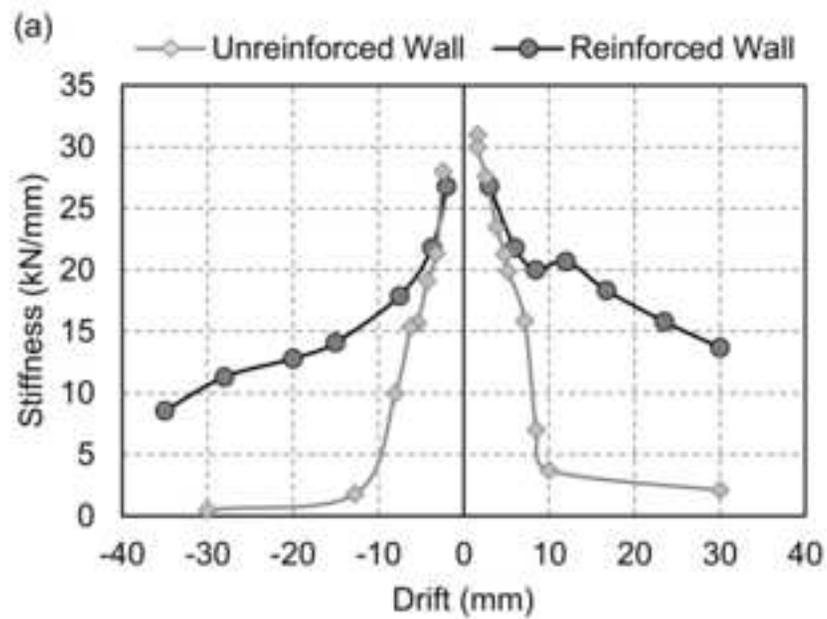
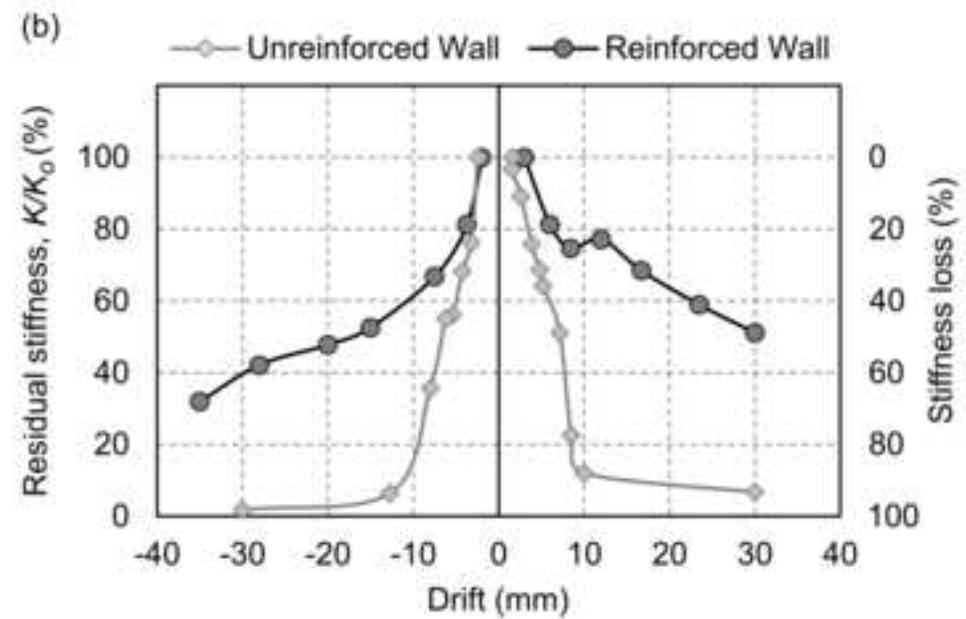
465 *Figure 8. Stiffness degradation: (a) Stiffness vs drift; (b) Relative stiffness  $K/K_0$  and*  
466 *stiffness loss vs drift.*

241 In order to assess the structural degradation, the stiffness  $K$  corresponding to a certain  
242 drift value was obtained as the secant stiffness at 70% of the maximum load of the cycle  
243 [20,27]. Stiffness was determined for both directions of displacement –push (-) and pull  
244 (+)–, all of which seemed to present similar degradation. Fig. 8 includes this stiffness  
245 change vs the drift of each cycle. For a better comparison, Fig. 8.b represents the  
246 stiffness as the residual value (i.e. with respect to the initial stiffness), or as the  
247 percentage of that initial stiffness that was lost after a certain drift. As confirmed by  
248 visual inspection, no damage occurred during the first elastic phase. Afterwards  
249 significant cracking appeared on the wall, as shown in the stiffness drop. Even though  
250 the initial stiffness –at low drifts– for both walls was similar, the stiffness of the U-W

251 specimen was rapidly reduced as the damage level increased, while the TRM-W  
252 specimen preserved the mechanical response, showing a slower degradation. Therefore,  
253 the TRM can guarantee a better performance because for the same deformation of the  
254 wall, it presented less structural degradation. Actually, the U-W specimen suffered  
255 almost a linear loss from the beginning. After suffering 1 cm drifts the U-W specimen  
256 lost approximately 90% of its original stiffness. On the other hand, after the same drift  
257 was applied to the TRM-W specimen, the average loss was only 31%, i.e. when U-W  
258 had already failed TRM-W still had 69% of its original stiffness. In fact, after suffering  
259 displacements more than three times wider, [-35, 30] mm approximately, the TRM  
260 reinforcement was capable of still responding with 50 to 60% of its initial stiffness.

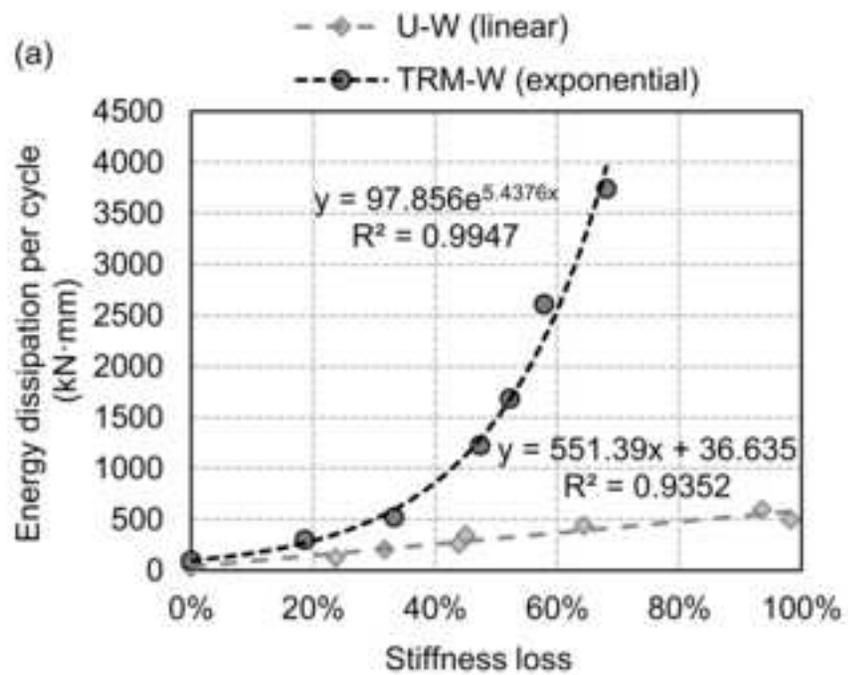
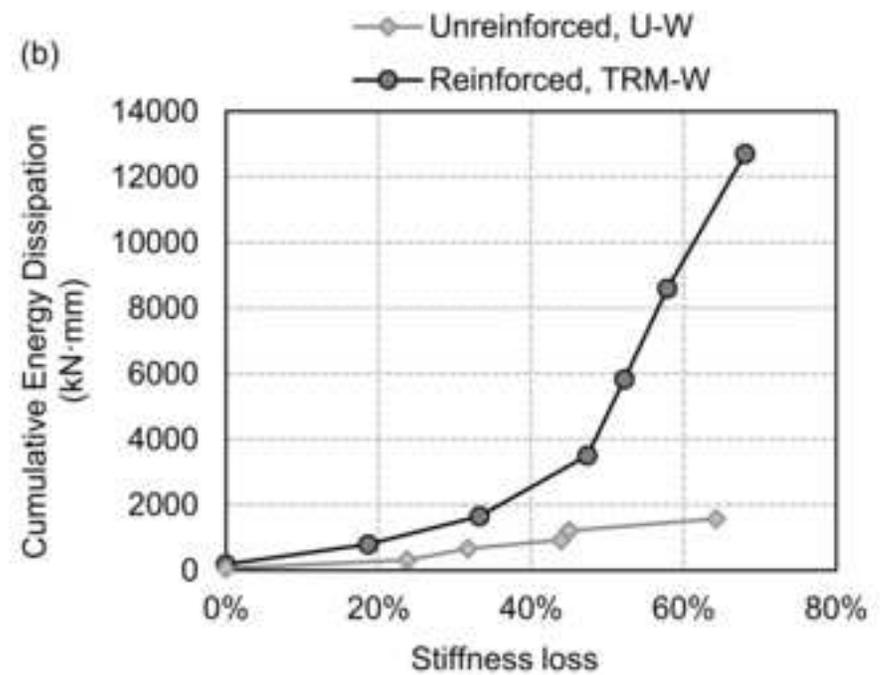
467 *Figure 9. Energy dissipation vs stiffness degradation: (a) cycle's energy loss vs stiffness*  
468 *loss; (b) cumulative energy vs stiffness loss.*

261 Fig. 9 presents the relationship between the energy dissipation and the stiffness  
262 degradation. The energy dissipation of each cycle (Fig. 9.a) or the cumulative energy up  
263 to a certain drift (Fig. 9.b) have been plotted vs the stiffness loss. In both graphs, the  
264 different behavior between both specimens can be observed. The U-W presented a  
265 linear increase of the energy dissipation as more damage was generated. However, the  
266 TRM-W registered an exponential growth of the energy loss per cycle (see Fig. 9.a).  
267 This trend of the TRM-W led to a practically bilinear function of the cumulative energy  
268 dissipation-stiffness loss curve (Fig. 9.b), in which a 50% stiffness loss seemed to be the  
269 transition point between the higher and lower dissipation phases. Despite the main  
270 effect of TRM was observed for big drifts, it could be seen even at small deflections

271 when there was not still any damage. Fig. 9(a) includes regression analyses for both  
272 series, and the energy loss at 0% stiffness degradation were 36.6 kN·mm (U-W) and  
273 97.9 kN·mm (TRM-W). Thus, even in an undamaged wall, the dissipation capacity of  
274 the TRM-W was 268% with respect to the U-W value.

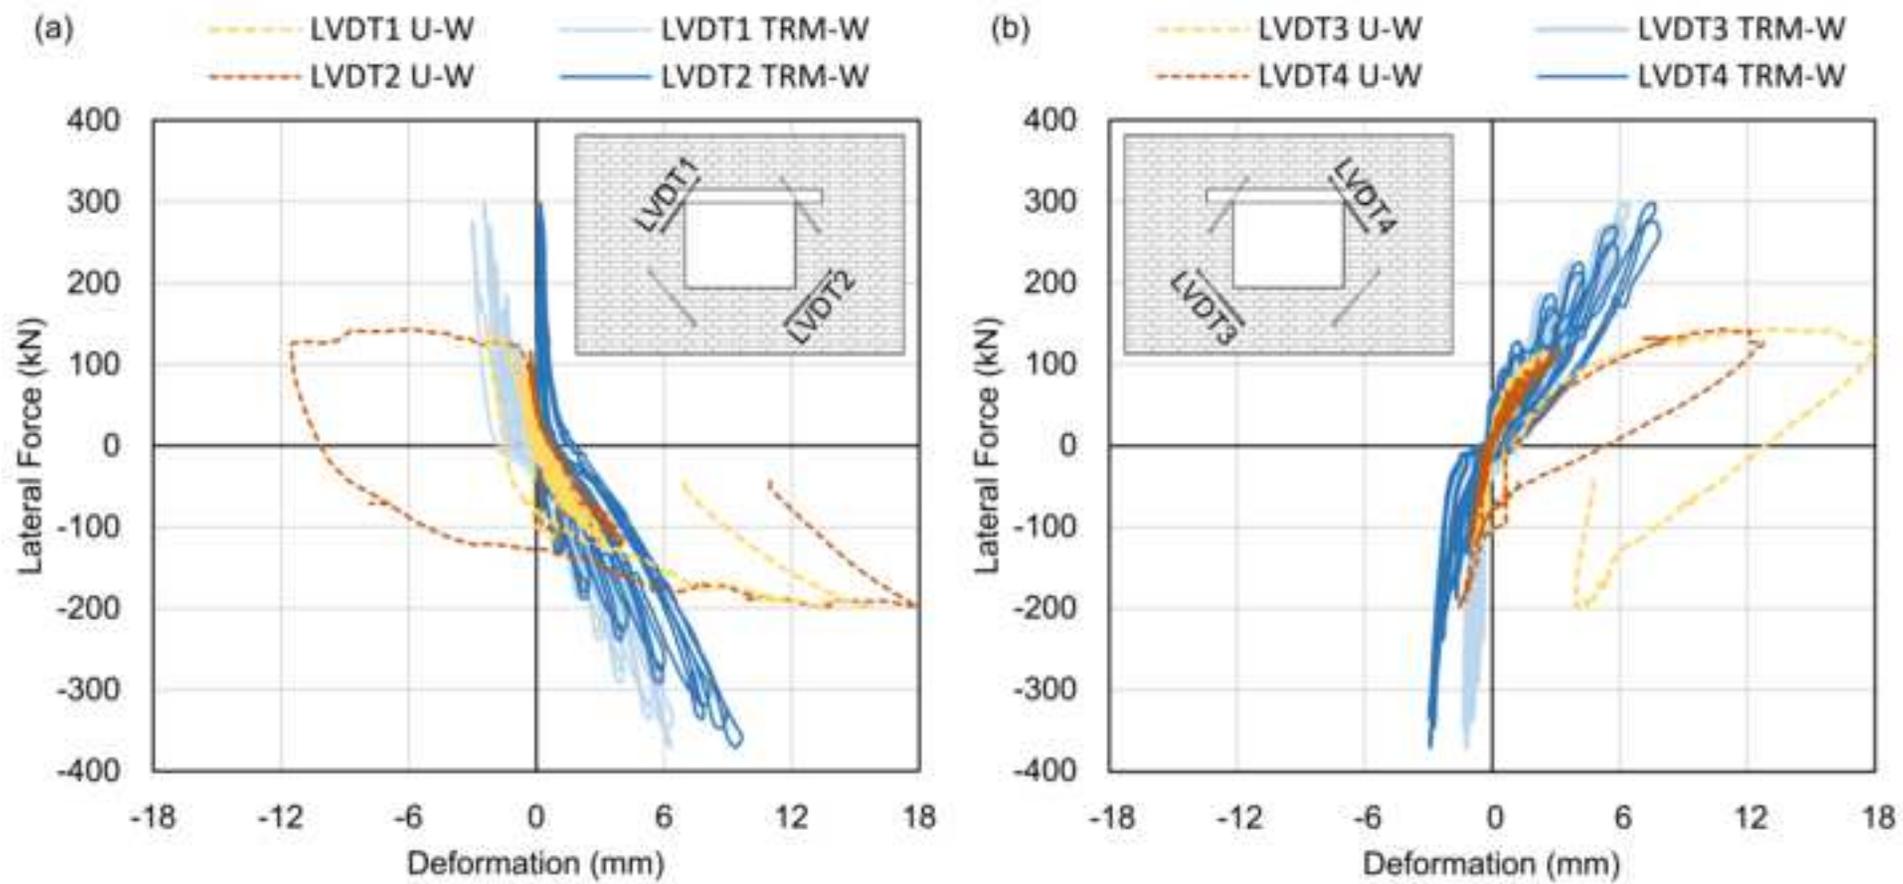
469 *Figure 10. Shear vs LVDT measures: (a) LVDT1 and LVDT2, (b) LVDT3 and LVDT4.*

280 Fig.10 includes the values registered in the LVDTs vs the shear load. Each graph  
281 includes the two sensors located in one diagonal direction or the other. Fig. 10  
282 represents positive force values in the push direction (to the left), and negative ones in  
283 pull cycles (to the right). Push cycles generated compressions in LVDT1-2 and tensions  
284 in LVDT3-4, while pull cycle's behavior was reversed (tensions in LVDT1-2 and

285 compressions in LVDT3-4). Therefore, compressions in Fig. 10 may be seen as  
286 negative deformations, while tensions are elongations (positive deformations).  
287 Crack development may be seen as slope changes in the tension side of each curve. The  
288 U-W presented cracks in all four window's corners after the pushover tests. In this case,  
289 the maximum shear forces were between 150 and 200 kN, and the measured elongations  
290 almost reached 18 mm in the bottom corners, while were only 12 mm in the upper ones.  
291 Besides, LVDT2 showed more deformation than LVDT1 in the left direction, which  
292 was another evidence of the relative displacement as rigid bodies between the upper and  
293 lower parts, and the friction between both surfaces.

294 The TRM-W sample was capable of controlling the crack opening, and the maximum  
295 apertures (7.5 and 9.5 mm) were obtained at higher load values (300 kN and 360 kN). If  
296 both responses, U-W and TRM-W, are compared, the initial stiffness in both cases  
297 seemed to be similar. Damage was rapidly produced in the unreinforced wall, and the  
298 maximum capacity was reached even at low displacements. In addition, the TRM-W  
299 showed more mechanical capacity and progressive deterioration, with gradual stiffness  
300 loss in tension as loads increased and cracks developed. On the contrary, the TRM-W  
301 behavior in compression was linear during the whole tests. Therefore, the fiber mesh in  
302 the TRM served as a crack opening control element, improving the behavior of masonry  
303 wall structural members subjected to cyclic in-plane shear forces.

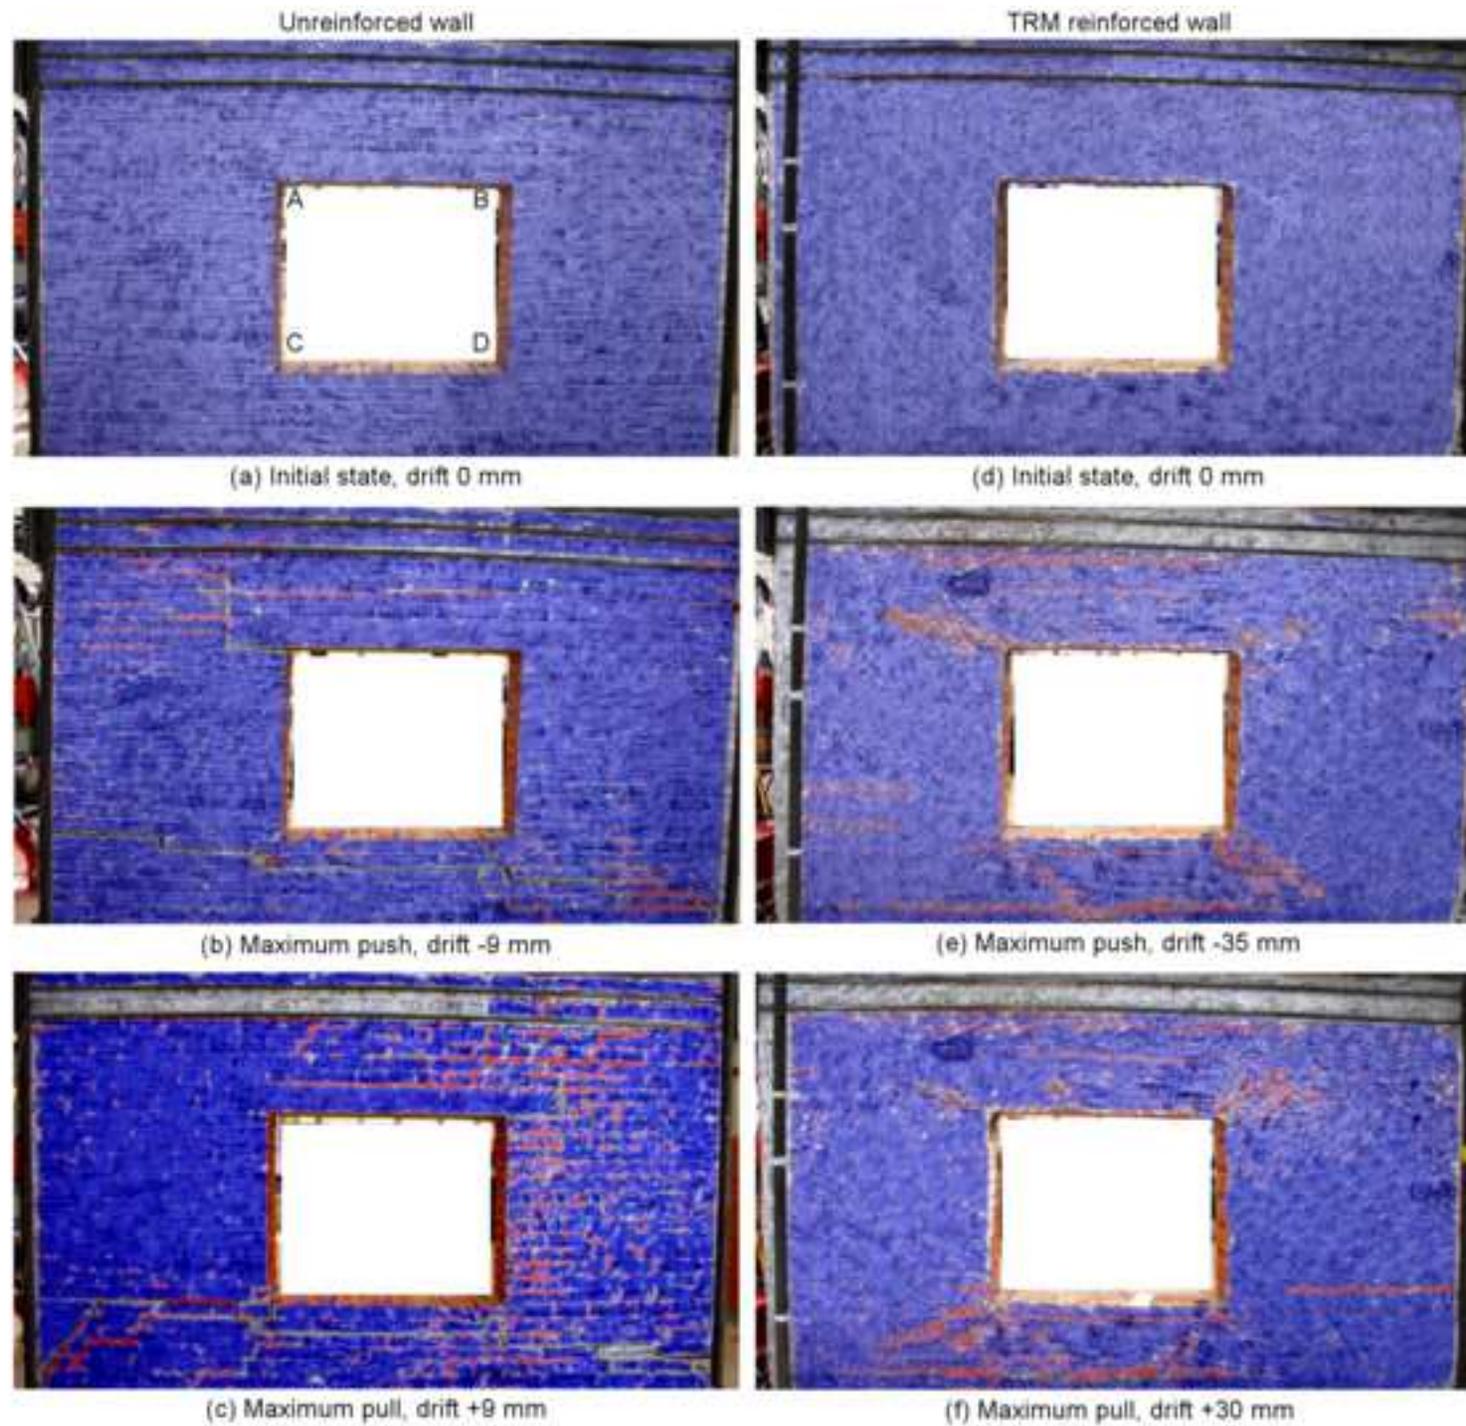
470 *Figure 11. Crack analysis by DIC, for different drift values (red lines represent tensile*  
471 *strains >1%).*

304 In order to evaluate the overall crack pattern, displacement evolution was monitored  
305 with digital images. Fig. 11 includes the results of the DIC analysis for the maximum  
306 drifts applied to each wall, in which red lines represent areas with tensile strain values  
307 higher than 1%. DIC images were taken on the opposite side of LVDT measures, hence,  
308 push cycles in Fig. 11 correspond to drifts to the right, and pull tests to the left (contrary

309 to the criteria in Fig. 10). In Fig. 11, the difference between both specimens was  
310 stronger. TRM-W showed a more controlled cracking, in which the ductile behavior  
311 was observed at higher shear forces despite all the distributed cracking. In both  
312 specimens, cracks initiated around the window corners, and developed following the  
313 diagonal direction. The U-W cracks developed along mortar joints, while TRM cracks  
314 were continuous. In the U-W, besides the widespread cracks highlighted in red in Fig.  
315 11.b and 11.c, there was a wider horizontal crack in the lower part cutting the wall in  
316 two independent elements. This continuous crack -typical failure mode of masonry  
317 walls [28]- disconnected the two parts, both of which moved separately for the rest of  
318 push-over tests. This crack can be easily observed in Fig. 12, which shows the  
319 horizontal displacement distribution of the U-W at the end of both pushover cycles. In
