# **In-plane shear cyclic behavior of windowed masonry walls reinforced with Textile Reinforced Mortars**

## **ABSTRACT**

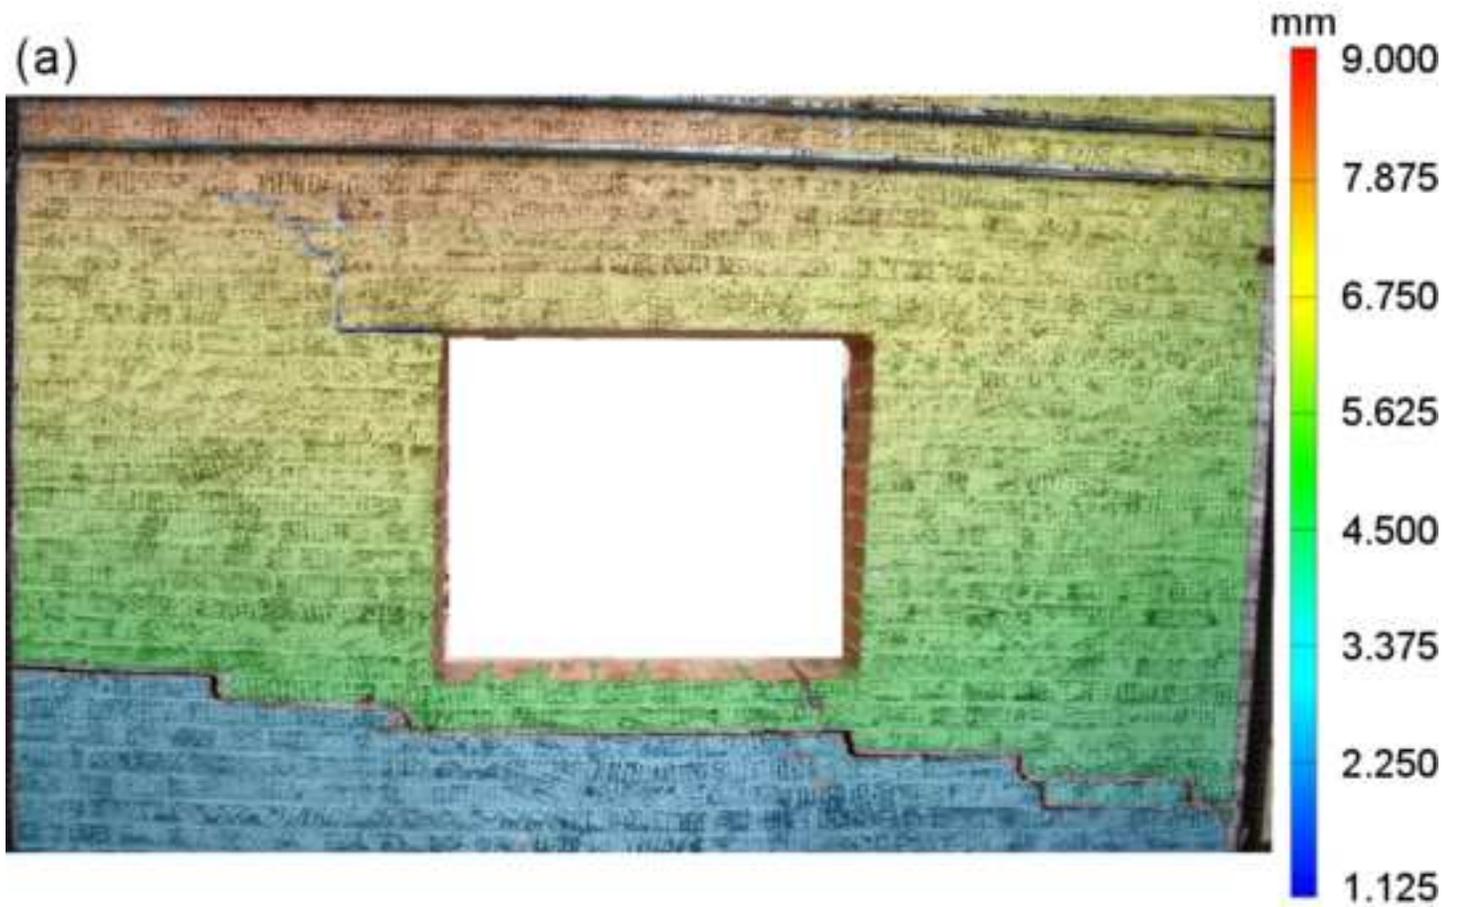
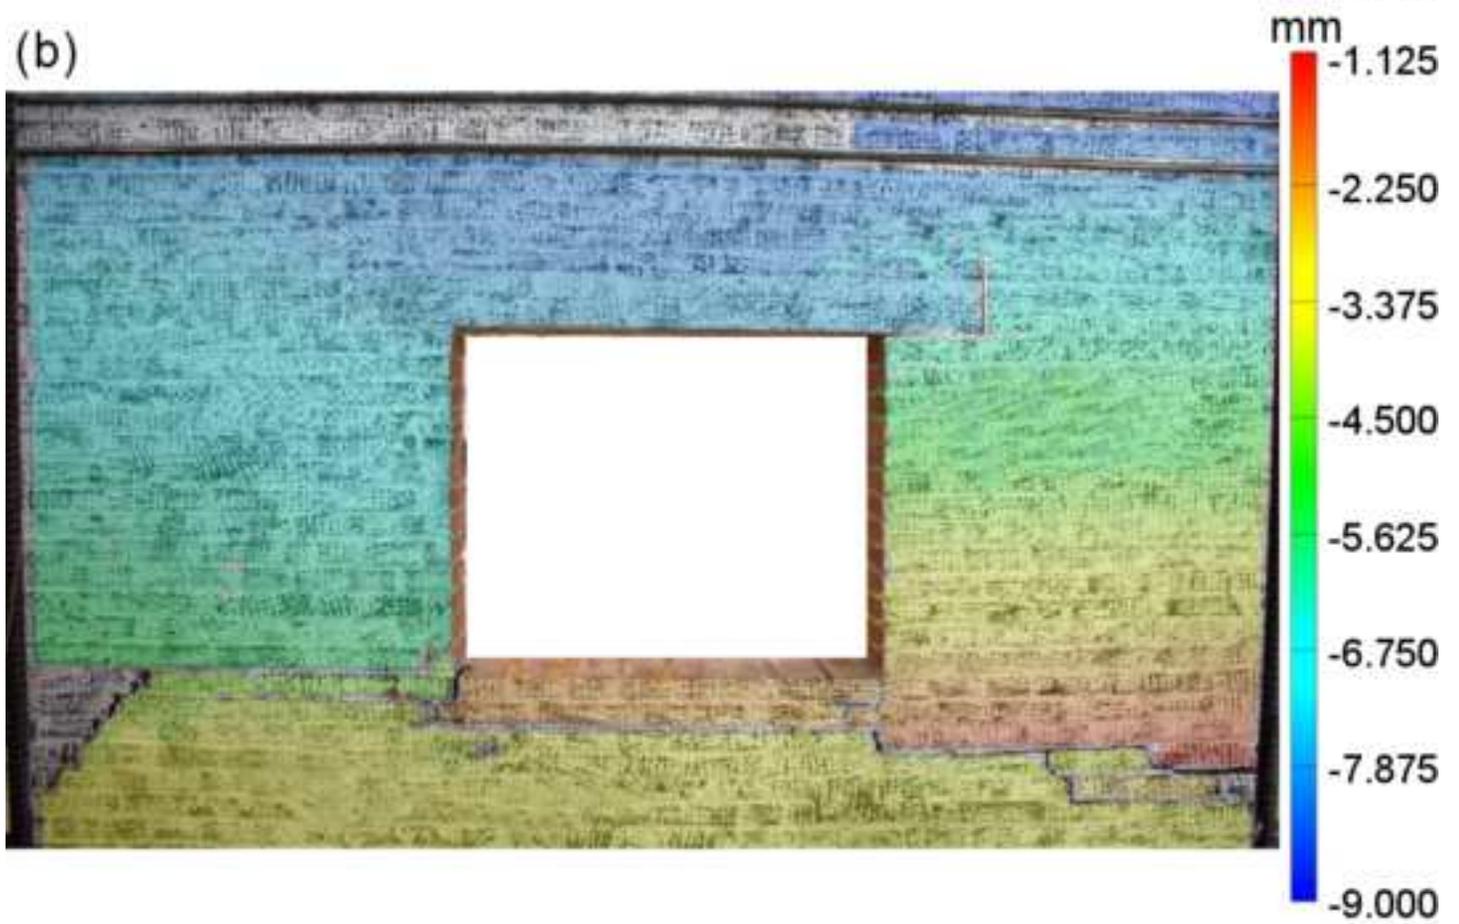
472 *Figure 12. Horizontal displacements of the U-W by means of DIC corresponding to*  
473 *maximum drifts in (a) push and (b) pull directions.*

320 this case, the difference between both wall's subsections was clearly detected.  
321 For future dynamic modelling of masonry structures, the equivalent viscous damping  
322 could be used to represent the energy dissipation capacity of the structure, and the  
323 stability of the hysteresis behavior. This equivalent damping  $\xi_{eq}$  can be defined by the  
324 ratio between the area of hysteresis cycles  $S_{ABC} + S_{CDA}$  and the corresponding elastic  
325 energy  $S_{OBE} + S_{ODF}$ , according to eq. (1), and as shown in Fig. 13(a).

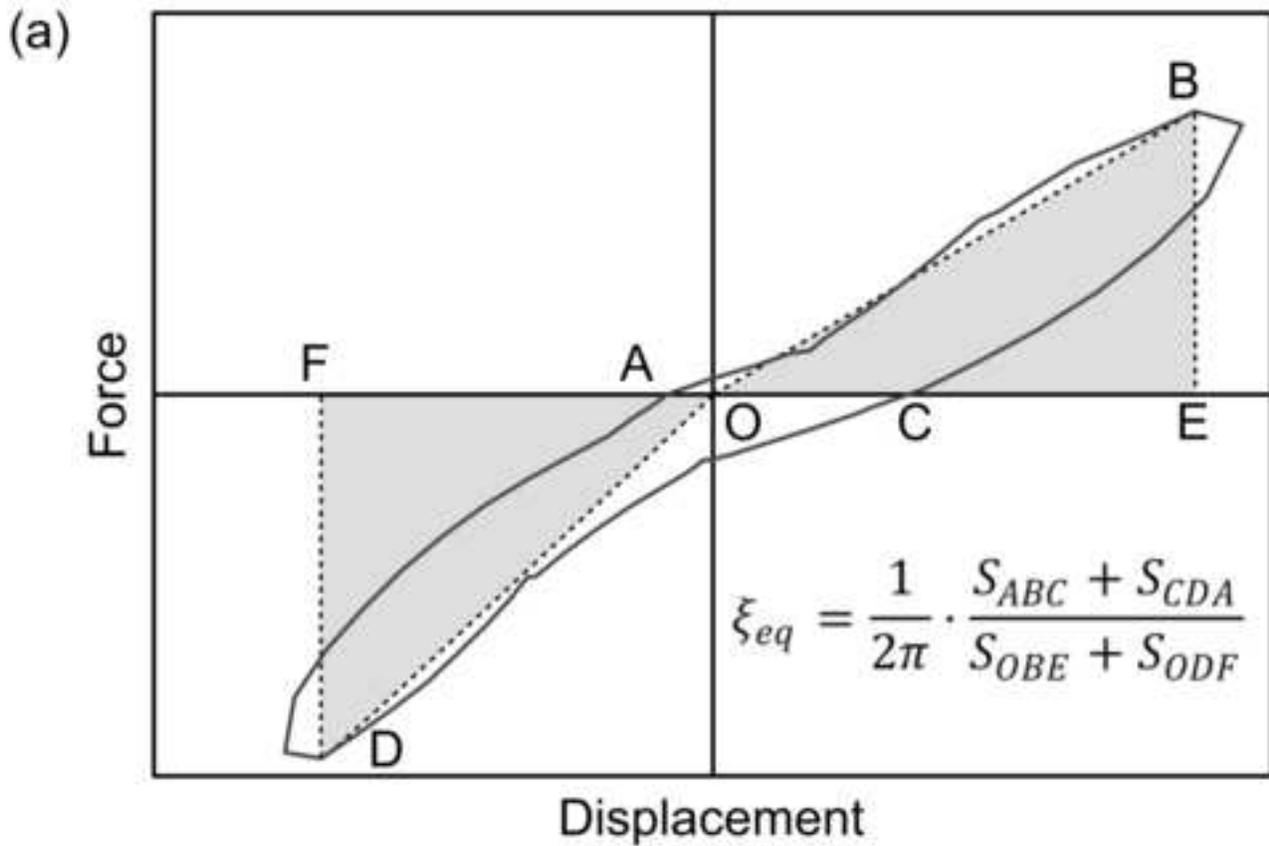
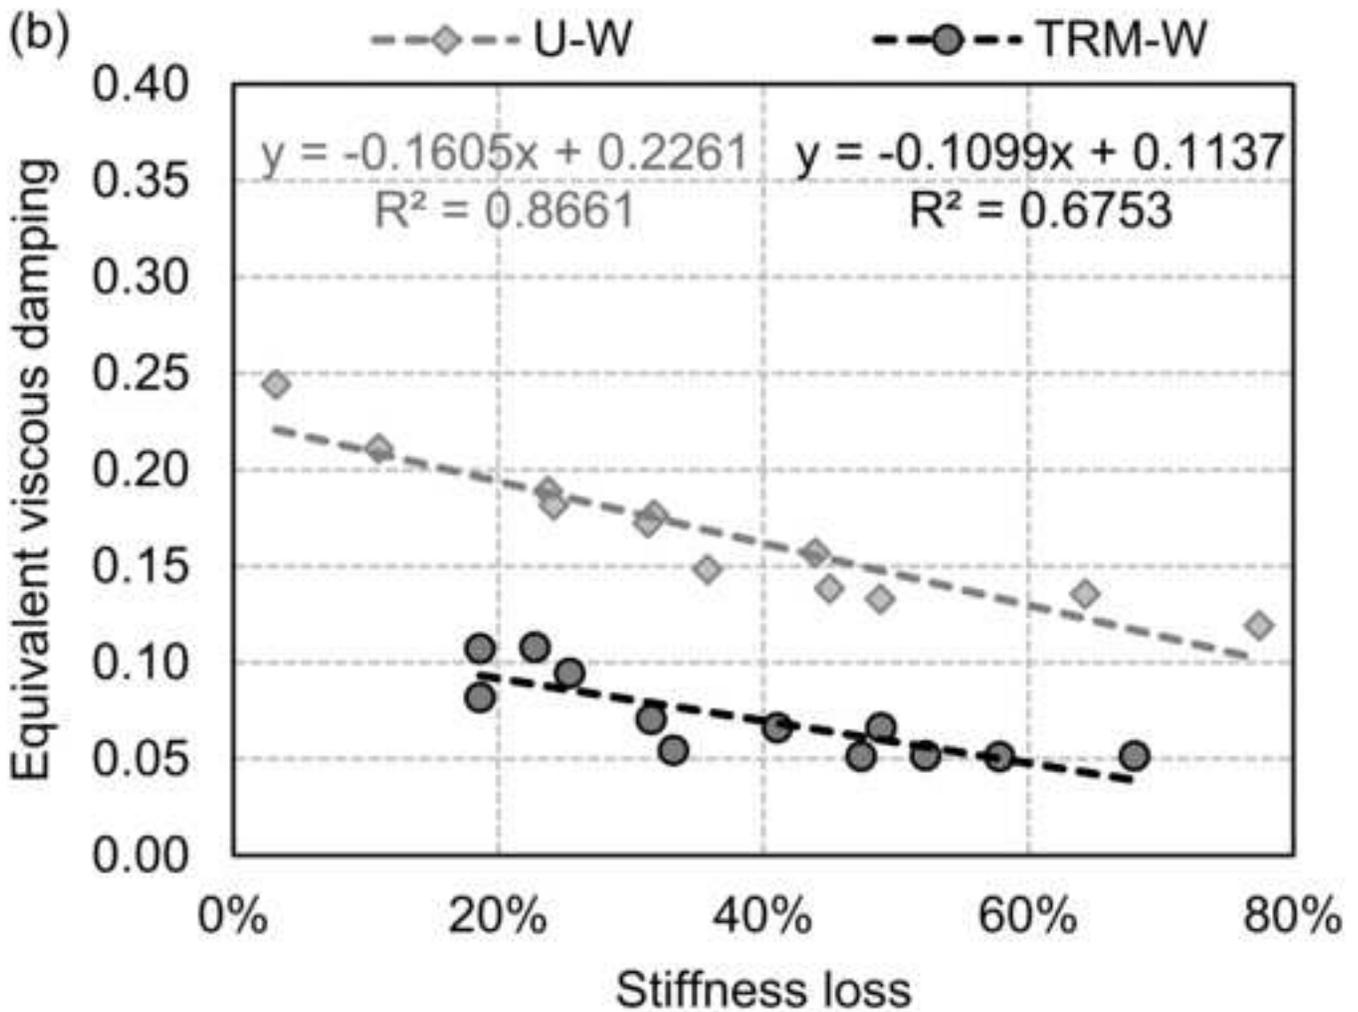
474 *Figure 13. (a) Equivalent viscous damping, and (b) its variation vs stiffness loss.*

$$\xi_{eq} = \frac{1}{2\pi} \cdot \frac{S_{ABC} + S_{CDA}}{S_{OBE} + S_{ODF}} \quad (1)$$

326 Fig. 13(b) includes the values of  $\xi_{eq}$  for each cycle, shown as the damage level (i.e.  
327 stiffness loss). Both structures, showed a similar trend, in which damping was reduced  
328 as damage was being accumulated. The European seismic code [29] prescribes a  
329 damping ratio between 5 and 10% for masonry structures. The damping values of the  
330 reinforced wall were basically in that interval, only a few were slightly higher than 10%.  
331 However, the equivalent viscous damping values of the unreinforced wall were much

332 higher than the recommended values in EC-8. At low displacements, damping values  
333 were almost 25%, but considering the fast degradation of the mechanical response, it  
334 may seem reasonable to adopt values closer to 10%, as those shown by the unreinforced  
335 wall after suffering severe damage. Nonetheless, according to the current results the U-  
336 W showed more equivalent damping than the TRM-W. Unreinforced masonry  
337 presented wider crack distribution along the whole structure, which may be responsible  
338 for the bigger damping. While the TRM prevented crack development, which were  
339 more localized around the corners. Hence, the fissure length (i.e. friction areas) was  
340 controlled, and the energy had to be accumulated in the TRM itself, as cracks in the  
341 mortar, or elastic energy in the fiber mesh.
