Voyagaki, E., Kloukinas, P., Novelli, V., De Risi, R., Kafodya, I., Ngoma, I., Goda, K., & Macdonald, J. H. G. (2020). *Masonry panel testing in Malawi*. Paper presented at 17th World Conference on Earthquake Engineering, Sendai, Japan.

## MASONRY PANEL TESTING IN MALAWI

*Keywords: Masonry panel testing; laboratory testing; Malawi; Seismic vulnerability assessment*

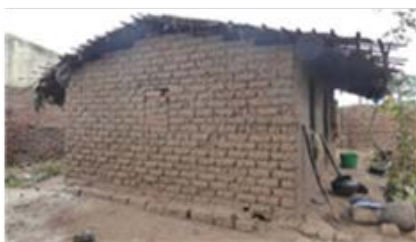
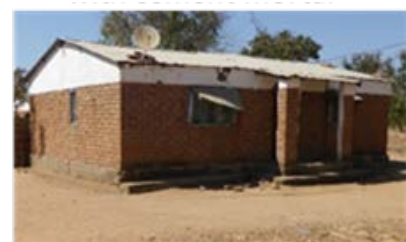
(a) unfired bricks / mud mortar

(b) fired bricks / mud mortar

(c) fired bricks / cement mortar

Fig. 2 – Typical houses in rural and urban areas of Malawi made of unreinforced bricks and mortar. [7]

Fig. 2 shows typical houses in Malawi that are, almost exclusively, one-storey buildings made of locally moulded, sun-dried or fired clay bricks and mud or low-strength cement mortar. Walls are often single-skin, against the local guidelines. Double-skin walls are built in the case of higher-income households; however, they are not always adequately constructed. Roofs are typically pitched, constructed by wooden beams and covered using iron corrugated sheets, or thatched (Fig. 2(b)). Quality of materials is low; compressive strengths of bricks vary between 1 and 10 MPa (typically lower than 5 MPa), even within the same batch. The mortar used to bond the bricks varies from plain mud to cement-sand mixtures. The latter typically have a cement-to-sand ratio significantly lower than the either 1:4, suggested for structural masonry (or 1:3 for foundations and special applications) according to MS791-1 [17] or the minimum ratio of 1:6 recommended in the Safer House Construction Guidelines [8]. In local construction practice, the ratio typically depends on the income level of the household and it is generally lower than 1:6 (often 1:8 or even lower) [9].

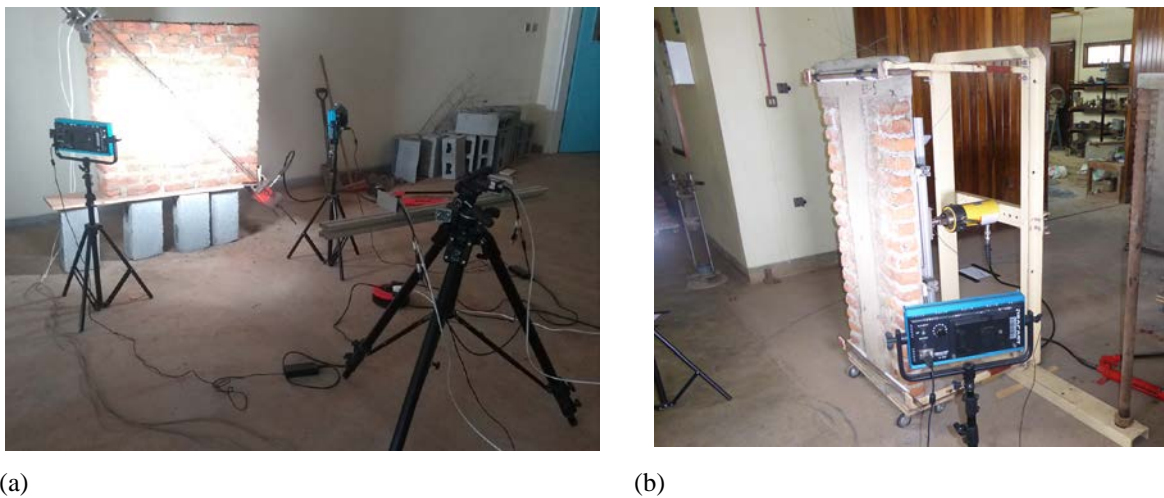
The laboratory testing equipment (Fig. 6) consisted of a combination of (1) conventional testing devices with a number of portable testing rigs mountable on the specimens directly and on the strong floor, and (2) a high-precision video tracking system to measure displacements (Imetrum Video Gauge, [25]), with synchronised analogue load cell signals connected to it.

Fig. 6 – The (a) in-plane and (b) out-of-plane testing apparatus and Imetrum Vision System.

The diagonal compression test was performed according to the in-situ variant of the test with the wall panel upright [26]. Test measurements were: (i) analogue, taken through two synchronised load cells (Fig. 6) attached to the loading shoe in the upper left corner of the specimens; and (ii) digital, monitored by the vision system, in the case of the specific test as strain gauges along the two diagonals of the specimen. In interpreting the above measurements into shear strength, RILEM standards were chosen [26, 27] shown in Fig. 7.

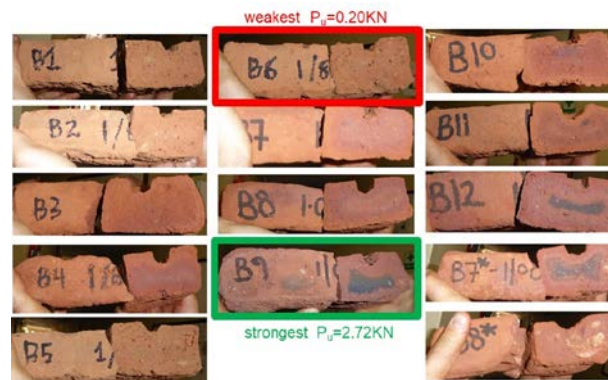
Fig. 9 – Fired clay bricks tested in flexure(/shear) (3-point bending test) from the 2019 batch.
