1 Experimental characterization of monumental brick masonry in Nepal

2 Rishi Ram Parajuli¹, Aiko Furukawa², Dipendra Gautam^{3,*}

8 Abstract

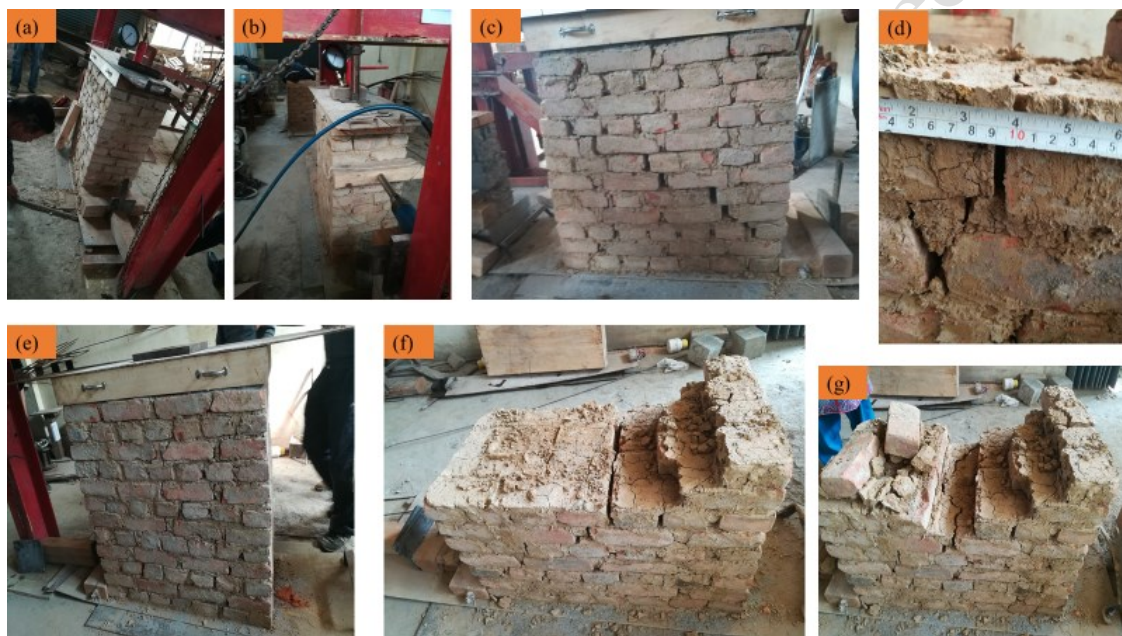
132
133 Fig. 1 a) and b) Loading arrangement for masonry wallet, c) crack initiation in wallet, d)
134 cracked specimen, e) specimen contained by metal plates, f) and g) cracks propagated in
135 masonry wallets

123 Test setup for the shear test was arranged in such a way that the target forces and

124 measurement of displacements would be achieved. Fig. 1 shows some evidence of the
125 experimental campaign conducted at the Heavy Lab at Institute of Engineering, Pulchowk
126 Campus, Nepal. A wall panel and loading directions are shown in Figs. 2a and 2b.
127 Constant vertical load was applied at the top of the wall and monotonic lateral load was
128 applied gradually up to the failure point. The horizontal load was applied at the two third
129 of the height of the wall, i.e. 600 mm from the bottom of the wall. Four samples were
130 tested with varying constant vertical loads of 10, 12, 15, and 18 KN, meanwhile,
131 displacements in each load increment was recorded.

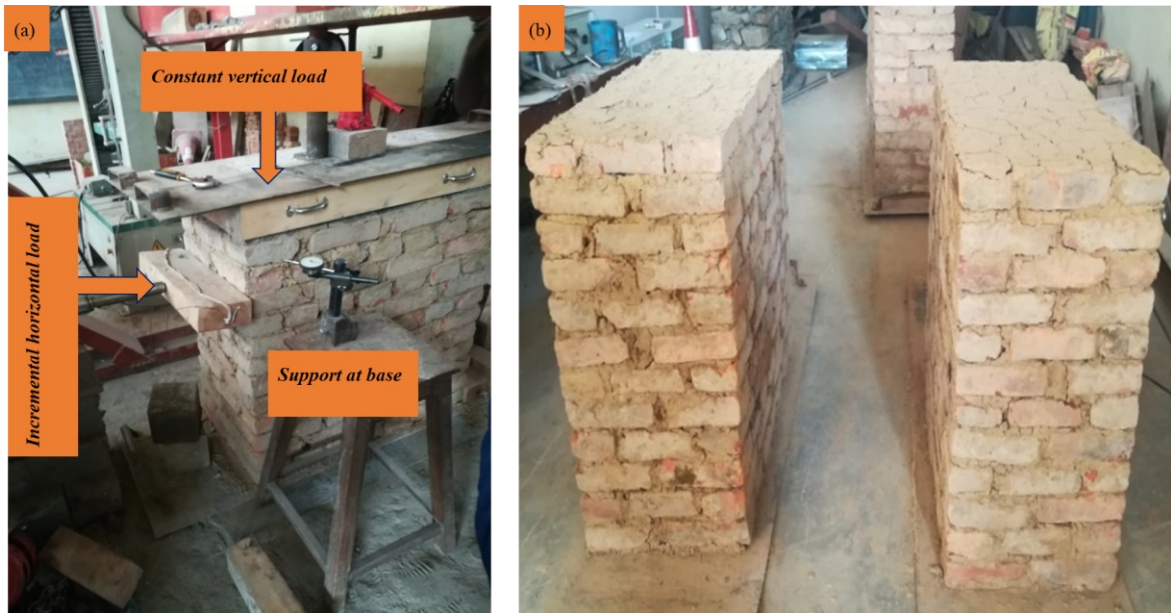
137 Fig. 2 a) Experimental setup for in-plane shear test showing loading direction, b) wall
 138 samples prepared for in-plane shear test
