## PERFORMANCE OF ELECTRODEPOSITED NICKEL/CHROMIUM, ZINC, TIN-BISMUTH ALLOY COATING PANELS EXPOSED AT MANDAPAM CAMP

K CHANDRAN AND S GURUVIAH

Central Electrochemical Research Institute, Karaikudi 623 006

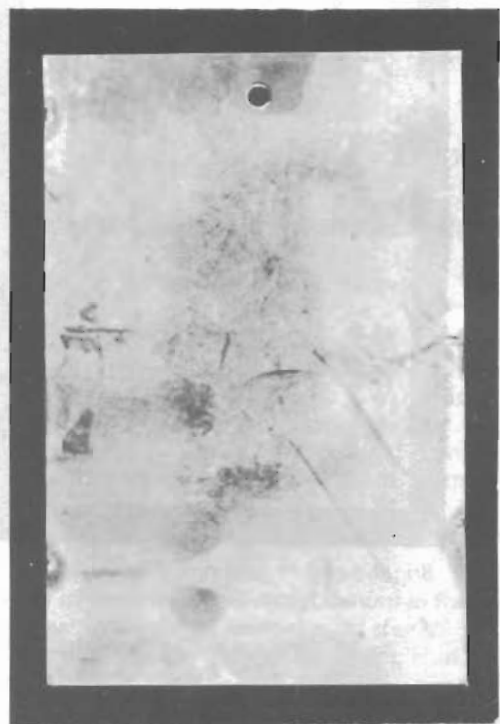
1. Matte nickel + (Acid) bright copper + bright nickel + flash chromium

It is obvious from the Table that the performance of nickel-iron/Cr combination (1 and 2) and bright-nickel/Cr combination (3) are same as seen from the photographs (1 and 2) and observations recorded in the Table II. The performance of protective schemes

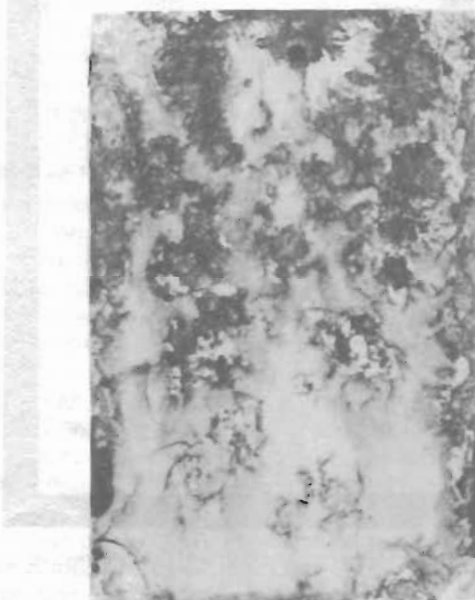
4. Nickel-iron alloy (The same thickness as in (3))

with lower thickness (4-6) is given in Table II. It is seen from the Table that the performance of Ni-Fe alloy (No. 7) failed within six months and the photograph No. 4 indicates the total failure at the end of one year, whereas the same Ni-Fe alloy with flash chromium

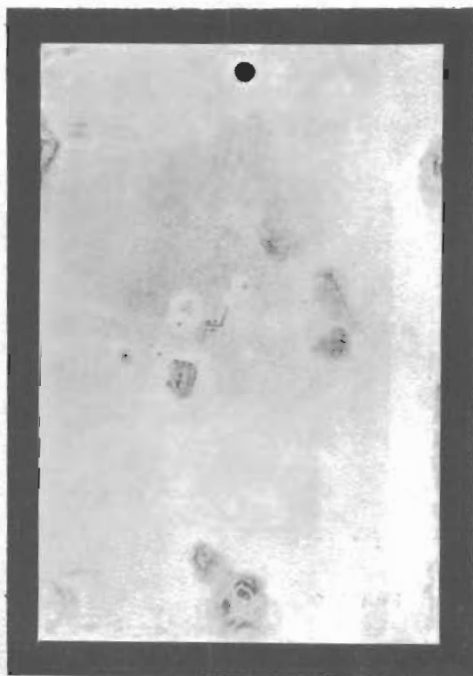
7. Tin-bismuth alloy (on brass substrate) (for aggressive atmosphere)

photograph 7 that the protective scheme based on tin-bismuth alloy on brass plate failed completely within six months and brass substrates are visible. The protective scheme with zinc coatings (acid or cyanide bath) on mild steel panels exposed at Mandapam Camp failed within three months. At the end of six months the coatings peeled off from the surface. It is seen from photograph 8 that the zinc protective coatings failed completely.
