## Assessing the Long-term Success of Reigate Stone Conservation at Hampton Court Palace and the Tower of London

Martin Michette , Heather Viles , Constantina Vlachou-Mogire & Ian Angus

To cite this article: Martin Michette , Heather Viles , Constantina Vlachou-Mogire & Ian Angus (2020) Assessing the Long-term Success of Reigate Stone Conservation at Hampton Court Palace and the Tower of London, *Studies in Conservation*, 65:sup1, 225-232, DOI: [10.1080/00393630.2020.1752427](https://doi.org/10.1080/00393630.2020.1752427)

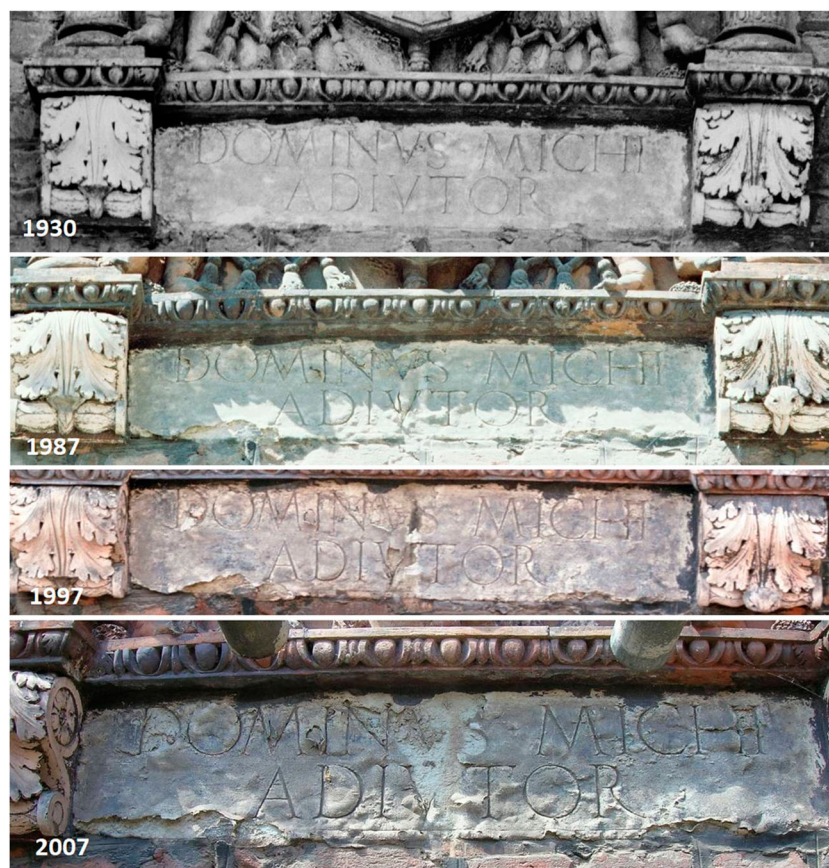
**Figure 1.** Cardinal Wolsey Plaque at HCP showing acceleration of decay rate on wax-treated Reigate stone surface.

accelerated decay patterns, which have been documented at HCP on the Cardinal Wolsey plaque (Figure 1). Coatings do not show uniform signs of decay. In some sheltered areas, coats have partially detached, spalled or eroded to reveal sound stone. In

other sheltered areas, coats have blistered and flaked to reveal flaking stone and gypsum crust. In many exposed areas remnants of coat are isolated, and the stone surface is friable and soiled. Most coats appear discoloured by pollution. Microclimatic stability appears to control the performance of wax treatment.

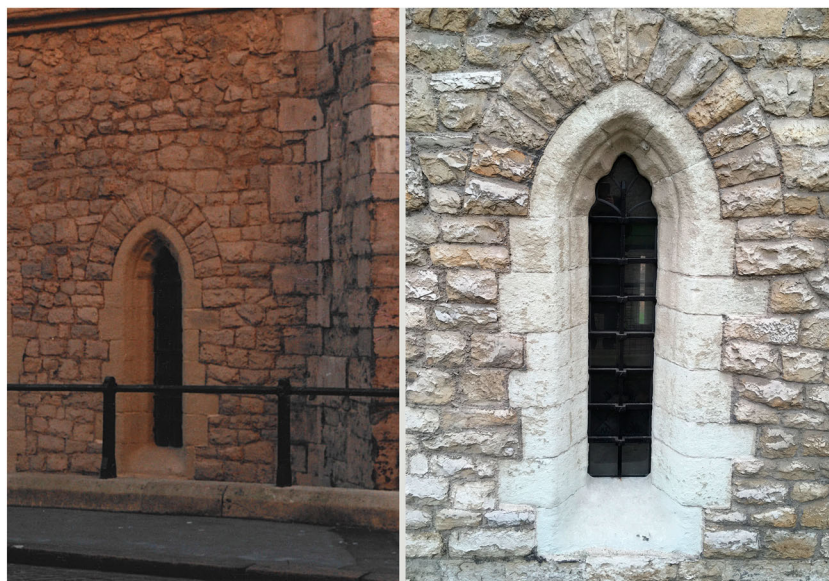
**Figure 2.** Left: limewashed Reigate stone at Cradle Tower, ToL, shortly after treatment in 1990 and right: in 2018 showing good state of preservation.

The lime method emerged in the 1980s as a holistic technique for treating limestone. It consists of consolidation with calcium hydroxide (limewater), plastic repairs with lime-mortar and protective coatings of lime diluted in water (limewash) (Doehne and Price 2010, 36–37). Various additives are added to the limewash in attempts to improve resilience. The technique was widely used on Reigate masonry at ToL in the early 1990s. Initial use of limewater in the upper Bell Tower in 1988 caused concern over the high level of water uptake. There are conflicting accounts of where it was applied after this; contemporary documentation suggests masonry at the Cradle and Wardrobe Towers was also treated with the full lime method (Table 1). Most coats have since detached from Reigate stone at the highly exposed Wardrobe Tower, however, some remain intact. Coats have also largely detached from the lower Bell Tower and the Bell Tower parapet. Rapid decay has been recorded in all three areas, with distinct environmental mechanisms likely to be responsible in each case, ranging from deep wetting of the masonry to rapidly fluctuating conditions (Mchette et al. 2019). The more benign environment of the upper Bell Tower has led to longer lasting coats, however recent prolonged moisture ingress in the southern alcove due to defective guttering has rapidly accelerated localised decay. Intact coats are not exclusive to internal masonry; coats applied to the external Cradle Tower have also survived (Figure 2). These observations imply microclimate and

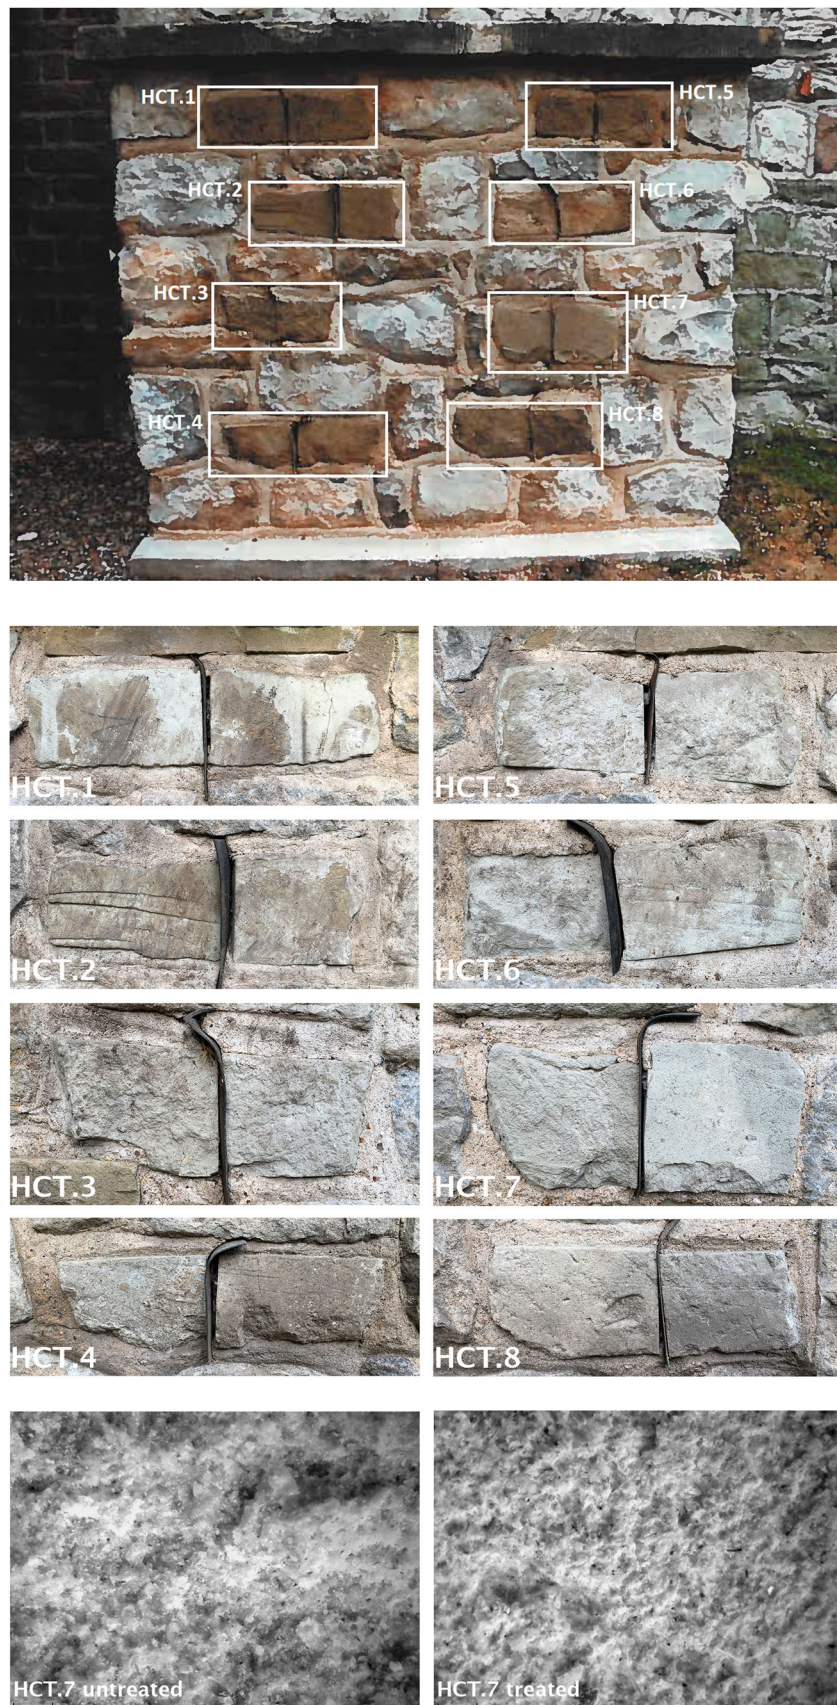
**Figure 4.** HCT trial wall at ToL. Top: shortly after treatment in 2001 (dark surfaces due to residual moisture following treatment). Middle: individual stones in 2018 (each stone treated on right hand side only). Bottom: micrograph taken with Dinolite USB microscope, showing consolidation of treated surface.

An HCT test wall was built at ToL in 2001 (Figure 4). Eight stones were cut in half and separated by an

impermeable membrane. The right half of each stone was treated with HCT, the left acted as an untreated control. Photos taken shortly after construction of the test wall show that individual stones displayed a range of different textures, colours and pre-existing decay features. This suggests various sources. HCT.1, HCT.2 and HCT.4 had a yellow-brown discolouration of varying density but covering most of the surface area, probably related to a previous surface treatment, possibly linseed oil or wax (Odgers and Henry 2012, 136). HCT.3 and HCT.5 had rough surfaces. HCT.6, HCT.7 and HCT.8 had smooth, pale grey surfaces with localised damage.

Visual inspection of the test wall reveals that HCT.6 and HCT.7 have become noticeably more resistant to decay following treatment (Figure 4). In both cases, granular disintegration has affected large parts of the untreated area, but only small parts of the treated area. Decay has progressed most rapidly around pre-existing decay features, which were more evenly spread across the surface of the untreated areas. Whilst decay was visible in other stones, there was no apparent difference between the decay rates of treated and untreated areas.

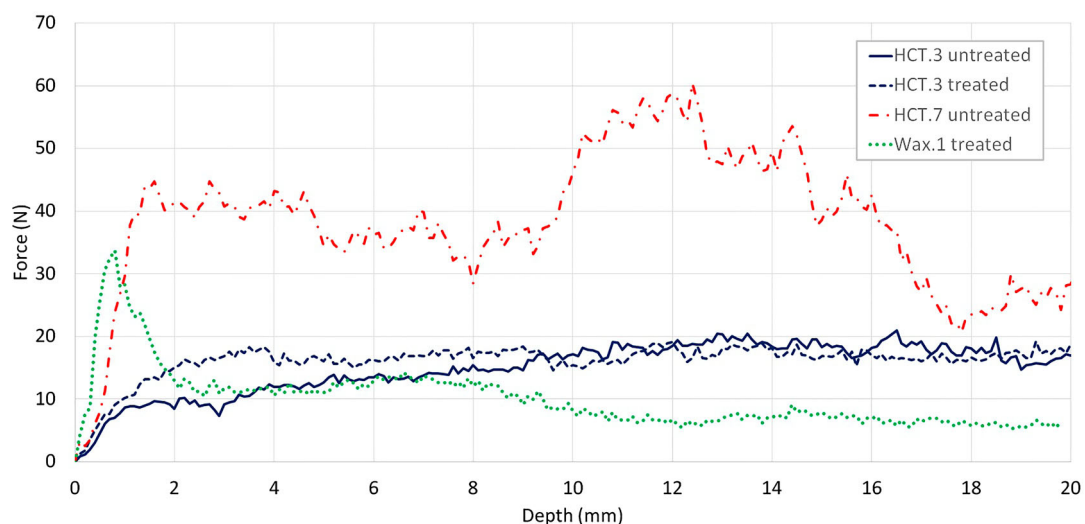
**Figure 5.** DRM profiles of selected stones.

repellent effect. Absorption was lower in treated areas on fewer than half the stones. Instead, factors such as individual stone composition or position appear to control water uptake. Environmental and mineralogical factors also appear to influence DRM more than treatment. Only HCT.3 and HCT.6 required a slight increase in force to penetrate the initial subsurface of the treated area. Where DRM does indicate a consolidating effect, profiles suggest a penetration depth of at least 5 mm (Figure 5). Comparison of resistance across stones should be treated with caution due to rapid deterioration of the drill bit: HCT.2 and HCT.6 were measured on a different day from the other stones using a new drill bit and appear accordingly less resistant. Nevertheless, HCT.7 was significantly more resistant and more heterogenous than any other stone (Figure 5). This could reflect a higher calcite content, which would explain effective treatment. HCT.4 displayed crust formation or case hardening of the outer 3–4 mm of both treated and untreated areas. HCT.4 sits on the lowest course of the test wall and showed signs of salt contamination. Regardless of any effect treatment may have had, inherent mineralogy and environmental stresses appear to exert a greater control on on-going decay.
