**DOE NIEA Standing Freshwater Monitoring of Special
Areas of Conservation (SAC) and Areas Special Scientific
Interest (ASSI) (Second Round) P_12324**

ECRC Research Report Number 168

2015

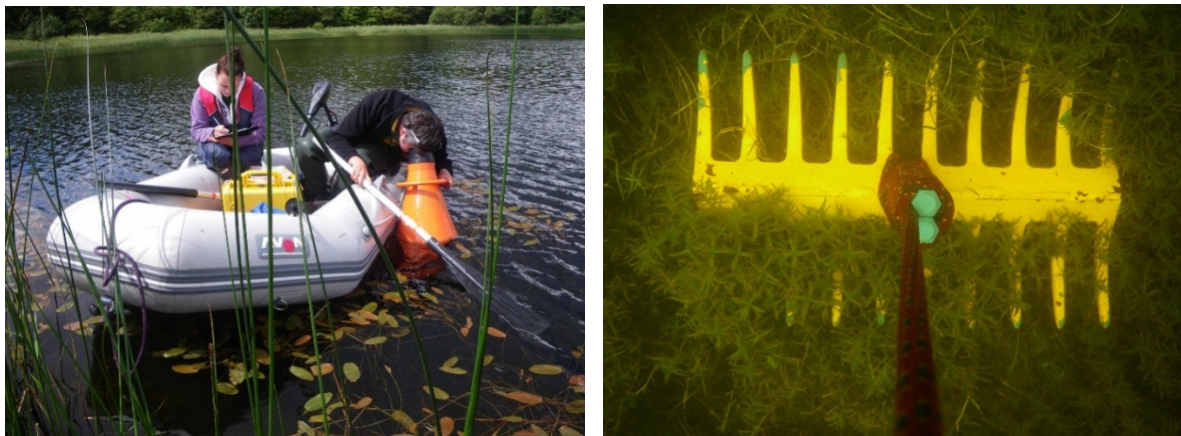
Figure 2 Sampling methods: bathyscope (a) and double-headed rake (b)

Where possible, surveying was performed using a bathyscope (Figure 2 a), but a double-headed rake (grapnel, Figure 2 b) was also deployed in deeper water or where poor water clarity restricted visibility. The location of all survey sections and boat transects was recorded using Global Positioning System (GPS), backed up with digital photographs, all of which are provided in the data appendices. All boats and survey equipment were cleaned between sites using an approved aquatic disinfectant (Virkon AQ), with additional care being taken where alien plant species were present (e.g. *Elodea* spp.). Sites where zebra mussels (*Dreissena polymorpha*) were observed (e.g. Lough Erne system), or where crayfish (*Austropotamobius pallipes*) were known to occur were treated with additional care to ensure complete disinfection.

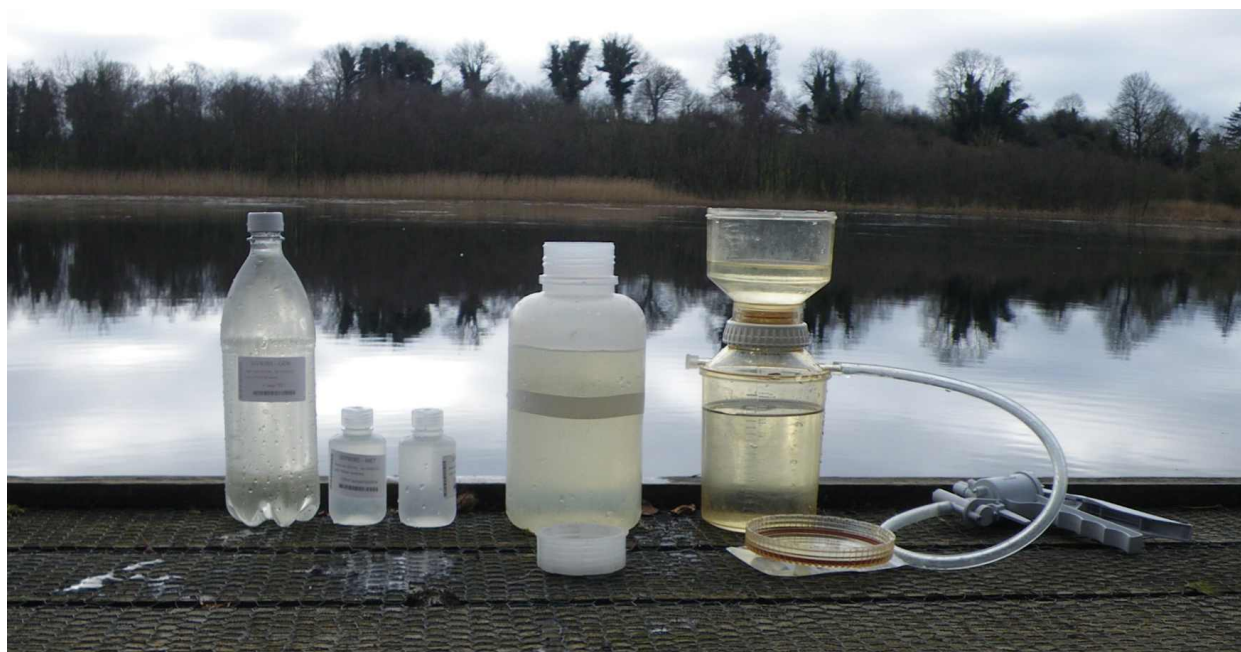
Figure 5 Water sample collection and Nalgene filtration unit (right)

Due to the large number of sites involved, the deployment of boats was not feasible and therefore a throw bottle was used to obtain representative lough water samples. The beach throw consists of a weighted polypropylene sample bottle, with a buoy attached to a rope 50 cm above the mouth of the bottle. After rinsing 3 times with sample water, the bottle is thrown into the lake from the shore to a distance in excess of 10 m. The weight is sufficient to cause the bottle to just dip under the water surface at first and then descend through the water column as the bottle fills. The buoy holds the full bottle 50 cm below the water surface. The sample is retrieved by pulling the rope. The opening of the sample bottle is large enough to allow the bottle to fill in a reasonable time but small enough to prevent water from entering it when the full bottle is pulled to shore. This method is accepted as the most practical and cost-effective for CSM sampling (JNCC 2015) and has been previously demonstrated by staff at the Freshwater Science Research Group
