International Congress of Science and Technology of Metallurgy and Materials, SAM -
CONAMET 2013

Coppers from the Battle of Trafalgar: Metallurgical Analysis of Structural Fastenings from the French ships *Fougueux* (1785-1805) and *Bucentaure* (1804-1805)

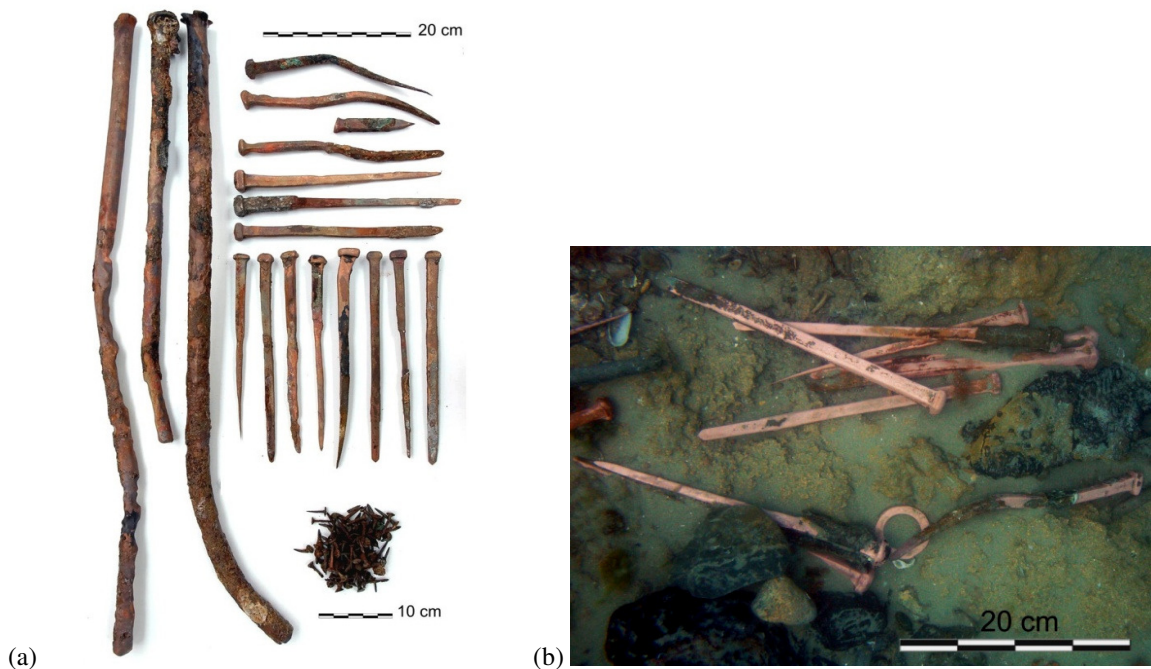
Fig. 1. (a) remains of fastenings (bolts, spikes and sheathing tacks) recovered from the Camposoto site; (b) some examples of spikes, located *in situ*. Photos: courtesy of CAS-IAPH 2011.

The artifacts from the *Fougueux* (1805) are two copper spikes (see McCarthy 2005), which originally belonged to the ship's structure. The samples were selected from an array of fastenings recovered from the site, where they were found in isolation, on the surface (Fig.1). The pieces come from a ship area that possibly corresponds to the projection of the keel, detected during other surveys (Rodríguez Mariscal 2010).

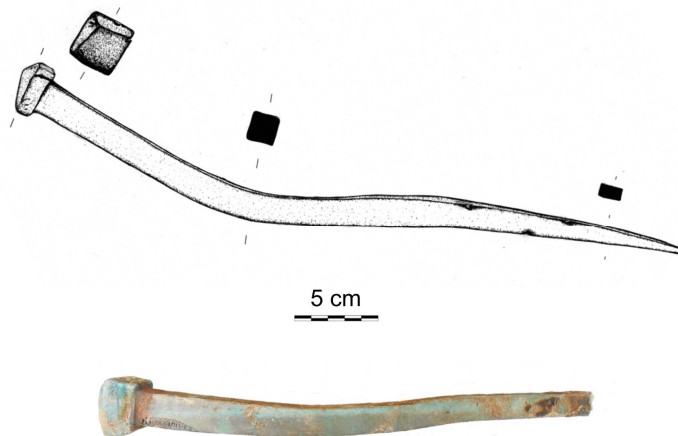
Fig. 2. Copper spikes from the site Bajo Chapitel: BCH/CA 05 – 20 (above) and BCH/CA 07 – 117/1 (below, analyzed). Drawing and photo: courtesy of CAS-IAPH 2011.

As was mentioned, in order to make a comparison between technologies of both vessels, two spikes recovered from the site Bajo Chapitel (*Bucentaure*) were also analyzed. These pieces (BCH/CA 05 – 10 and BCH/CA 07 – 117/1) are morphologically similar to the objects previously described (Fig.2).

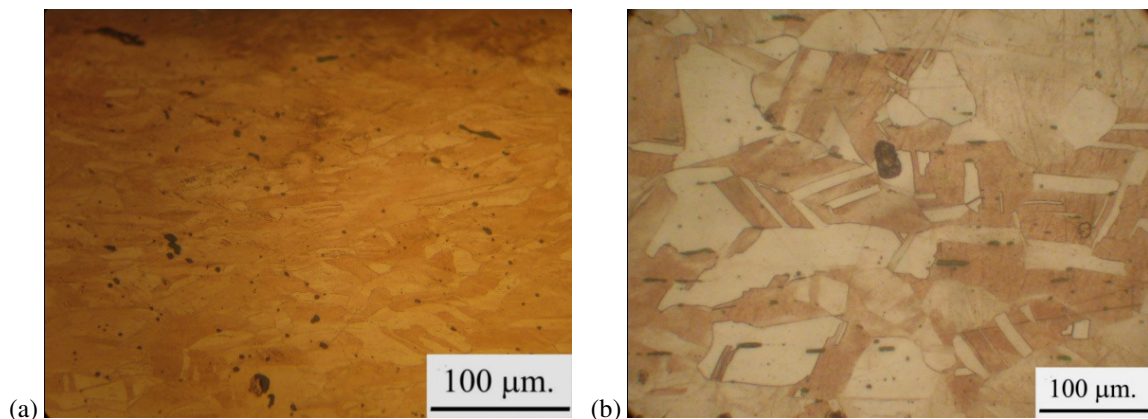
Two samples were analyzed, corresponding to the head-shank and the shank-tip zones of the spike. Observations made on longitudinal sections revealed a single-phase microstructure (with the characteristic reddish copper color) of variable grain sizes, annealing twins and elongated –apparently non-metallic– inclusions. In the head area, grains present shape variability (Fig.3-a); whereas in the shank, a tendency to equiaxial morphology can be notice (Fig. 3-b).

Fig. 3. (a) single-phase microstructure formed by copper grains of variable shape and size; annealing twins and inclusions are also present (head); (b) microstructure with a tendency to equiaxiality –compared with that observed in the head–, annealing twins and inclusions (shank). Etchant: NH_4OH , H_2O , H_2O_2

The described structure suggests that the spike was manually manufactured, by hot forging. Variations observed are associated with differential strains undergone by each zone during the manual fabrication process. In the head, the effort applied during shaping was probably done in many directions; in the shank, this work is likely to have been perpendicular to its axis. The orientation of non-metallic inclusions may be considered as further evidence of that process, since these inclusions are randomly ordered in the head, whereas in the shank they are markedly aligned in the longitudinal direction (Fig.4).

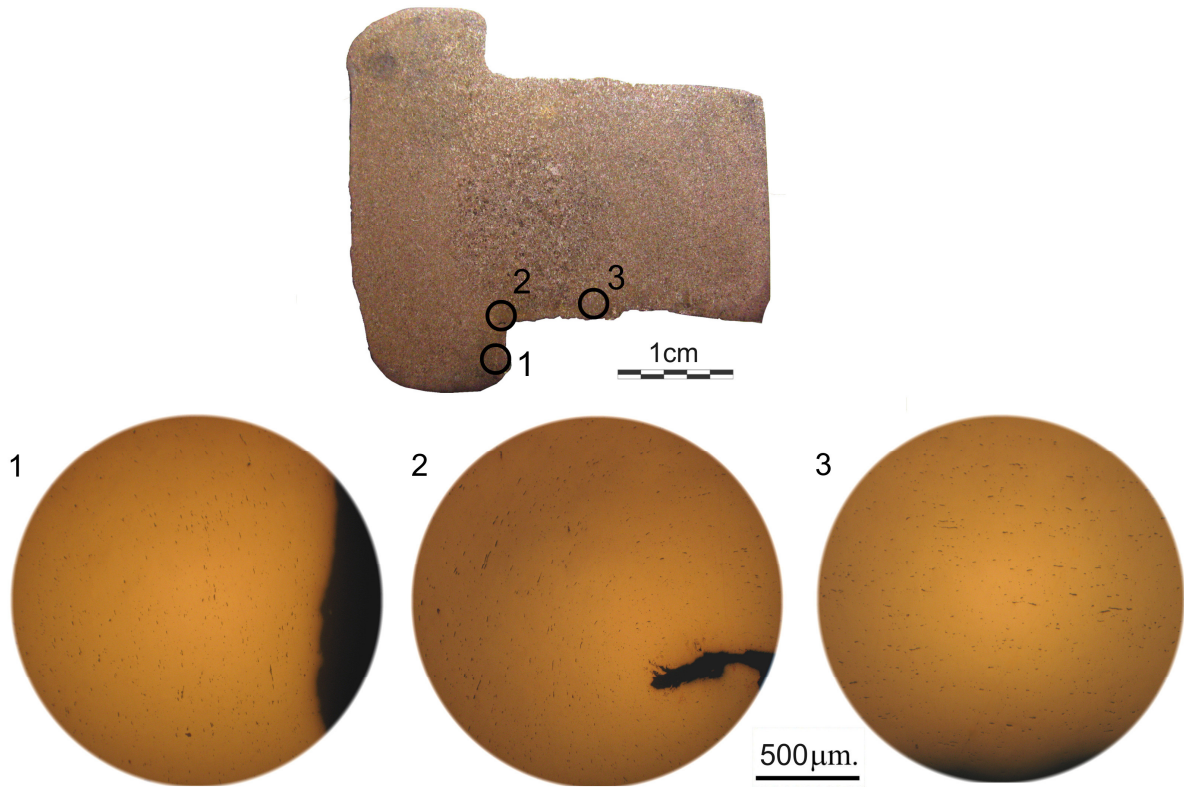
Fig. 4. Optical micrographs of the head-shank transition zone, where the orientation of inclusions according to shaping direction can be seen (spike CAMP/CA 07 – 85/3).

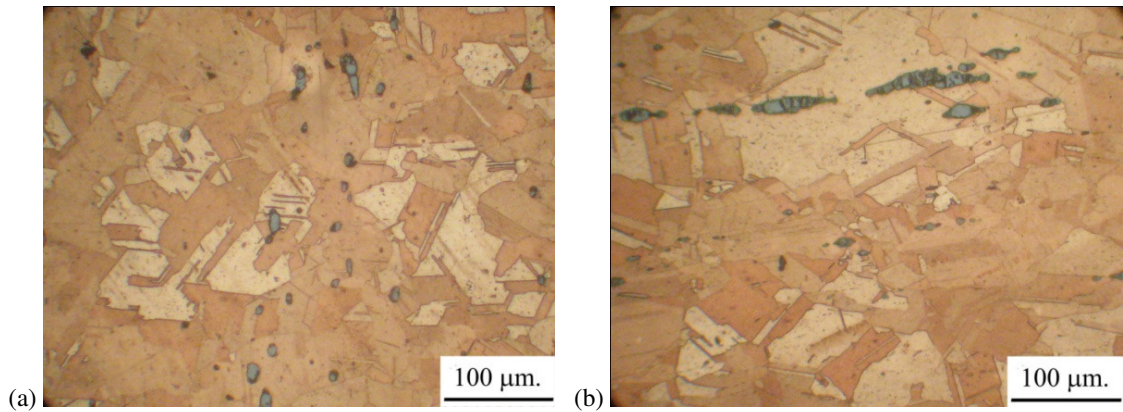
Two samples were analyzed; one corresponding to the head-shank zone (longitudinal section, seen in plant) and the other to the shank-tip (longitudinal section, seen in profile). From the observations made, a single-phase microstructure with different grain sizes, annealing twins and non-metallic inclusions can be distinguished. In the head zone, annealed grains with irregular shapes and dimensions are also noticeable. There is no evidence of plastic deformation or preferential orientation (Fig.5-a). Inclusions show no defined alignment, but towards the head-shank transition they begin to acquire a notorious change. They finally converge in the shank, where their orientation is clearly in accordance with the forming direction (Fig.5-b).

Fig. 5. (a) single-phase microstructure of copper grains of different shape and size, with annealing twins and inclusions, randomly ordered in the head; and (b) markedly aligned in the shank (spike CAMP/CA 07 – 85/10). Etchant: NH_4OH , H_2O , H_2O_2

These features may be associated with a manufacturing procedure similar to that experienced by the previous spike, although in this case the shape and size of grains suggest that the heating and working processes applied to give shape to the head were more uniform.

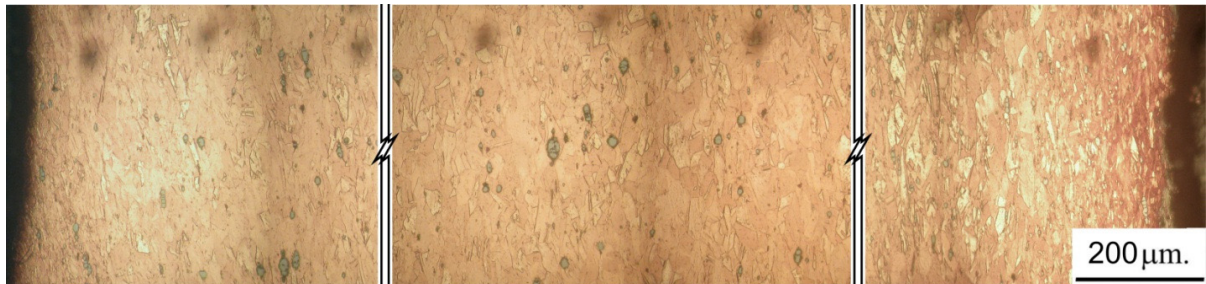
The grain size variation extends from the center to the periphery and from the tip to the shank. On the periphery, very small grains can be observed, while inward the spike these are larger (ten times the size of the smaller ones). The most noticeable difference is seen at the end of the shank, adjacent to the tip (Fig.6), whereas in the tip itself, the grain size is more regular within the whole section.

Fig. 6. Microstructure of copper grains of different sizes (band cross to the longitudinal direction of the shank, section adjacent to the tip).
Etchant: NH_4OH , H_2O , H_2O_2

This suggests that, during the penultimate forming operation, the piece underwent greater deformation in the periphery than in the core. When subjected to temperature, the grains that had been deformed recrystallized; while the interior grains, which presumably did not reach the critical deformation, only experienced growth. Additionally, the observed deformation of the grains is considered as the product of cold hammering during the last forming instance. Deformation can be appreciated in most grains, although the most affected are those in the periphery. This final step would have been directed to enhance the hardness of the piece.

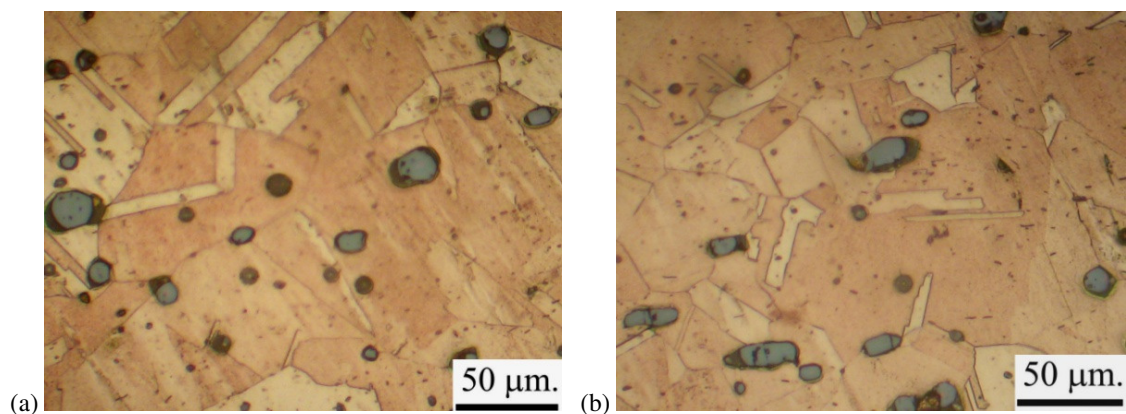
The metallographic observation was performed on a longitudinal section of the shank. The piece presents a microstructure of equiaxial grains, uniform in size, with annealing twins, no signs of deformation and a typical copper or copper alloy color. Furthermore, abundant non-metallic inclusions of different size and color, with a slight orientation, can be appreciated. The larger, that appear to be copper oxides, have smaller ones adhered, that in view of their tonality correspond to different compounds. Small dark grey inclusions that look like lead particles can also be distinguished (Fig.7). The features observed can be associated with a forming process by means of hot manual hammering.

Fig. 7. Optical micrographs of the recrystallized microstructure, with non-metallic inclusions (longitudinal section). Etchant: NH_4OH , H_2O , H_2O_2 .

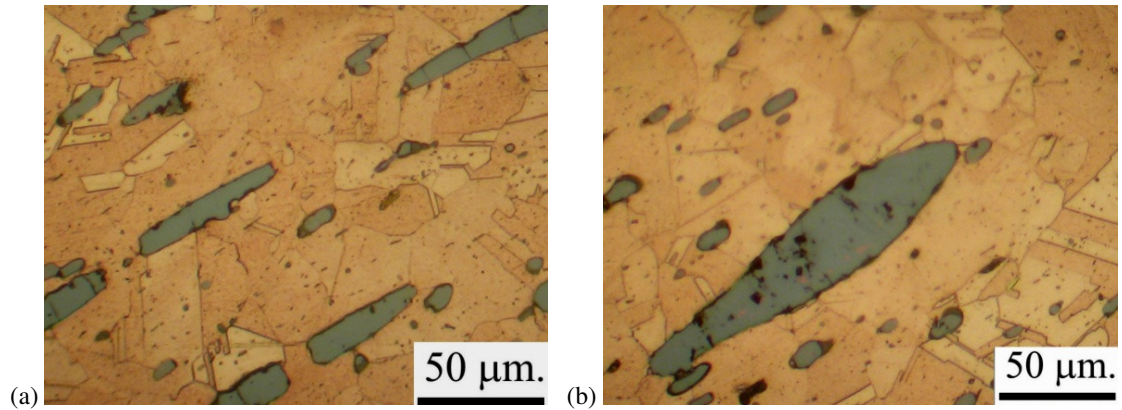
The microstructure detected in the longitudinal section of the shank consists in a solid solution or pure metal grains, mostly equiaxed, with annealing twins. It also presents abundant non-metallic inclusions, combining copper oxides with a smaller quantity of other compounds, differentiable by their color (Fig.8). In this case, inclusions present a significant alignment in the longitudinal direction of the shank. As in the previous piece, these microstructural features are consistent with a hot forming process.

Fig. 8. Optical micrographs of the recrystallized microstructure, with elongated non-metallic inclusions (longitudinal section). Etchant: NH_4OH , H_2O , H_2O_2

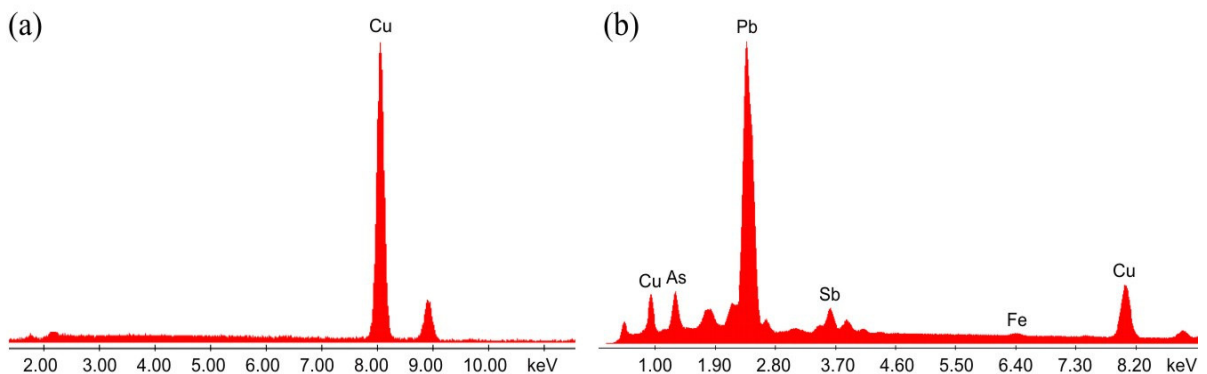
The sample from the shank-tip was analyzed via EDXRS. The overall composition of the matrix, assessed in several sectors, indicates that the raw material used for the piece manufacturing was unalloyed copper (Fig.9-a). The (punctual) analyses of several inclusions in different sections of the piece indicate a major composition of Pb, together with small concentrations of As, Sb, and Fe (Fig.9-b).

Fig. 9. Elemental composition (EDXRS spectra) of the spike: (a) overall matrix composition (tip); (b) composition of an inclusion with high lead content (shank).

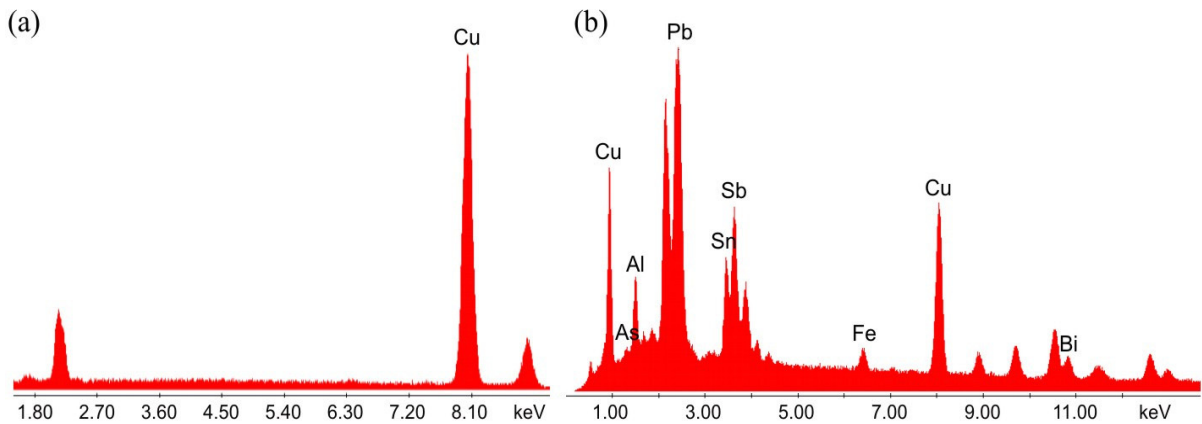
The spectra of Fig.10-a shows the quantification obtained by EDXRS in the matrix (global analysis), which indicates that the piece was made of unalloyed copper. Furthermore, the analyses show that most of the inclusions are of copper oxide. Other inclusions were also detected, although in a smaller amount. They are composed mainly of Pb, with varying amounts of Sb, As, Sn, Bi, and Fe (Fig.10-b).

Fig. 10. Elemental composition (EDXRS spectra) of the spike: (a) overall composition of the matrix (tip); (b) composition of an inclusion with high lead content (shank).

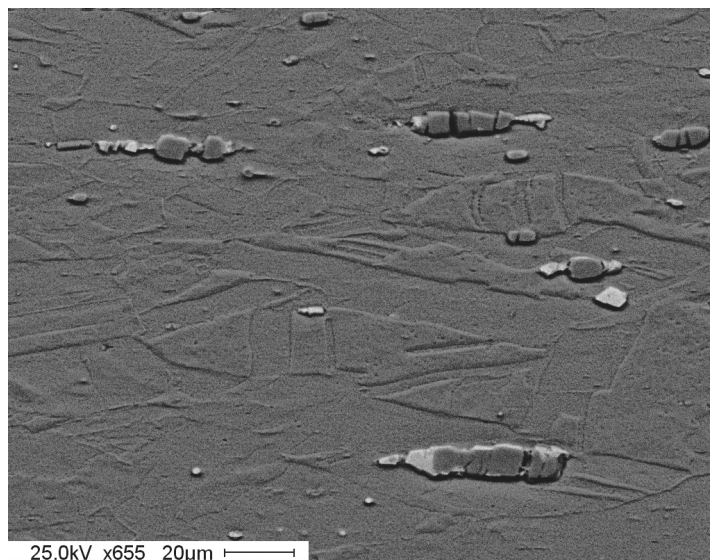
A SEM image produced by backscattered electrons revealed differences in the chemical composition of the inclusions, by brightness differences in the image (Fig.11). Thus, it was possible to differentiate between copper oxide inclusions and those with high lead content (brighter).

Fig. 11. Backscattered electron SEM image, where differences in chemical composition can be detected by changes in image brightness (shank). Photo: Gisela Maxia 2012.

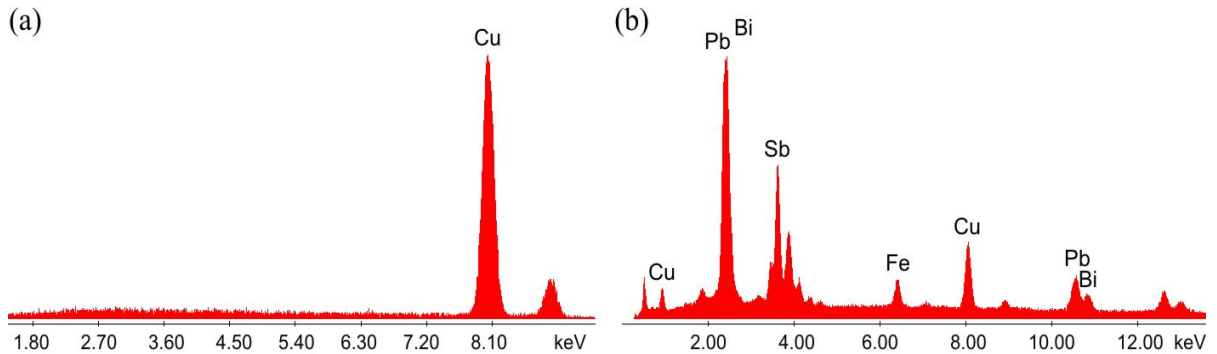
As in the case of *Fougueux* spikes, the overall composition of the matrix corresponds to unalloyed copper (Fig.12-a). Furthermore, some of the inclusions analyzed indicate a comparable elemental composition, although with some minor differences. As was the case of the previous objects, the raw material used contained impurities of Pb and other elements (Fig.12-b).

Fig. 12. Elemental composition (EDXRS spectra) of the spike: (a) overall matrix composition; (b) composition of an inclusion with high lead content.
