View metadata, citation and similar papers at core.ac.uk

J Clin Exp Dent. 2020;12(5):e514-8.

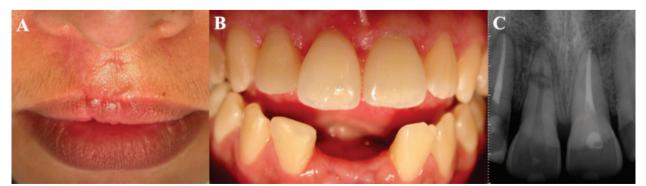
Fig. 1: A) Scar on the right upper lip due to trauma. B) Absence of teeth 31 and 41, avulsed. C) Initial x-ray suggestive of apical horizontal fracture.

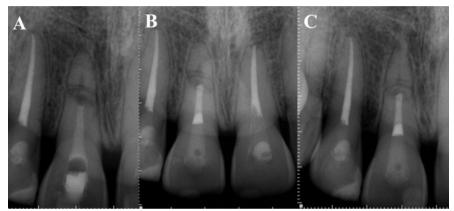
**Fig. 3**: A) Intracanal medication, B) Bioceramic obturation and 2 mm cervical obturation with thermoplastic gutta percha - 1 year control C) Proservation after 2 years.
