Identifying the Original Colour of the Paintwork on the Artistic and Industrial Recreation Pavilion Designed by Antonio Palacios for the Galician Regional Exhibition Held in 1909

Abstract: The former Artistic and Industrial Recreation Pavilion, which was designed by Antonio Palacios (1874–1945) and built for the Galician Regional Exhibition held in 1909 in Santiago de Compostela (Galicia, north-western Spain), and which currently houses a nursery school, was completely restored in 2018. The main purpose of the restoration was to recover the original exterior colour of the building. For this purpose, a study was undertaken to identify the original colour of the paintwork by first consulting historical archives and then conducting a micromorphological analysis of stratigraphic paint samples by stereomicroscopic examination and scanning electron microscopy (SEM) coupled with electron dispersive spectroscopy (EDS). Three reformations of the building are documented: one carried out in 1926, when the metal roof was replaced with a tile roof; another conducted between 1967 (when the old pavilion was described as a "destroyed building") and the mid-1970s (when it began to be used as a nur

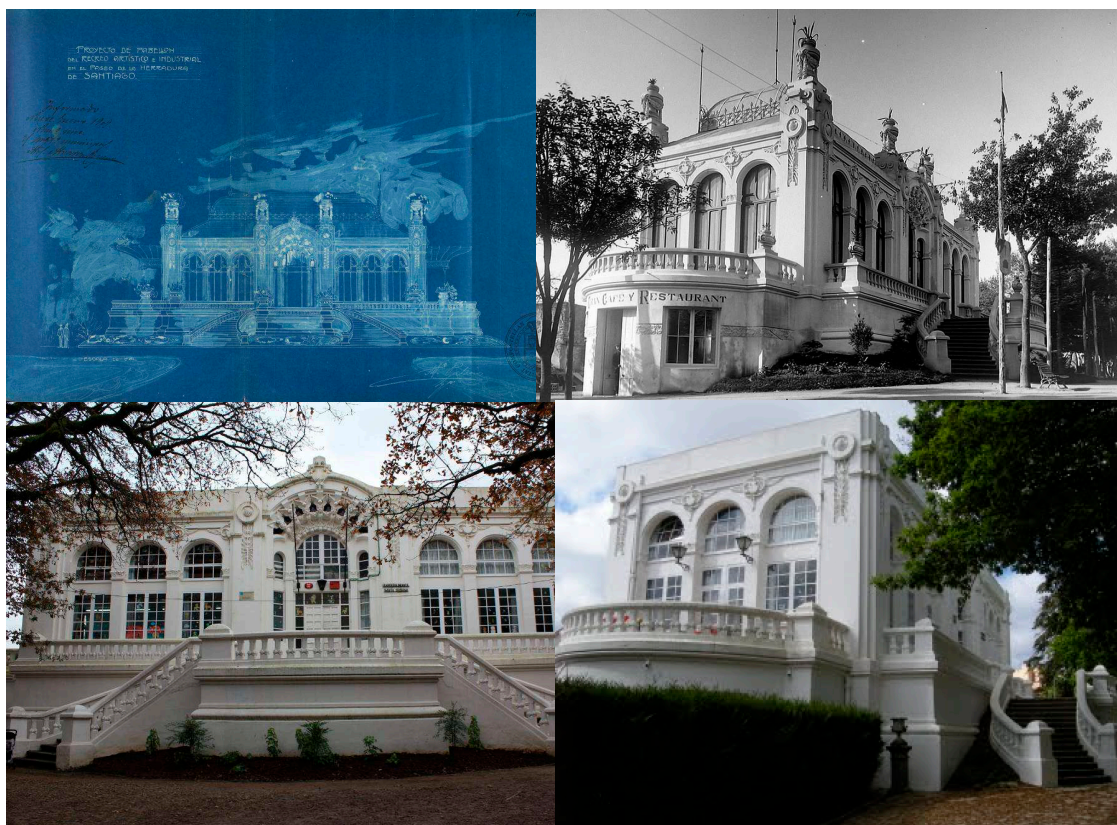
Figure 1. Images of the Artistic and Industrial Recreation Pavilion. From left to right and top to bottom: original design of the Pavilion by Antonio Palacios in 1908 [2]; photograph of the building in 1915, by Manuel Chicharro Bissi (Source: La Voz de Galicia, newspaper); and two recent (2018) photographs of the building, housing the Santa Susana nursery.

The former Artistic and Industrial Recreation Pavilion (Figure 1), designed by the architect Antonio Palacios Ramilo (O Porriño, Pontevedra 1874 - El Plantío, Madrid 1945) and constructed by master builder Manuel Pereiro Caeiro, was one of the eleven pavilions constructed for the Galician Regional Exhibition held in 1909. After the exhibition, the building was used for other purposes, i.e., as a venue for exhibitions and other artistic events, as a laboratory, as a cinema, as headquarters of the Falange, and, since the mid-1970s, as a nursery school.

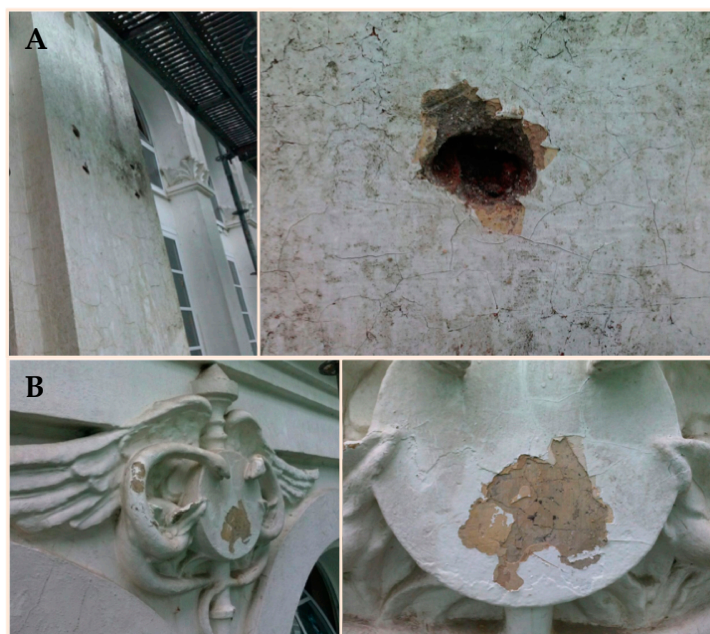
Figure 2. General image (left) and detail (right) of the sampled areas of the building: (A) pillar and (B) ornamental part. Photographs: Marta Díaz.

As the purpose of the work reported here was to identify the original colour of the paintwork, the building was inspected for areas where the paint was chipped and the inner layer was exposed. Ten samples of about 70–100 mm of diameter were obtained from different areas. The sampling points were recorded, and the samples were examined by microphotography under a stereomicroscope (Nikon, SMZ-2T) and light microscope (Nikon Eclipse 50i). After the initial analysis, two representative samples in each set were chosen for further analysis (Figure 2): a building pillar (Figure 2A) and an ornamental part (Figure 2B). In order to observe the morphology of the pictorial preparations and determine the elementary composition of pigments and fillers, the samples were embedded in epoxy resin and, once this had set, cut transversally to the paint layers and polished. The cross-sections thus obtained enabled detailed study of the different paint layers. The cross-sections were observed under an OLYMPUS SZX7 (Germany) zoom stereomicroscope, and the general characteristics of the sample (number, colour, thickness, degree of adhesion and state of conservation of the different paint layers) were determined. The cross-sections were then studied under a Scanning Electronic Microscope EVO-LS15 (ZEISS, Germany) in variable pressure mode (10–400 Pa), which minimises the charge of the sample without the need for a metallic coating. The backscattered-electron images (BSE) were obtained at 15 kV. Analysis of the elemental composition was performed with a coupled energy-dispersive X-ray spectroscopy (EDS) micro-probe, with an X-Ray detector (Oxford Inca X-act, of resolution 129 eV). Measurements were made on spots and areas representative of the materials investigated and, in some cases, the distribution of elements was also mapped on the sample. The working conditions were as follows: 20 kV accelerating voltage, 2.3–10.29 A; beam current, 100 s; and working distance, 8.5 mm.

The front view of the samples taken from the pillars (Figure 2A) revealed vanilla (yellow ochre) coloured remains of a superficial and more recent layer of a largely disintegrated layer of paint (Figure 3).

The samples from the ornamental part of the building (Figure 2B, henceforth, sample B) contained an upper white coating and a lower yellow ochre coating (Figure 6), each consisting of several layers. SEM-EDS analysis revealed that both coatings contain large amounts of Ti (Figure 7), indicating that the entire sample contained coats of paint applied after the 1920s and, therefore, that this sample did not contain the original exterior paint of the building.

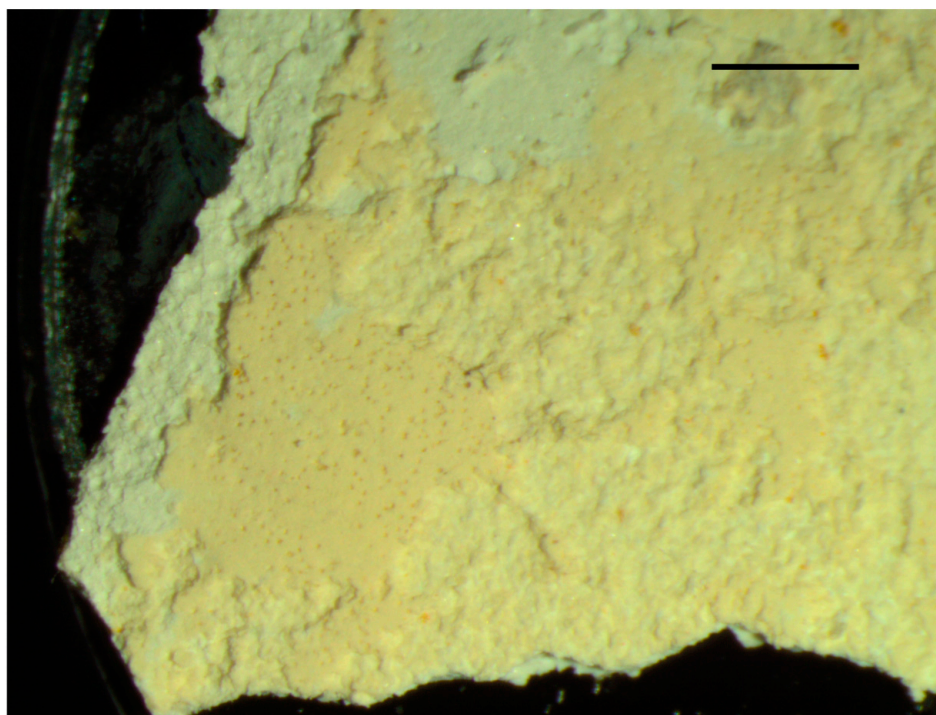
Figure 3. Front view of the surface of a sample taken from the pillars. Scale bar is 1 mm.

As seen in Figure 5, the microanalysis by SEM/EDS of the most superficial layer (layer 1), vanilla-coloured and highly disintegrated (Figure 3), indicates that the major elements are Ca and O, both indicative of the presence of lime, and also Ba, which indicates the presence of barite (barium sulphate). Si also appears along with other elements, such as Mg, Al, S, K, Fe and Zn, typical of clays, such as kaolin (Al, Si, O).

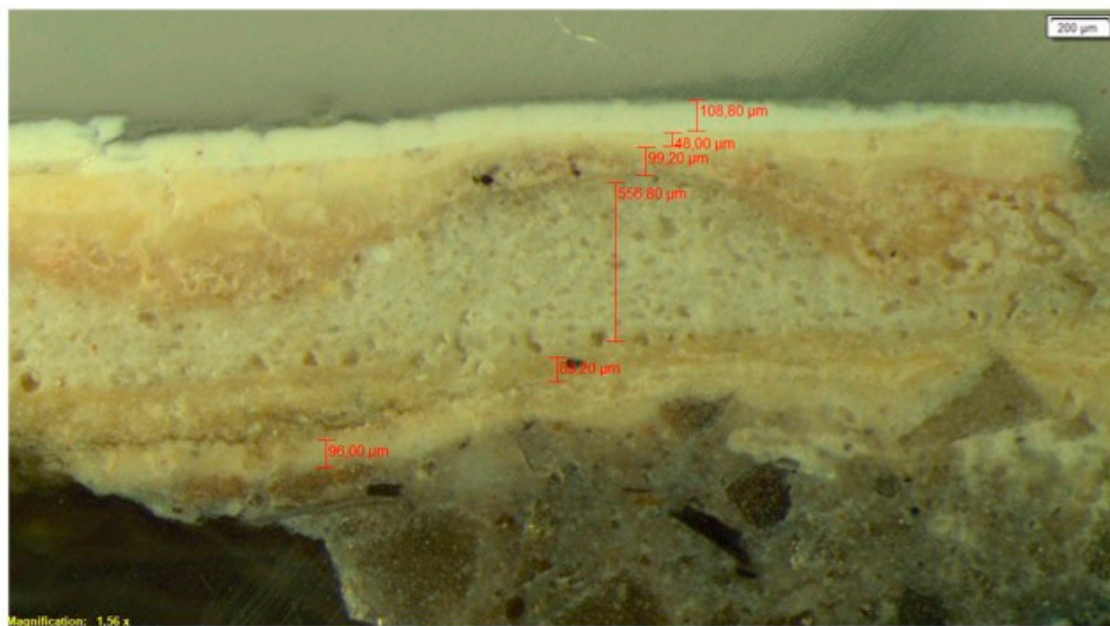
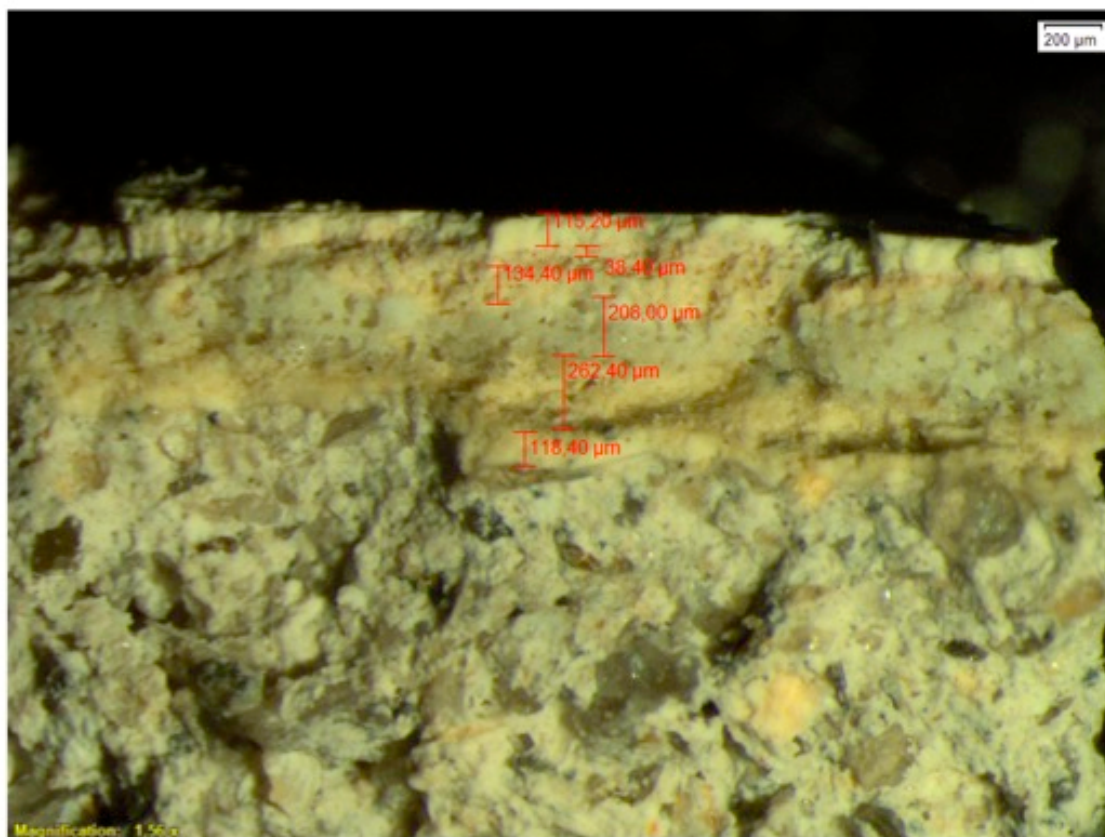
Figure 4. Stereomicroscope images of a cross-section of samples taken from the pillar (sample A), embedded in acrylic resin (**upper image**) and prepared for micromorphological study by scanning electron microscopy and elemental analysis (**lower image**). In both images, six segments (indicated in red) corresponding to the layers of different thicknesses were observed. The most recent and the oldest two levels (upper and lower) were observed and analysed by SEM/EDS.

The cross-sectional samples of the pillars (henceforth, sample A) consisted of seven different layers, of different thicknesses, on a cement substrate (Figure 4). The layers, ordered from the most superficial (i.e., the most recent) to that adhered to the cement substrate (i.e., the oldest or original layer), were characterised as follows: (1) remains of a highly disintegrated vanilla-coloured layer, (2) a white layer of approximately 110 microns thick, (3) a thin, pinkish layer of about 40 microns thick, (4) a yellow ochre layer of between 100 and 130 microns thick, (5) a thick porous, whitish layer of between 200 and 600 microns thick, (6) a yellowish-whitish layer ranging from 80 to 300 microns thick, followed by (7) another very similar layer of 100 microns thick, but of a more solid colour (Figure 4).

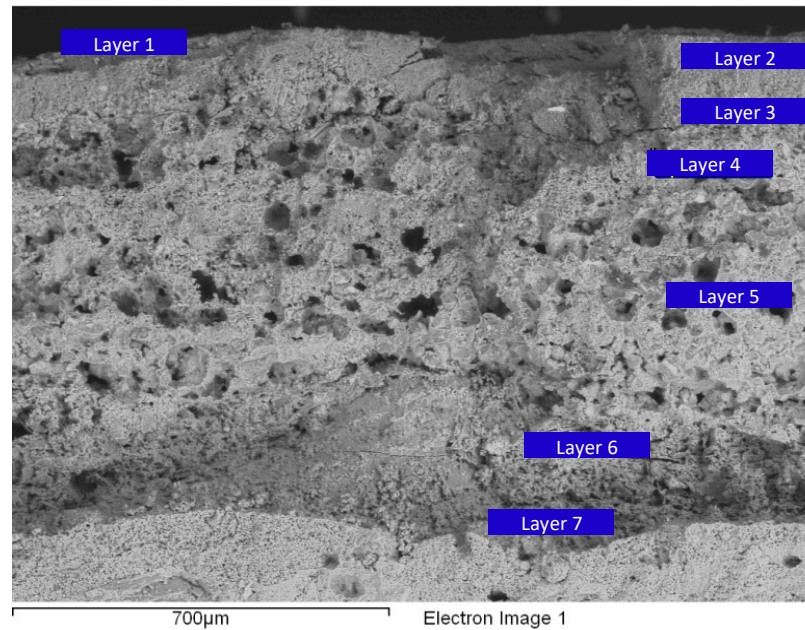
Figure 5. Results of the micromorphological analysis by SEM/EDS of the seven layers of sample A, taken from the pillars of the building.

The next, white-coloured layer (layer 2, Figure 5) mainly contained O, Ti and Ca, and also Si, Mg, Al, S and K. The base of the paint therefore appears to be lime and the white pigment, Ti oxide or titanium white (TiO_2), which was not manufactured regularly or marketed until the 1920s [6,7], after which it became the most abundantly used pigment in the 20th century. Si, Mg, Al, S and K, which appear in a proportion of less than 2% (percentage weight), form part of the clays that make up the base of the paint. S may also be associated with the presence of gypsum or other sulphates, soluble salts that are very common in plasters.

The underlying pink-coloured layer (layer 3, Figure 5) was found to contain large amounts of Ca and O, and also Si and Mg, in non-negligible proportions, of percentage weight of around 8% and 9 %, respectively. Other elements such as K, Al, S, Na, Fe, Ti, and Zn were detected in smaller quantities, and the amount of the latter two (Ti and Zn) was almost negligible. It is therefore a plaster or lime preparation (Ca, O) with silicates as kaolin minerals (Al, Si, O) and other clays (Mg, Si, O) in its composition. The clays contain iron, giving rise to the pink colour. Cl, an uncommon component of paint, was also detected, and assumed to be associated with the presence of sodium (Figure 5), indicating the possible origin of marine aerosols usually found in the air, even in inland environments [8].

The next yellow ochre layer (layer 4, Figure 5) also contains elements of lime and silicates that make up the mortar or plaster, mainly Ca and O, and also C (a lighter element, the content of which is difficult to measure by EDS, especially in samples embedded in epoxy resin), Mg and Si. Other elements, already present in low proportions, include Na, Al, S, K, Fe and also Cl, as in the previous layer.

The next thick, porous white layer (layer 5, Figure 5) also mainly contained Ca and O, as well as a non-negligible amount of Si, around 7% by weight. Al, Mg, S, K and Fe appear in proportions of around 1%, indicating that lime was again mixed with some silicates to form the plaster. Some Zn was also detected, but may represent contamination from the underlying layers 6 and 7.

The last two layers (6 and 7, Figure 5) are of very similar composition, mainly containing Ca, O, C and Si, typical of the paint bases already mentioned, and also Al, which in these two oldest layers appear in non-negligible proportions of around 4% and 7% respectively (percentage weight). Both layers contain important amounts of Zn, an element that appeared in almost residual amounts in the previous layers. The amounts of Zn and Si in these layers are very similar, with percentage weights of around 15% and 17% respectively. The composition indicates that the base support of pigments or load is lime mixed with silicates rich in Al, and the pigment material is zinc white (ZnO). This pigment provides a “snow” white colour, of a cooler shade than lead and titanium white. Formulation of this pigment dates back to the 18th century and is therefore consistent with a paint formulation used in 1909.

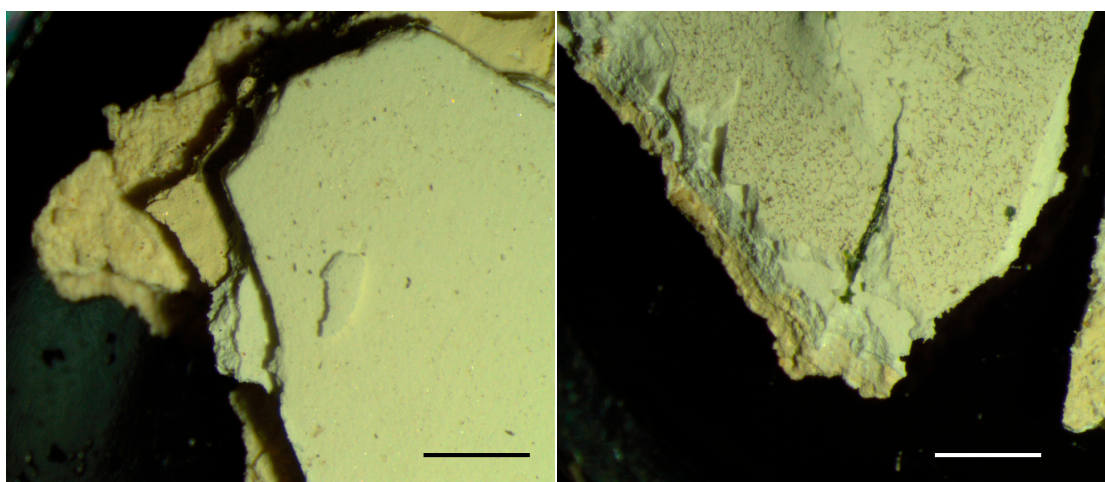
Figure 6. Stereomicroscope images of the samples taken from the ornamental parts of the building (sample B). In both front views, the upper white coating and the lower yellow ochre coating can be observed: both are thick coatings consisting of several layers. Scale bar is 1 mm.

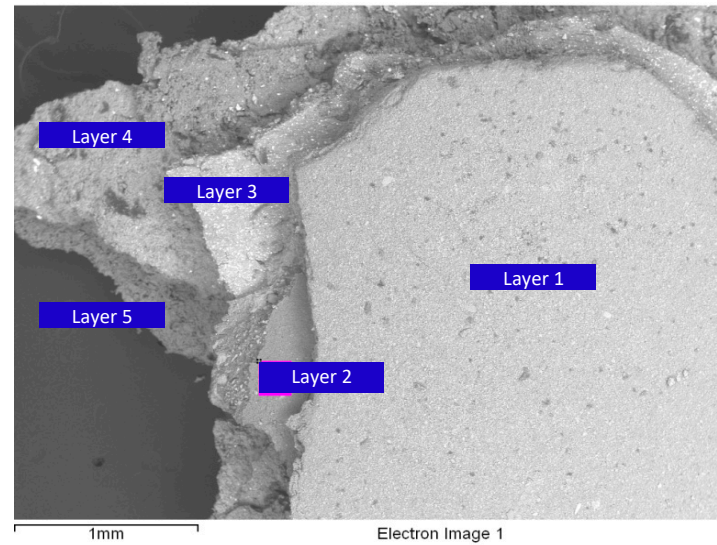
Figure 7. Results of the micromorphological analysis by SEM/EDS of the five layers of sample B, taken from the ornamental part of the building.

The upper and more recent white coating consists of two distinguishable layers (layers 1 and 2, Figure 7), a lower one with a high content of C, O, Ca and Ti (layer 2) and an upper one with a high content of O, Ca and Ti (layer 1), apparently indicating that the paint contained lime and titanium oxide (titanium white). Na, Mg, Al, Si (in a higher proportion in the upper layer), S and K, silicate elements, also appear in both layers.

Three layers were distinguished in the yellow ochre coating, which corresponds to the innermost part of the sample (layers 3-5, Figure 7). The oldest layer mainly contains C and O and, to a lesser extent, Ca and Ti, and it therefore appears to be a lime preparation (Ca, C, O) with Ti oxide as pigment filler (layer 5). Al and Si, typical of the clays that also make up the pigment charge, also appear. The next layer, i.e., the layer above the previous one, also yellow ochre (layer 4), contains large amounts of Ca and O, as well as Si and Ba, with scarce presence of Ti. This finding seems to indicate that the layer represents a silicates/barite lime preparation that serves as a plaster or mortar for the upper layer (layer 3), of the same colour and containing significant amounts of Ca, O, Ti, Ba and Si, i.e., lime with silicates and containing titanium white as pigment (TiO_2). In all three layers, the ochre colour is due to the presence of Fe.
