Article

# The Church Tower of Santiago Apóstol in Montilla: An Eco-Sustainable Rehabilitation Proposal

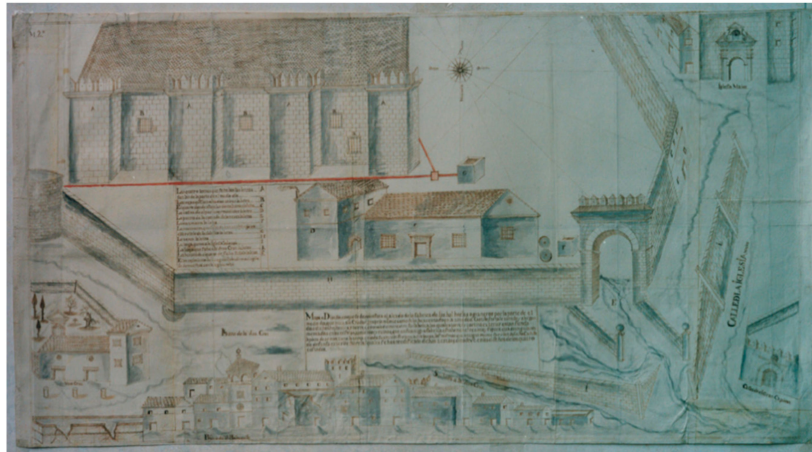
**Figure 1.** Plan for Montilla's barn built by Juan Antonio Camacho in 1723. (Archivo Ducal de Medinaceli, Sección Priego, Original. Leg 113, Num I).

Taking Camachos's drawing (Figure 1) and the documentation consulted in various sources as a reference, it has been possible to approximate the main exterior of the church lost after the reform of the doorway in the early 17th century, when the tower designed by Hernán Ruiz was still standing (Figure 5). The imagined reconstruction of Hernan Ruiz's tower has been put together based on the description preserved in the Montilla Historical Archive [26] and drawings made by Enrique Garramiola, located in the Montilla Municipal Archive (Figure 6). The digital reconstruction of the 15th century doorway in (Figure 4) is based on a study of the *fernandine churches* of Cordova, built during this period.

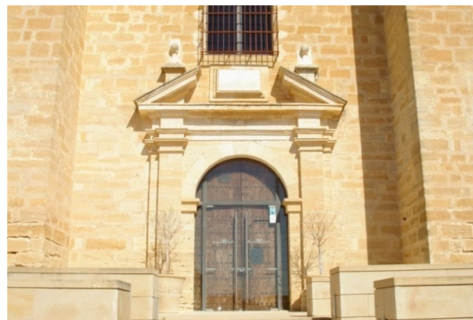
**Figure 2.** Facade of Montilla's barn built by Juan Antonio Camacho. (Author: A. Calvo).

Almost no records about the original façade of the church have been found. There are just a few brief references from the beginning of the 17th century, in which Lucas Jurado y Aguilar points out that the façade and main doorway were constructed in 1624 [17]. The façade appears in a drawing of the Montilla barn (*alhorí*) made by the Cordovan architect Juan Antonio Camacho, master builder of the Duke of Medinaceli and the Bishopric of Cordova [24]. In the upper right section of this drawing dated 1723, we can see the façade and the tower before its destruction by the 1755 earthquake (Figure 1). Typical details of a Renaissance doorway are present including the great attention paid to the harmony of proportions, following the guidelines established in Vitruvio's treatise *De Architectura*, a reference book for the architects of the time. The façades of this style consist of two main parts and a pediment, with classicist structural and decorative elements. Regarding the main bodies, the semicircular arch, columns, entablatures, and roof with coffered ceilings stand out, with values such as symmetry, simplicity, and structural clarity prevailing. As for the decorations, the pilasters, scrolls, keys, medallions, and the pediment are typical. Usually, a niche was included in the second section over the doorway with a sculpture of the saint to whom the church was dedicated [25]. We understand that it is not the original, since its style, as we have explained, is one that postdates the original construction of the church. Furthermore, documentation exists stating that it was rebuilt in 1624 [17]. If we compare this doorway with the *alhorí* built by Camacho we see how the architect was inspired by the doorway of the church (Figure 2).

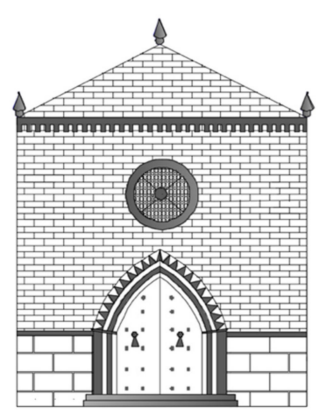
**Figure 3.** Outline of the possible doorway of the church of Santiago Apostol in Montilla in the 15th Century. (Author: A. Calvo).

To gain a clearer understanding of how the original façade of the church might have looked (Figure 3), and having consulted some documented references about its existence from as early as the 14th century, we must compare the façades of the *fernandine* churches in Cordova. They are simple, with buttresses and a rose window, and a main doorway at the foot of the central nave with pointed arches adorned with diamond tips (“*punta de diamante*”) or dog teeth (“*diente de perro*”) and crowned by a roof tile on modillions (Figure 4).

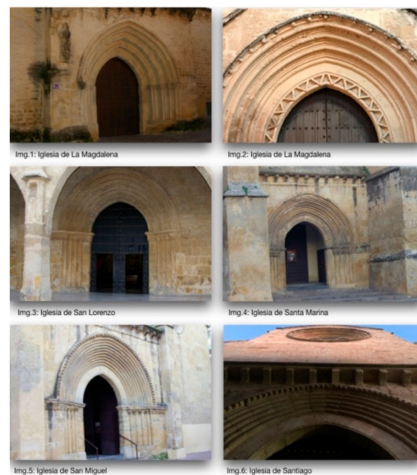
**Figure 4.** Details of the doorways of the most important fernandine churches in Cordova (Author: A. Calvo).

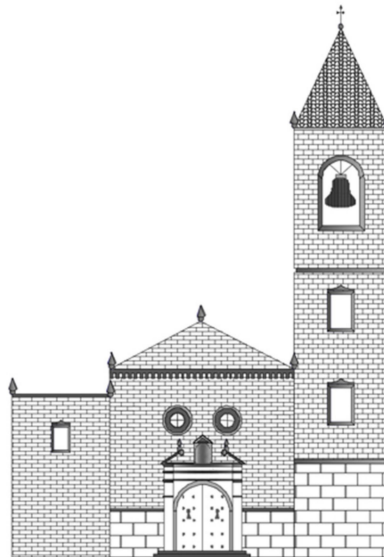
**Figure 5.** Elevation of the facade after the reconstruction of 1624 and the original tower of the Church of Santiago Apóstol of Montilla (Author: A. Calvo).

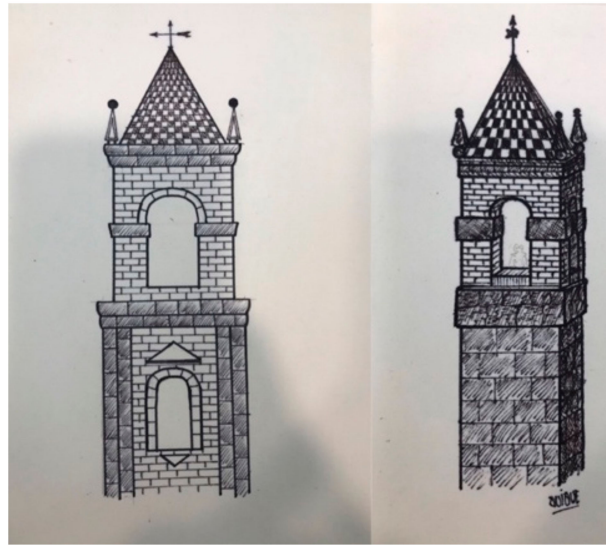
**Figure 6.** The tower of the Church of Santiago built by Hernán Ruiz, by Enrique Garramiola. (Municipal Archive of Montilla. Church of Santiago Folder).

Garramiola refers to it in an article in which he describes how the tower should be built according to the contract they signed [18], alluding to a drawing by Hernán Ruiz that would serve as a guide for the construction project. The contract indicates that it should have a first stone section from the Aguilar quarry that is 20 feet long and a cornice. The second section would be of brick plastered with lime and sand and capitals of the same stone as the first section that framed the windows, with blue tiles embedded in the stone adorning the windows. There would be stone pyramids on the corners of the roof and a spiral staircase ascending to the bell of the tower.

With the help of these detailed descriptions, Garramiola draws a picture of the tower (Figure 6), which is kept in the Municipal Archive of Montilla. Both the written account and this drawing help to make an approximation of the tower, and lead to a comparison with towers of other churches from the time built by the Hernán Ruiz I-III in the kingdom of Cordova. Also, in the image of Montilla prepared by Pier Maria Baldi in 1668 for the book “Cosme de Medicis’s journey though Spain and Italy”, plate XXXVII shows a small sketch of this tower, which closely resembles those presented by Garramiola.

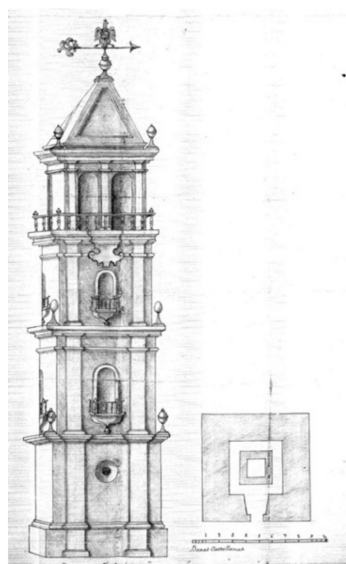
**Figure 7.** Tower of the Church of Santiago by José Vela. Torre de la iglesia parroquial. Planta y alzado. s.f. (siglo XVIII). (Archivo Ducal de Medinaceli., Mapas y Planos, cajón M. Ref. 1988025218).

Six years later, two projects for the construction of the new tower were presented to the Duke, one by Vela himself and the other by Fernando Moradillo, a famous Spanish architect of the time based in Madrid, who carried out important projects in the capital city (Figure 7). Finally, the Duke, in line with the wishes of the Montillans, chose Vela’s proposal, which underwent some changes. The Moradillo tower (Figure 8) consisted of three sections. The first one with rustic pilasters preserved the style of the Hernan Ruizes. The second one was simple without any adornments, and the bells covered by a double capital with a weathervane. In the center, there was a staircase with a square floor plan, which was supported by the tower walls and illuminated by windows on its sides [28].

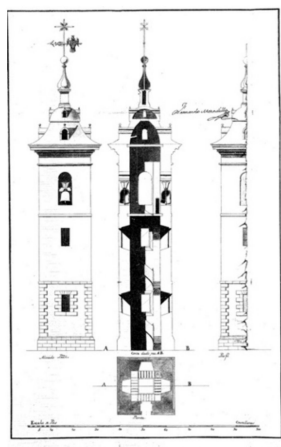
**Figure 8.** Tower of the Church of Santiago by Fernando Moradillo. Torre de la iglesia parroquial mayor del Señor Santiago. Fernando Moradillo, arquitecto (1777). (Fuente: A.D.M., Mapas y Planos, cajón M. Ref. 1988025219).

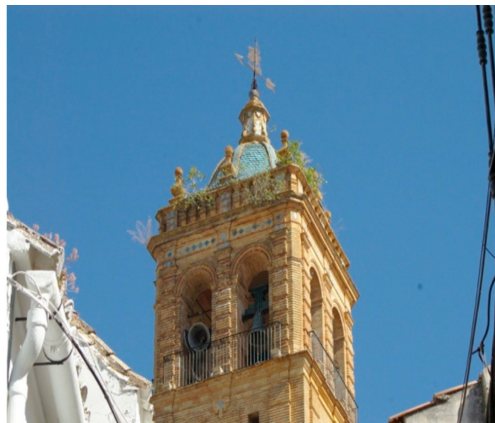
Figures 9–11 show images of the current state of the tower, where the damage caused by the birds that nest inside it and other factors are observed, which help to understand the need for this intervention.

**Figure 9.** Detail of the current state of the dome.

As for the first intervention, cleaning the roof, it is advisable to use soft brushes and small spatulas and to then continue with a deeper cleaning by applying eco-sustainable products to remove plant and organic debris. These products should have a low contamination index and should not negatively affect the glazing of the tiles. A general review of the roof should be carried out to, if needed, replace the defective tiles and check the waterproofing of the roof.

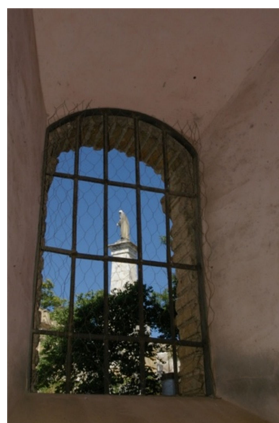
**Figure 10.** Detail of the current enclosure of one of the windows.

For the second intervention, it is necessary to review the wire mesh covering the windows (Figure 10), as well as the covering made with the same material on the spiral staircase that ascends to the bell tower (Figure 11) in order to avoid the entry of birds by this route. The wire mesh currently in place is in very poor condition. Most of the covering “screens” or nets have either been lost or have large tears that facilitate the entry of birds. For this reason, and to avoid the negative effects of the nesting and the highly corrosive organic residues coming from them on the monument, the revision of the wire mesh screens should be undertaken, and anti-bird netting should be installed.

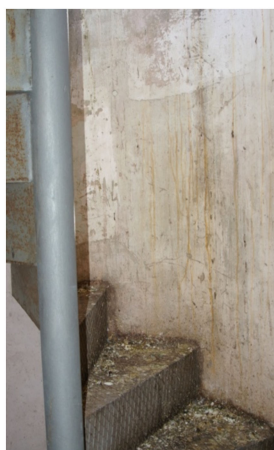
**Figure 11.** Stairs access to the bell tower.
