**A PROTOTYPE DECISION SUPPORT SYSTEM FOR STREAMBANK  
REHABILITATION**

Submitted in partial fulfilment of the academic  
requirements for the degree of  
Master of Environment and Development  
at the  
Centre for Environment and Development  
University of Natal

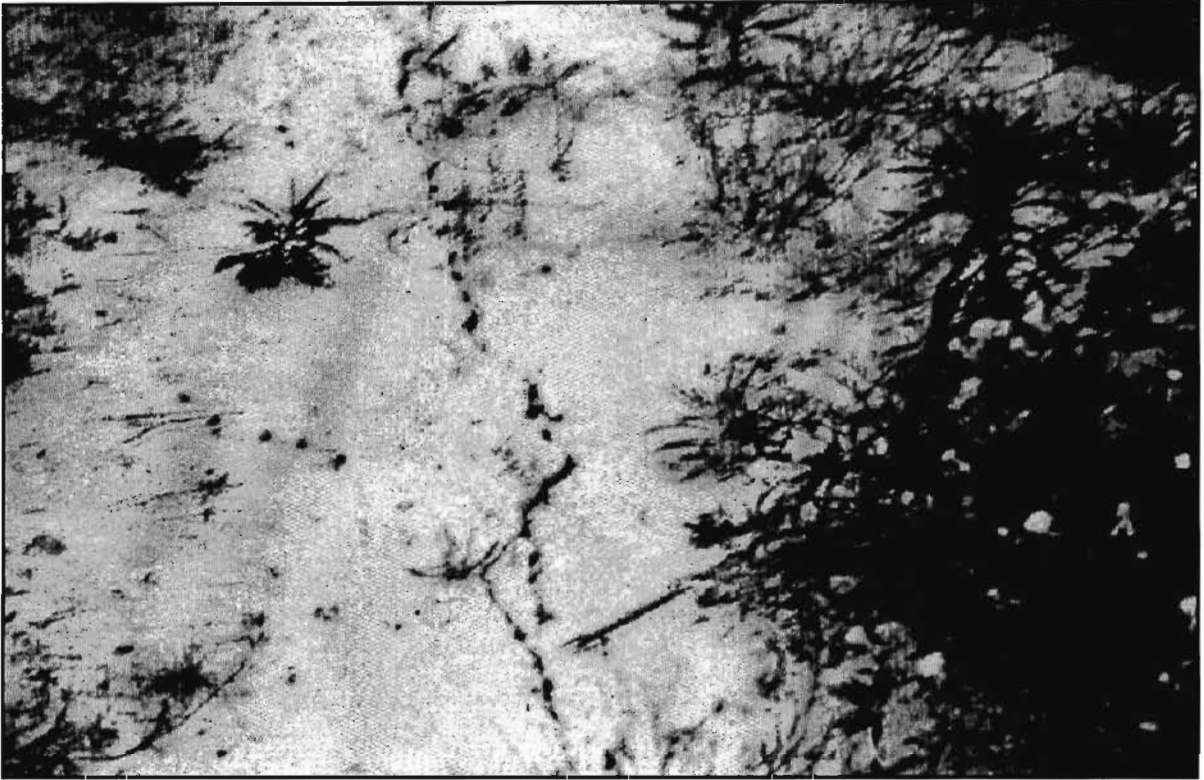
**Figure 1:** Tension cracks on a steep, actively eroding streambank. Above: Crack forming in the floodplain surface behind the bankline; Below: a wide crack behind the failure block (Thorne, 1998).

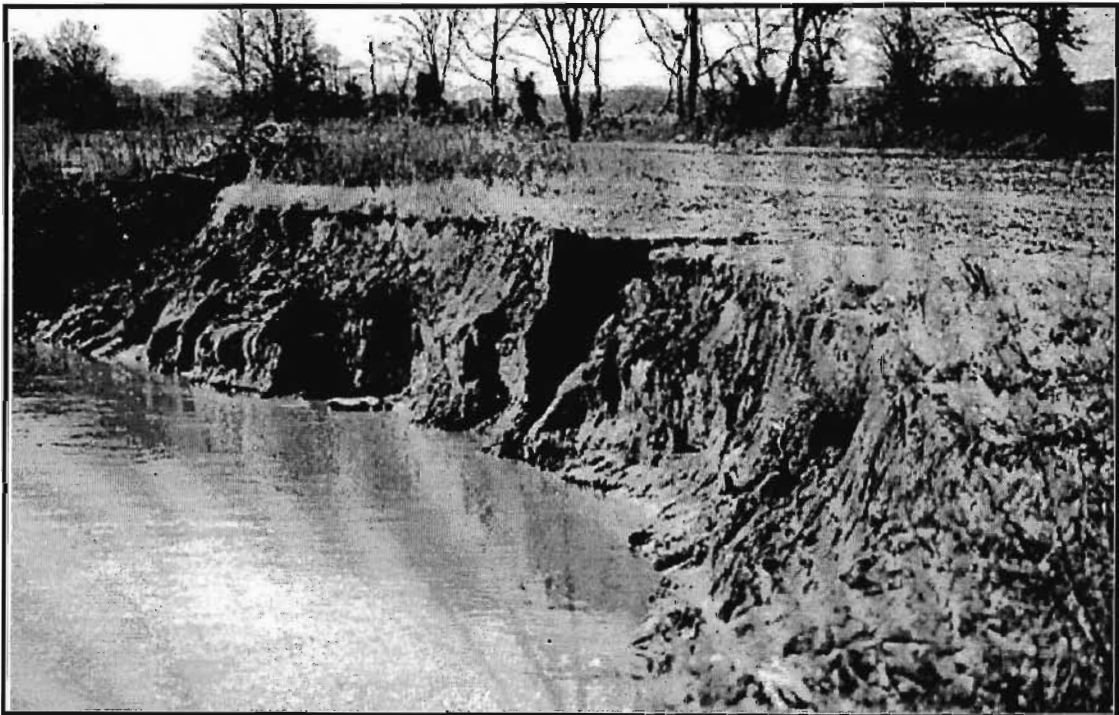
**d) sheet erosion plus major rilling and gulying:** is the removal of soil by non-channelised (sheet erosion) and channelised (rilling and gulying) surface runoff. It results from surface water draining over the bank edge, especially where the riparian and bank vegetation has been destroyed.

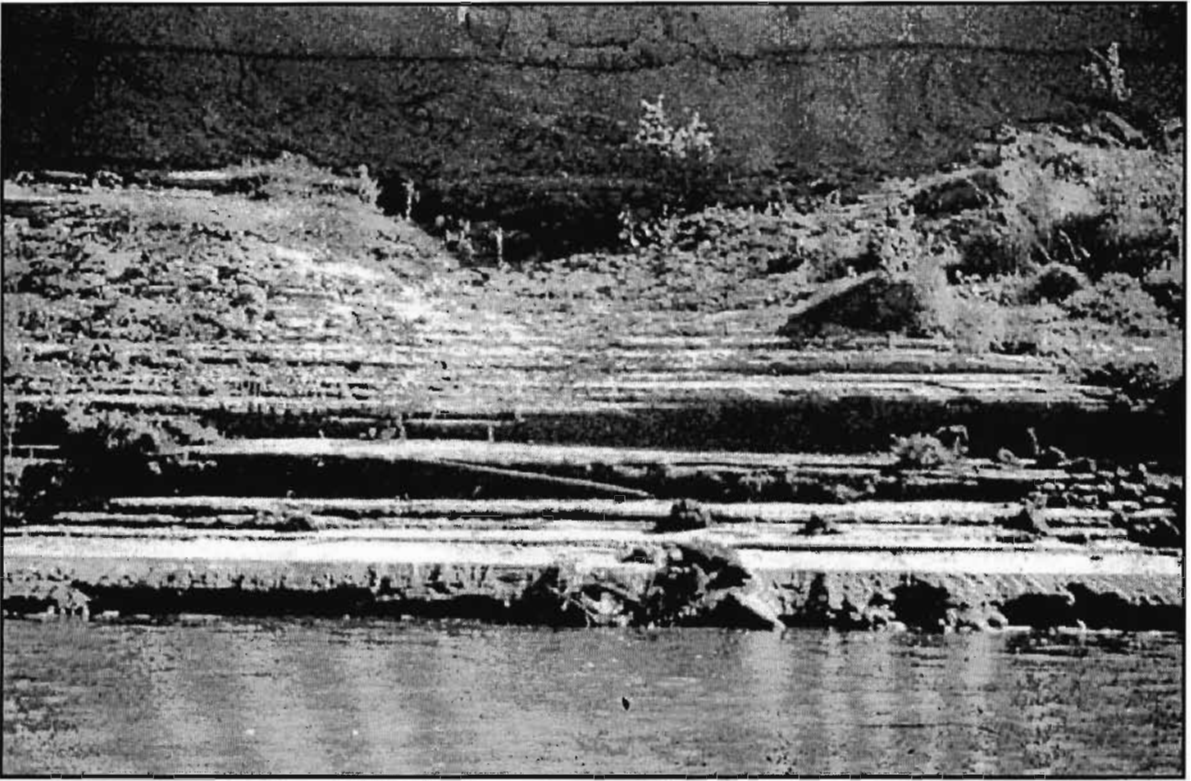
f) **wind waves:** cause near-bank velocities and shear stresses to increase and generate rapid water level fluctuations at the bank.

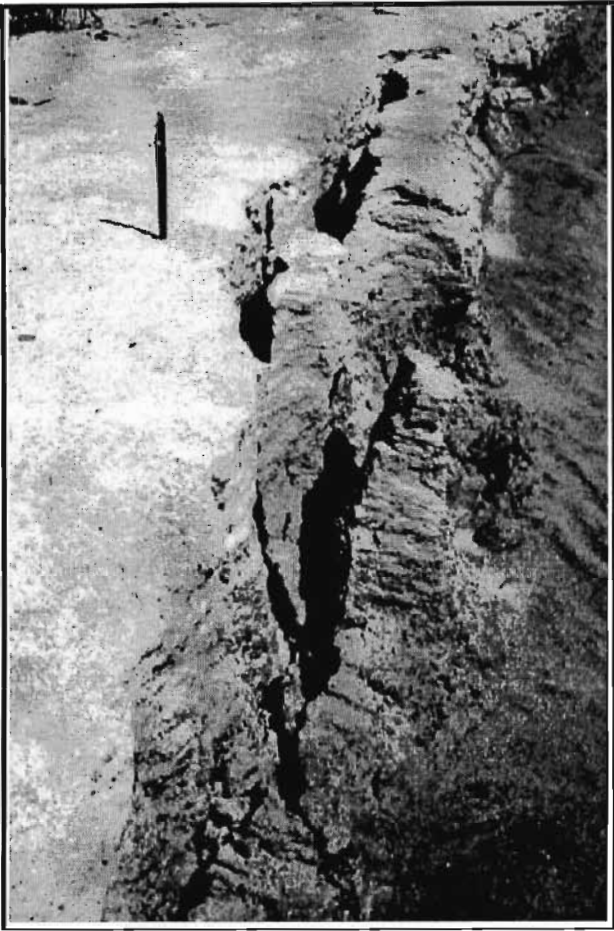
a) **major soil fall**: occurs only on steep banks, where grains, grain assemblages or blocks fall into a channel. Such failures are found on steep, eroding banks of low operational cohesion.

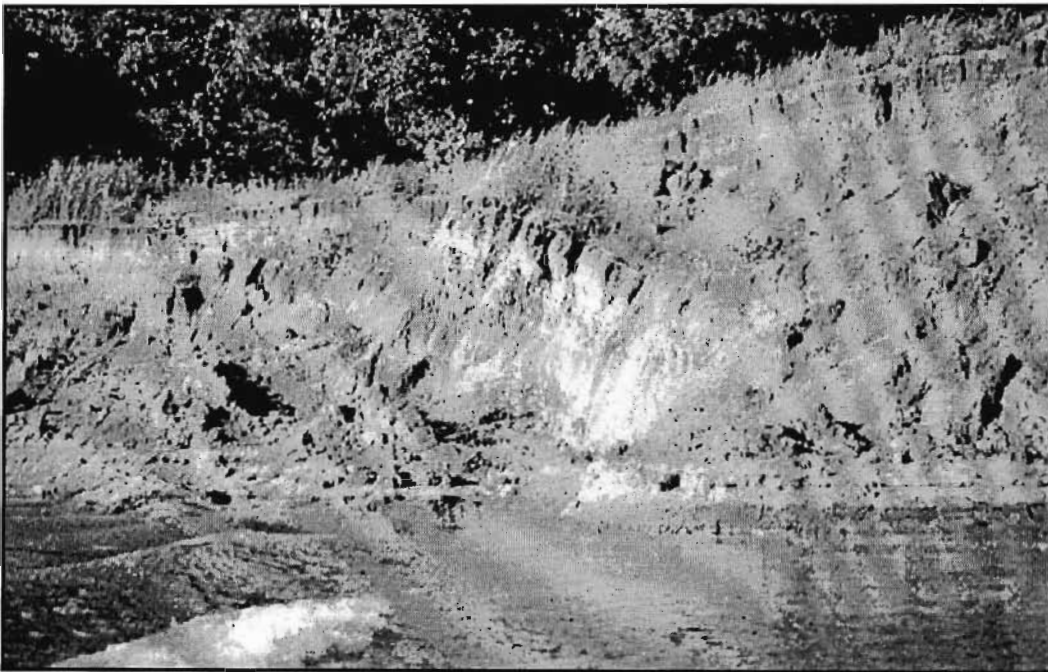
b) **rotational failure**: most widely recognised form of bank failure. A deep-seated failure along a curved surface results in back-tilting of the failed mass towards the bank.

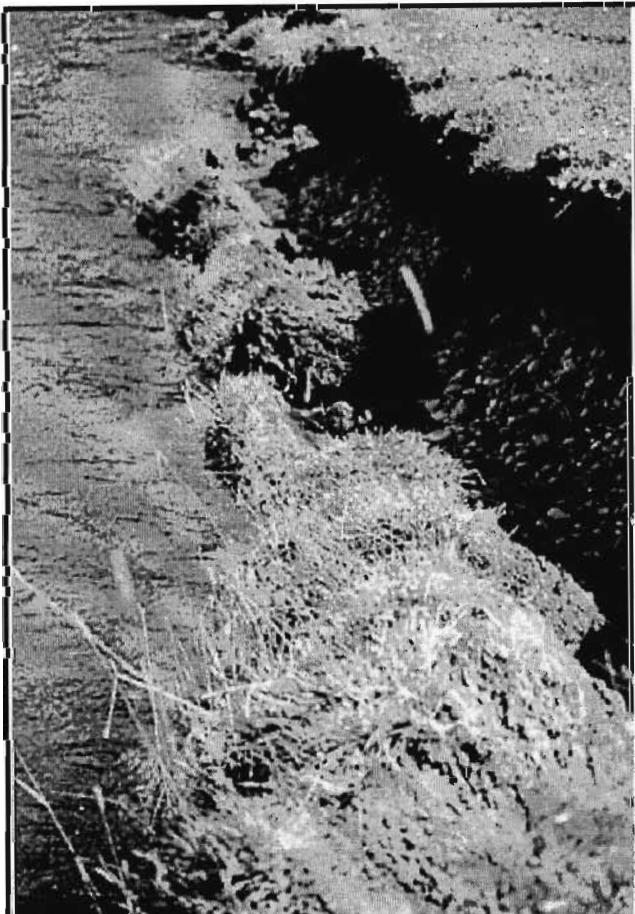
d) **cantilever failure**: the collapse of an overhanging block into the channel.

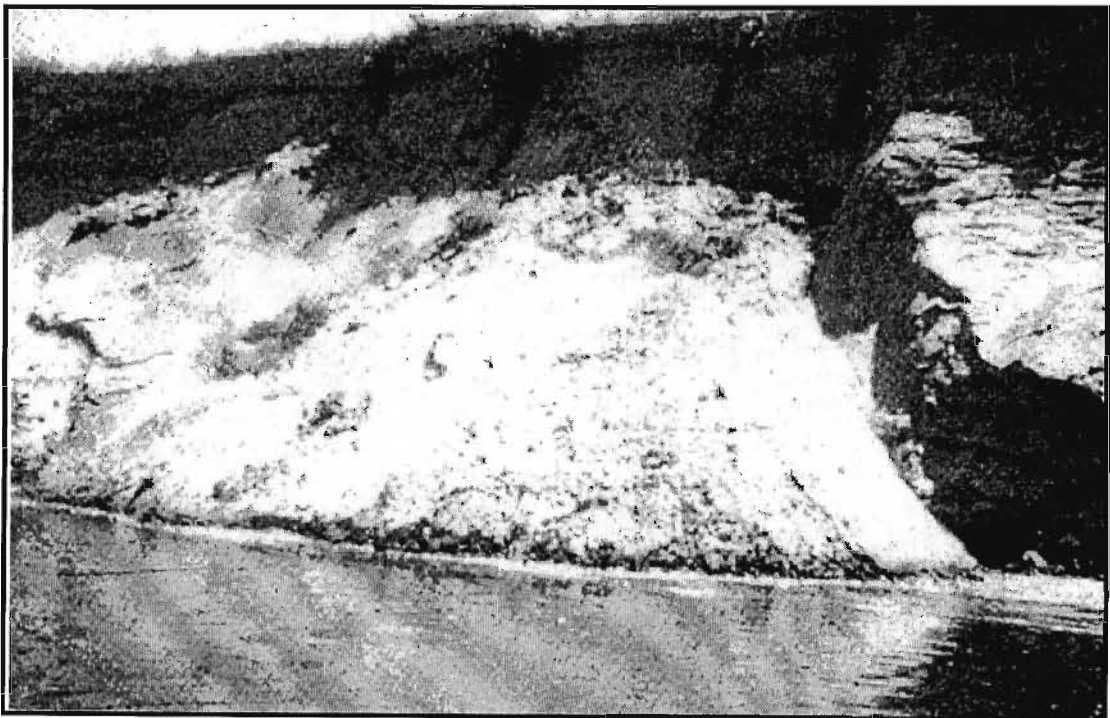
f) **dry granular flow (soil fall)**: such failures occur when a non-cohesive bank, at close to the angle of repose, is undercut, increasing the bank angle above the natural angle of repose, causing soil fall to occur.

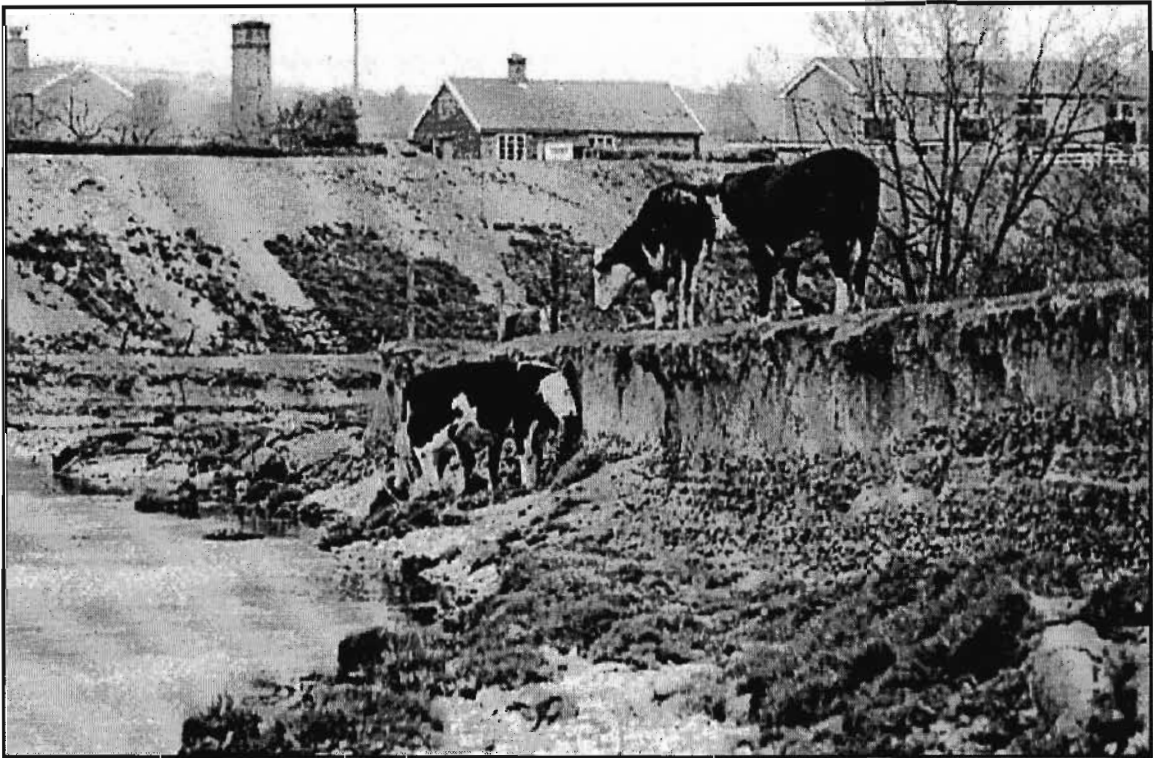
**h) a common form of bank failure caused by cattle grazing and trampling:** grazing animals cause degradation in two ways 1) by physically breaking the bank structure down and loosening the soil with their hooves, and 2) by reducing the vegetation so that its bank supporting role is reduced.

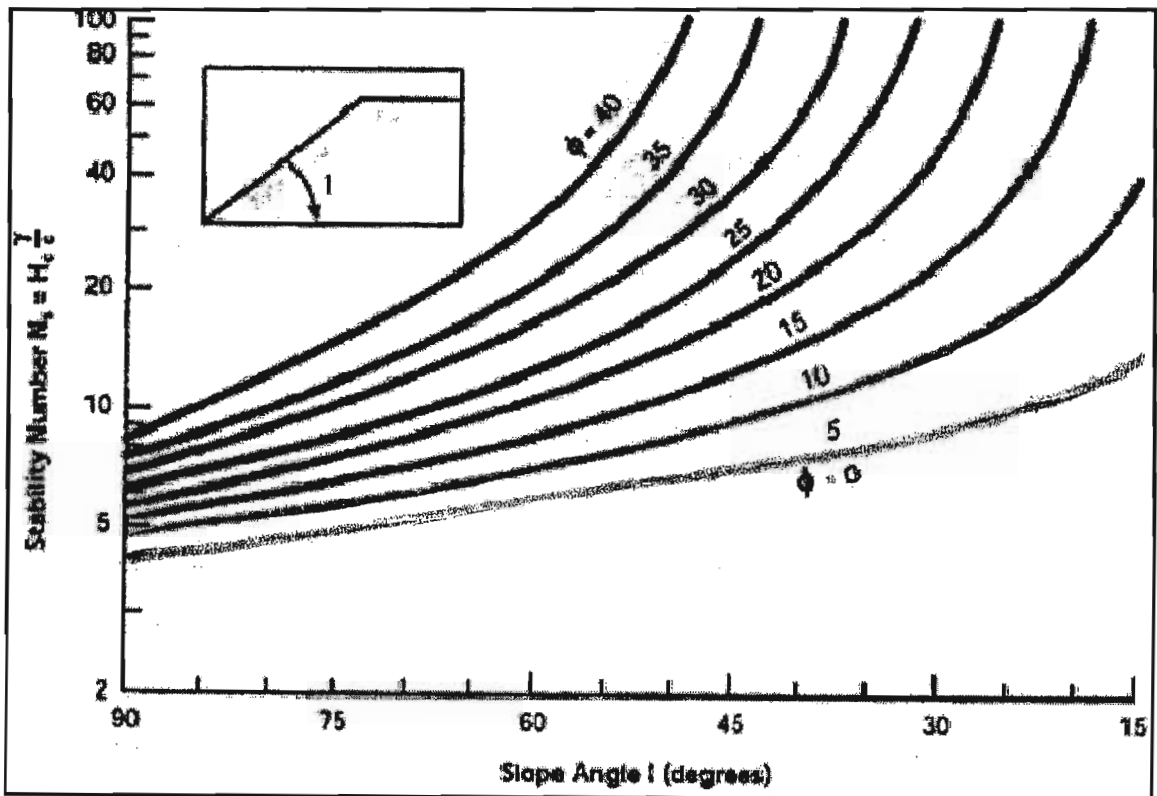
**Figure 7:** Chart providing the critical height for worst case condition. The stability number ( $N_s$ ) is a function of bank angle ( $i$ ) for a failure surface passing through the bank toe (Chen 1975).

required, a river engineer may refer to bank stability charts. These make it possible to establish a critical bank height in relation to the bank slope, moisture conditions, cohesive properties of the bank materials etc. To produce bank stability charts such as the one below (Figure 7), a stability number ( $N_s$ ) representing a simplification of the bank (slope) stability equations, is used. The stability number is a function of the bank-material friction angle ( $\Phi$ ) and the bank angle ( $i$ ) and is acquired from a stability chart. Numerous authors have developed bank stability charts, examples include, Chen (1975) (Figure 7) and Lohnes and Handy (1968).

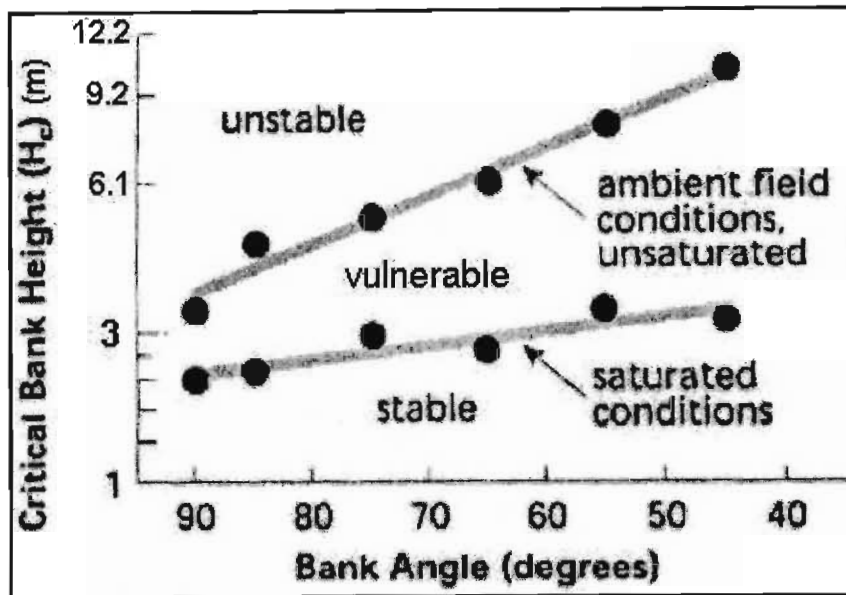
**Figure 8:** An example of a bank stability chart for estimating the critical bank height ( $H_c$ ). (FISCRWG, 1998).

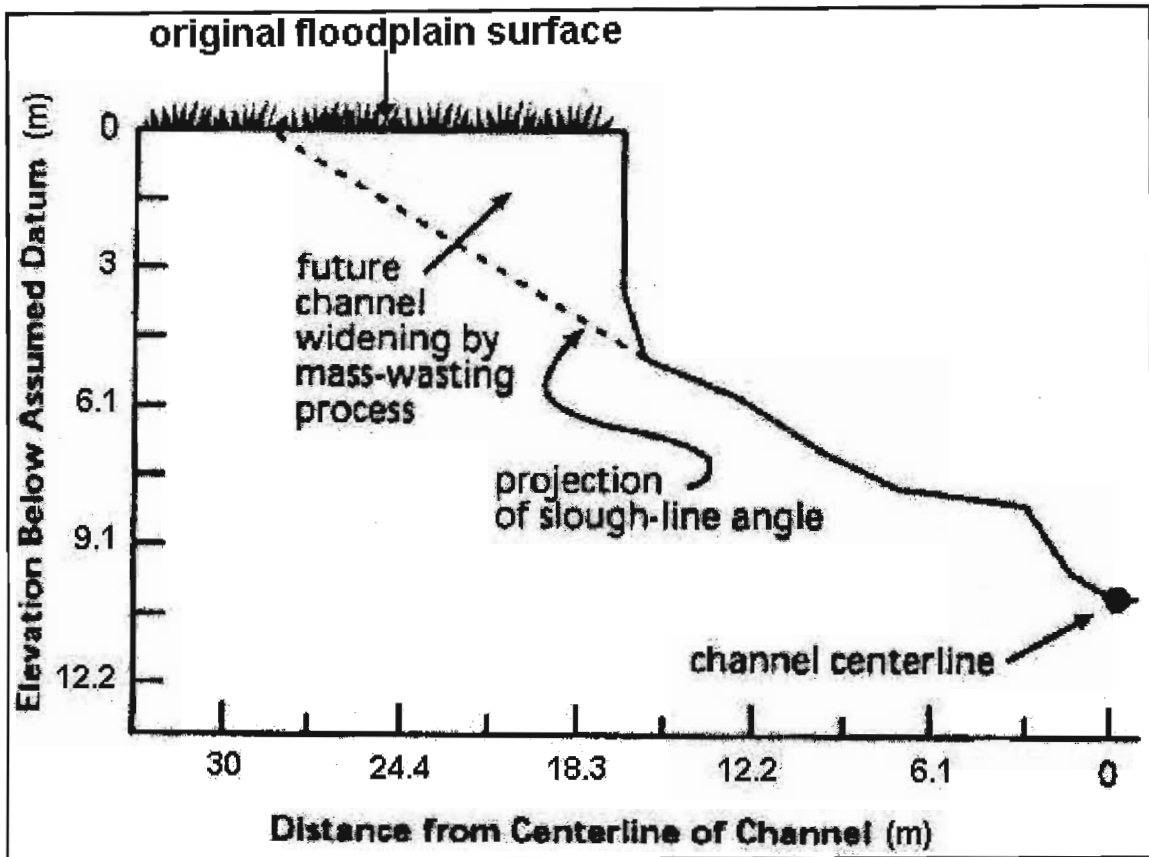
Figure 10: An example of a method to estimate the future channel widening for one side of the channel (FISCRWG, 1998).

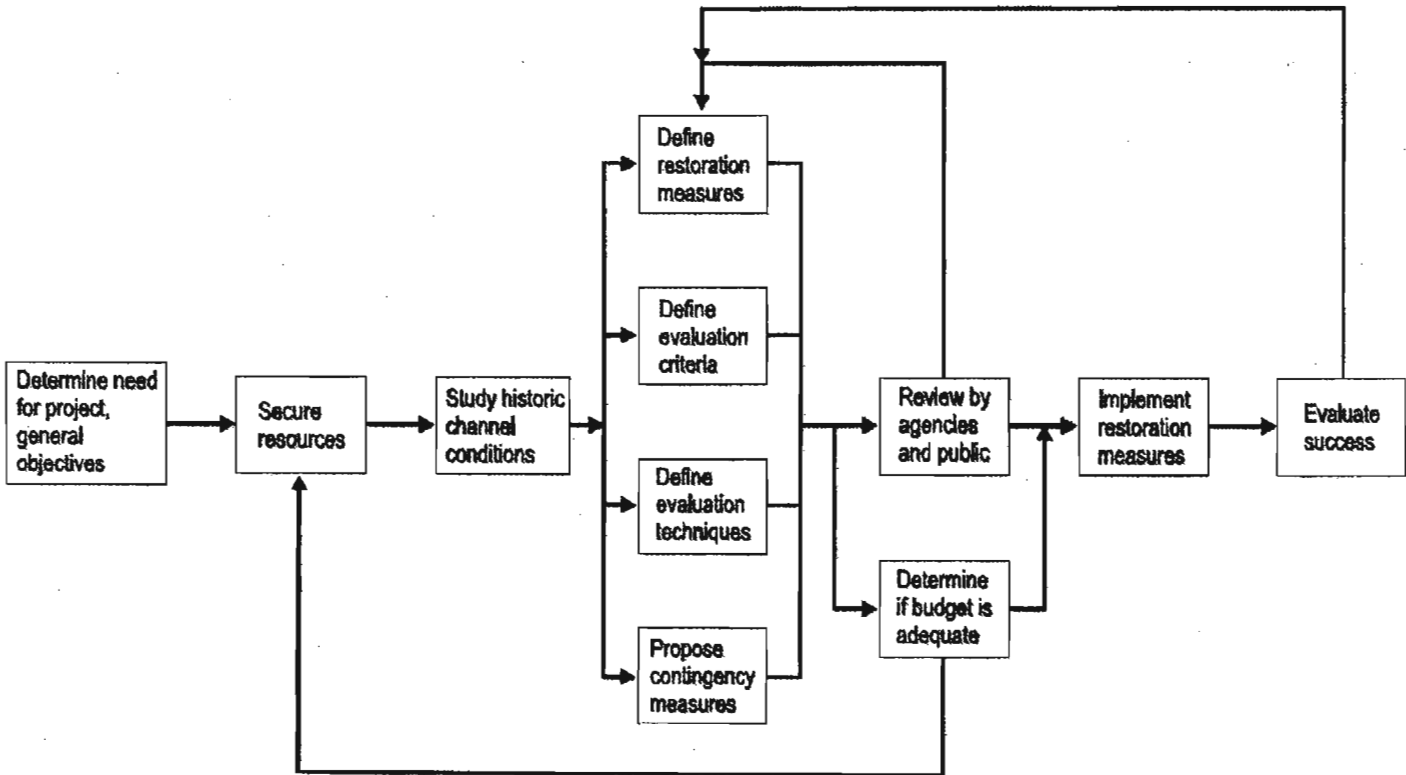
**Figure 14:** A simplified flow chart of the process of planning, implementing, and evaluating a streambank rehabilitation project (Kondolf and Micheli, 1995).

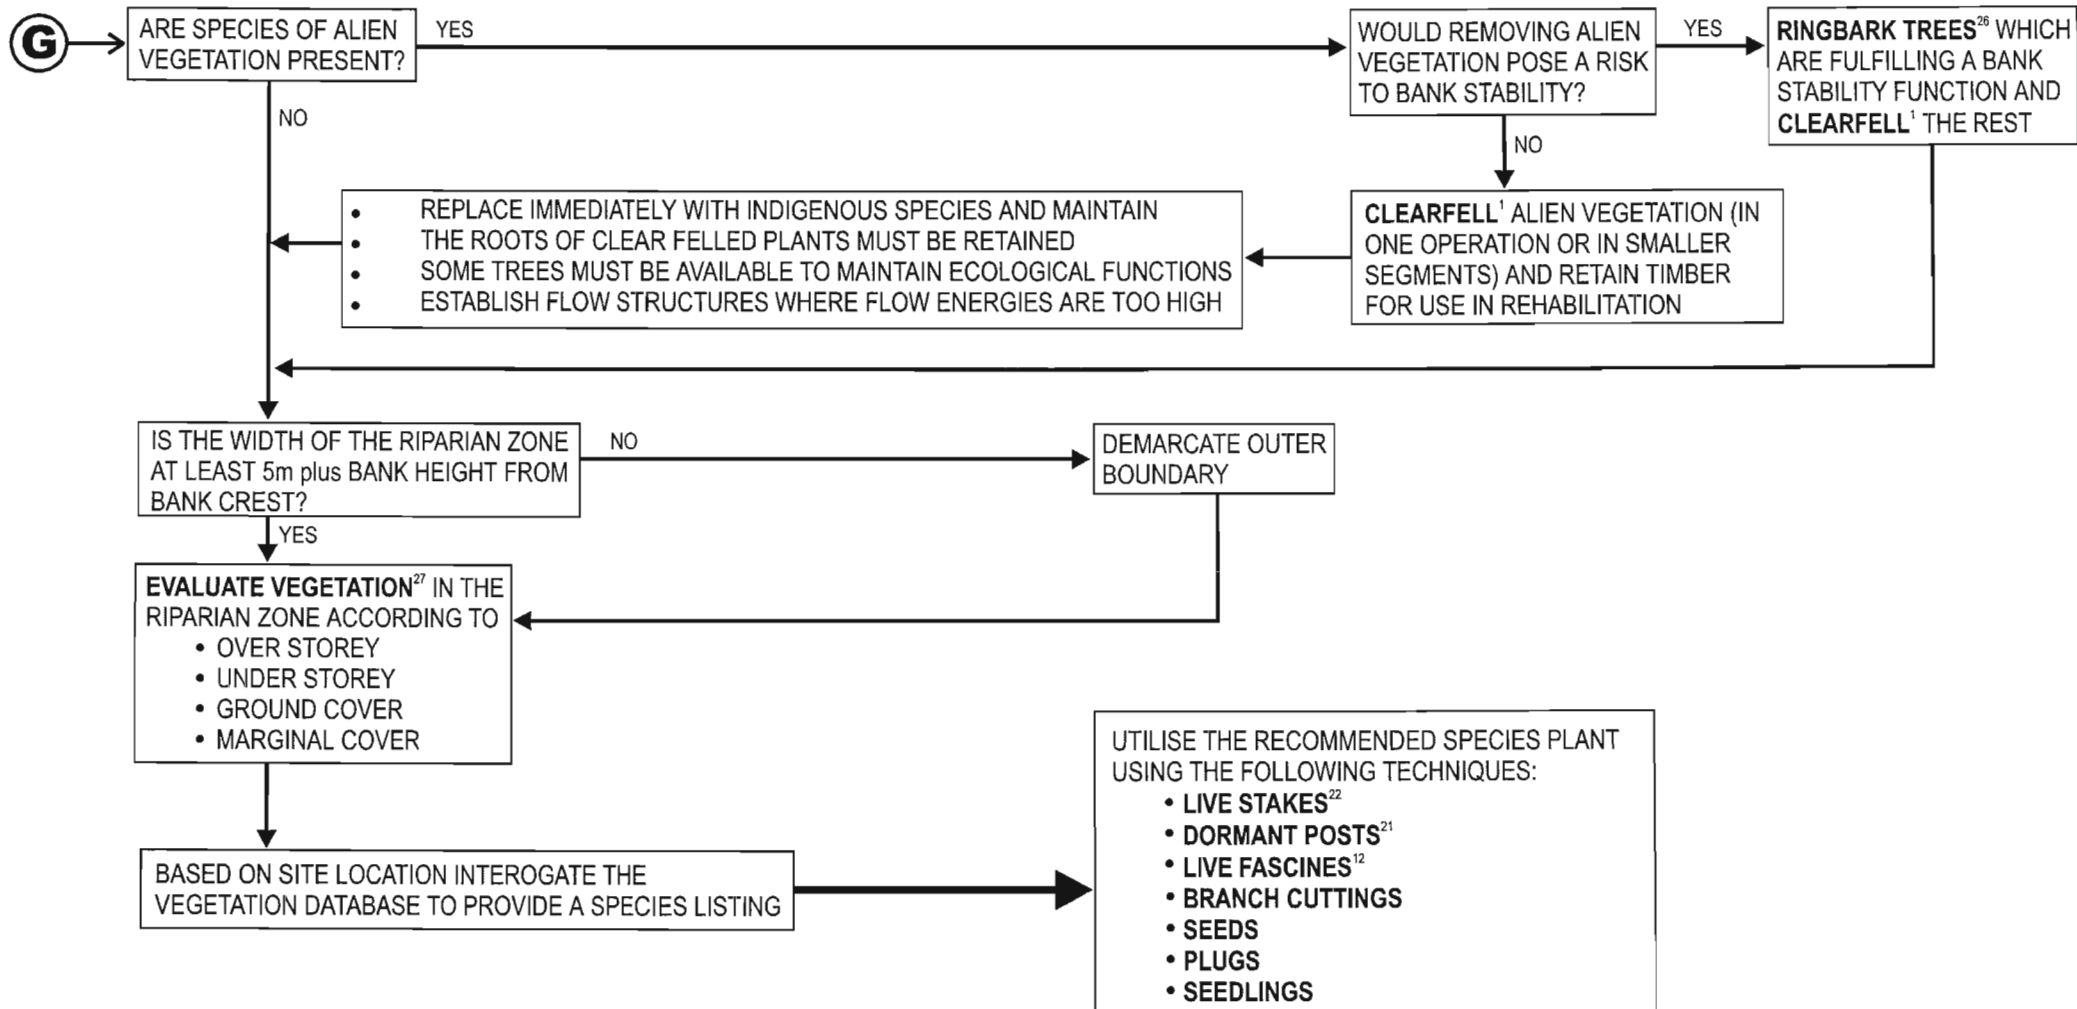
Figure 15: Flow chart presenting Streambank Rehabilitation Decision Support System.

Subscripts refer to techniques in Appendix 2.

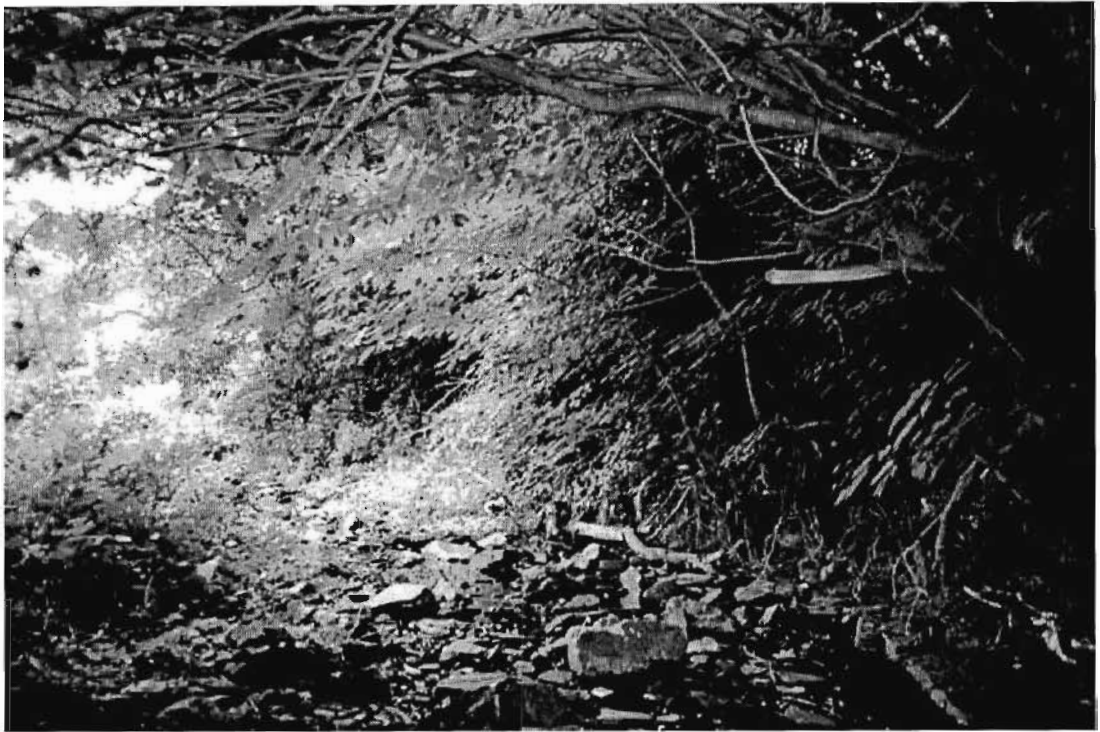
## **SITE 11**

Establish live cribwalls or vegetated gabions depending on supply; Stabilise upper bank with dormant post plantings or live stakes; Clearfall exotic species; Demarcate outer boundary of at least 7.5 metres from bank crest (5m + height of bank). Evaluate vegetation in the riparian zone according to over storey, under storey, ground cover and marginal cover; Derive species list from vegetation database (Table 7 and Kellner *et al.*, 2000); Plant the recommended species to the zone width.

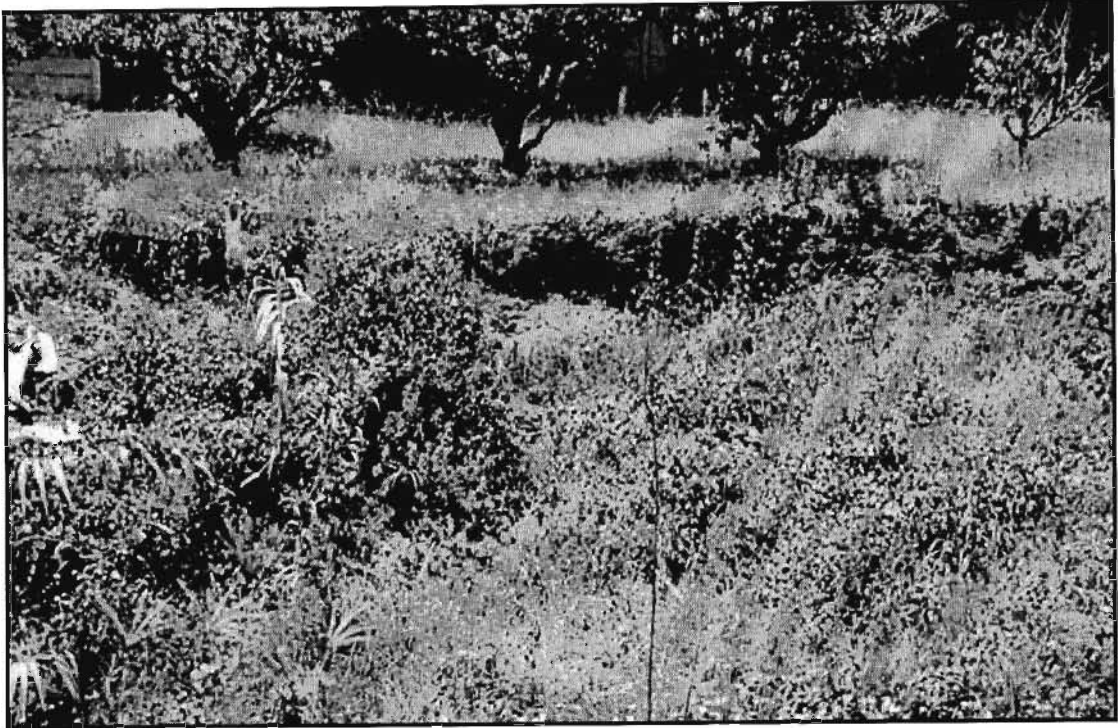
## **SITE 10**

Undertake bank shaping and planting; Vegetate using vegetated geogrids; Stabilise upper bank with dormant post plantings or live stakes; Clearfelled exotic species; Demarcate outer boundary of at least 8 metres from bank crest (5m + height of bank). Evaluate vegetation in the riparian zone according to over storey, under storey, ground cover and marginal cover; Derive species list from vegetation database (Table 7 and Kellner *et al.*, 2000); Plant the recommended species to the zone width.

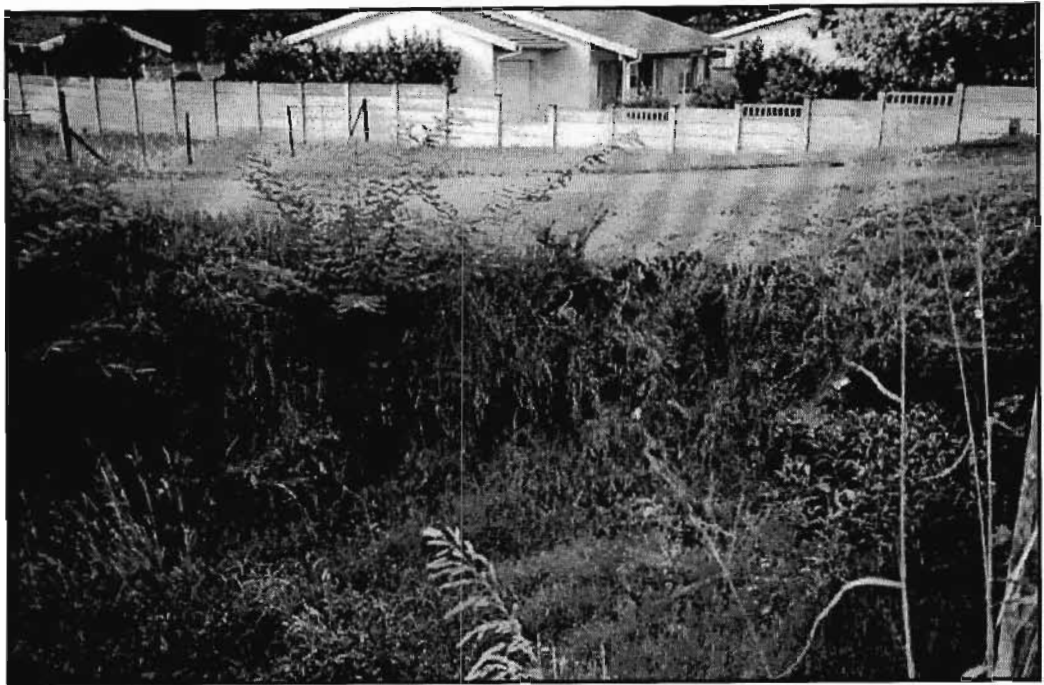
## **SITE 8**

Establish live cribwalls or vegetated gabions; Stabilise upper bank with dormant post plantings or live stakes; Ringbark alien trees which are fulfilling a bank stability function and remove the rest; Demarcate outer boundary of at least 7.5 metres (5m + height of bank). Evaluate vegetation in the riparian zone according to over storey, under storey, ground cover and marginal cover; Derive species list from vegetation database (Table 7 and Kellner *et al.*, 2000); Plant the recommended species to zone width.

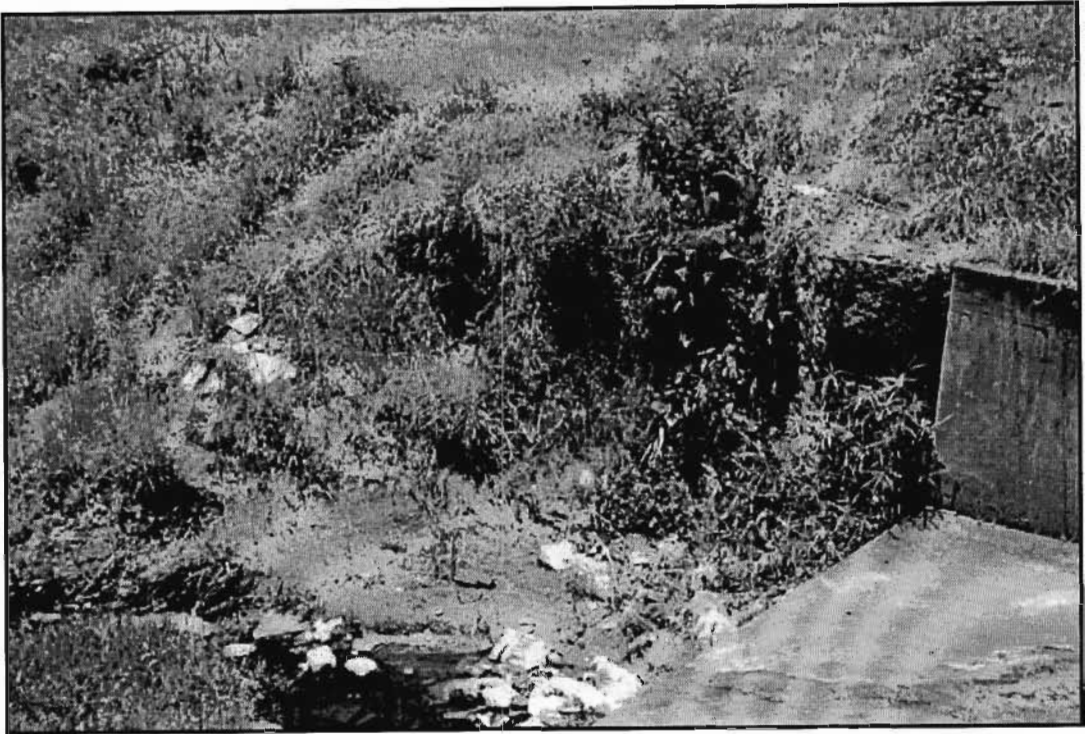
## **SITE 12**

Establish live cribwalls or vegetated gabions; Stabilise upper bank with dormant post plantings or live stakes; Ringbark alien trees which are fulfilling a bank stability function and remove the rest; Demarcate outer boundary of at least 7.5 metres (5m + height of bank). Evaluate vegetation in the riparian zone according to over storey, under storey, ground cover and marginal cover; Derive species list from vegetation database (Table 7 and Kellner *et al.*, 2000); Plant the recommended species to zone width.

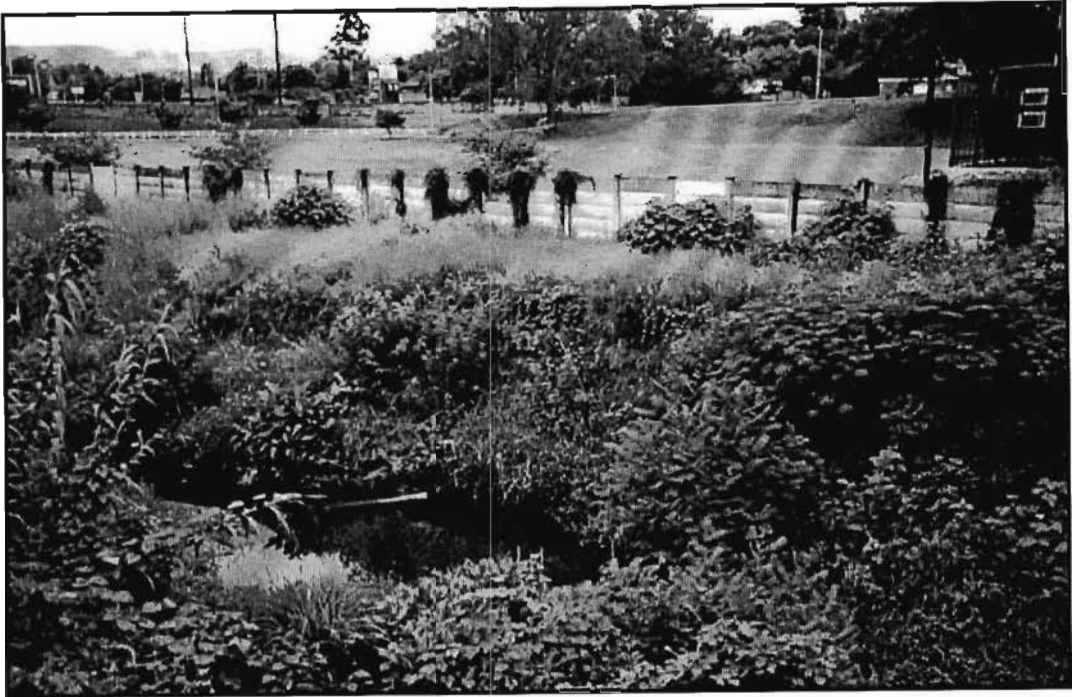
## SITE 18

Establish live cribwalls or vegetated gabions; Stabilise upper bank with dormant post plantings or live stakes; Ringbark alien trees which are fulfilling a bank stability function and remove the rest on both banks; Demarcate outer boundary of at least 7.5 metres (5m + height of bank). Evaluate vegetation in the riparian zone according to over storey, under storey, ground cover and marginal cover; Derive species list from vegetation database (Table 7 and Kellner *et al.*, 2000); Plant the recommended species to zone width.

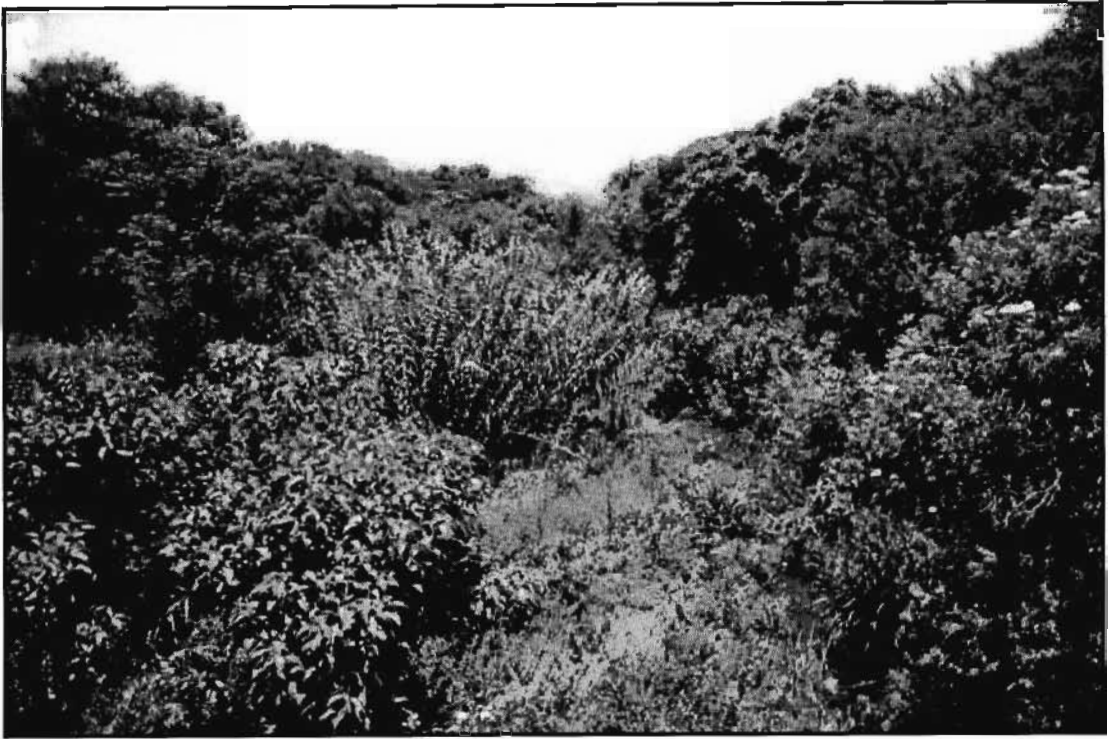
## **SITE 2**

Human access to be managed, and the foot path to be upgraded and erosion proofed; A ford or bridge should also be built; Demarcate outer boundary of at least 7.5 metres from bank crest (5m + height of bank). Evaluate vegetation in the riparian zone according to over storey, under storey, ground cover and marginal cover; Derive species list from vegetation database (Table 7 and Kellner *et al.*, 2000); Plant the recommended species to the zone width.

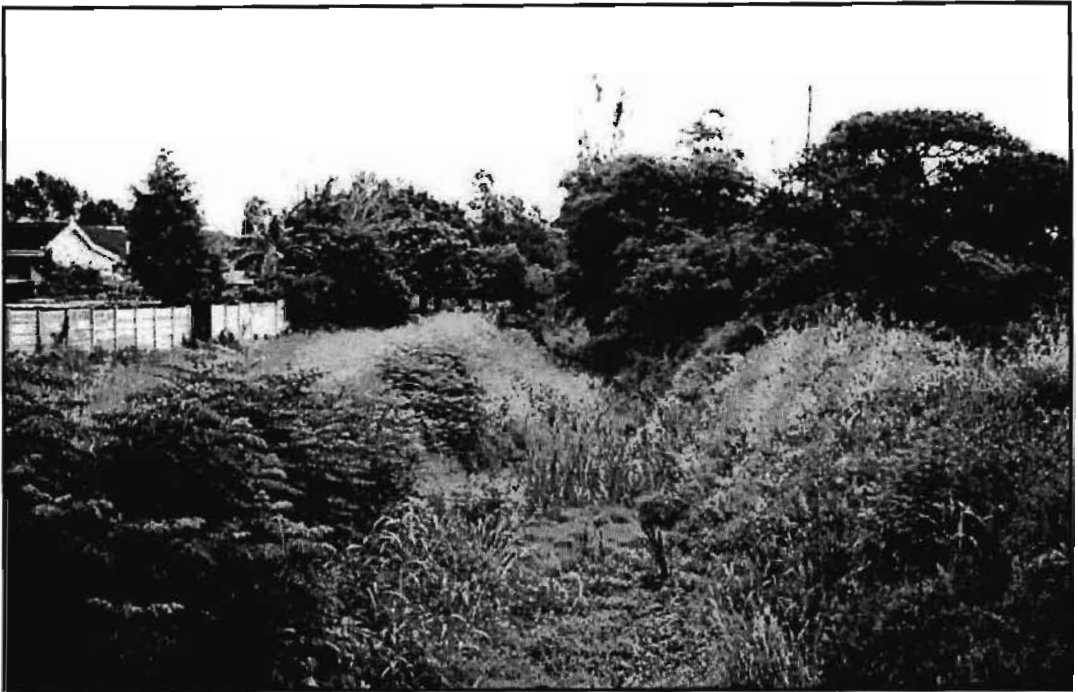
Utilise vegetated geogrids or soil filled cells; Ringbark alien trees which are fulfilling a bank stability function and remove the rest on both banks; Demarcate outer boundary of at least 7.5 metres (5m + height of bank). Evaluate vegetation in the riparian zone according to over storey, under storey, ground cover and marginal cover; Derive species list from vegetation database (Table 7 and Kellner *et al.*, 2000); Plant the recommended species to the zone width.

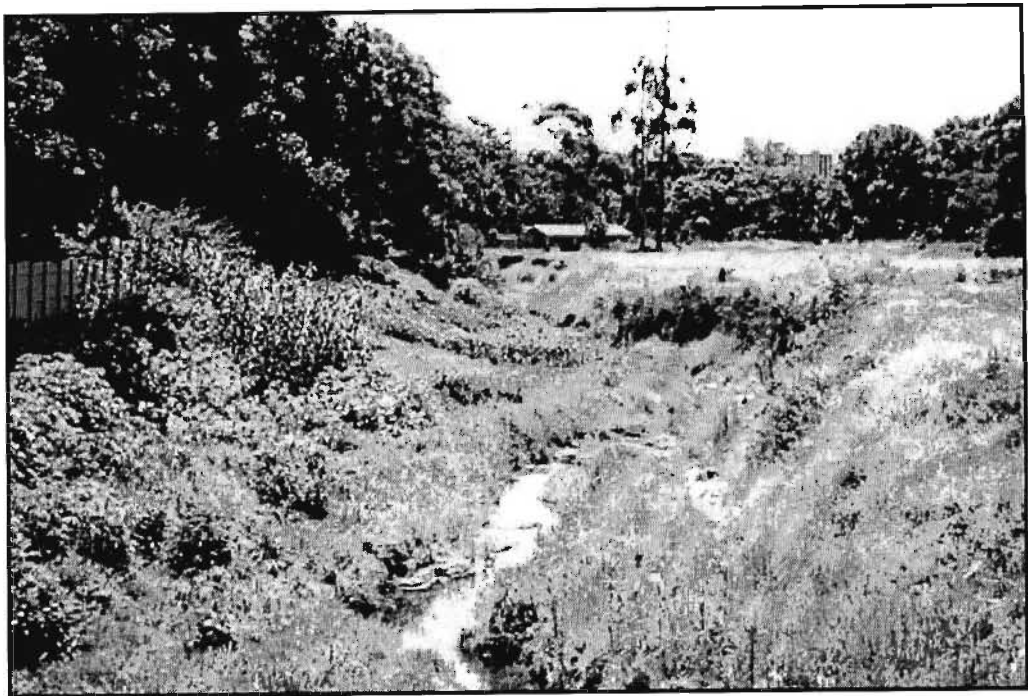
No direct human use of this site. Pressures include, the consistent cutting back of vegetation and the invasion by exotics. Water flowing at high velocity may also cause problems.

Lack of desired vegetative cover and presence of exotics, together with very steep banks allow water, in a high energy state, to cause degradation.

Utilise live fascines in combination with brush mattresses and a stone toe protection; Ringbark alien trees which are fulfilling a bank stability function and remove the rest; Demarcate outer boundary of at least 8 metres (5m + height of bank). Evaluate vegetation in the riparian zone according to over storey, under storey, ground cover and marginal cover; Derive species list from vegetation database (Table 7 and Kellner *et al.*, 2000); Plant the recommended species to the zone width.

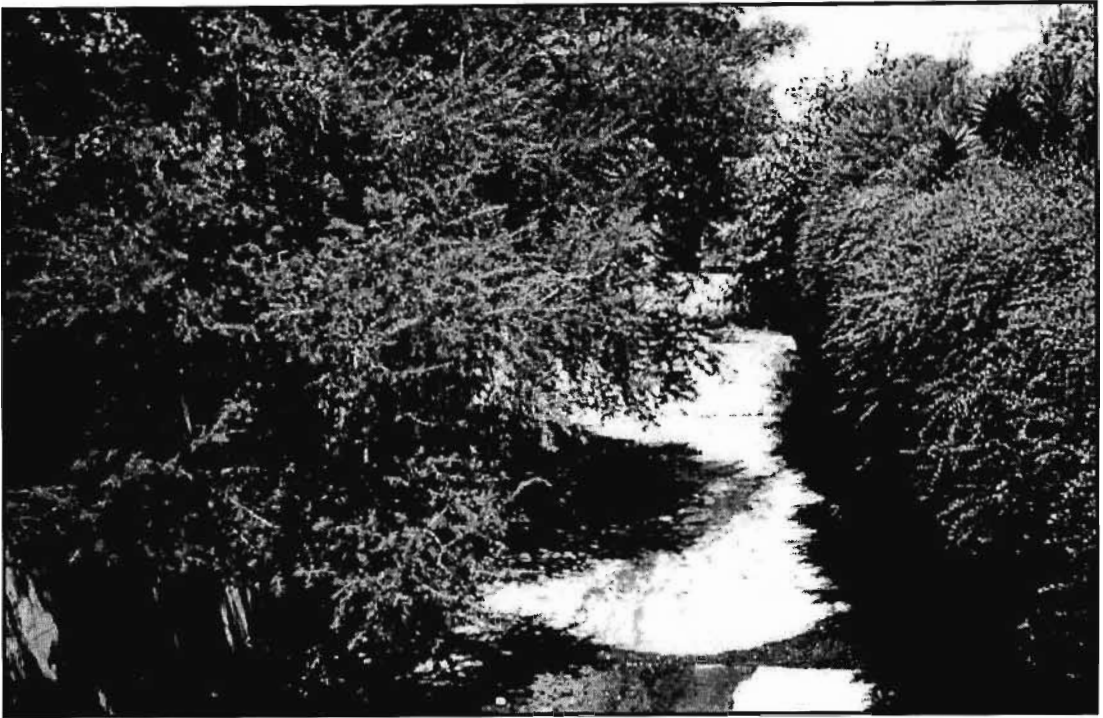
Below Ritchie Road. Note two areas on the outside bend which are scoured out, undercut and resulting in mass failure. This bank is 2 to 2.5 metres high and  $>81^\circ$ . The over storey and under storey are non-existent although there is a wide riparian zone. A high infiltration by exotics can be seen on the left bank. Note, the inside meander has been re-profiled and is successful, showing no signs of degradation.

Undertake bank shaping and planting; Apply mattress cells with joint plantings; Stabilise upper bank with dormant post plantings or live stakes; ringbark alien trees which are fulfilling a bank stability function and remove the rest on both banks; Demarcate outer boundary of at least 7.5 metres (5m + height of bank). Evaluate vegetation in the Riparian zone according to over storey, under storey, ground cover and marginal cover; Derive species list from vegetation database (Table 7 and Kellner *et al.*, 2000); Plant the recommended species to the zone width.

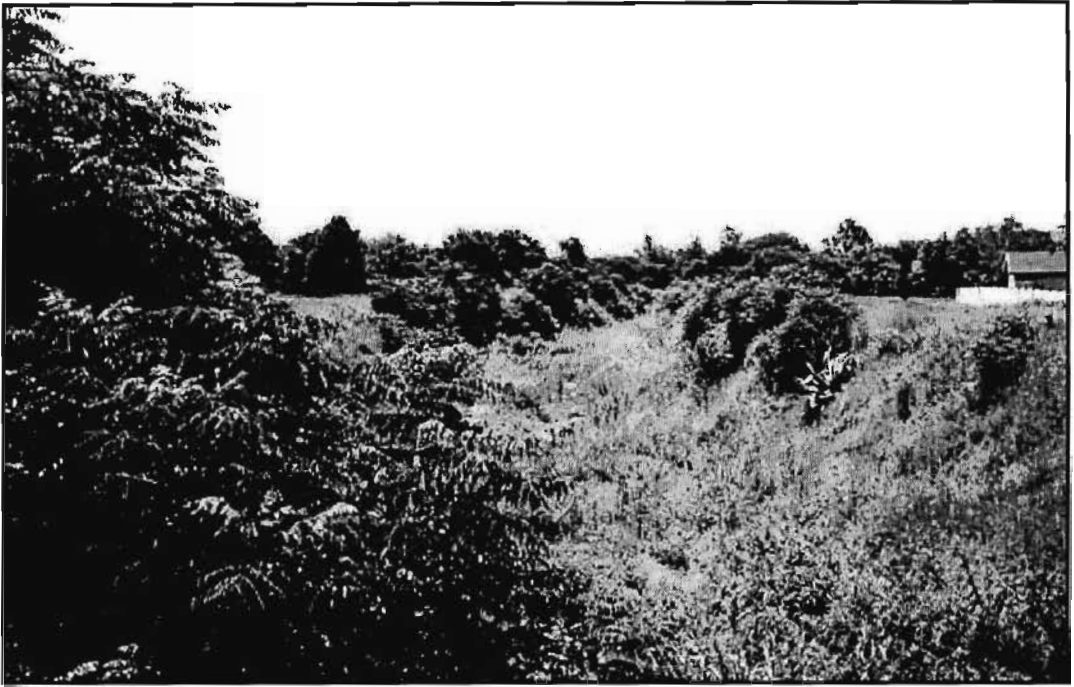
Between service railway bridge and Andries Pretorius Road Bridge. The site is structurally sound with no signs of degradation. However, being cement lined, it performs no ecological functions. Plant growth on the upper banks low (40 to 20% cover).

Clearfell exotic species; Evaluate vegetation in the riparian zone according to over storey, under storey, ground cover and marginal cover; Derive species list from vegetation database (Table 7 and Kellner *et al.*, 2000); Plant the recommended species to the zone width. No recommendation is given about the concrete lining.
