**A PROTOTYPE DECISION SUPPORT SYSTEM FOR STREAMBANK  
REHABILITATION**

Submitted in partial fulfilment of the academic  
requirements for the degree of  
Master of Environment and Development  
at the  
Centre for Environment and Development  
University of Natal

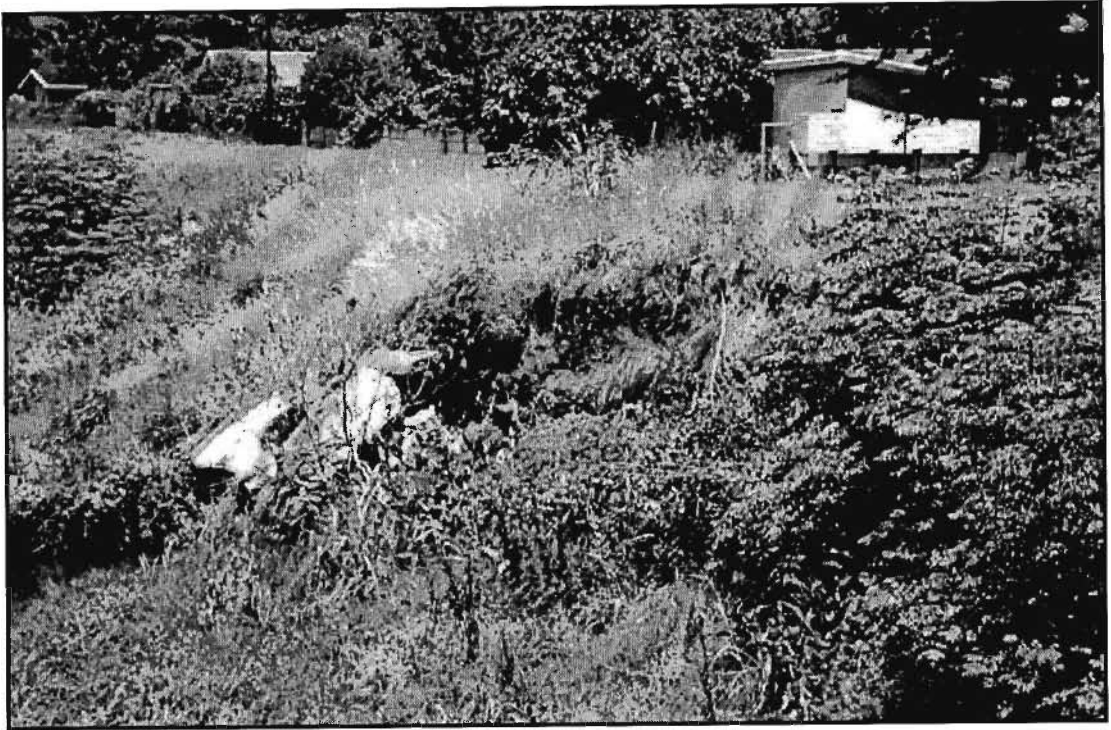
About 100 metres below Andries Pretorius Road Bridge. Site is about 50 metres long and situated on an outside meander. There is large scale degradation, the dominant process being slumping caused by undercutting. This is a high energy environment. The site lacks an over and under storey cover and there is a significant invasion by exotic species.

Water is directed against the outer bank during high flows scouring the bank, causing steepening, resulting in mass failure. The area is cleared of vegetation, increasing the susceptibility of the site.

Undertake bank shaping and planting; Apply mattress cells with joint plantings; Stabilise upper bank with dormant post plantings or live stakes; Clearfell exotic species; Demarcate outer boundary of at least 7.5 metres from bank crest (5m + height of bank). Evaluate vegetation in the riparian zone according to over storey, under storey, ground cover and marginal cover; Derive species list from vegetation database (Table 7 and Kellner *et al.*, 2000); Plant the recommended species to the zone width.

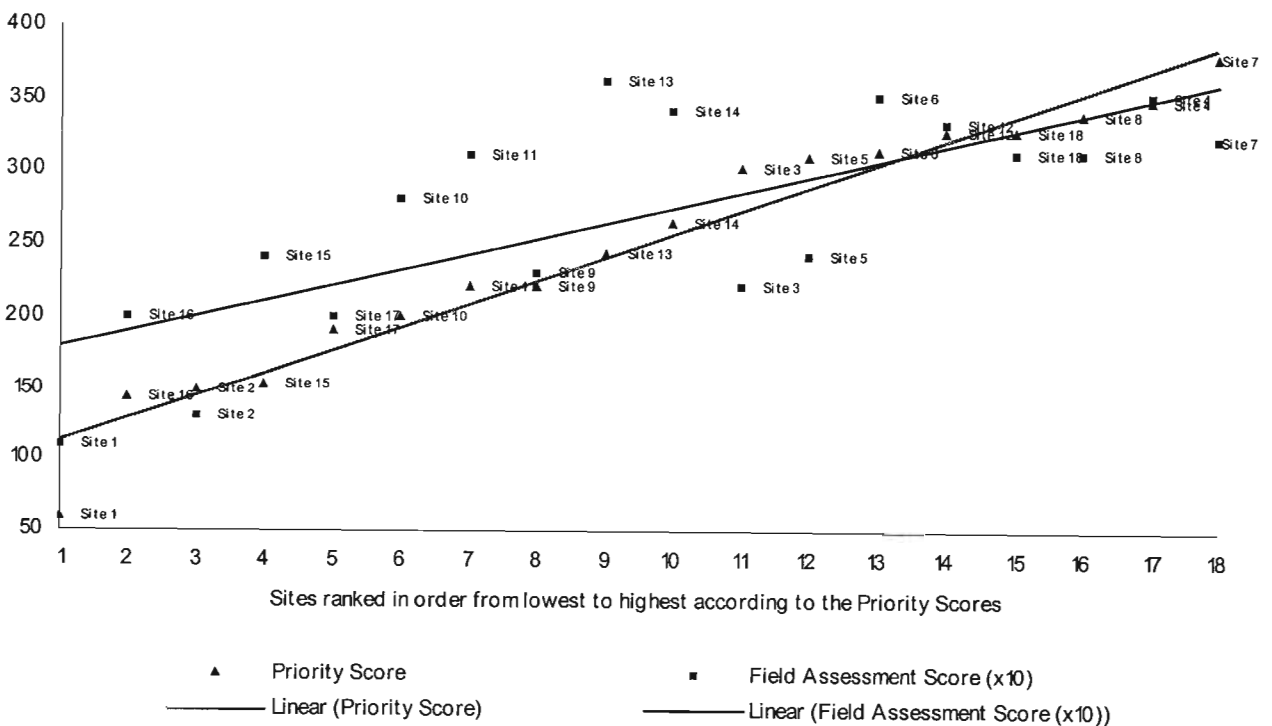
**Figure 17:** Graph depicting the similarity between the field assessment scores and the priority scores.

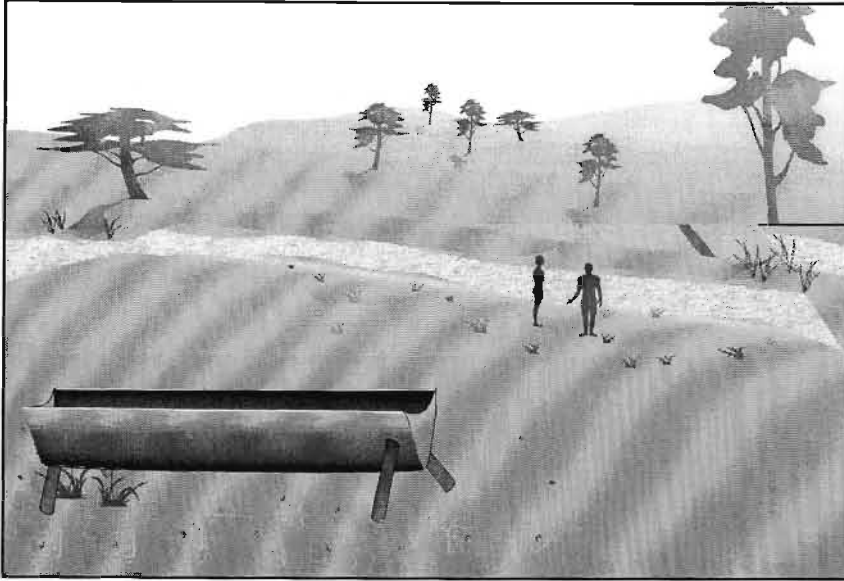
## Technique Number 2: Stock watering troughs

- Effective in providing stock alternative access to water
- Helps reduce the pressure exerted on the bank and the vegetation that occurs there
- Helps keep stock out of dangerous areas such as steep banks

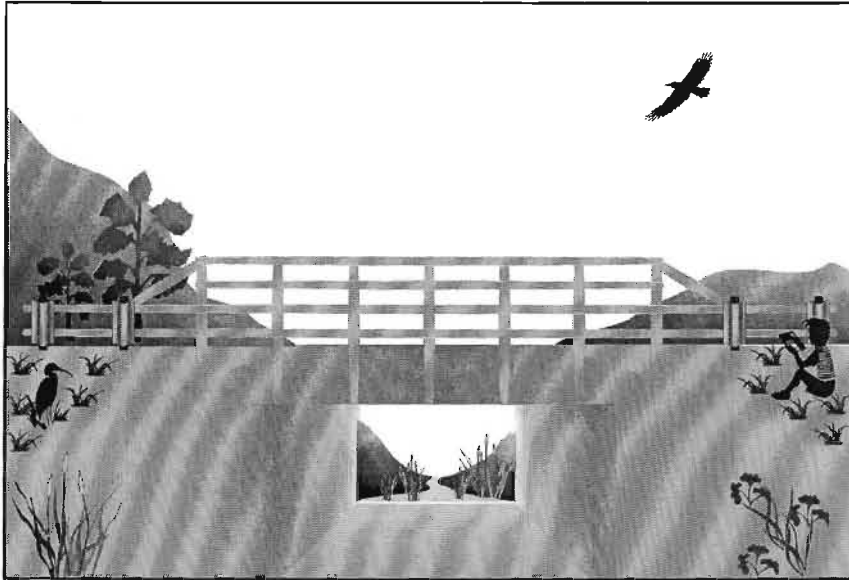
## Technique Number 5: Bridge

- Manageable and cost effective crossings for vehicles and stock
- Have high aesthetic value
- May be constructed from readily available pre-fabricated materials
- Its construction may reduce the pressure resulting from continual trampling by vehicles and stock

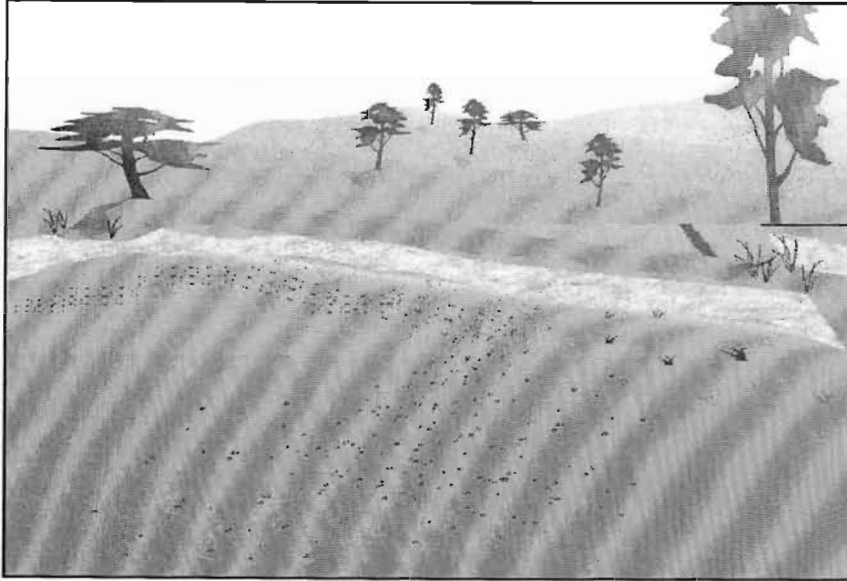
## Technique Number 7: Erosion proof path and upgrade

- Effective where the bank is degraded as a result of an informal path
- Erosion proofing and upgrading will attempt to deal with the problem of drainage and rainwater that runs down a bare path
