A digital-based integrated methodology for the preventive conservation of cultural heritage: the experience of HeritageCare project

M.G. Masciotta^{a*}, M.J. Morais^a, L.F. Ramos^a, D.V. Oliveira^a, L. J. Sanchez-Aparicio^b and D. Gonzalez-Aguilera^b

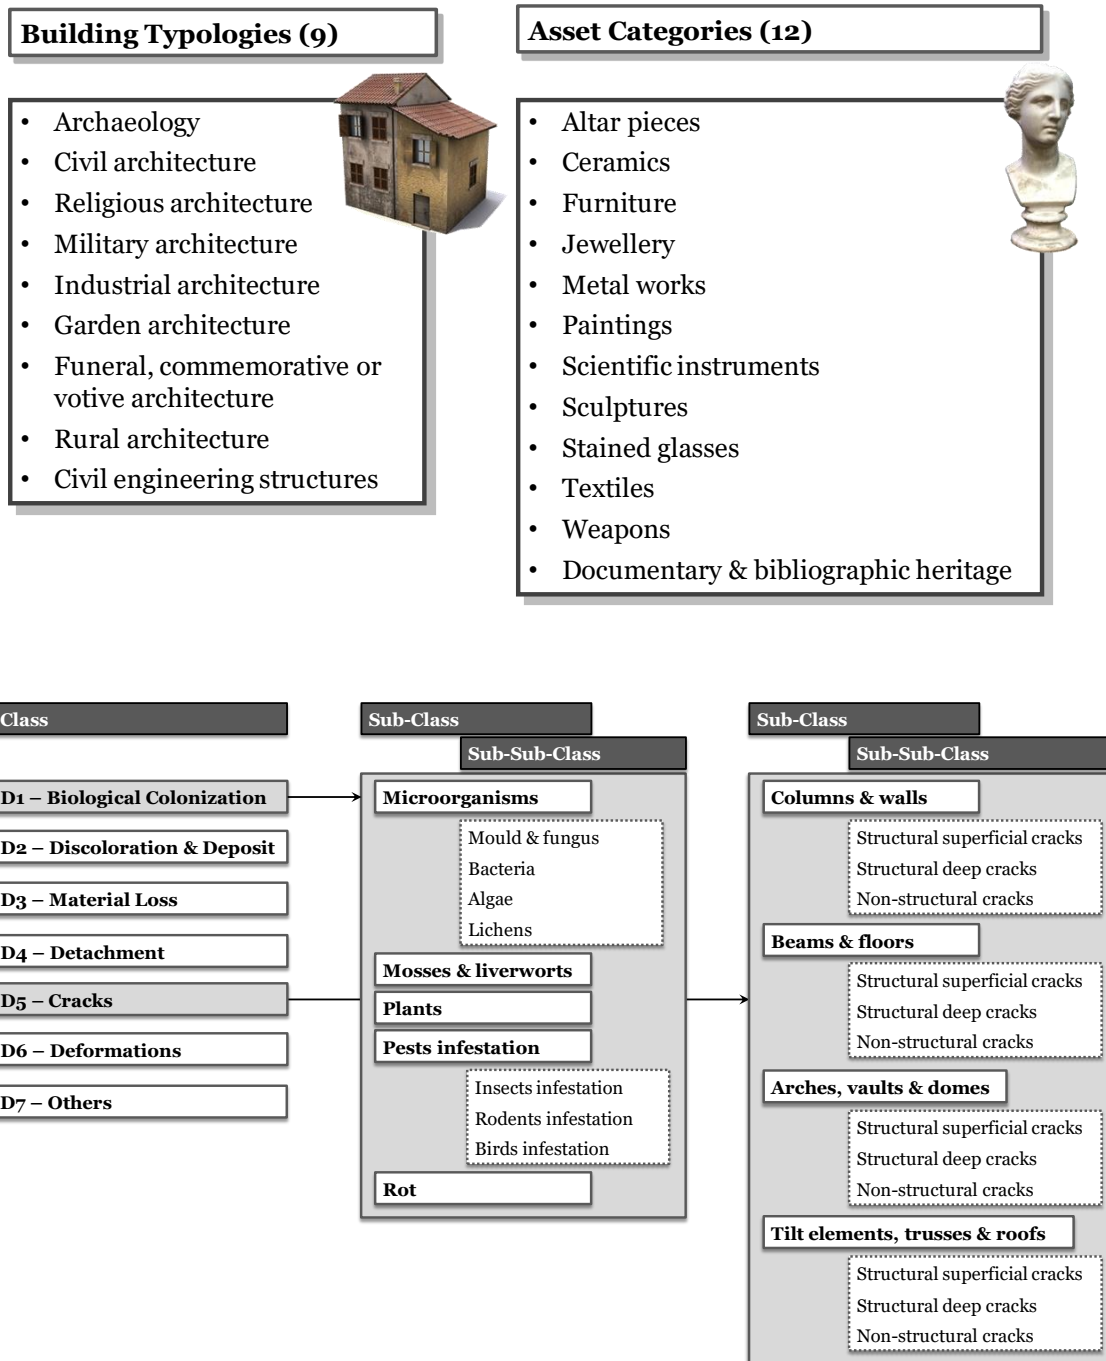
Figure 3. HeritageCare cataloguing framework: (a) buildings typologies and assets categories; (b) example of hierarchical classification of damages adopted in the Building Damage Atlas.

As a first step towards the definition of a common cataloguing framework, historic buildings were grouped into 9 typologies, while movable and integrated heritage assets were organized into 12 categories (Figure 3-a). In what concerns the damages, a hierarchical taxonomic classification was adopted on the basis of shared characteristics, distinguishing among 7 damage classes further divided into sub-classes and sub-sub-classes (Figure 3-b), for a total of 87 types of damages for buildings and 79 for assets, organized in the form of a Damage Atlas. Translated into 4 languages (English, Portuguese, Spanish and French), such a supporting tool represents a fundamental part of the HeritageCare database, providing valuable reference information during inspection activities for the characterization and preliminary diagnosis of the observed pathologies as well as for the identification of suitable mitigation actions to minimize the damage consequences. Moreover, with the objective of creating a common representation

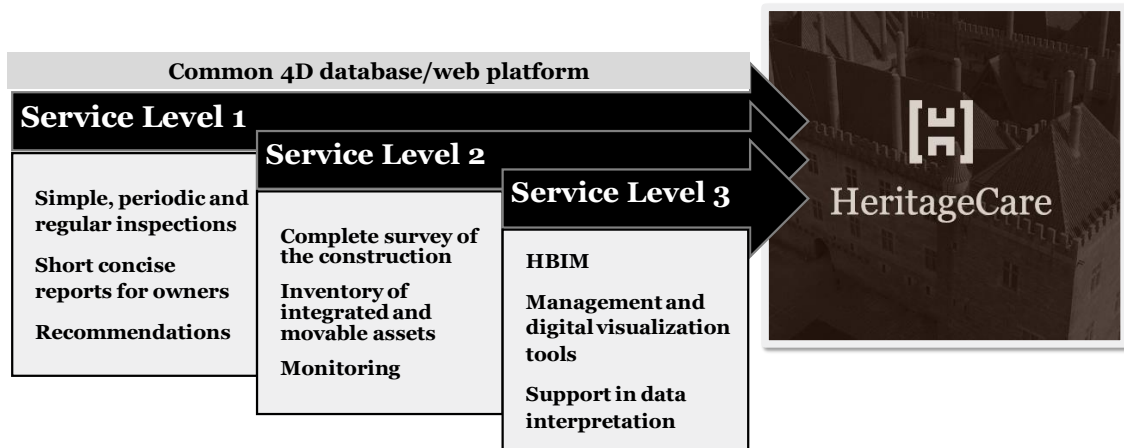
Service Level	Designation	Functionality
SL1	StandardCare	Provision of what is essential for the primary health and ordinary maintenance of the heritage building
SL2	PlusCare	Provision of what is necessary for the primary health, ordinary maintenance and thorough screening of the heritage building along with its integrated and movable assets, including monitoring data to support decision making
SL3	TotalCare	Provision of what is necessary for the primary health, ordinary maintenance, thorough screening and enhanced management of the heritage building along with its integrated and movable assets

Figure 4. The HeritageCare multi-level system for preventive conservation.

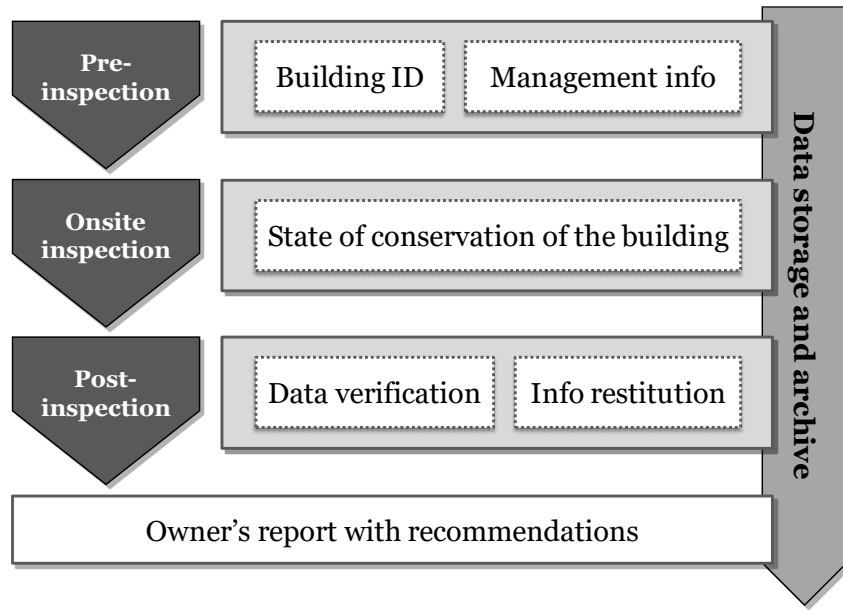
Figure 5. HeritageCare protocol for Service Level 1 (StandardCare).

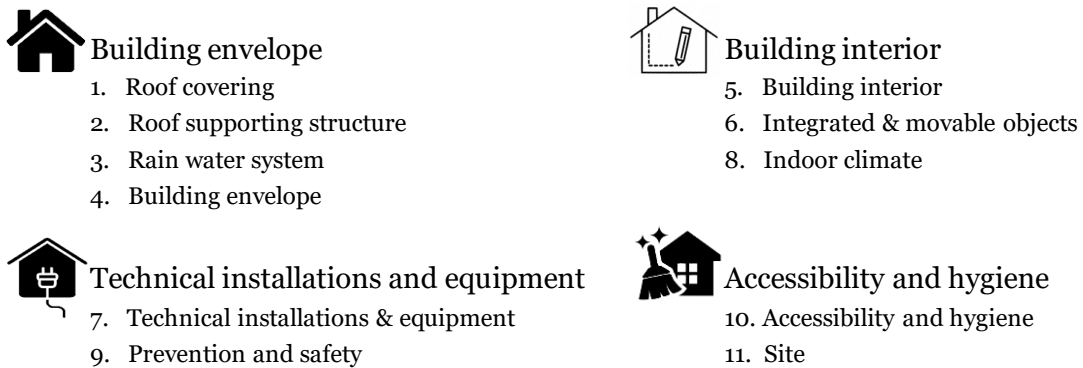
Figure 6. Inspection checklist: (a) list of items to inspect (only two lists of sub-items are shown as an example); (b) macro-categories of items.

of each item is rounded up to the condition grade of the most damaged sub-item. Lastly, an overall condition classification is provided by averaging the grades scored by the inspected items organised into four macro-categories (Figure 6-b). This procedure helps ranking the building condition in a nearly objective way and assists in prioritizing the necessary maintenance and preventive conservation actions.

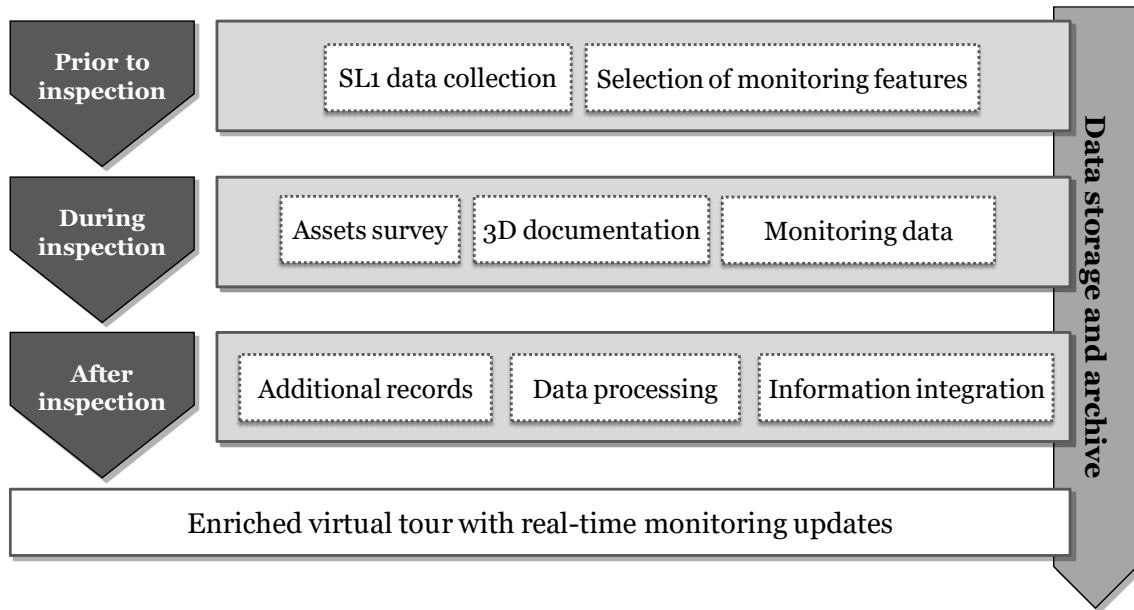
Figure 7. HeritageCare protocol for Service Level 2 (PlusCare).

The *PlusCare* protocol entails the three main steps of the *StandardCare* protocol plus five steps accounting for further data categories and information, aimed to enrich and extend the SL1 documentation about the heritage ensemble: (1) Assets ID and condition survey; (2) 3D documentation; (3) Monitoring data; (4) Additional records; (5) Data processing and information integration (Figure 7).

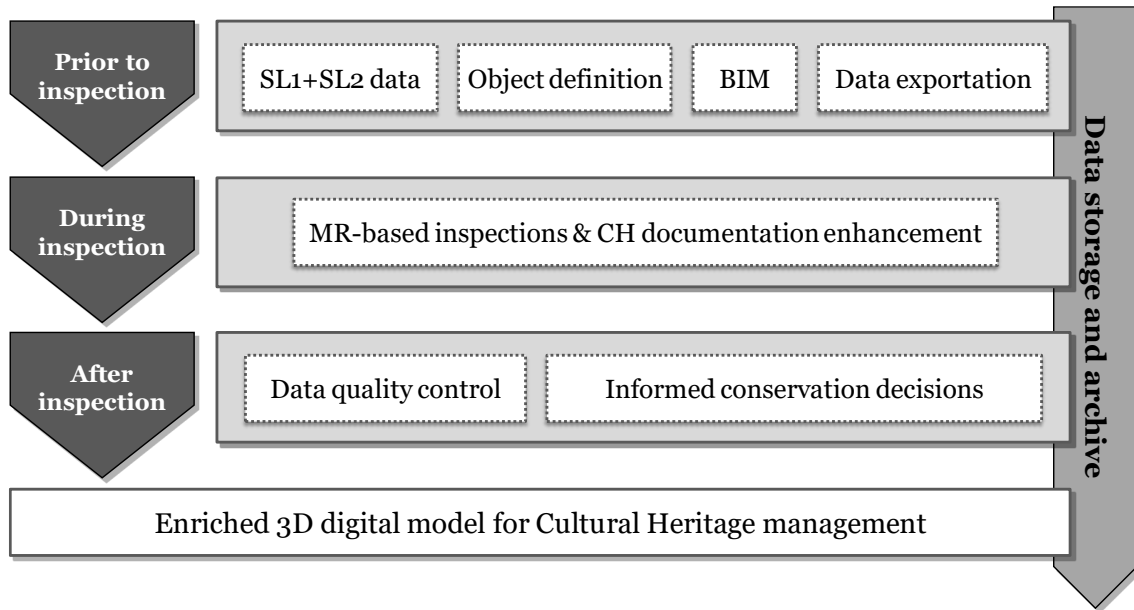
Figure 8. HeritageCare protocol for Service Level 3 (TotalCare).

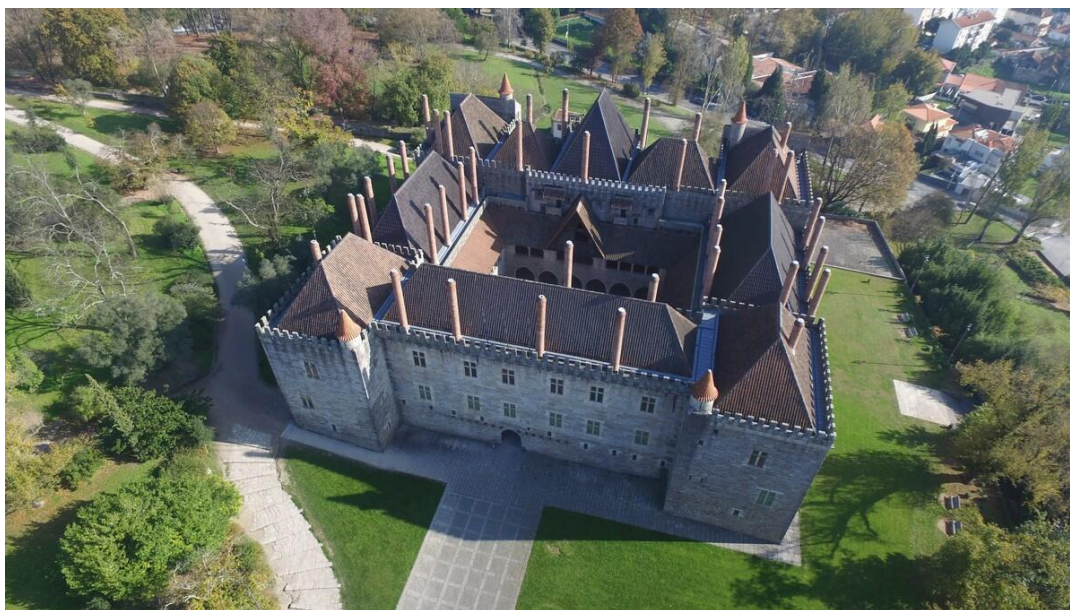
Figure 9. Bird's eye view of the Ducal Palace of Guimarães, Portugal.

Spain and Southwestern France. As an example, this section summarizes the application of the HeritageCare protocol to one of the Portuguese case studies, the Ducal Palace of Guimarães. The building features a quadrilateral layout with protruding bodies on the rear façade and corners. It develops around a rectangular courtyard, surrounded by a two-story portico, occupying a ground area of about 3143 m² (Figure 9). The thick bearing masonry walls are made of regular shaped granite stones and pierced by iron glazed windows, while chestnut wood is used for the timber roof supporting structures. The floors are supported by timber clad concrete beams and covered with tiles. A complex system of hip roofs boasting 39 brick chimneys, each linked to its own fireplace with only four being original, crowns this noble construction. The Ducal Palace was built in the 15th century by D. Alfonso (illegitimate son of the King João I and Inês Pires Esteves), first Duke of Bragança and eighth Count of Barcelos, on the occasion of his second wedding with D. Constança de Noronha. During the following centuries, owing to political and economic reasons, the palace was abandoned and fell into ruin. Starting from 1807 until 1935, the building was used as a military quarter, thereby suffering several alterations. The actual configuration of the palace is the result of a profound intervention of reconstruction that took place between 1937 and 1959 aimed at reintegrating the missing parts of the building and restoring its primitive unity. Elevated to national monument in 1910, the Ducal Palace hosts a museum inaugurated in 1959 and is one of the most visited monuments in Portugal.

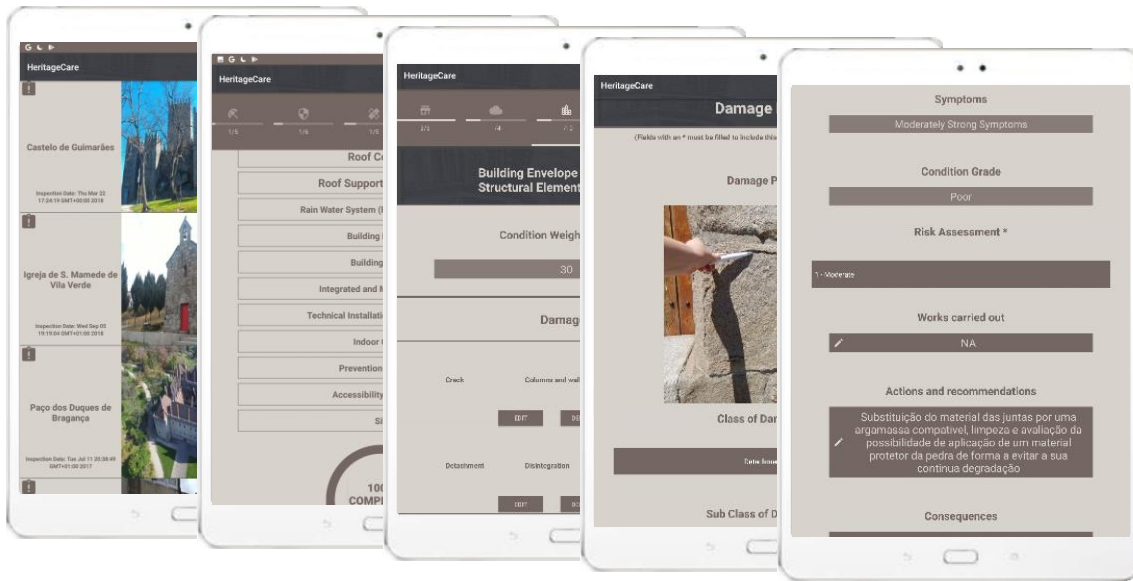
Figure 10. HeritageCare mobile app used for onsite inspection of the Ducal Palace.

Each damage was accurately documented and assessed according to the defined damage rating system. Thanks to the use of the mobile e-form (Figure 10), a real-time digitization of the entire inspection process was possible, being the app provided with synchronization options that allow the direct storage of the uploaded information into the HeritageCare database, with tremendous advantages in terms of data reporting time.

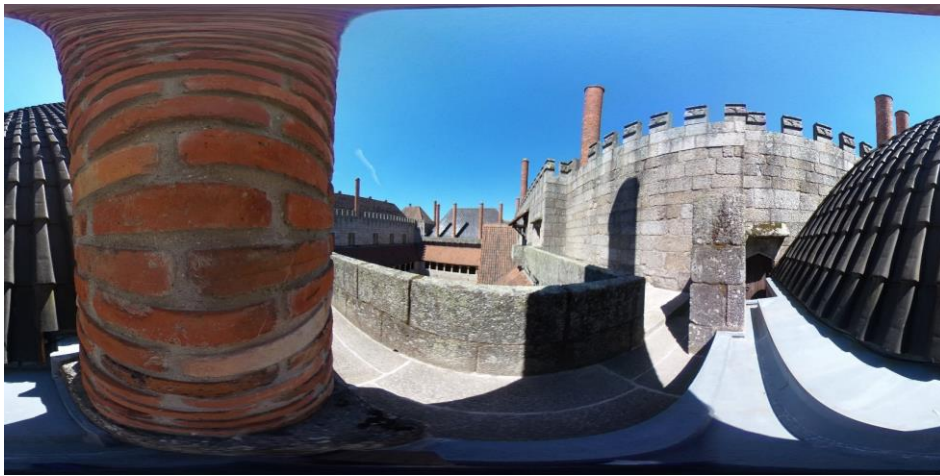
Figure 12. Geomatic products required for the PlusCare system: (a) high-resolution point cloud; and (b) spherical panorama.

To obtain high-resolution information about the geometry and onsite conditions of the palace, a laser scanner survey was carried out to digitally capture 3D geometric data as point clouds. Given the dimensions of the structure, the adoption of geomatic techniques offered remarkable advantages, allowing to collect significantly higher and more precise volumes of data in much less time. Considering the final aim of the survey, a Leica ScanStation P20 was used. This laser scanner is based on the Wave Form Digitizer principle which combines the time-of-flight and phase shift measurement technology to capture the data. Apart from that, this laser has a maximum range of 120 m and a maximum capture rate of 1.000.000 points per second. Four full working days were

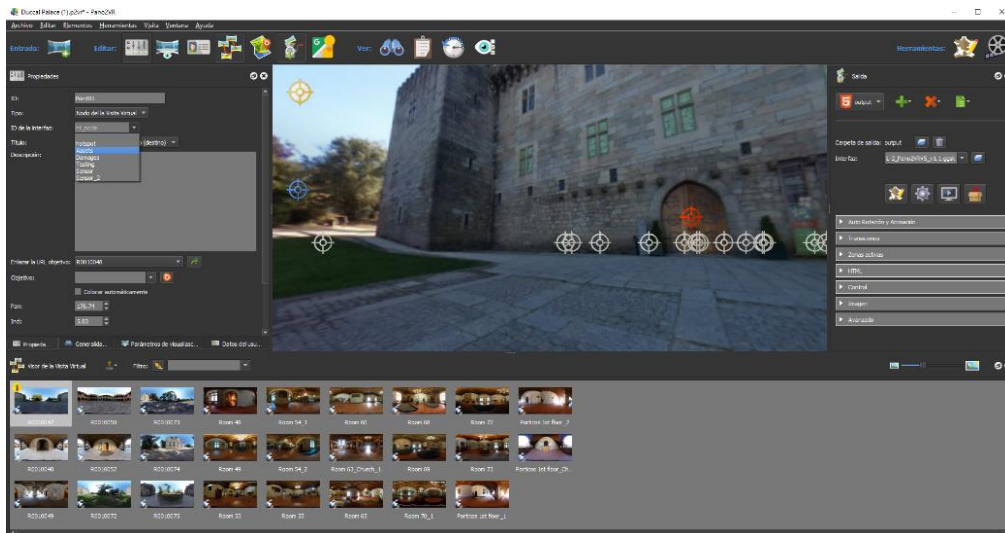
Figure 14. PlusCare system: (a) integration of information through the HeritageCare plugin for Pano2VR; (b) and (c) excerpts from the virtual tour of the Ducal Palace with display of monitoring data in real time.
