**Experimental investigation on the bond behavior of a compatible TRM-based solution  
for rammed earth heritage**

**Antonio Romanazzi , Daniel V. Oliveira, Rui A. Silva**

ISISE, Institute of Science and Innovation for Bio-Sustainability (IB-S), Department of Civil  
Engineering, University of Minho, Guimarães, Portugal.

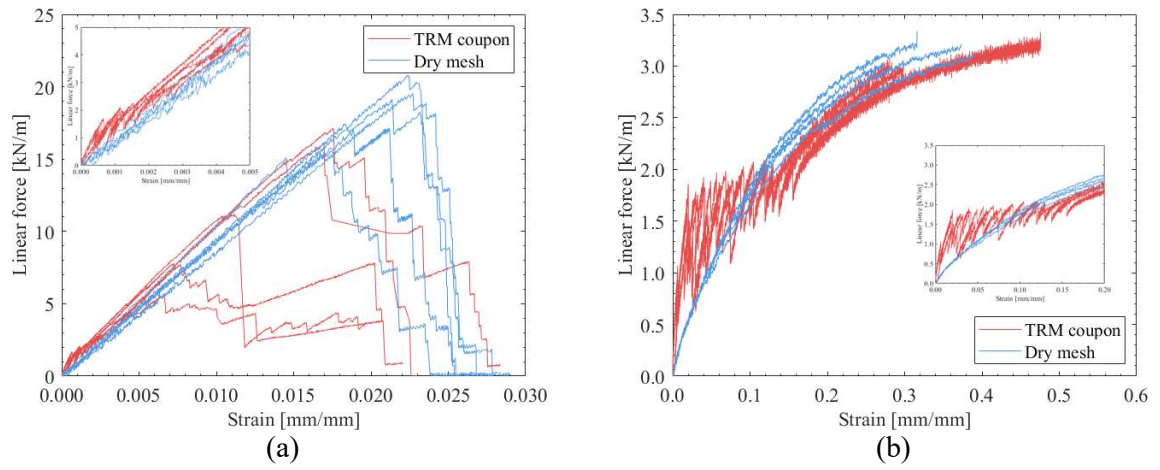
**Figure 31.** Comparison of the direct tensile tests on dry mesh and TRM coupon specimens:

(a) TCGM; (b) TCNM

Figure 11 highlights the changes in behavior introduced by the TRM coupons with respect to the behavior of the dry meshes. In both cases, a significant increase of the stiffness is observed at the initial stage, due to the contribution of the mortar. As this contribution is dissipated by cracking development, the behavior tends to approximate to that of the dry mesh. Furthermore, the average maximum linear force achieved in TCNM (3.14 kN/m) is similar to the one obtained in TNM (3.18 kN/m), while the strength of TCGM (14.82 kN/m) is lower than the one of TGM (18.42 kN/m). This suggests that the friction between earth mortar and mesh causes damage to glass fibers.
