THE USE OF CONTACT SPONGE METHOD TO MEASURE WATER ABSORPTION IN EARTHEN HERITAGE TREATED WITH WATER REPELLENTS

Telma Ribeiro^{1*}, Daniel V. Oliveira², Susanna Bracci³

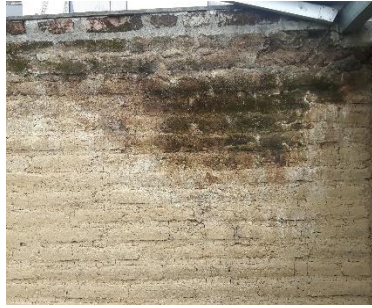
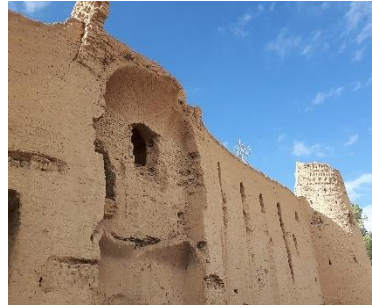
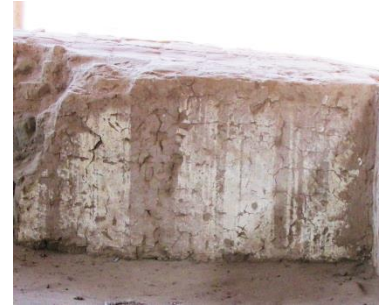
Figure 3: Examples of degradation phenomena in earthen constructions: (a) Biological growth in a vernacular house in Quito, Ecuador; (b) Material loss in Fahraj Castle, Yazd, Iran; (c) Cracking in earthen plaster, Huaca de la Luna, Peru.

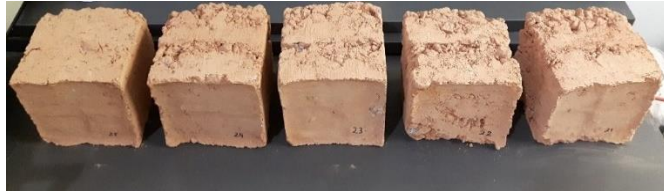
Figure 4: Specimens prepared for the experimental part: (a) Adobe; (b) Rammed earth.

In order to understand the possibility and reproducibility of using the contact sponge method in unstabilized earthen materials, adobe and rammed earth specimens were prepared, see Figure 4a and Figure 4b, respectively.

Adobe blocks ($3 \times 15 \times 7 \text{ cm}^3$) from Montemor-o-Novo (South of Portugal) were cut into cubes of approximately 7 cm size. In the case of the rammed earth samples, soil collected in Cercal (South of Portugal) was used to prepare specimens in the laboratory according to traditional techniques, which involved compressing the earth manually into a wood formwork creating cubes of approximately 10 cm, and then left to dry for four weeks. A total of twenty-three specimens for each construction technique were prepared: three specimens for capillarity test; five specimens as reference; and fifteen specimens for water repellents application (five specimens for each of the three water repellents). Specimens were characterized in terms of porosity, as showed in Table 2. Porosity is usually assessed through the immersion of the specimen in water. Since it is impossible to perform this test with earthen materials, porosity (n) was calculated as follows [19]:

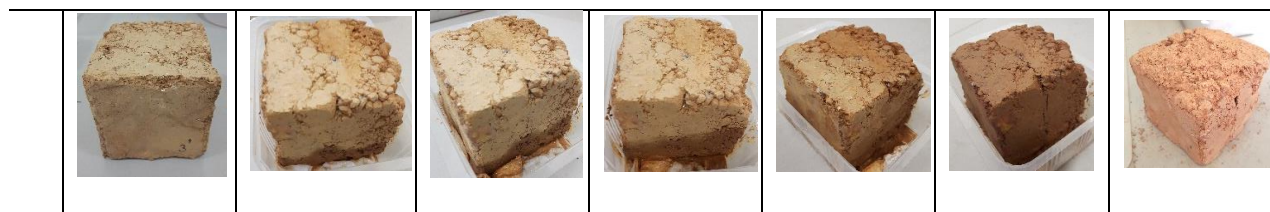
Figure 5 illustrates the main differences between the initial and final states of the six studied specimens. Additionally, it is possible to observe the material attached to the bottom layer and the development of cracks.

Figure 5: Different stages of capillarity test for each adobe and rammed earth specimen.

In the first 30 minutes, the adobe specimens showed an increase of mass by 3%, after three hours an increase of 8%, and after 24 hours the weight increased by 10% (this latter value remained stable until 72 hours). In the case of rammed earth specimens, after 30 minutes an increase of 1% of the mass was observed, after three hours by 3%, and 5% after 24 hours (this latter value remained stable until 72 hours). However, during the test, some difficulties in weighting the specimens were observed, due to material loss in both earthen techniques. A considerable amount of soil remained onto the bedding layer in the bottom of the box, making impossible to achieve accurate weight values and leading to misleading percentages of gained weight during the test. After 24 hours in contact with water, adobe specimens started to crack and rammed earth

specimens showed deformation at the base, increasing the material loss. After 72 hours, the test was stopped, and the specimens were placed inside an oven at 100 °C to complete water evaporation. Specimens were again placed in laboratory conditions at 20 °C and 60% RH and weighted. The material loss was calculated by the difference of initial and final weight, with an average value of 6% for adobe specimens and 5% for rammed earth specimens.

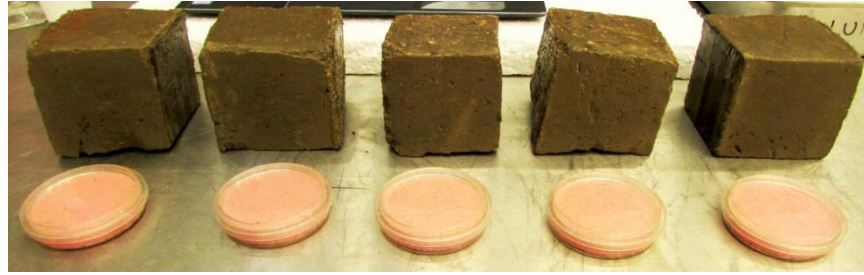
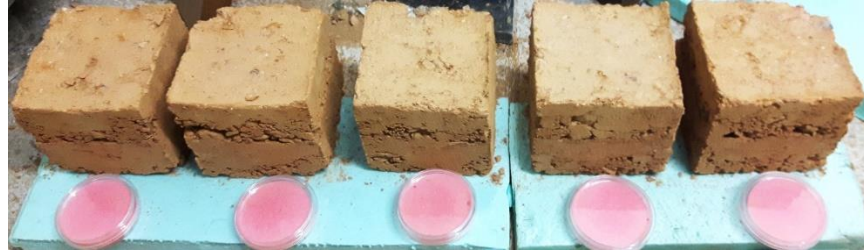
Figure 6: Contact sponge method apparatus: (a) adobe specimens; (b) rammed earth specimens.

Contact sponge method was performed following the Italian Standard UNI 11432 [51], using five sponges and capsules for each set of five specimens tested (Figure 6). Preliminary tests were done in order to define the time in which the sponge must be in contact with the specimen (should be between 30 seconds and 3 minutes, according to the standard). For this experiment, 60 seconds of contact time was chosen. Following the procedure, 5 ml of distilled water was poured on the top of each sponge. The weight of the sponge inside the capsule is taken before and after contact with each specimen. It is also important to mention that no pressure was applied on the sponge, since it is confined inside the plastic capsule and the experiment was always carried out in the vertical position to simulate *in situ* conditions (Figure 7). All specimens were kept inside a controlled environmental temperature of $20 \pm 5^\circ\text{C}$ and relative humidity of $60 \pm 5\%$. Likewise, contact sponge tests were also carried out in the same conditions.

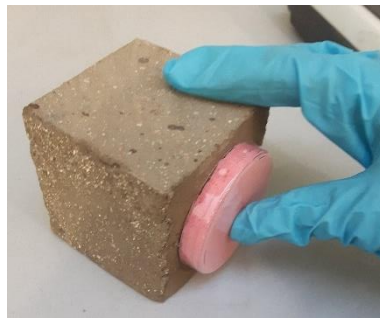
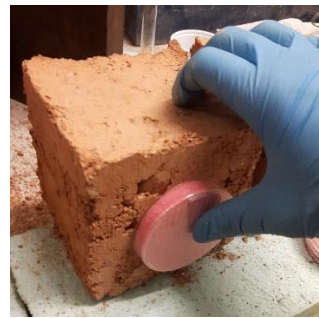
Figure 7: Example of contact sponge test procedure: (a) adobe specimen; (b) rammed earth specimen.
