Improvement of Steel Ladle Lid Circulation and Lifetime

Diplomityö

University of Oulu, Process Metallurgy

Master's thesis 2020, 66 pp.

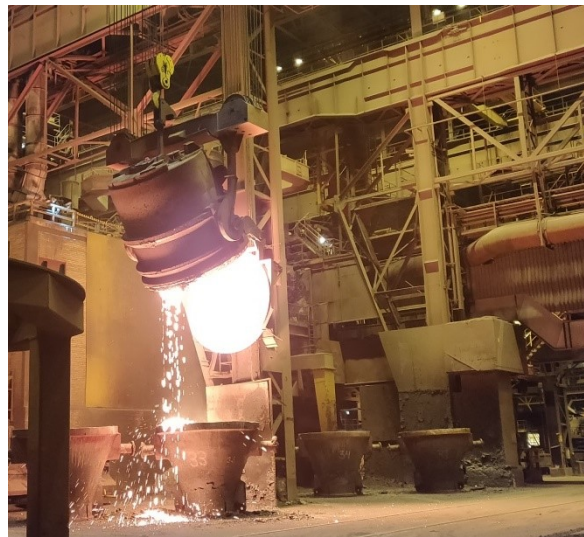
Figure 7. Lid remains attached to the ladle during slag pouring.

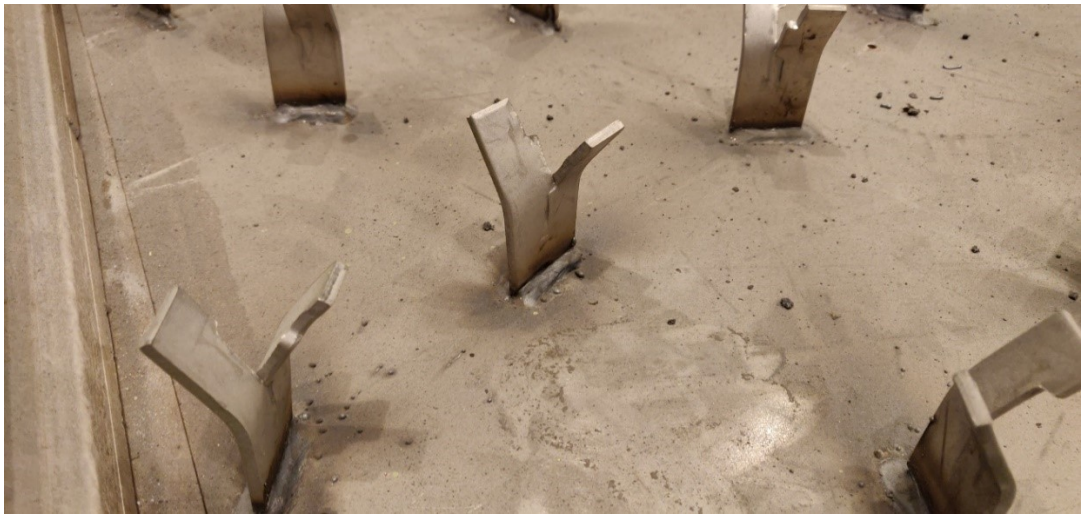
Figure 10. Metal anchors welded on the back plate of the lid.

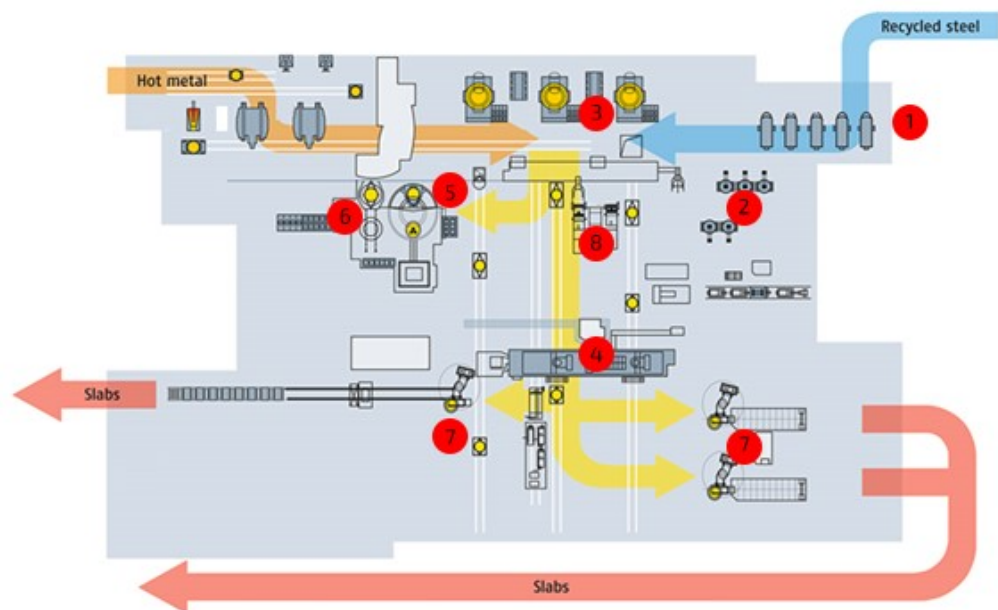
Figure 11. Material flow and process unit map of Raahe steel plant (Based on Ollila, 2015).

The steel plant uses mainly two types of ladles. The charging ladles are only used between the mixers and the converters. All the other process units use steel ladles for storing the steel. Figure 11 represents a process map of the Raahe steel plant where the units in which steel ladles are used are marked with red circles.

Lid storing methods at the ladle furnace (5 in Figure 11) and vacuum degasser (6 in Figure 11) are different because these process treatments are not located on top of the ladle car tracks. At this area ladle traffic is mainly operated by cranes. For the duration of the ladle furnace treatments lids are stored on a rotary turret, which is presented in Figure 14. It is operated independently and can store up to two lids simultaneously. The turret uses hooks to grab and detach the lid from the top of the ladle. The vacuum degasser utilizes a similar storing method, but instead of a turret the hooks are attached to a sliding tray.

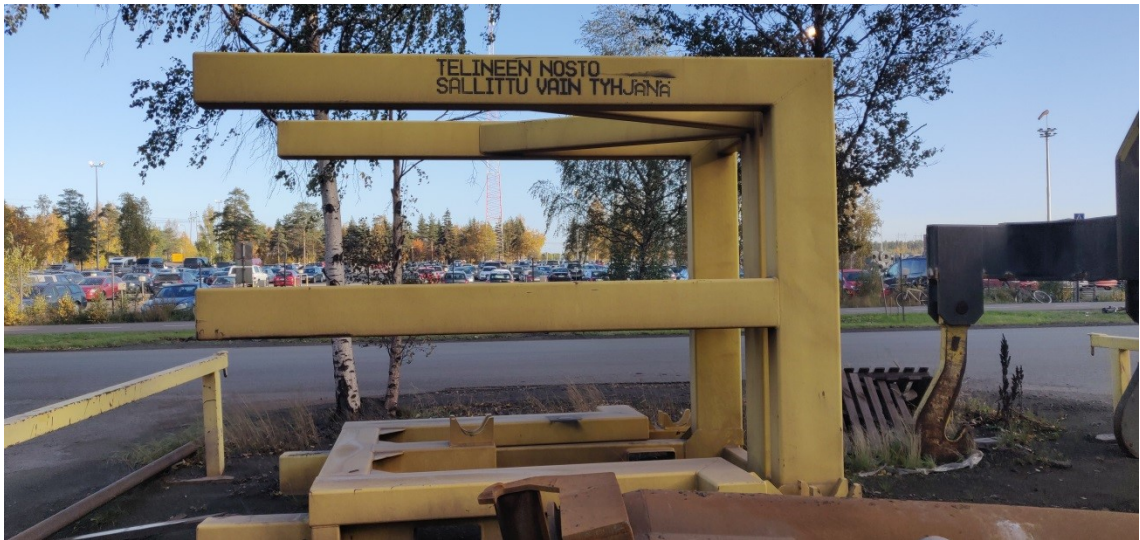
Figure 12. Storing rack for steel ladle lids.

To ease these storing challenges, SSAB acquired a storing rack for steel ladle lids (presented in Figure 12). The rack is designed to hold up to three lids simultaneously but there are still a couple of challenges to overcome before it can be deployed into use. To store a lid on the rack, the lining has to be facing downwards. However, lids usually leave the brick shop with their lining facing upwards. To use the lid storing rack reasonably, the forklift requires aid from the cranes to flip the lid around. With current procedures, the benefits of the rack are considered smaller than the benefits it would provide.

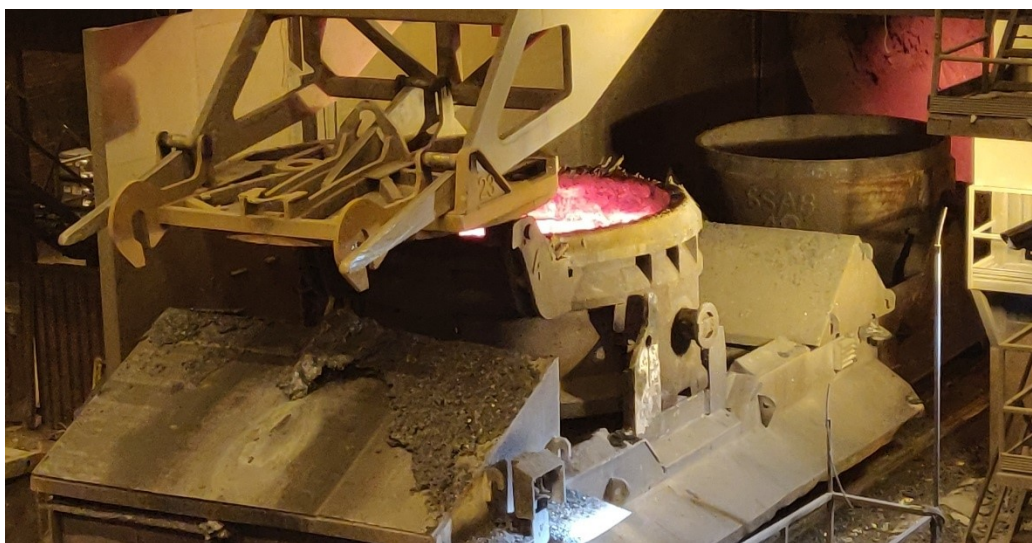
Figure 13. Lid stored on the rack near the converter (BOF).

For the duration of different steel production processes, lids are separated from their ladles and stored on holders. There are two different types of holders at the Raahе steel plant. The first one, spike racks, are used at converters (3 in Figure 11) and CAS-OB stations (4 in Figure 11). Racks are located above the ladle car track and are designed to capture lids as the car drives under. As the ladle car approaches, the rack is lowered to catch lids by the rolls. Movement of the car makes the lid slide slowly further and eventually lock its position in notches at the end of the rack. Eventually the rack is lifted to its original position to prevent the lid from falling. An image of the storing system is presented in Figure 13. After the treatment the lid is attached back on top of the ladle in reverse order.

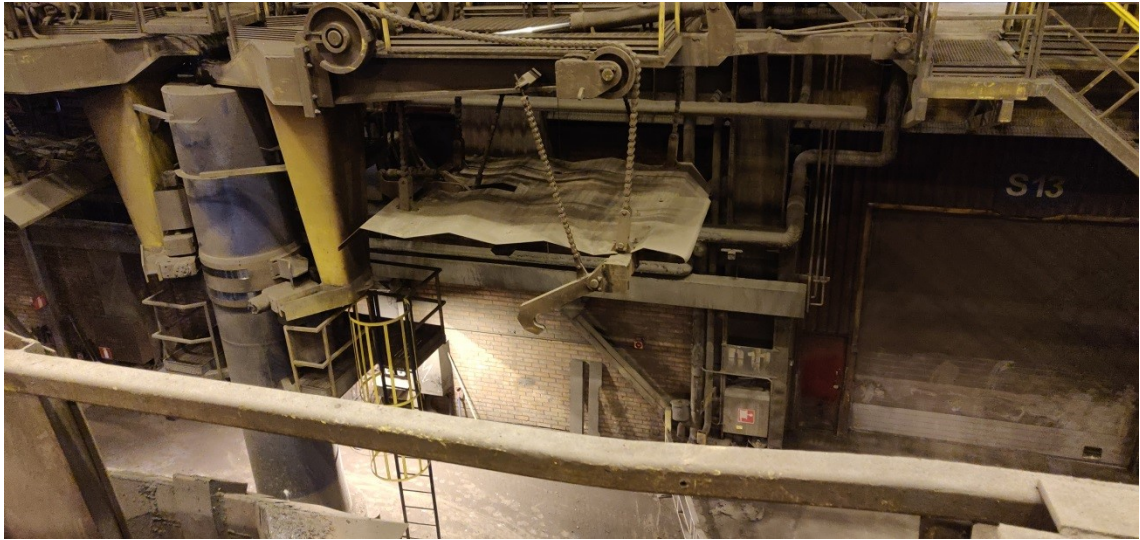
Figure 14. Lid storing system at ladle furnace.

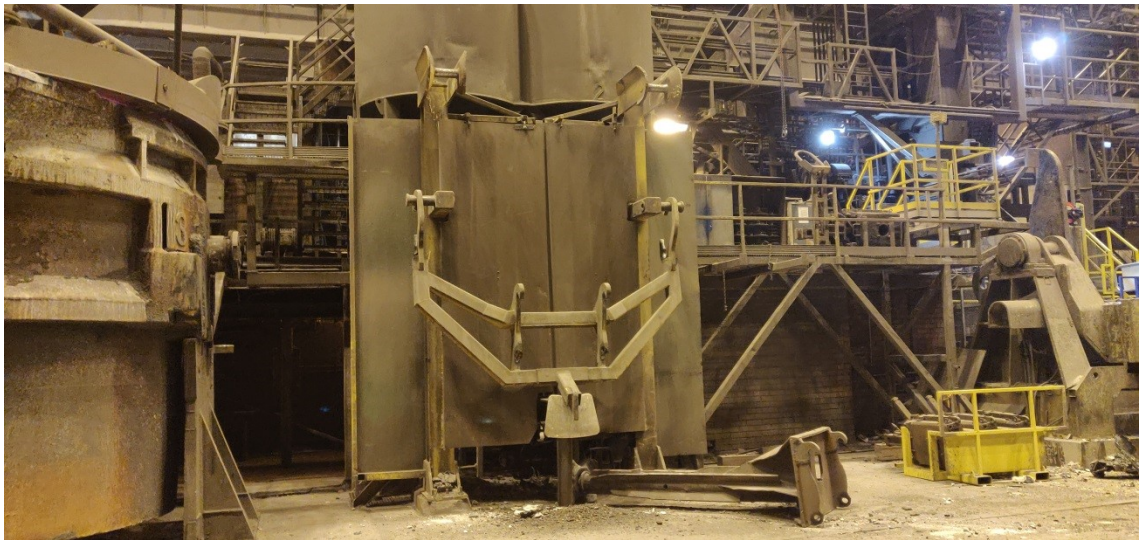
Figure 15. Devices at desculling station. Lid grabbing tool for a loader is hanging from the lid holder and deskulling anchor is on the ground.

Over time, slag splashes form a layer of skull on top of the ladle. Uneven surface of skull prevents placing the lid on top of the ladle properly. Excess skull also restricts volume of the ladle which is why it is regularly removed at the deskulling station. For this process the ladle is set down lying on top of a rig which keeps the ladle stationary. The lid is then detached with a loader to get access to the interior of the ladle. Usually the lid is set leaning on a ladle nearby or stored on a lid holder. After that, the loader operator removes the skull with an anchor and attaches the lid back to the ladle. Various tools used for moving and storing the steel ladle are presented in Figure 15.

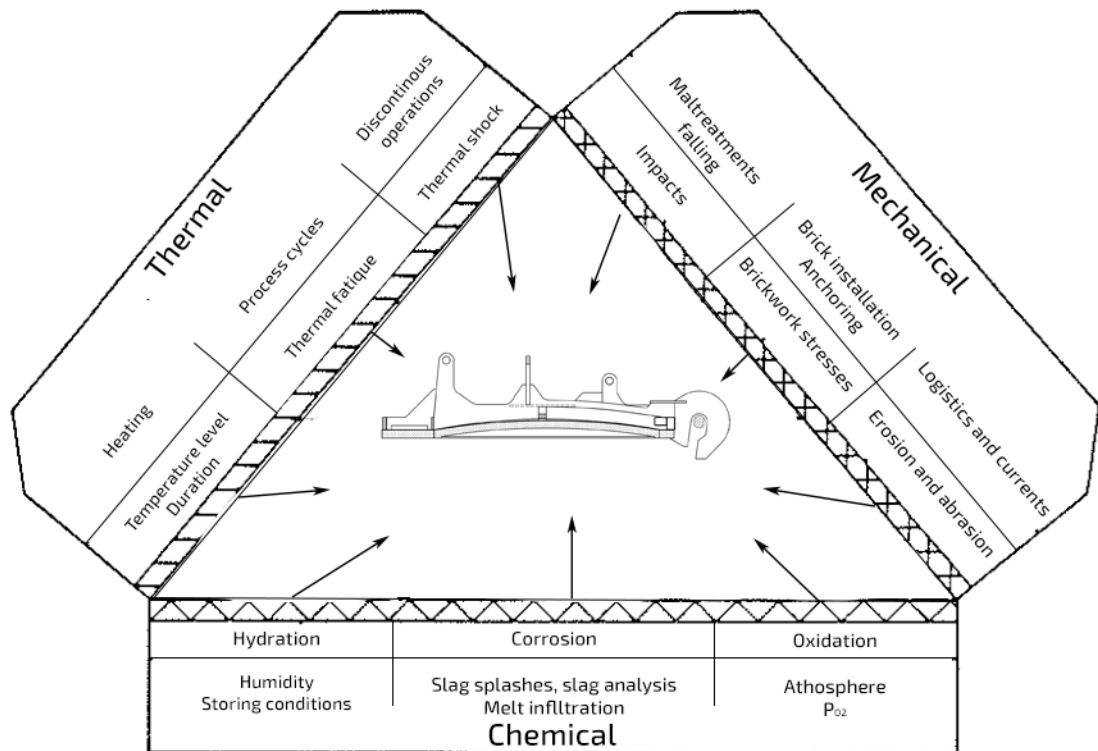
Figure 21. Wear stress on the refractory lining of steel ladle lid (modified from Helelä 1986).

Like refractory properties, their wearing mechanisms are also divided into three groups: mechanical, thermal and chemical wearing (Figure 21). Albeit these mechanisms are presented on separately, the real refractory wear is often combination of these.

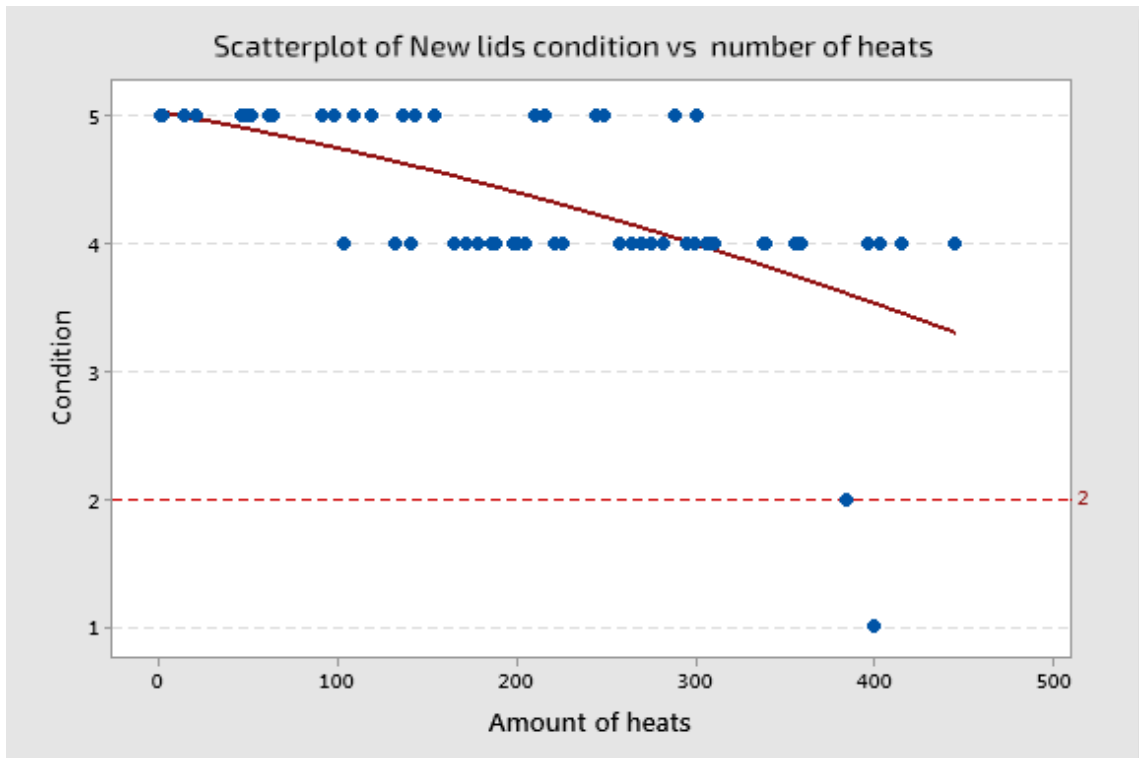
Figure 31. Condition of the new lining over the amount of heats.

The lids were classified by their condition during the deployment. At the beginning of the trial there were two lids that had not been repaired yet which were classified as “New”. Over the trial period, five lids were suitable for this classification. Out of these five lids, two were discarded during the inspections: one due to natural weariness and the other as a result of unfortunate external impact.

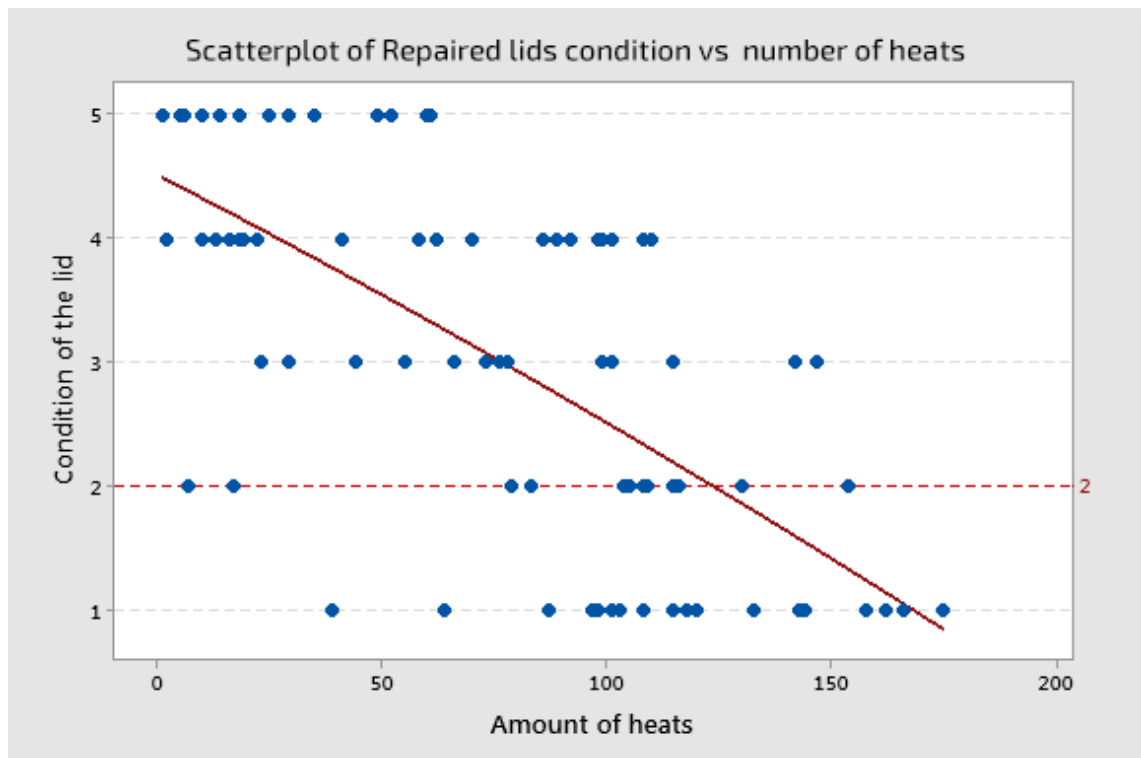
Figure 32. Condition of the repaired lids over the amount of heats.

The rest of the lids were classified as ‘Repaired’ lids. Even though the magnitude of the repairing varied from minor procedures to partial replacement of elements, they were studied as one group. During the trial period a total of 17 campaigns using repaired lids were monitored.

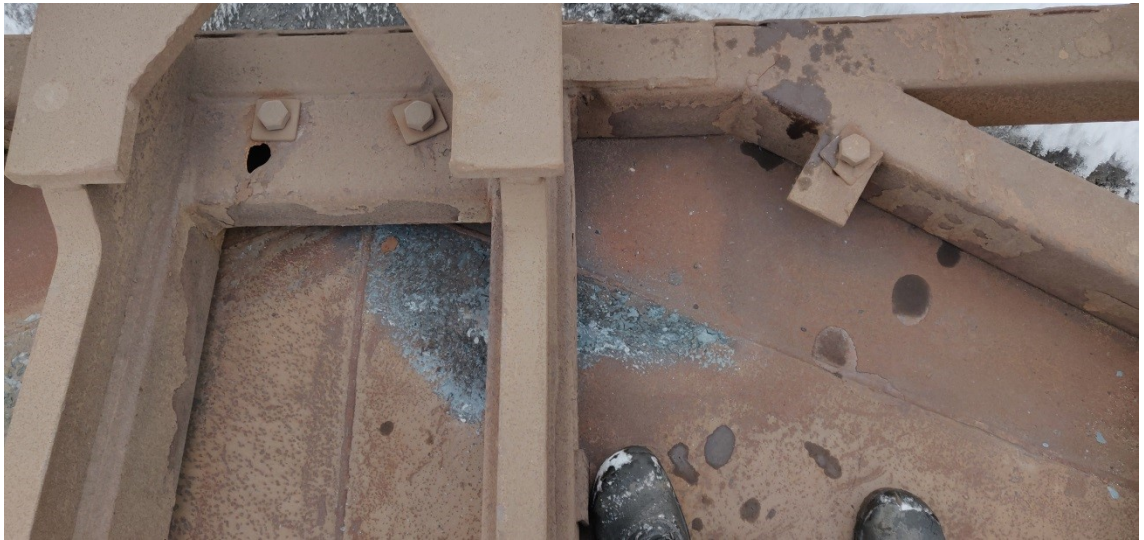
Figure 33. Large area has been exposed to the heat for a relatively short duration.

Defects presented in figures from 33 to 35 represent different degrees of plate exposure to heat. The main reason for these defects is insufficient lining and lids delayed discarding time. As seen in Figure 33 the heat causes the plate to rapidly oxidize leaving charred flakes on the surface of the plate. Continuing exposure to the hot atmosphere weakens the steel significantly, making the surface wavy as seen in Figure 34. Eventually the steel loses all of its strength, rupturing the surface (Figure 35).

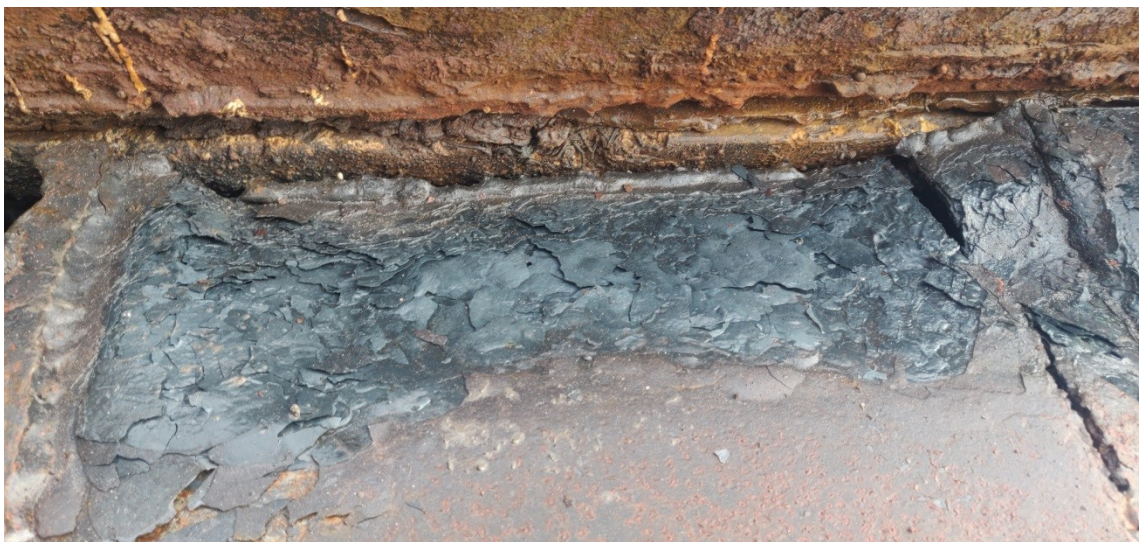
Figure 34. Repeating exposure to the heat makes metal structure to lose its shape and strength.

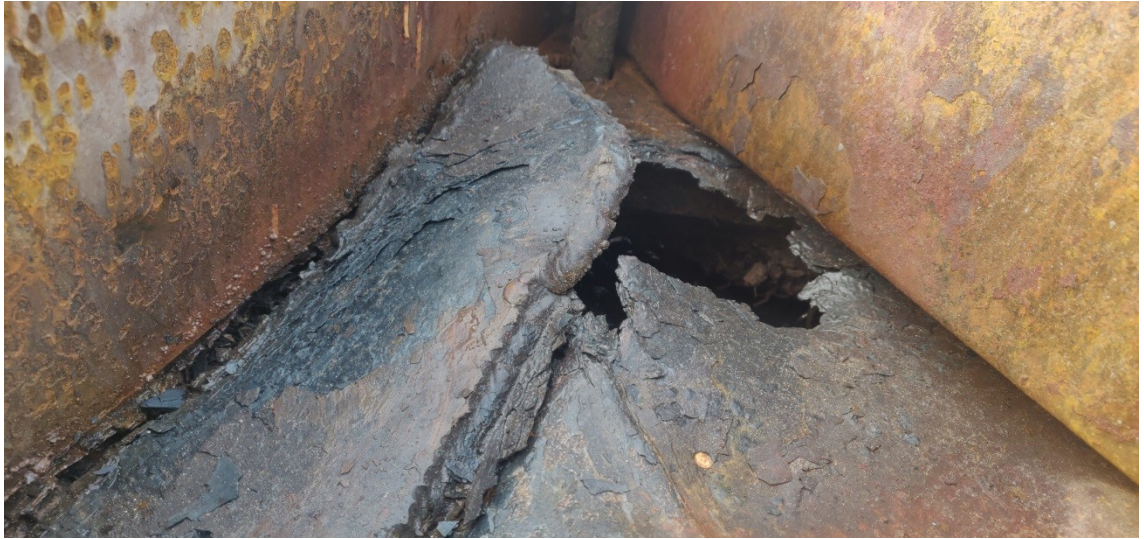
Figure 35. Continuous exposure to heat causes plate to lose its shape and rupture.

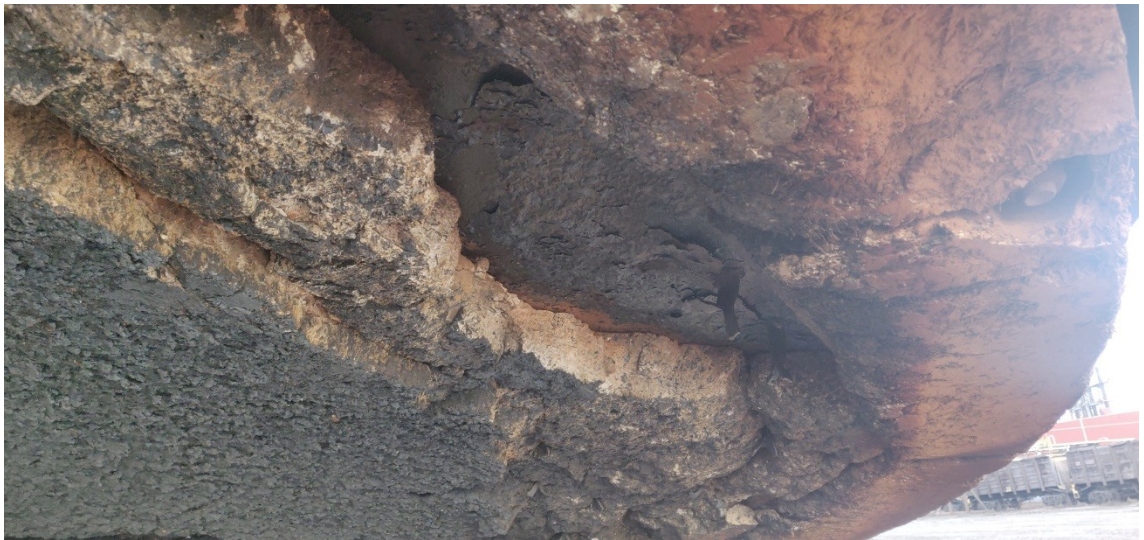
Figure 36. Heat has corroded most of the anchors and severely damaged the plate.

These defects are repaired by removing the damaged area and welding pieces of metal to cover the hole. A small amount of scaling does not necessarily require restoration if the inner surface is still intact. However even a small amount of scales prevents new anchors from being welded and therefore requires repair. An example of the inner surface can be seen in Figure36.

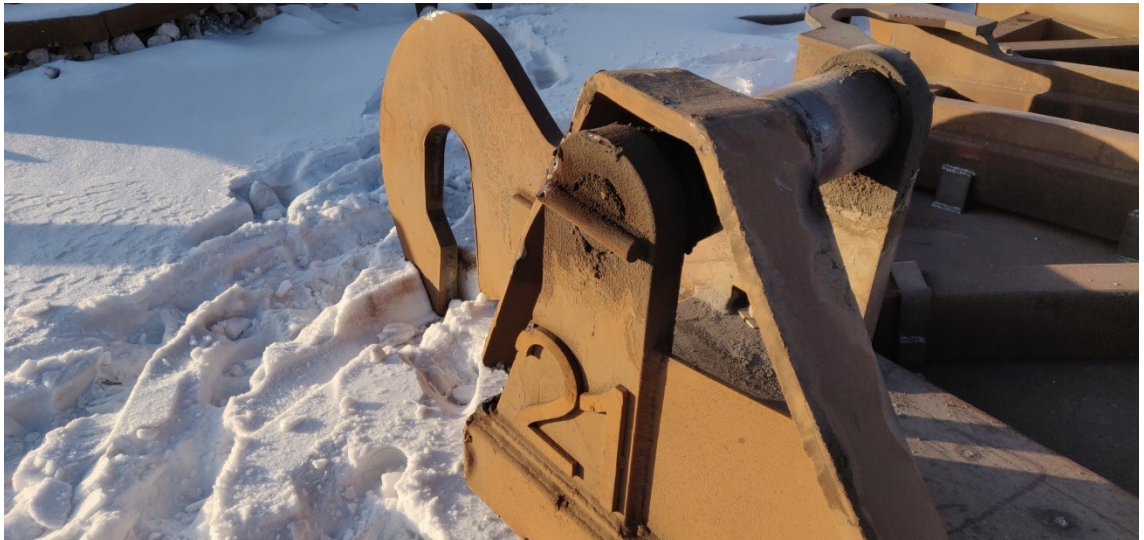
Figure 37. Protective guardrail of the bearing has bent as a result of impact.

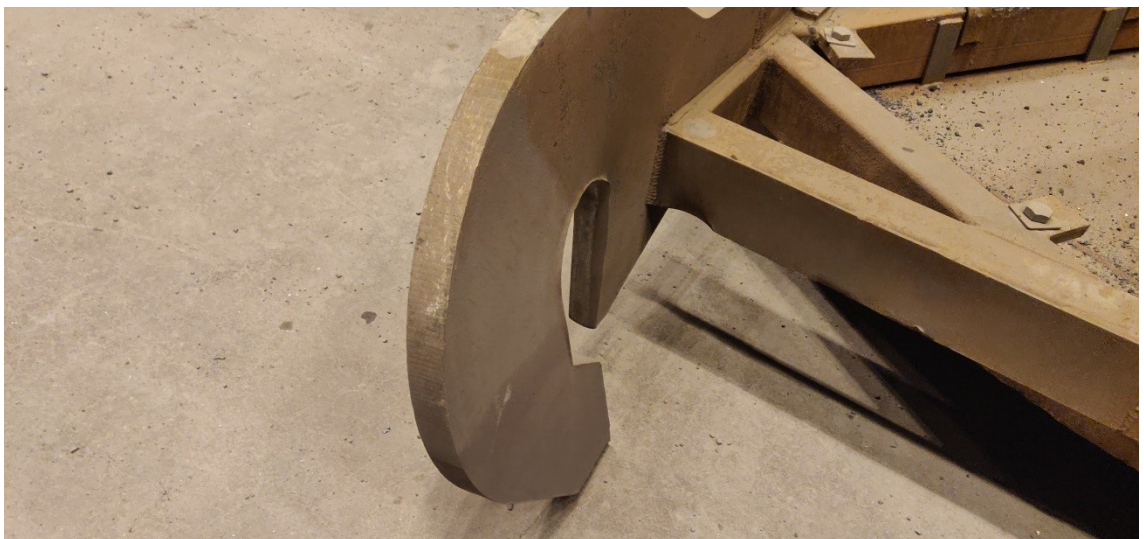
Figure 38. Hinges are usually bent if a lid falls off a rack.

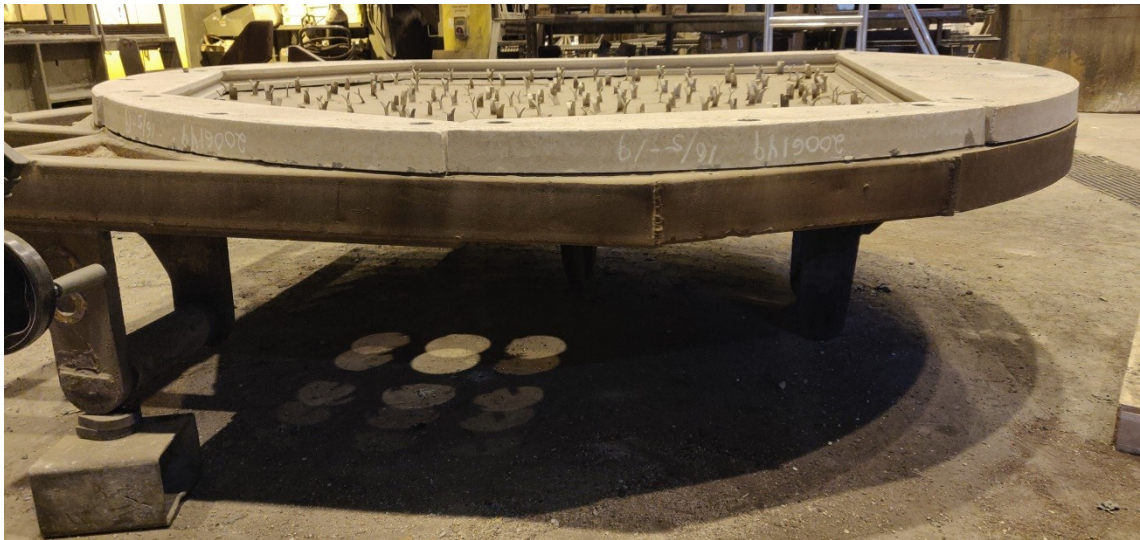
Figure 39. Lid has been crooked as a result of continuous maltreatment.

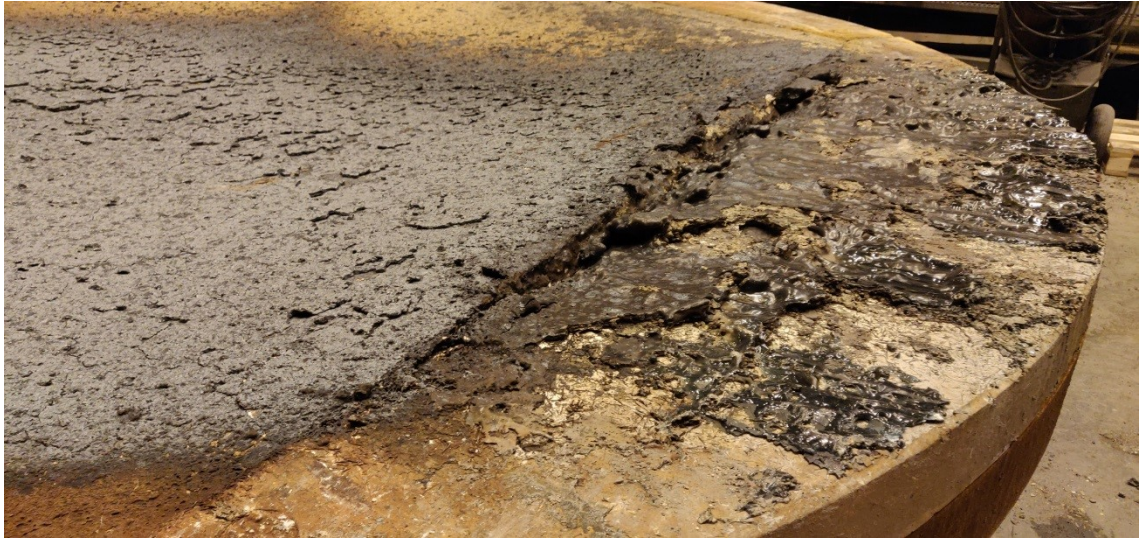
Figure 40. Condition of the peak brick after 200 heats.

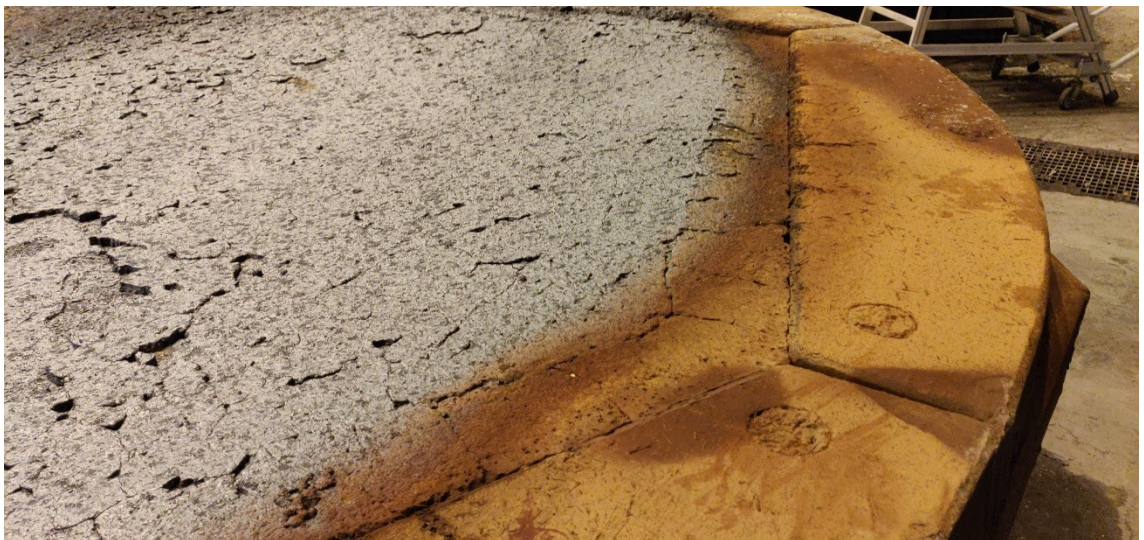
Figure 41. Minor cracks can be seen circling near the edge of the monolithic lining after 200 heats.

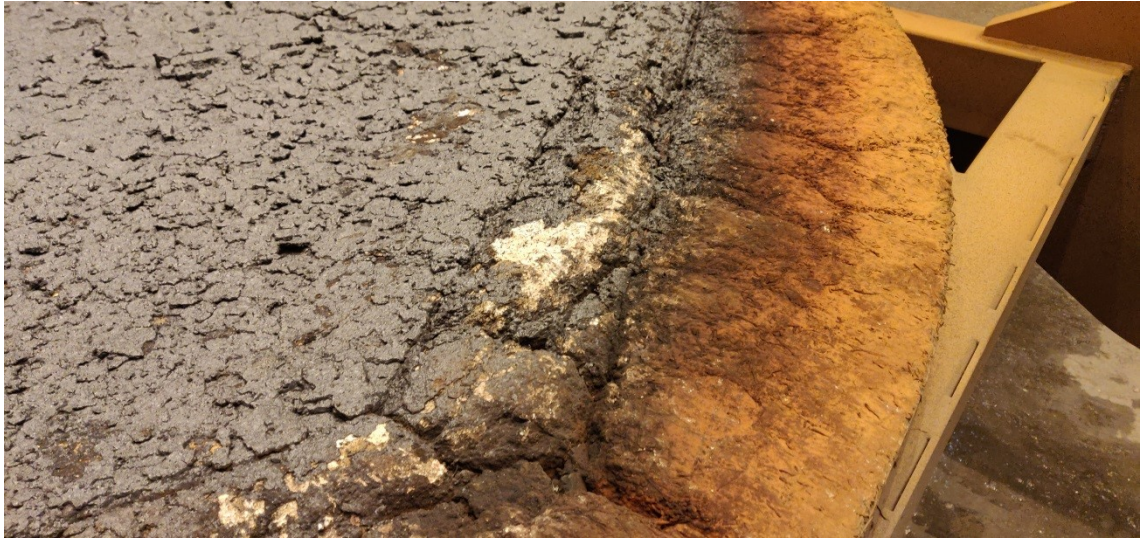
Figure 42. Fractures become deeper as time goes on.

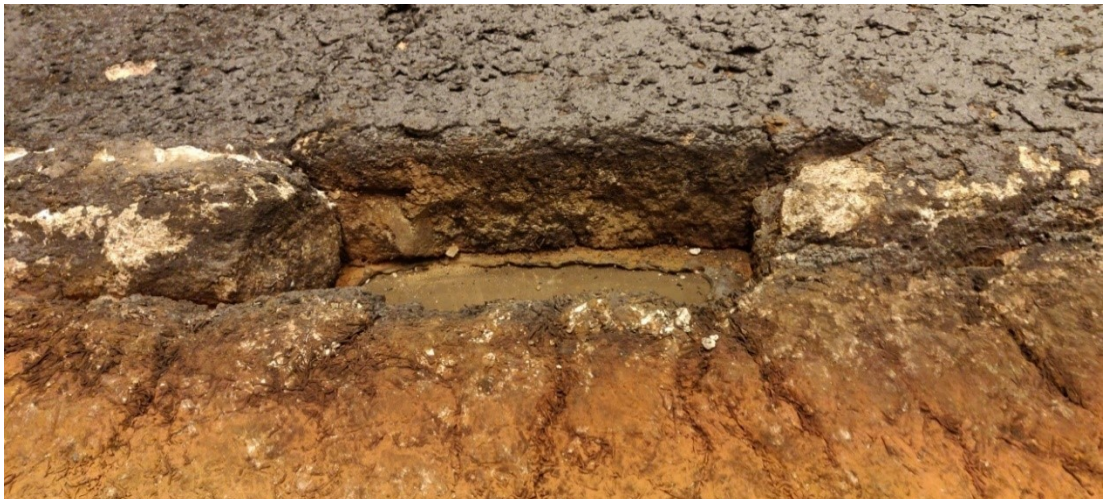
Figure 43. Large piece of refractory has fallen off exposing the metal cover.

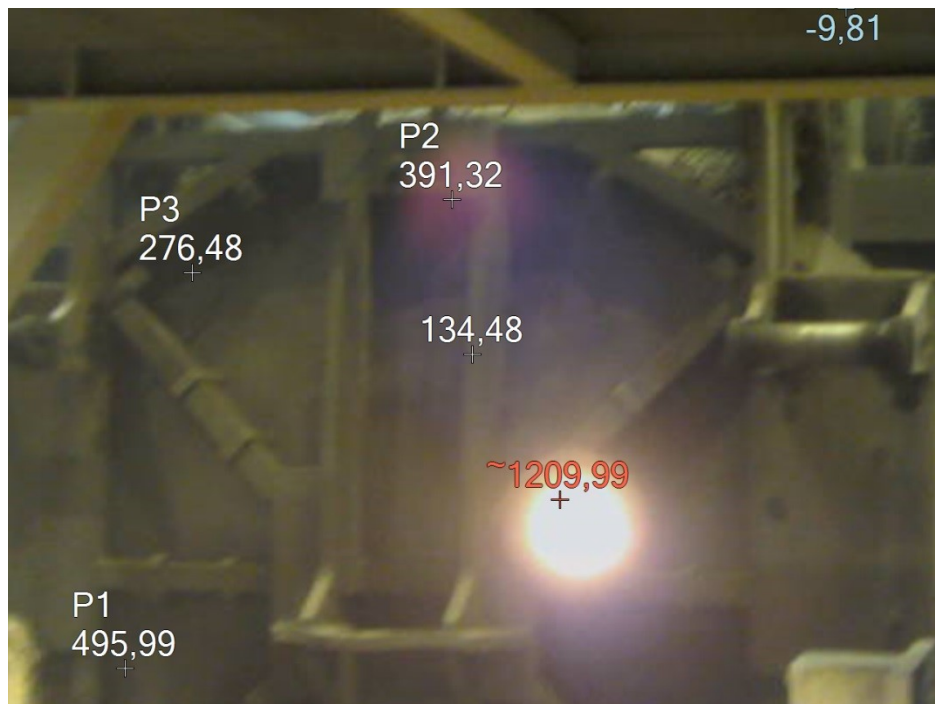
Figure 47. Visually, the backplate seems to be in decent condition.

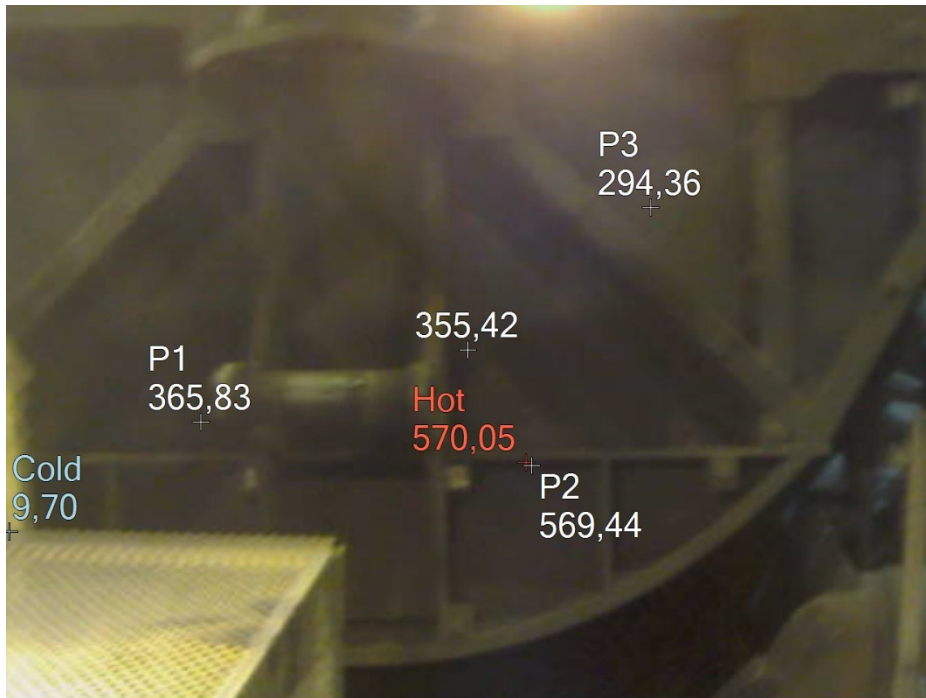
Figure 49. No visible defects observed on the backplate.

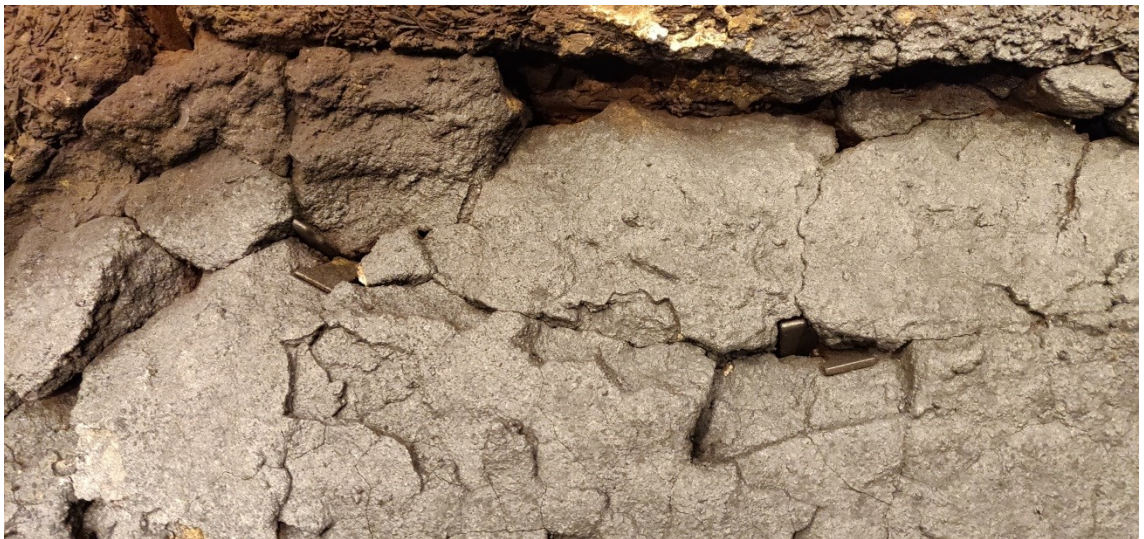
Figure 52. Metal anchoring seems to be in the focuses of the cracks.

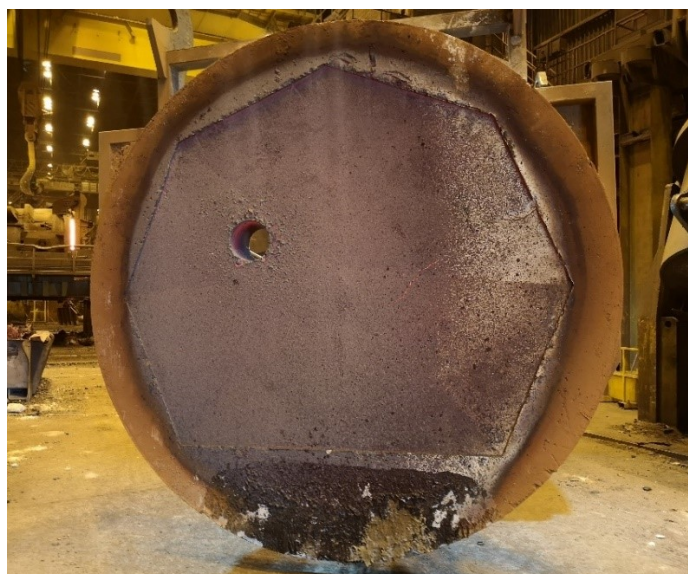
Figure 53. Experimental lining made with single cast.
