Cultural Resources Survey of the City of Hutto Transmission and Distribution Pumping Stations Phase I Project, City of Hutto, Williamson County, Texas

CULTURAL RESOURCES REPORT

Prepared for:
Texas Historical Commission
Texas Antiquities Permit #9196

Cultural Resources Report
June 2020

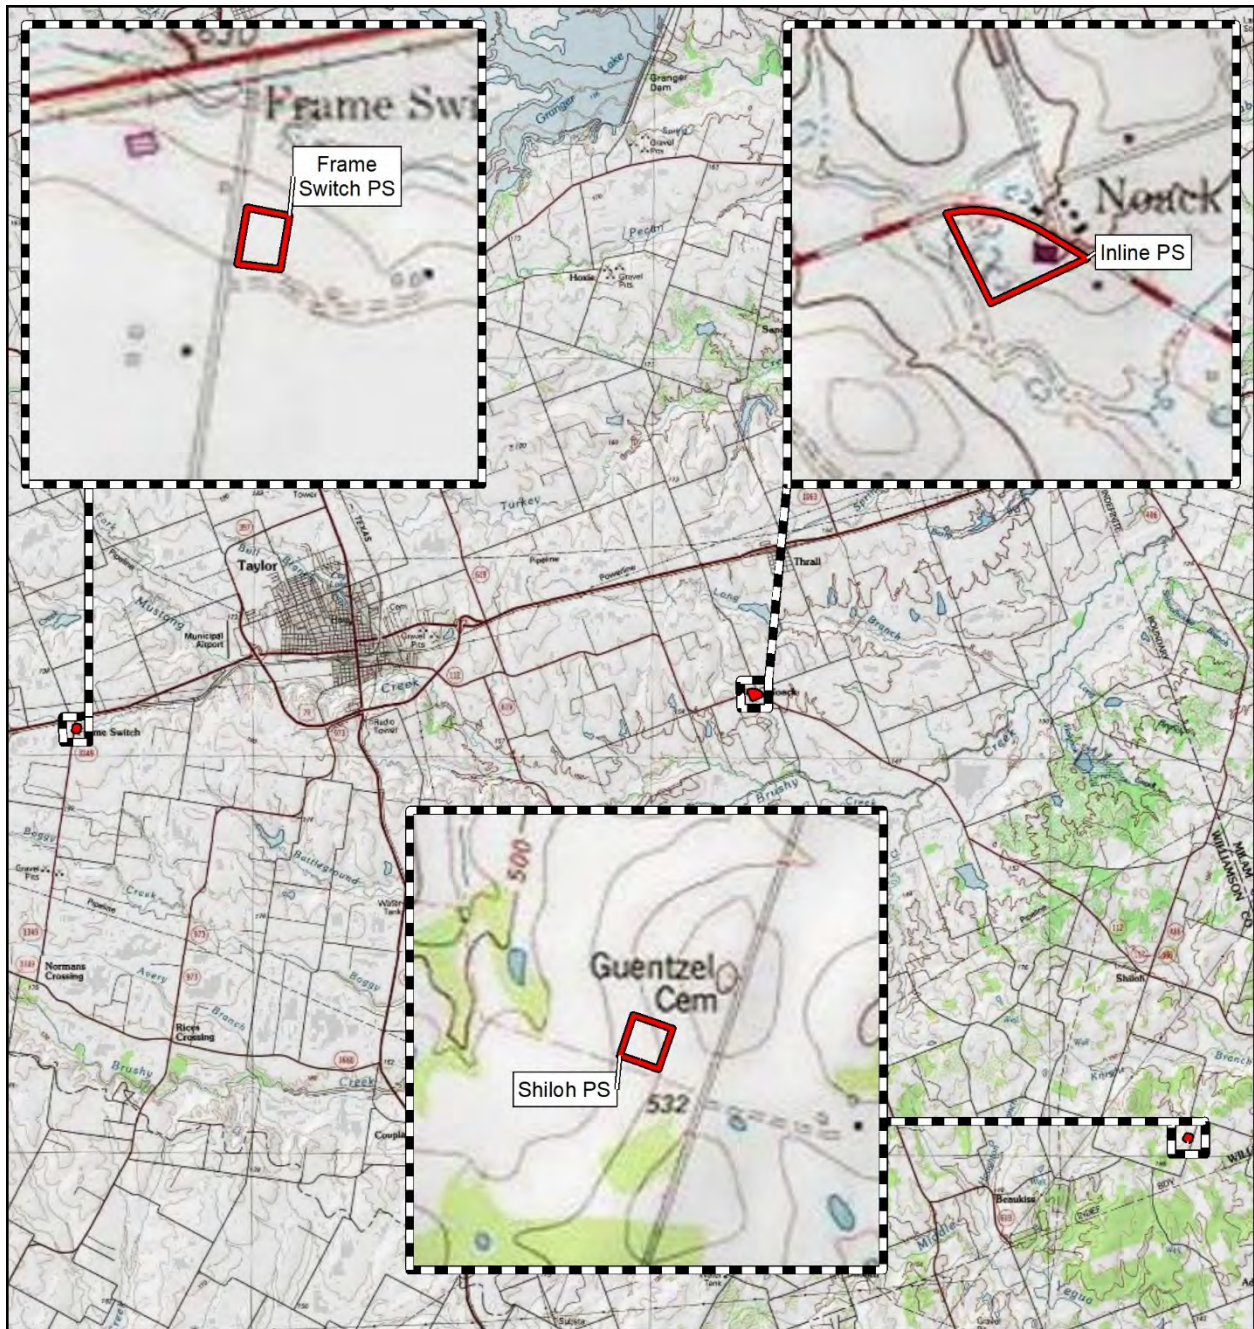
Figure 2.1
Topographic Setting

County: Williamson
 State: Texas
 Date map created: 4/28/2020
 Source: USGS Topographic Map
 7.5' Quadrangles: Beaukiss (1982)
 Taylor (1966), Thrall (1966)
 IES Project Ref. 04.274.008

The Taylor, Thrall, and Beakiss 7.5-minute USGS topographic maps illustrates that the project area is located within the Blackland Prairie ecoregion (**Figure 2.1**). The Frame Switch PS and Inline PS are located on an upland terrace that is a part of the Brushy Creek watershed structure. Brushy Creek, which runs west-to-east and drains into the larger Brazos River watershed, parallels Frame Switch PS and Inline PS to the south of the APE by 5 mi and 1.5 mi, respectively. The Shiloh PS is located on an upland ridge that gently slopes to the south and west with watershed draining into Sand Branch approximately 0.5 mi to the southeast. Sand Branch is a tributary of Brushy Creek that is approximately 3.5 mi south of the Shiloh PS.

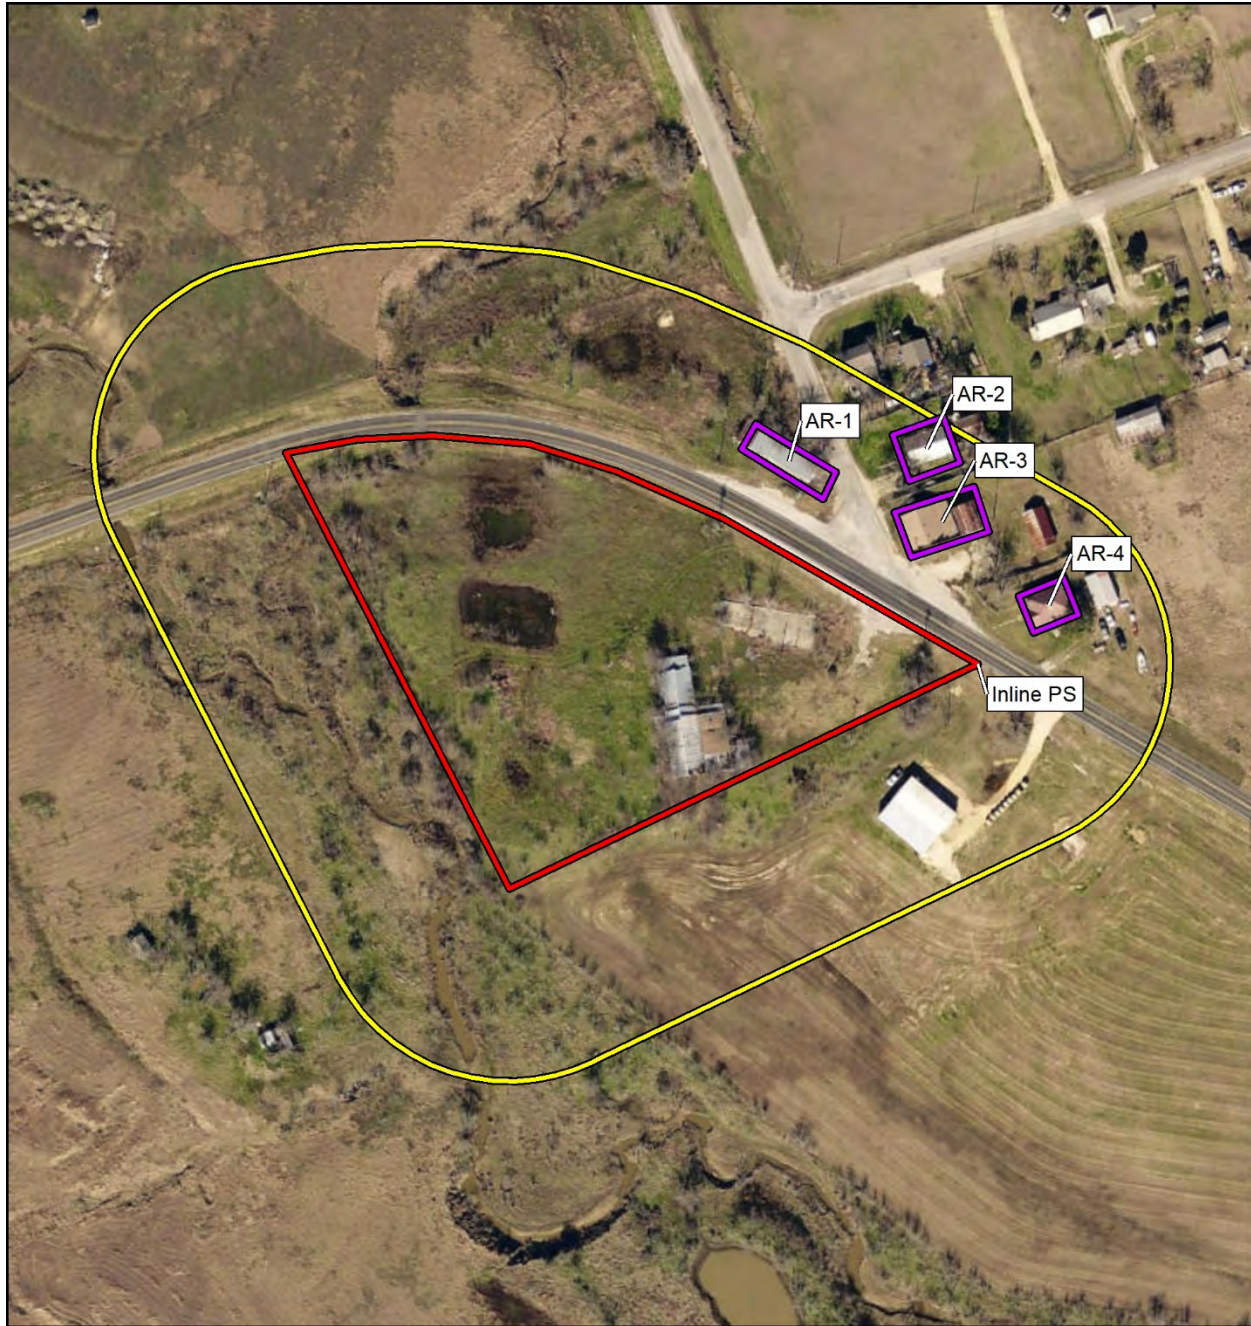
Figure 5.3
Architectural Resource Map

County: Williamson
 State: Texas
 Date map created: 4/28/2020
 Source: (c) 2009 Microsoft Corporation
 and its data suppliers; ESRI 10.6
 IES Project Ref. 04.274.008

To satisfy Section 106 requirements for the Inline PS, indirect visual impacts must be assessed. The indirect APE was designed to include the maximum distance adverse visual impacts of a new PS facility could occur to historic-age buildings and structures in the vicinity of the Inline PS APE. The indirect APE incorporated a 200-ft-wide buffer surrounding the direct APE. Through the reconnaissance survey, a total of four ARs within the indirect APE were identified and documented (**Figure 5.3**). The ARs assessed included residential homes and commercial business buildings. All resources were constructed in the early or mid-20th century. Representative photographs of each resource are provided within **Appendix B**.

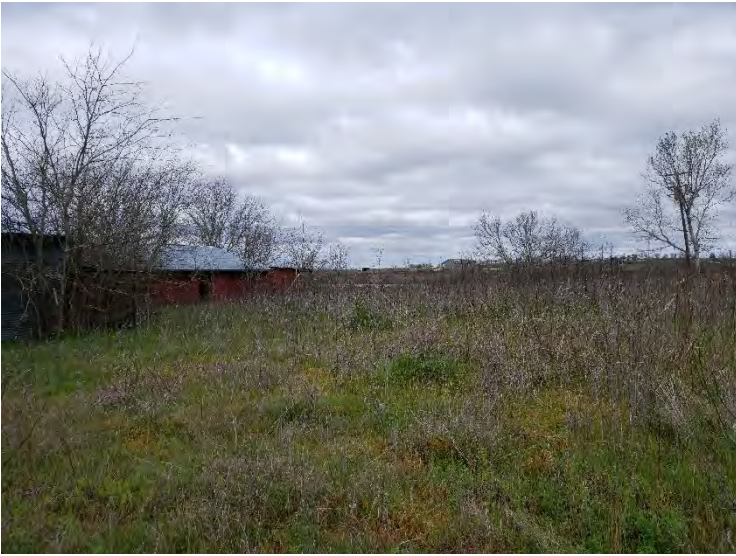
Photograph 1 – In-line PS APE, barn and grass field, view to the northwest.

The Inline PS project area was situated southwest of the intersection of FM 112 and CR 432 in the small rural community of Noack. The APE featured an upland setting in the eastern half of the property that sloped westward towards an unnamed tributary of Brushy Creek (**Appendix A, Photographs 1 through 7**). IES investigators observed short and tall grass species mixed with forbs and secondary tree growth near structures and water resources. According to historical aerial photographs, three water retention ponds had been excavated in the western half of the APE. Currently, the northern two pond locations contain small wetlands (**Appendix A, Photographs 8 and 9**).

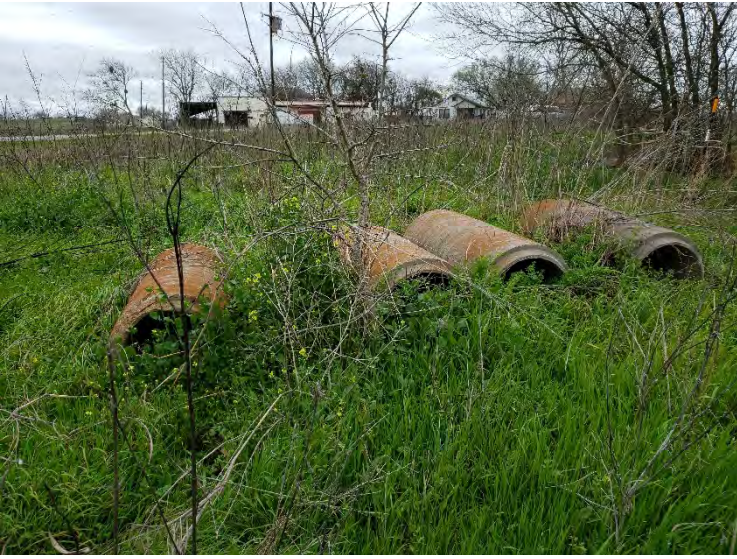
Photograph 7 – In-line PS APE, construction materials, view to the north.

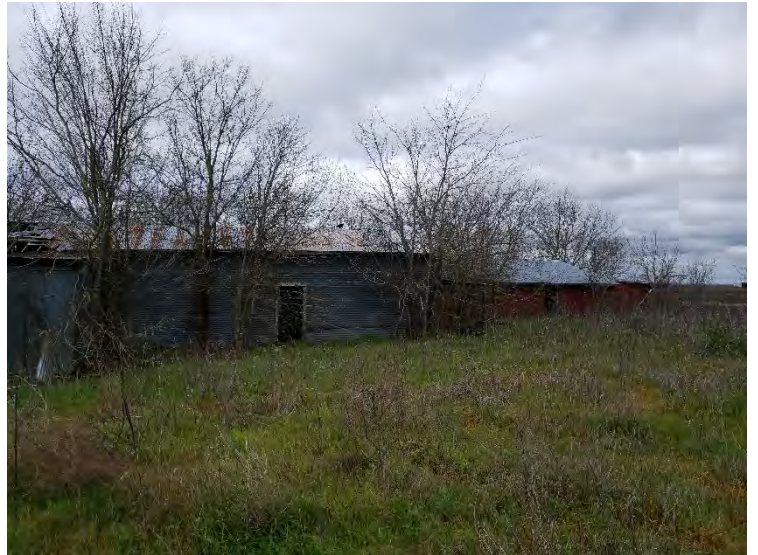
Photograph 10 – In-line PS APE, modern barn, view to the west.

A barn, previously determined to be of modern age, was located in the eastern half of the Inline PS APE (**Appendix A, Photographs 10 through 12**). The barn had been converted into a bar venue but appeared to have been closed for some time and was in very poor condition at the time of survey. In the western half of the APE, archeologists encountered an excavated depression containing concrete debris and a pile of metal building materials (**Appendix A, Photographs 13 through 18**). Through field observations and additional background research, it was determined the scatter of concrete debris and pile of scrap metal were most likely related to the demolition of a nearby modern-age building and potentially a historic-age building that once stood in the eastern half of the APE. The debris scattering was considered to represent an archeological site (41WM1419), which is discussed in **Section 5.2** of this chapter.

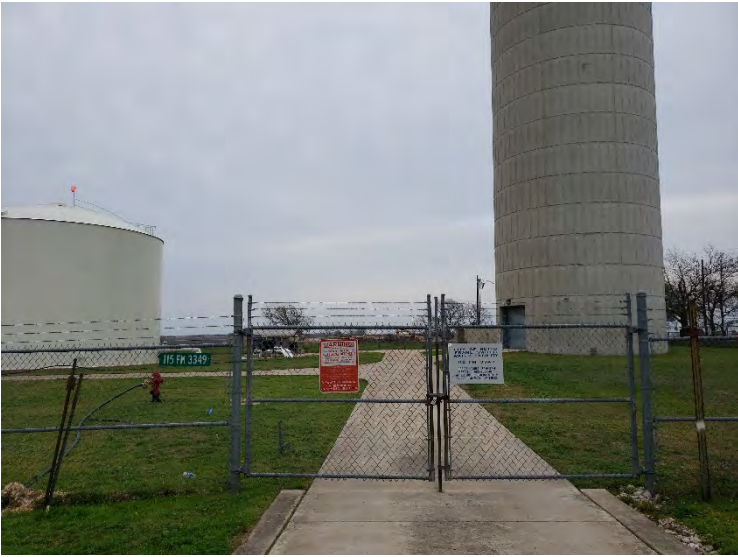
Photograph 19 – Frame Switch PS APE, view to the east.

The Frame Switch PS is located east of the existing PS facility on FM 3349. The topography within the property gently sloped northwards toward an unnamed tributary of Mustang Creek. The APE is entirely comprised of the existing PS, water tower, water tank, and associated infrastructure. Due to the extensive previous ground disturbances within this APE segment, related to previous water system improvement infrastructure, it was determined that there was negligible potential for archeological deposits (**Appendix A, Photographs 19 through 20**).

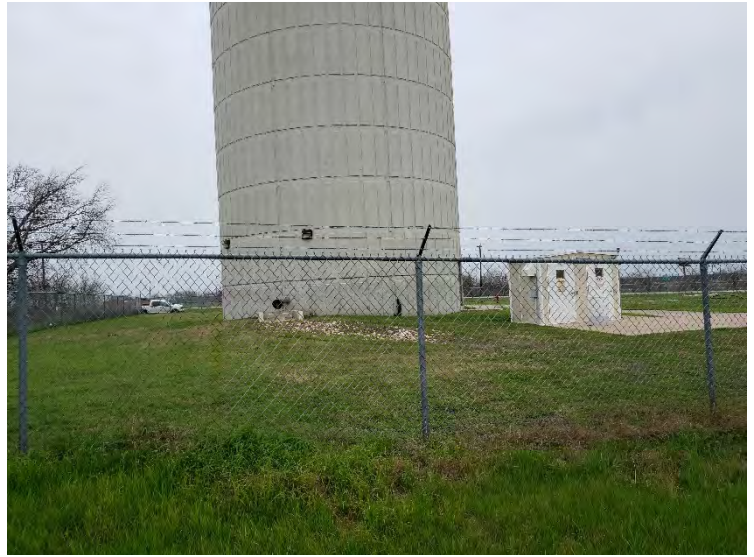
Photograph 20 – Frame Switch PS APE, view to the west.

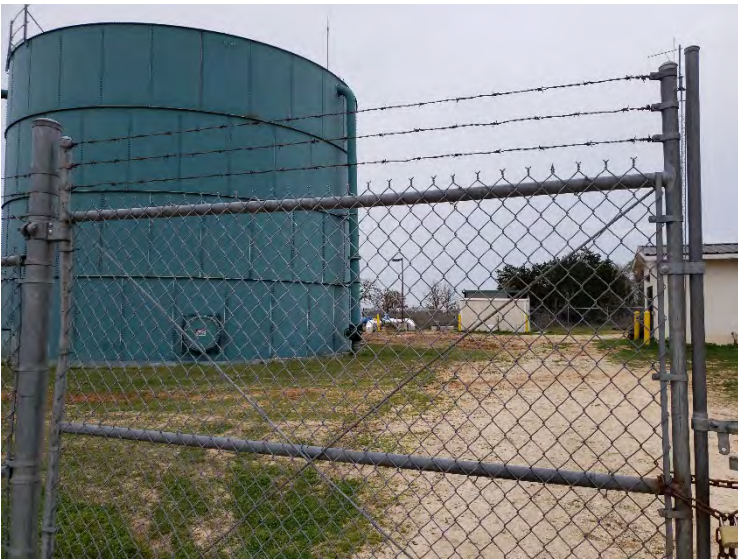
Photograph 21 – Shiloh PS APE, view to the north.

The Shiloh PS is located west of FM 481 in the southeastern quadrant of Williamson County. The Shiloh PS project area featured a flat terrain and the existing facility, which included water pumps, a water tower, water tank, and associated infrastructure. In addition, recent construction activities have transpired within the western half of the APE as evidenced by 100 percent ground visibility related to recent grading and infrastructure improvements (**Appendix A, Photographs 21 through 25**). This disturbance combined with the low to negligible potential negated the need for shovel testing at this location.

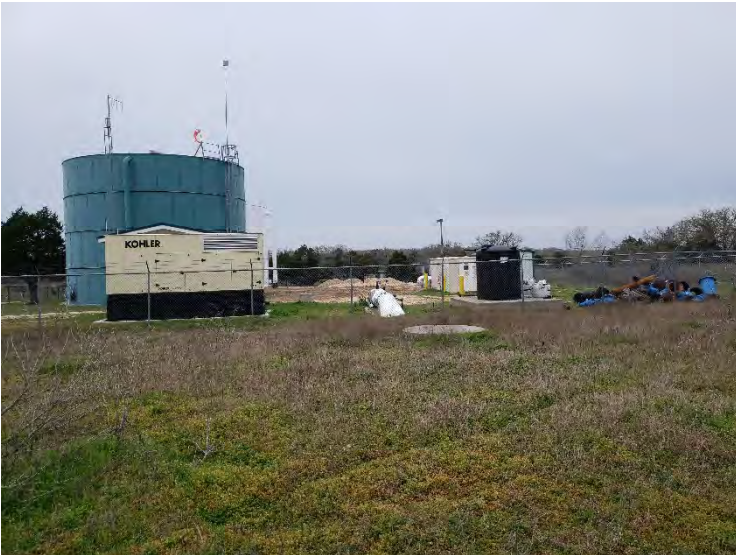
Photograph 25 – Shiloh PS facility, view to the northwest.

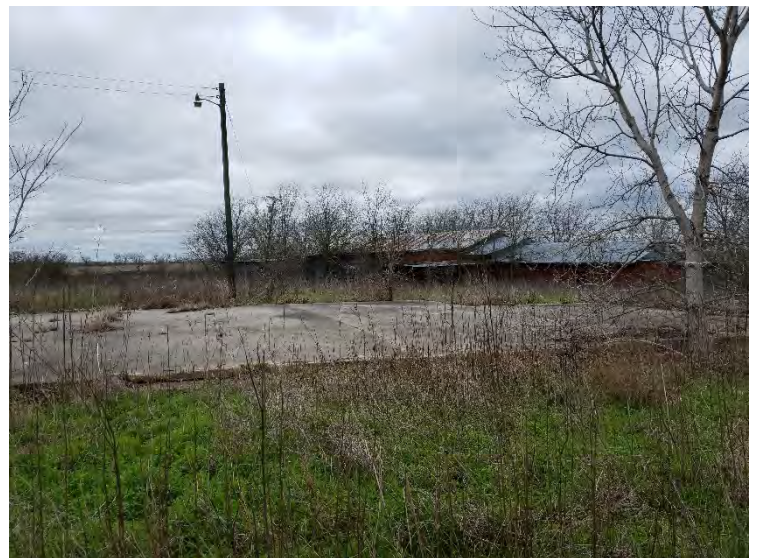
Photograph 30 – 41WM1419, Feature 1 historic-age building foundation, view to the southwest.

During the IES survey, newly recorded historic-age site 41WM1419 was encountered on a terrace within the Inline PS portion of the APE (**Appendix A, Photograph 30**). The site is located southwest of the intersection of FM 112 and CR 432 (**Figure 5.2**). The site was documented within an area extending approximately 112 ft (34 m) north-to-south by 278 ft (85 m) east-to-west, encompassing approximately 0.49 ac (0.2 ha). The site was delineated based on the distribution of archeological features, positive and negative shovel tests, and observed disturbances. Based on field observations and delineation shovel tests, it was determined that the site does not extend outside of the APE.

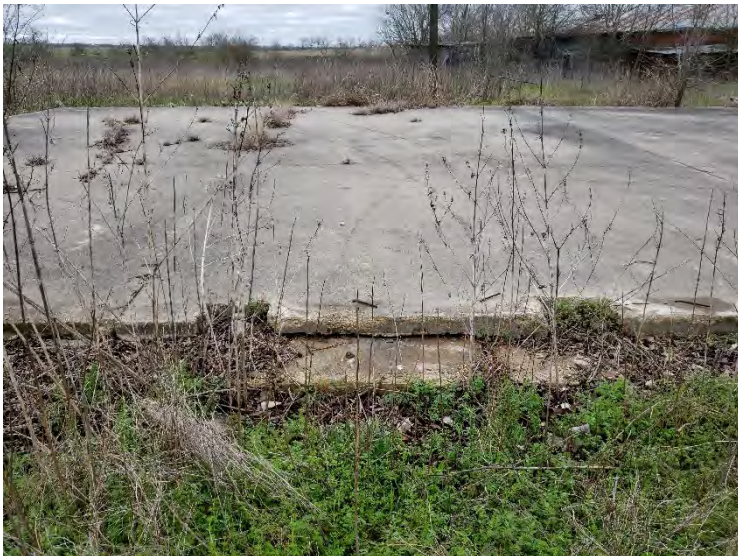
Photograph 35 – 41WM1419, Feature 1, view to the southwest.

Feature 1 was a concrete foundation measuring approximately 100 by 36 ft (30 by 11 m; **Appendix A, Photographs 35 through 38**). This feature was located approximately 60 ft (18 m) south of FM 112 within the APE. The foundation consisted of a concrete slab with anchor bolts extruding from the surface, cinder blocks, and a set of stairs. Historical maps and aerial photographs indicate the feature was part of a building that was constructed prior to 1934 and demolished in 2005 or 2006.

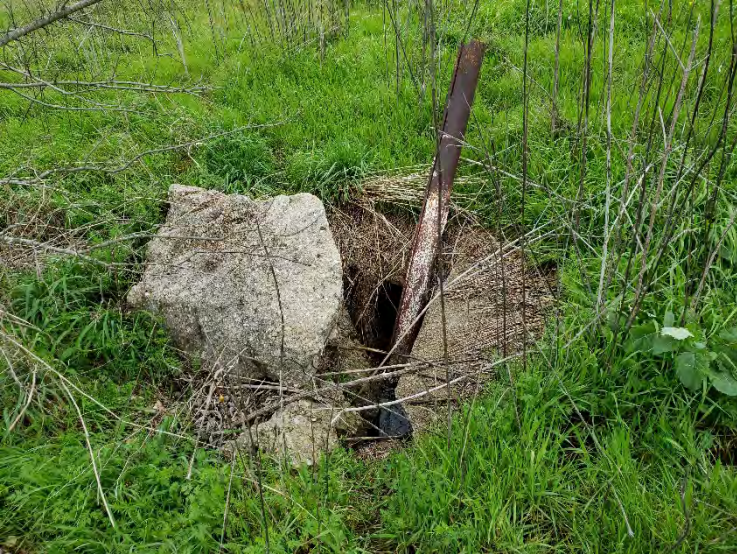
Photograph 41 – 41WM1419, Feature 3, view to the west.

Feature 3 was a squarish, concrete cistern or well measuring approximately 3 by 3 ft (1 by 1 m) near a modern barn (**Appendix A, Photographs 41 and 42**). The feature was located approximately 120 ft (36 m) southwest of Feature 1. The feature appears to have been partially destroyed as evident by large concrete fragments covering the opening. A metal pipe was observed within the feature.
