Intensive Cultural Resources Survey of the Brushy Creek Sewer Line Phase 3 Project in the City of Ingram, Kerr County, Texas

FINAL: INTENSIVE CULTURAL
RESOURCES SURVEY OF THE
BRUSHY CREEK SEWER LINE
PHASE 3 PROJECT IN THE CITY
OF INGRAM, KERR COUNTY,
TEXAS

TEXAS ANTIQUITIES PERMIT NO. 9243

SWCA Project No. 58725

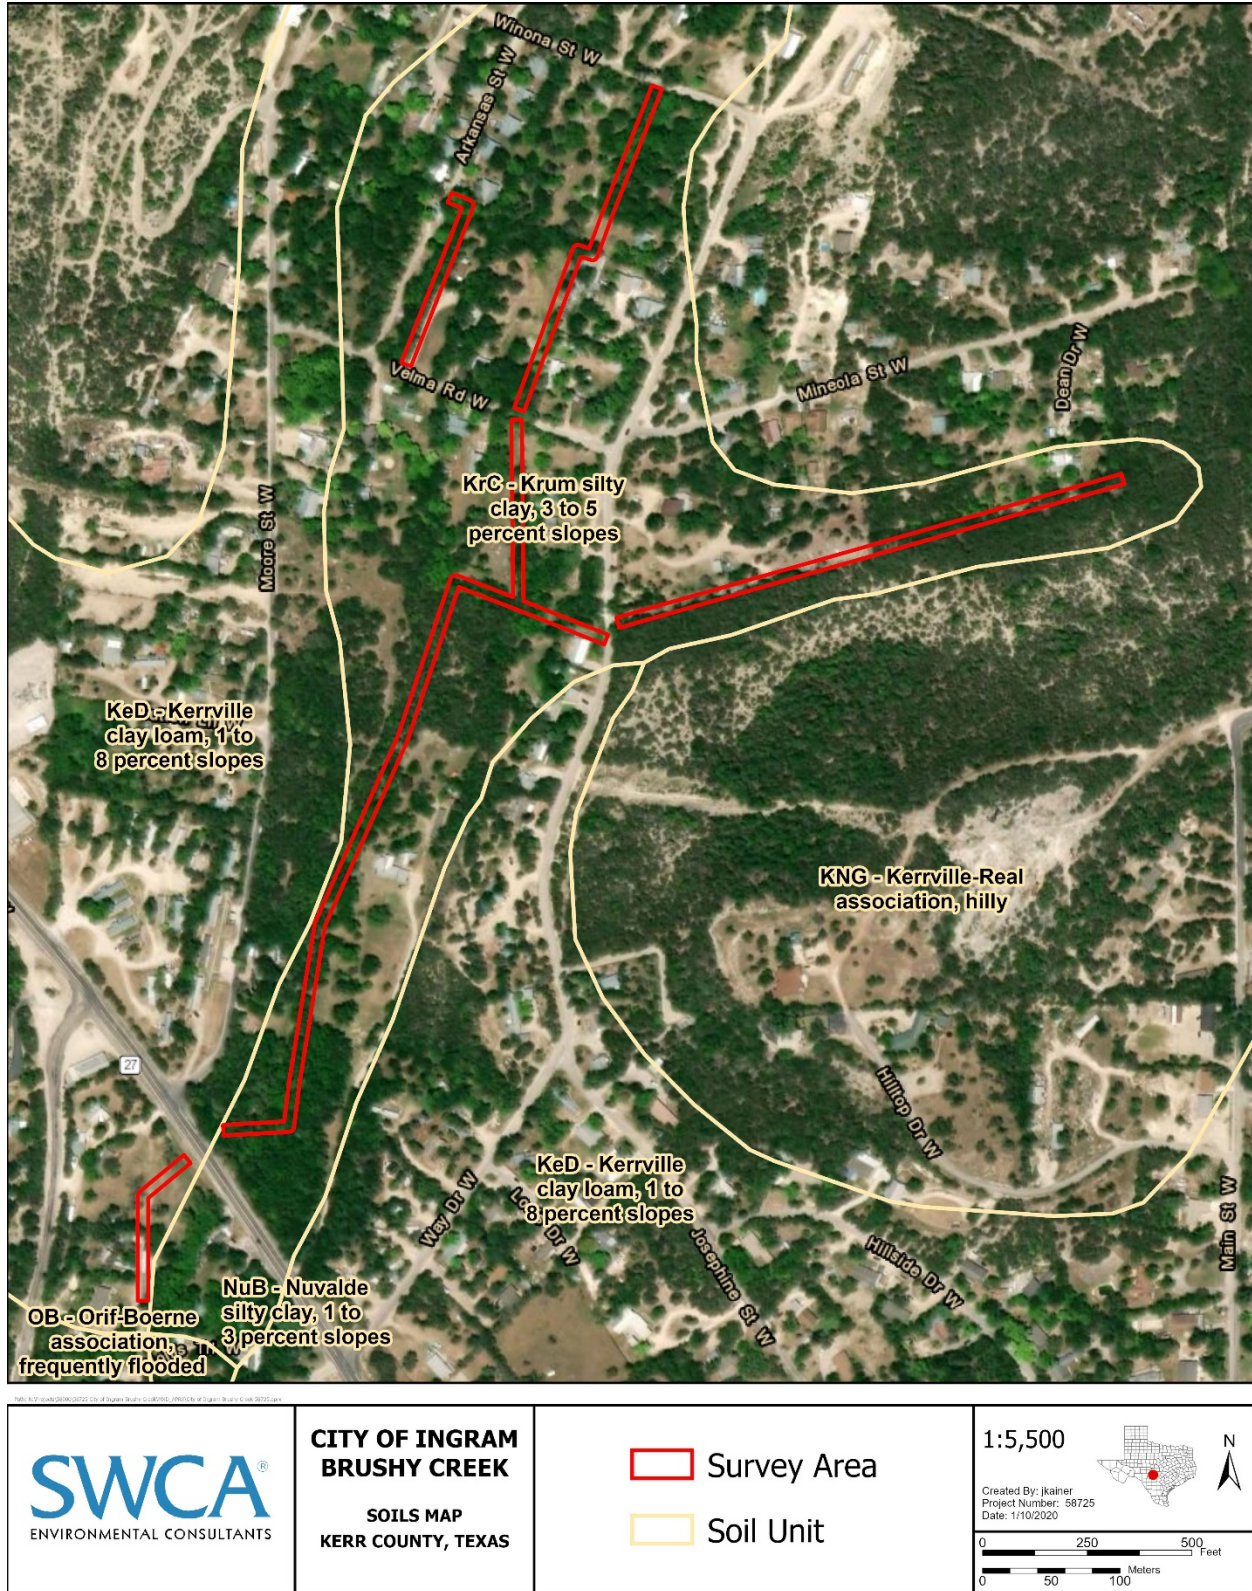
Figure 3. Project area soils map.

Soils mapped within the Project area include primarily the Krum silty clay, 3 to 5 percent slopes (KrC) with the Kerrville clay loam, 1 to 8 percent slope (KeD) positioned near the southern terminus. The Krum soils consist of very deep calcareous clayey alluvium sediments derived from interbedded chalk and marl and are found on level to moderately sloping treads of stream terraces on river valleys and dissected plains. The Kerrville clay loam consists of the Kerrville soil series and the Doss soil series, which are moderately deep Cretaceous-age indurated limestone that is weakly cemented. They are derived from Cretaceous age residuum and are found on the hill slopes, shoulders and summits of dissected plains (Figure 3; NRCS 2020).
