INTENSIVE PEDESTRIAN SURVEY FOR THE BCRUA
OHL REBUILD,
TRAVIS COUNTY, TEXAS

Final Report
June 2018

aci consulting
1001 Mopac Circle
Austin, Texas 78746

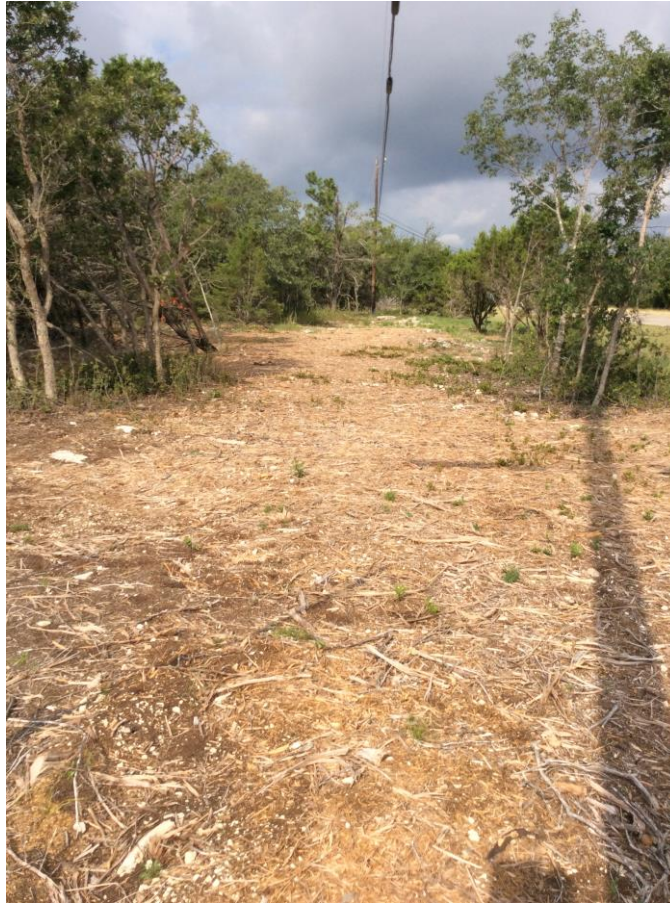
The alignment along North Rim Drive runs through a residential area and either the surface visibility was greater than 30 percent (Figure 7) or the area of the alignment was previously disturbed (Figure 8).

Figure 7. Surface visibility along North Rim Drive

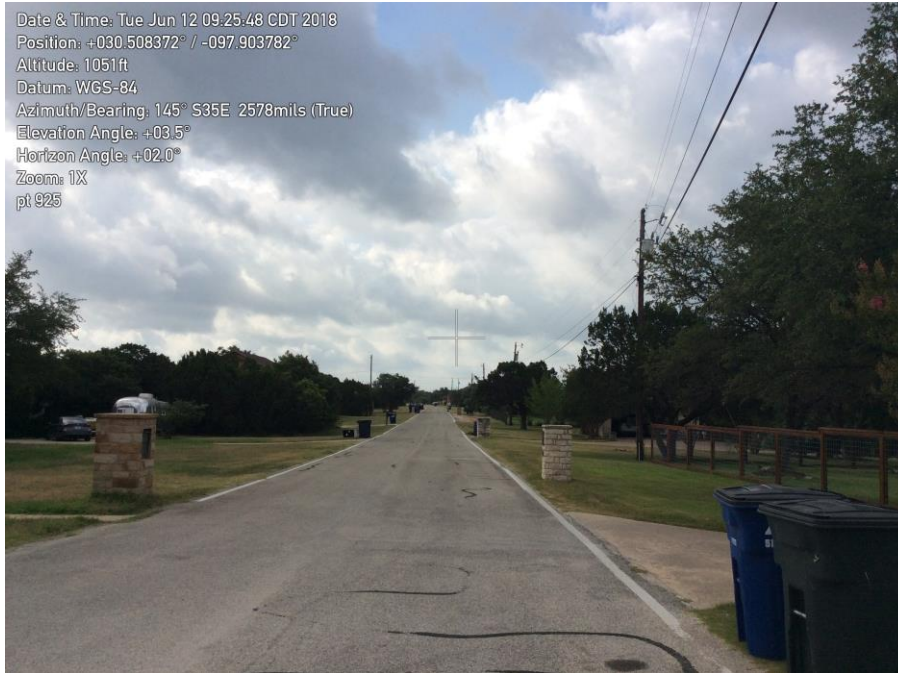
Figure 8. Road and residential disturbances along North Rim Drive

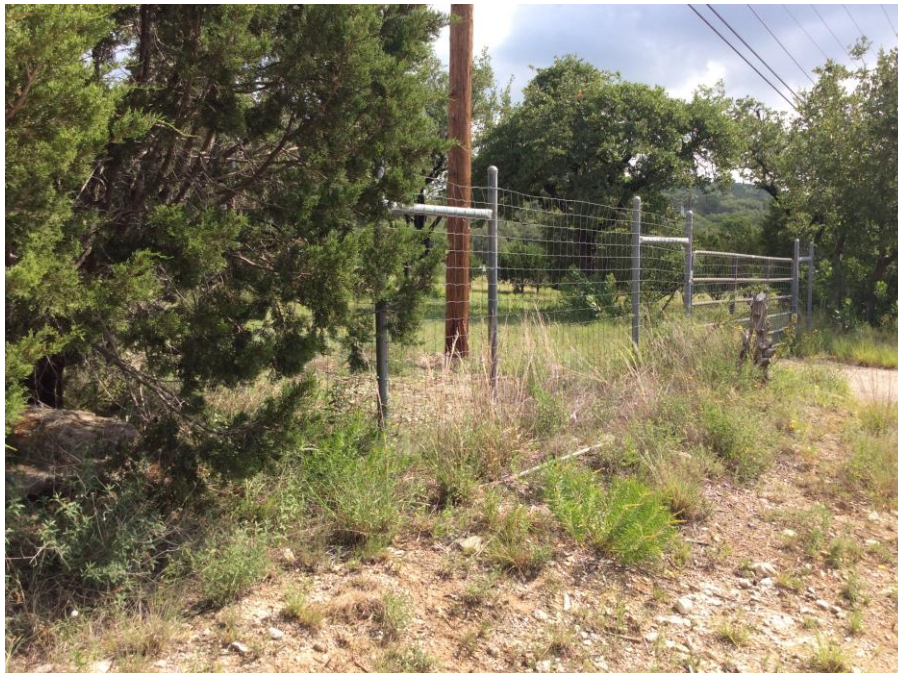
The majority of the remainder of the alignment follows Trails End Road. This is also the portion that was previously surveyed by aci consulting in 2009. This portion of the alignment either had surface visibility greater than 30 percent (Figure 9) or was previously disturbed (Figure 10). Only two shovel tests were conducted along this portion, placed in high probability areas (see Figure 6).

Figure 9. Surface visibility along Trails End Road

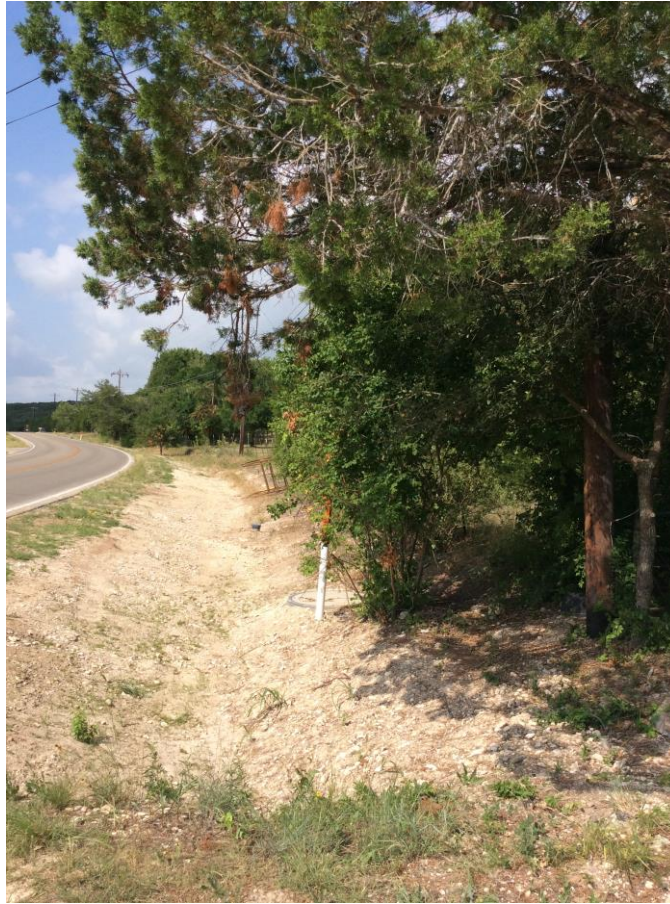
Figure 10. Disturbances along Trails End Road

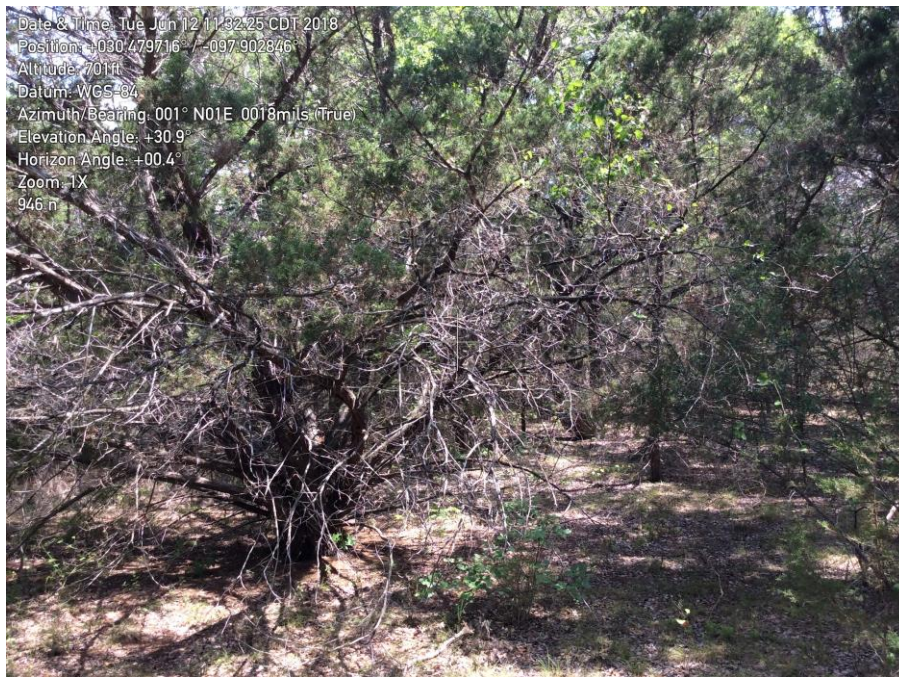
The southern portion of the alignment cuts southeast from Trails End Road through property towards Lime Creek Road. This portion of the alignment runs through undeveloped high probability areas and was where most of the shovel tests were excavated (Figure 11). The alignment also crossed a dry arm of Sandy Creek (Figure 12).

Figure 11. High probability area near Sandy Creek arm

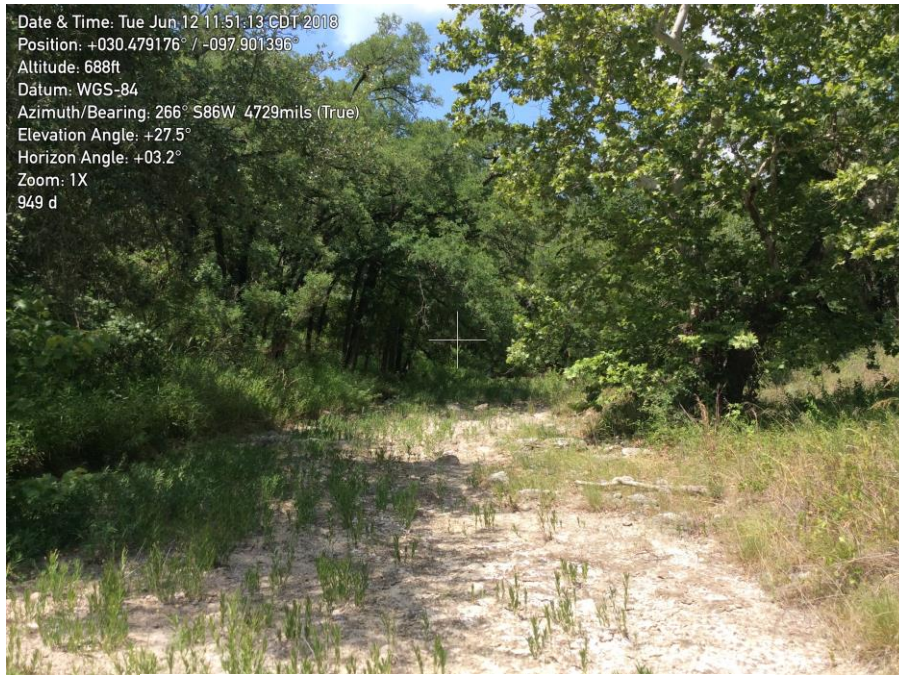
Figure 12. Dry crossing of Sandy Creek arm
