## Cultural Resources Survey Of Woman Hollering Creek Bridge, Bexar County, Texas

**CULTURAL RESOURCES SURVEY OF WOMAN HOLLERING CREEK BRIDGE,  
BEXAR COUNTY, TEXAS**

SWCA Project Number 12661-224-AUS  
SWCA Cultural Resources Report No. 2007-195

March 7, 2016

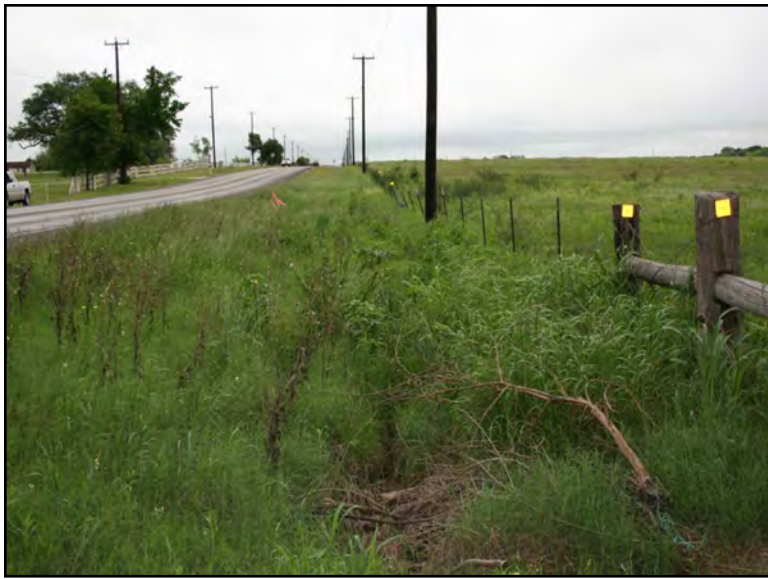
The project area is situated in a gently rolling upland topography and the Woman Hollering Creek drainage is a minor upland channel (Figure 3). The area surrounding the crossing consists of livestock pasturage along the west side of the roadway while residential development lines the east side of FM 1518. The vegetation in and around the project area is composed of

**Figure 3.** Rolling topography along south approach of project area; facing south.

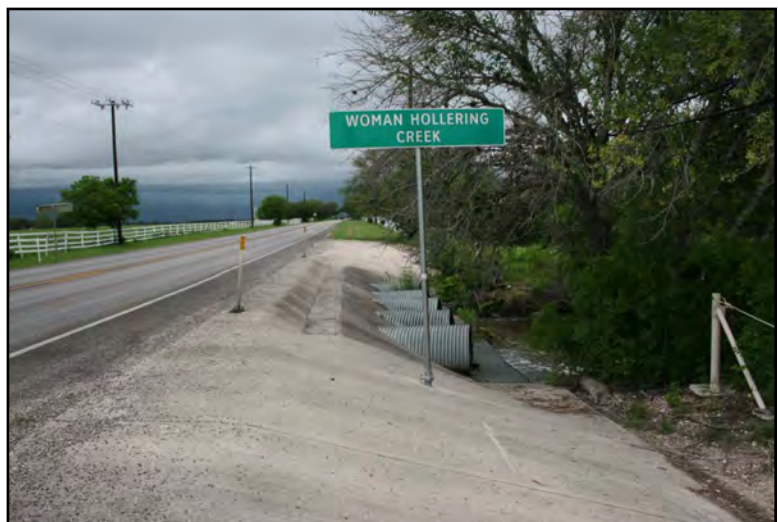
The existing structure is a bridge class culvert with five 4-foot diameter corrugated metal pipes (CMP) with a 32-foot wide deck consisting of two 12-foot lanes with two 4-foot shoulders and no railing (Figure 4). In this area, the FM 1518 roadway runs northwest to southeast and consists of two 12-foot wide lanes with no shoulders for a total pavement width of 24 feet. The Woman Hollering Creek drainage, at this crossing, trends west to east and is roughly 30-foot wide and exhibits roughly 3-foot high cutbanks. At the time of evaluation, the drainage contained over two feet deep water and had a low-energy flow.

**Figure 4.** Overview of existing structure at Woman Hollering Creek; facing north.

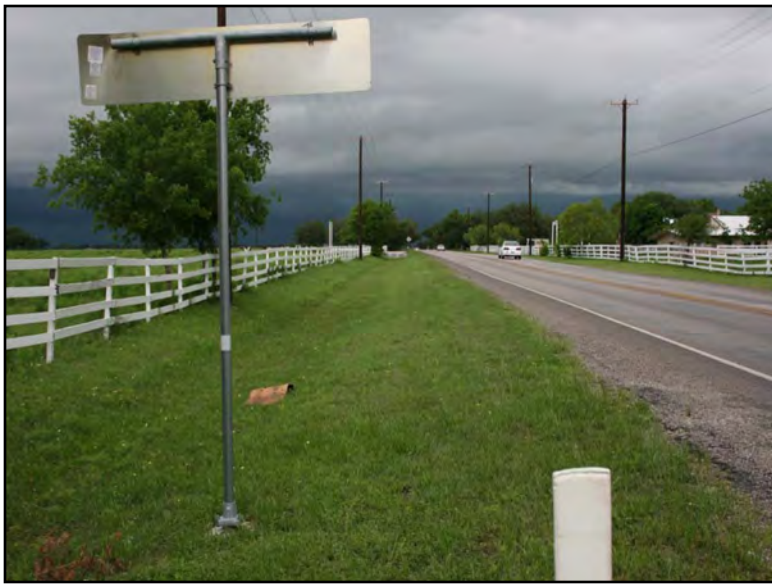
The project area has been significantly impacted by road construction, utilities, and fence lines. Specifically, both approaches along FM 1518 sits upon a fill section that is about 1–2 feet high and extends roughly 30 feet from the road centerline (Figure 5). The fill section for the north approach continues beyond the APE. However, the fill section of the south approach extends about 200 feet from the end of the bridge (EOB) where it tapers to grade as the roadway rises in elevation. Also, a concrete apron caps the fill section on the east side of FM 1518

Another project area construction impact was observed paralleling the western side of FM 1518 (see Figure 5). This side of the roadway has been contoured to form a ditch for water drainage. The base of the small (5 feet wide by 2 feet deep) channel is about 30 feet from the road centerline and parallels the edge of the road fill section.

**Figure 5.** Overview of FM 1518 fill section and ditch along roadway; facing north.

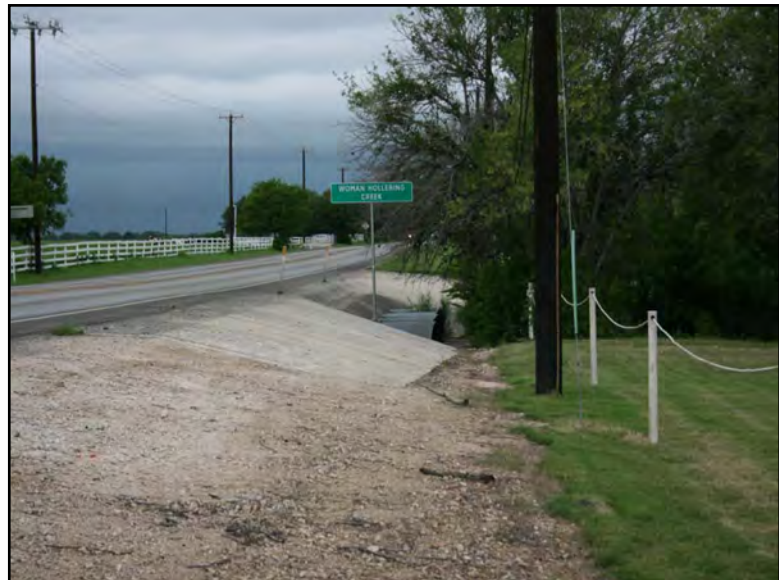
on both approaches of the crossing. The concrete apron extends about 60 feet from EOB and 32 feet from the road centerline. On the southern approach, a gravel apron continues beyond the concrete apron to 100 feet EOB (Figure 6).

**Figure 6.** Overview of concrete and gravel apron along east side of roadway; facing north.

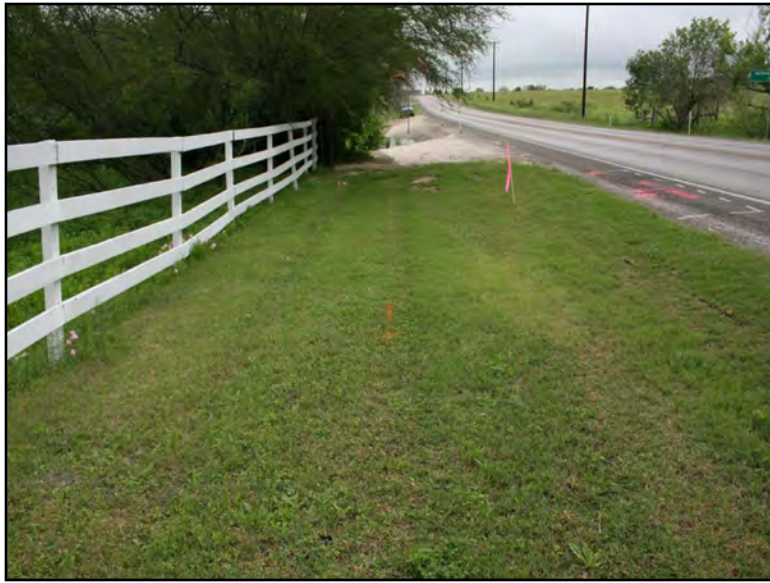
Furthermore, the project area has been disturbed by a buried SBC utility cable that parallels the eastern side of FM 1518 along both approaches about 35 feet from centerline (Figure 7). Similarly, an overhead power line parallels both sides of FM 1518 along both approaches about 38 feet from centerline. Finally, various fence lines (e.g., wooden and barbed wire) align both sides of the road generally 40 feet from the road centerline that continue beyond the APE (Figure 7).

**Figure 7.** Note orange buried utility paint markings along fence line; facing south.

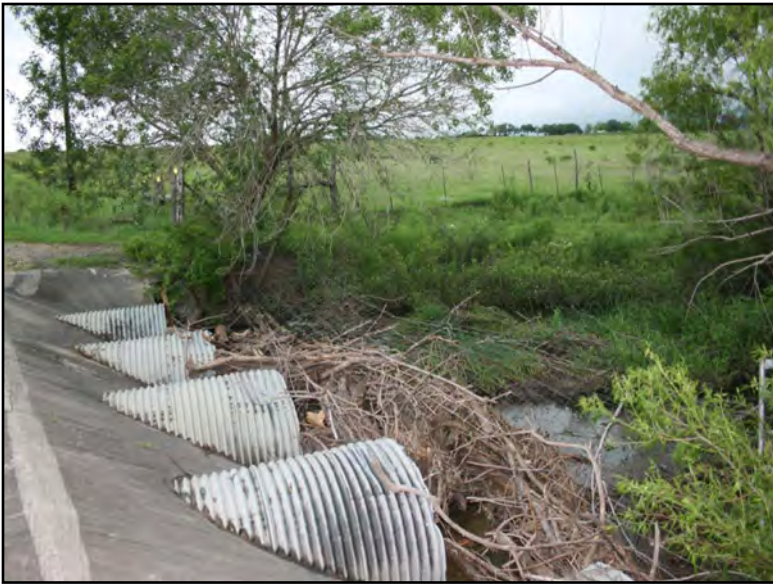
exhibit some disturbance, the upstream portion appears to be the most intact. The upstream side contains roughly 2-foot high cutbanks that gradually slope up and away from the drainage (Figure 8). The upstream portion appears to have been partially disturbed by livestock grazing and fence line construction. The downstream side of the crossing has about 3-foot high cutbanks with a profile that exhibits very rocky soil (Figure 9). Also, the downstream side overlaps a residential yard located east of FM 1518 and south of Woman Hollering Creek. Due to the depositional setting and observed disturbances, neither side of the crossing appears to have a real potential to contain sites.

**Figure 8.** Overview of cutbank on upstream side of crossing; facing southwest.

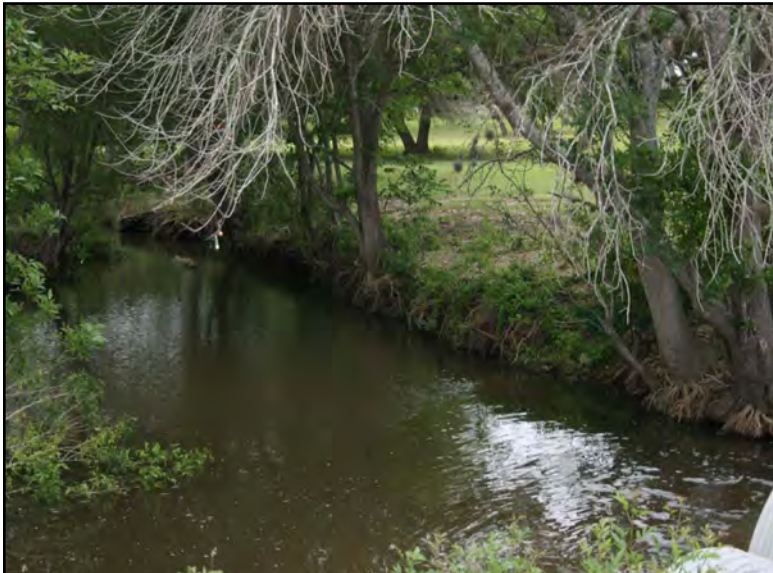
**Figure 9.** Overview of cutbank on downstream side of crossing; facing southeast.
