Archaeological Resources Survey

SYSTEMATIC INTENSIVE PEDESTRIAN SURVEY OF HELOTES HIKE-BIKE TRAIL HELOTES, BEXAR COUNTY, TEXAS

Terracon Project No. 90157499

CSJ 0915-12-537

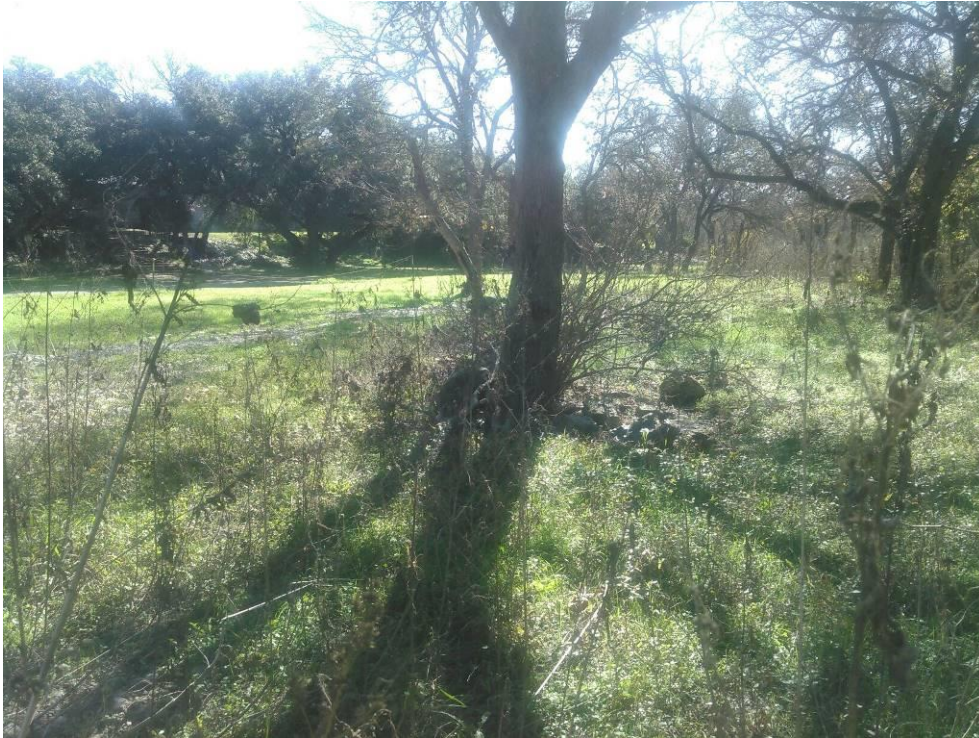
Photo #1: View south across southern-most portion of trail easement in proximity of landscaped channel at Our Lady of Guadalupe Church.

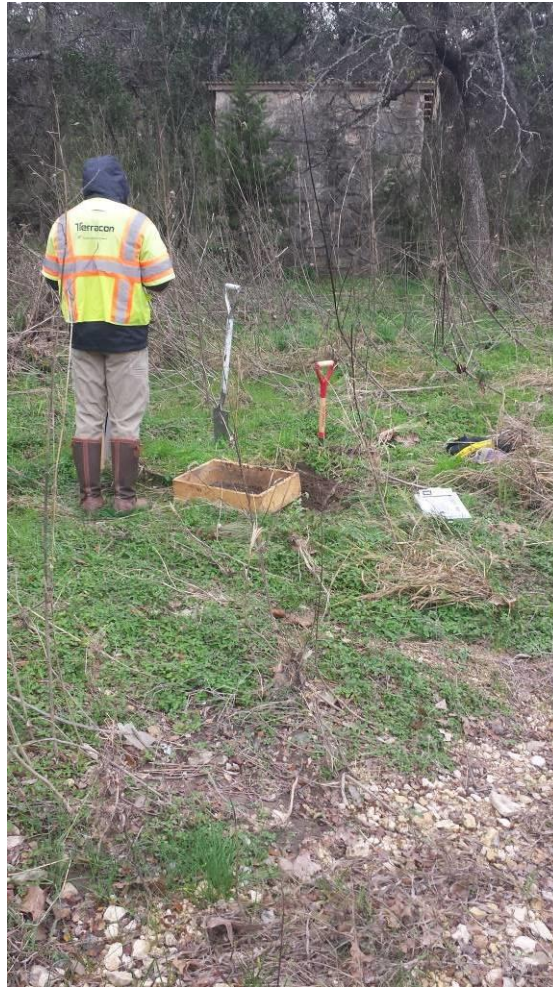
Photo #3: Shovel test TJ01 in the southwestern corner of park space. The modern cinderblock and stone outbuilding is approximately 20 feet beyond the project boundary.

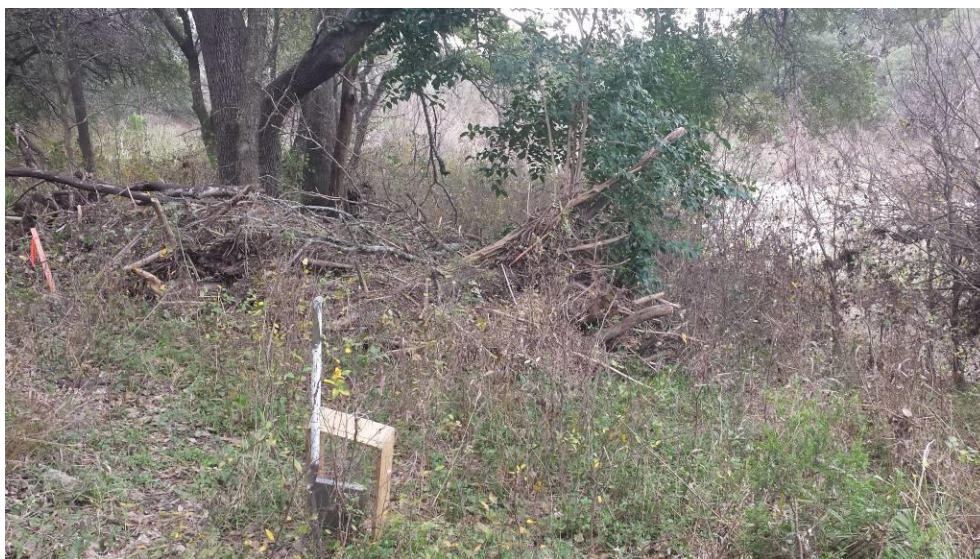
Photo #4: View south across shovel test DY01 where the trail easement meets the park space. Note the woody debris deposited by recent flooding in the background.

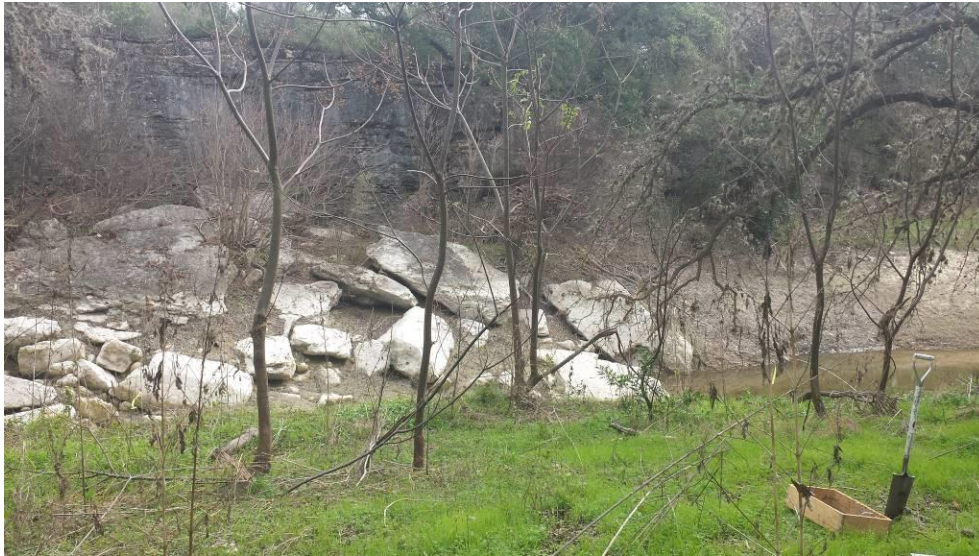
Photo #5: Boulder garden, bedrock cliff, and possible sinkhole in background past shovel test DY02 location.

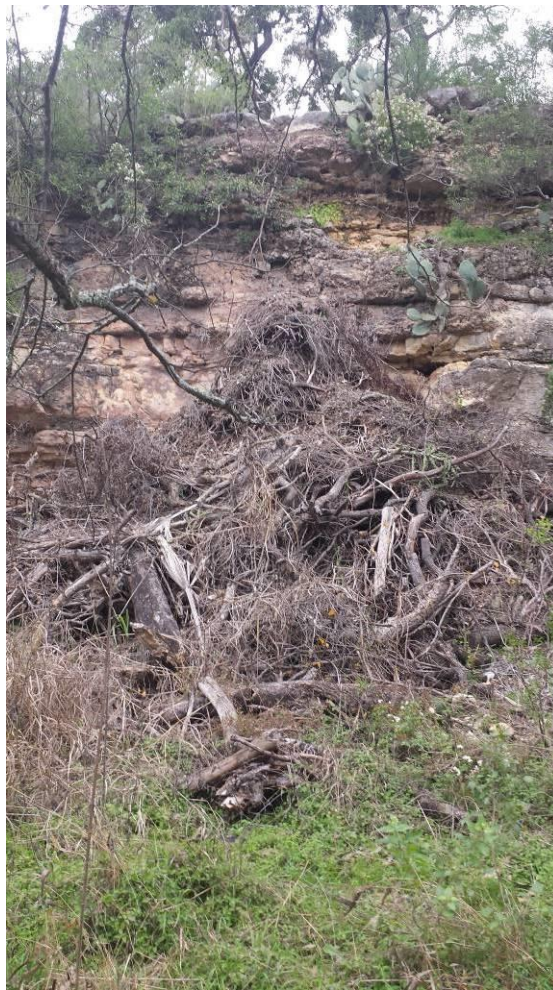
Photo #6: Woody debris likely deposited along tall bedrock cut bank in right bend of Helotes Creek by October flooding.

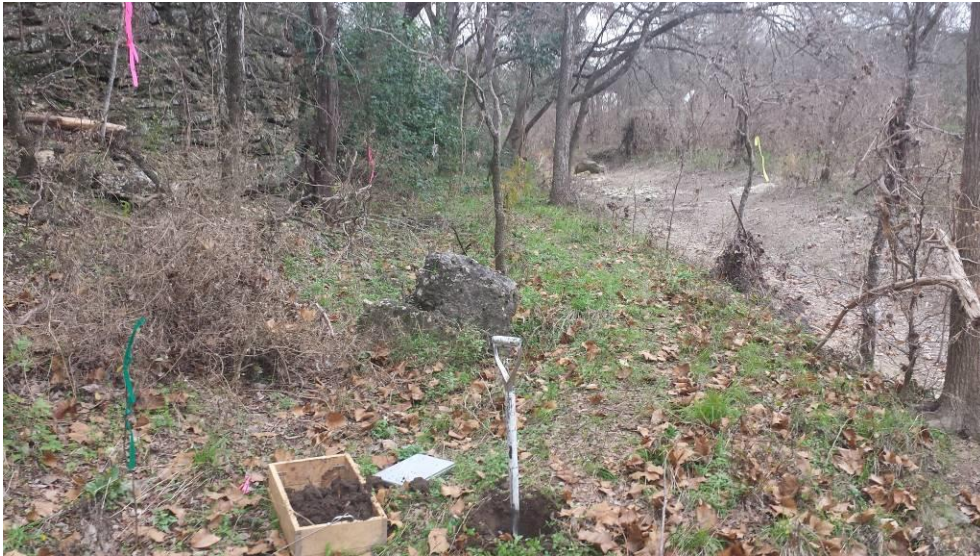
Photo #7: View north across shovel test DY04, showing small channel at left and rock escarpment at right.

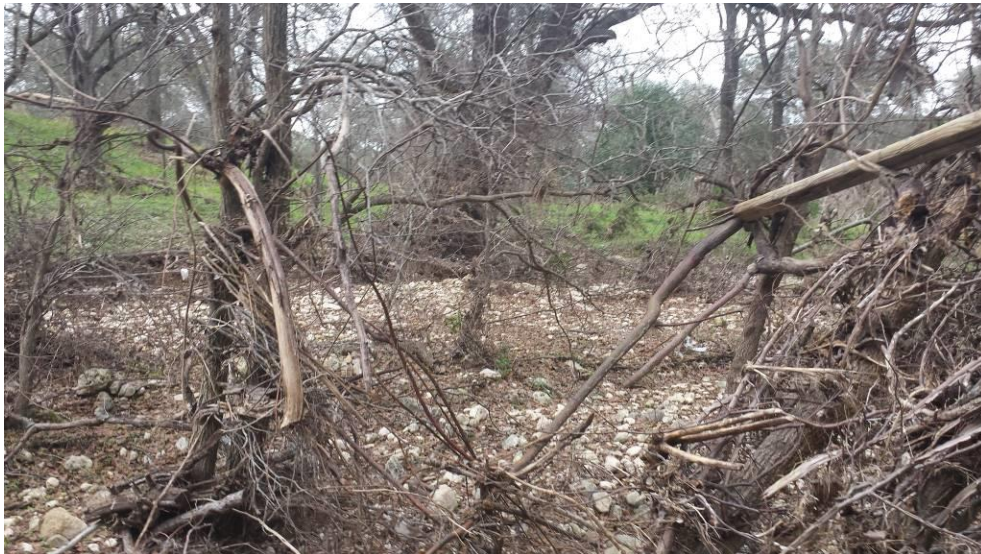
Photo #8: View across channel in the northern-most portion of the park space and trail area.

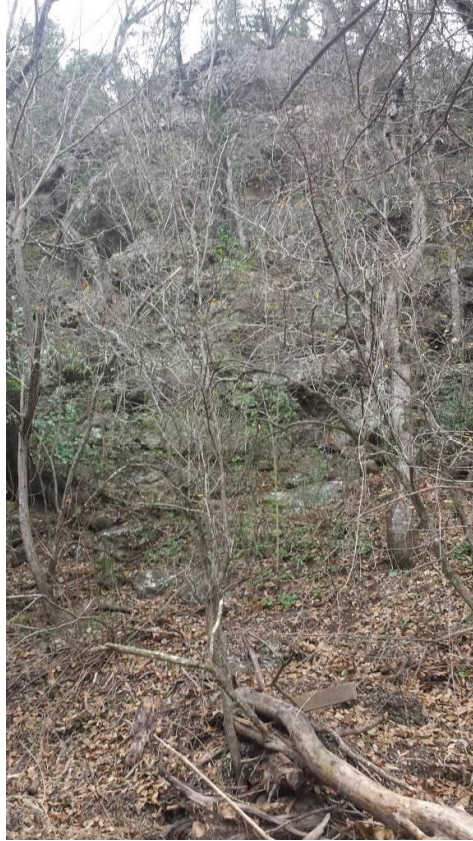
Photo #9: View west up escarpment in the northern-most portion of the parkspace and trail area.

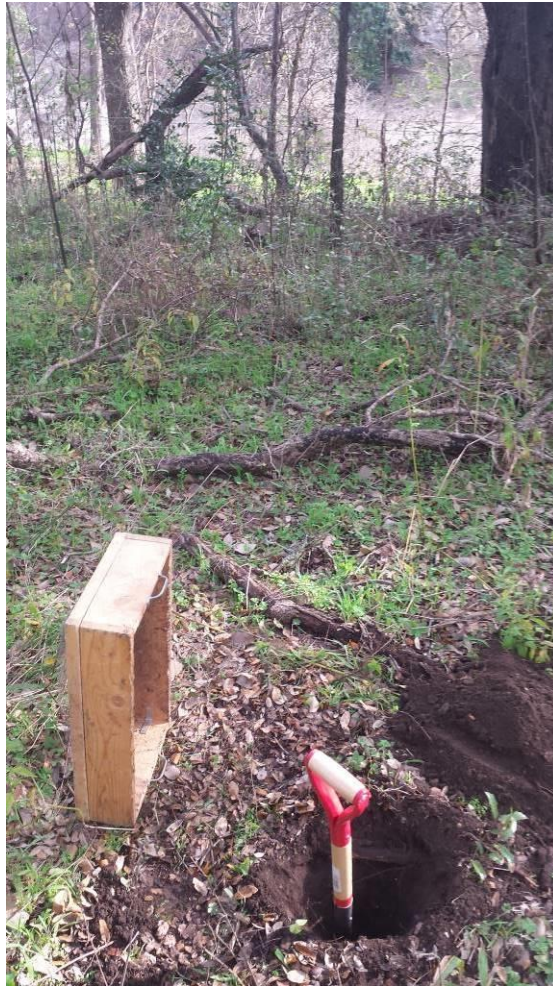
Photo #11: View north across shovel test DY05 in the vicinity of the construction staging area.

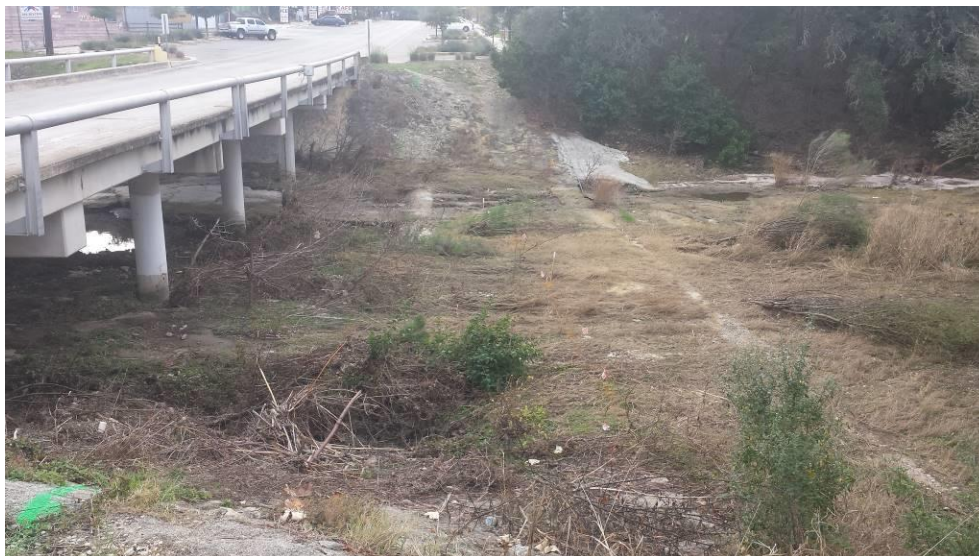
Photo #12: View south across Helotes Creek at the location of the proposed pedestrian bridge. Note the linear concrete features marking buried utility lines.

The proposed location of the pedestrian bridge was visually inspected by two survey transects, which revealed a number of (marked) existing buried utility lines and other disturbances associated with the modern vehicle bridge. A fiber-optic cable, gas line, and sewer line are all buried beneath the modern channel of Helotes Creek within the footprint of the proposed pedestrian bridge. These lines were apparently trenched into place, as opposed to horizontally bored, which is apparent by ribbons of concrete marking each line. On either side of Helotes Creek, the proposed bridge would tie into existing sidewalks.

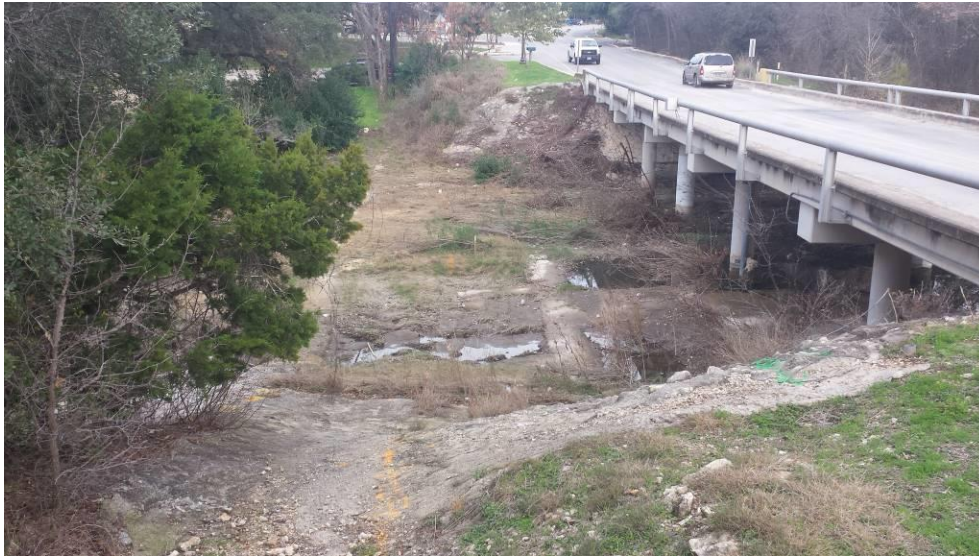
Photo #13: View north across Helotes Creek at point of proposed pedestrian bridge. Note the orange (center) and green (right) spray paint in the foreground marking buried fiber-optic and sewer lines, respectively.

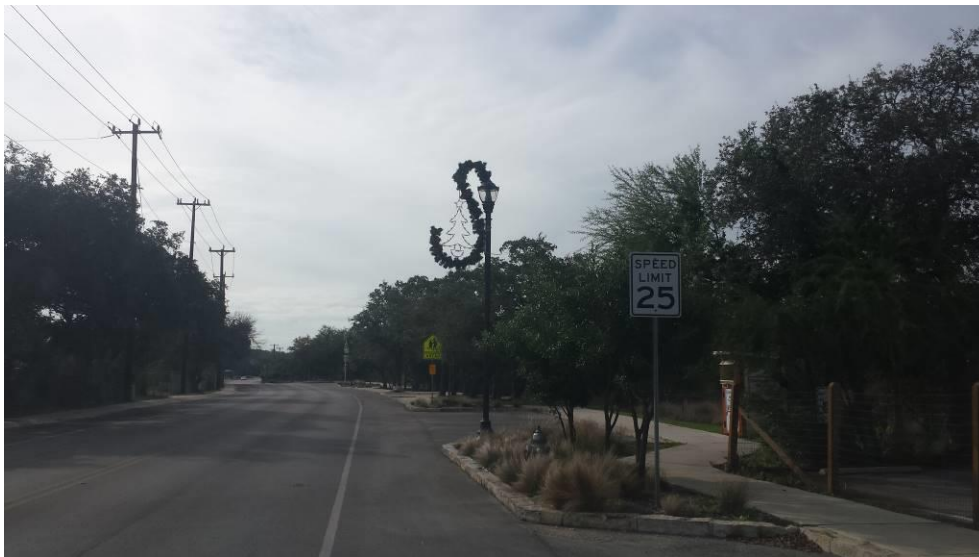
Photo #14: View south along Riggs Road featuring alternating parking spaces and landscaped areas where benches and trashcans would be placed.

A suite of benches and trashcans are proposed for the length of Riggs Road between the parking area at the southern end of the overall project area north to the roundabout intersection with Old Bandera Road. These benches and trashcans would be anchored into place along a stretch of the west side of the road that has previously been improved for parking and pedestrian access to Old Town Helotes. Benches and trashcans would be placed on landscaped *islands* between groups of parking spaces.

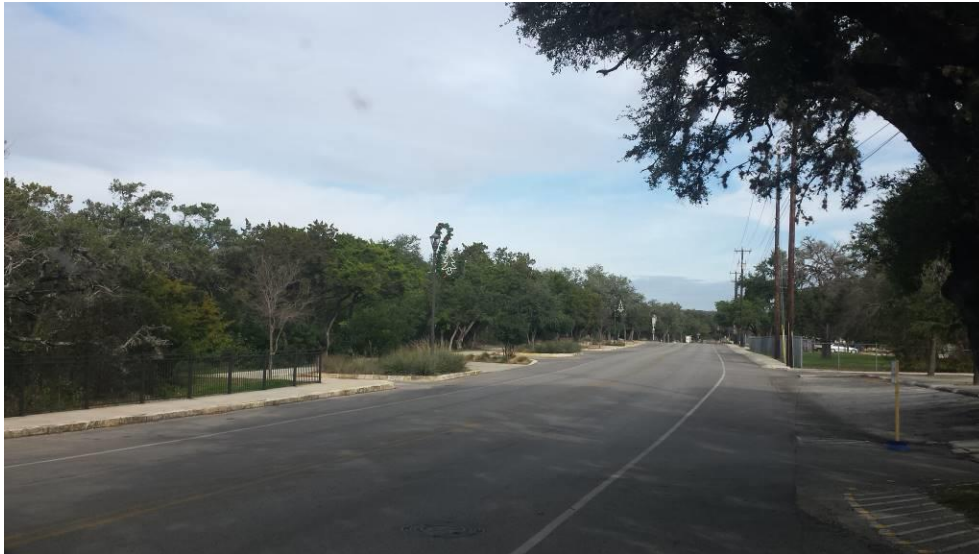
Photo #15: View north along Riggs Road showing landscaped areas where benches and trashcans would be inserted among parking spaces (left/west side of road).

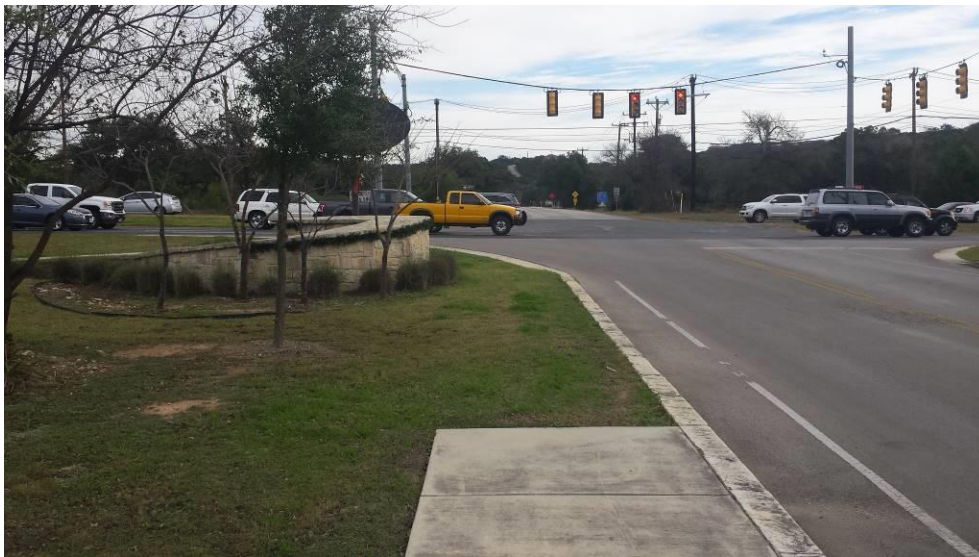
Photo #16: View east across intersection of Scenic Loop Road and Highway 16 from west side.

A previous survey conducted along Highway 16 (Nichols and Luzmoor 2015) did not identify archaeological resources on the east side of the intersection at Scenic Loop Road. Visual inspection of the intersection revealed that the local landscape was previously disturbed for drainage and utilities in association with development and improvement of the roadways. Though this area was visually inspected, intensive pedestrian survey of the location was not deemed necessary due to confirmed previous impacts.
