## **Cultural Resources Survey of Four Frio County Bridges, Frio County, Texas**

SWCA Cultural Resource Report No. 07-66

January 2015

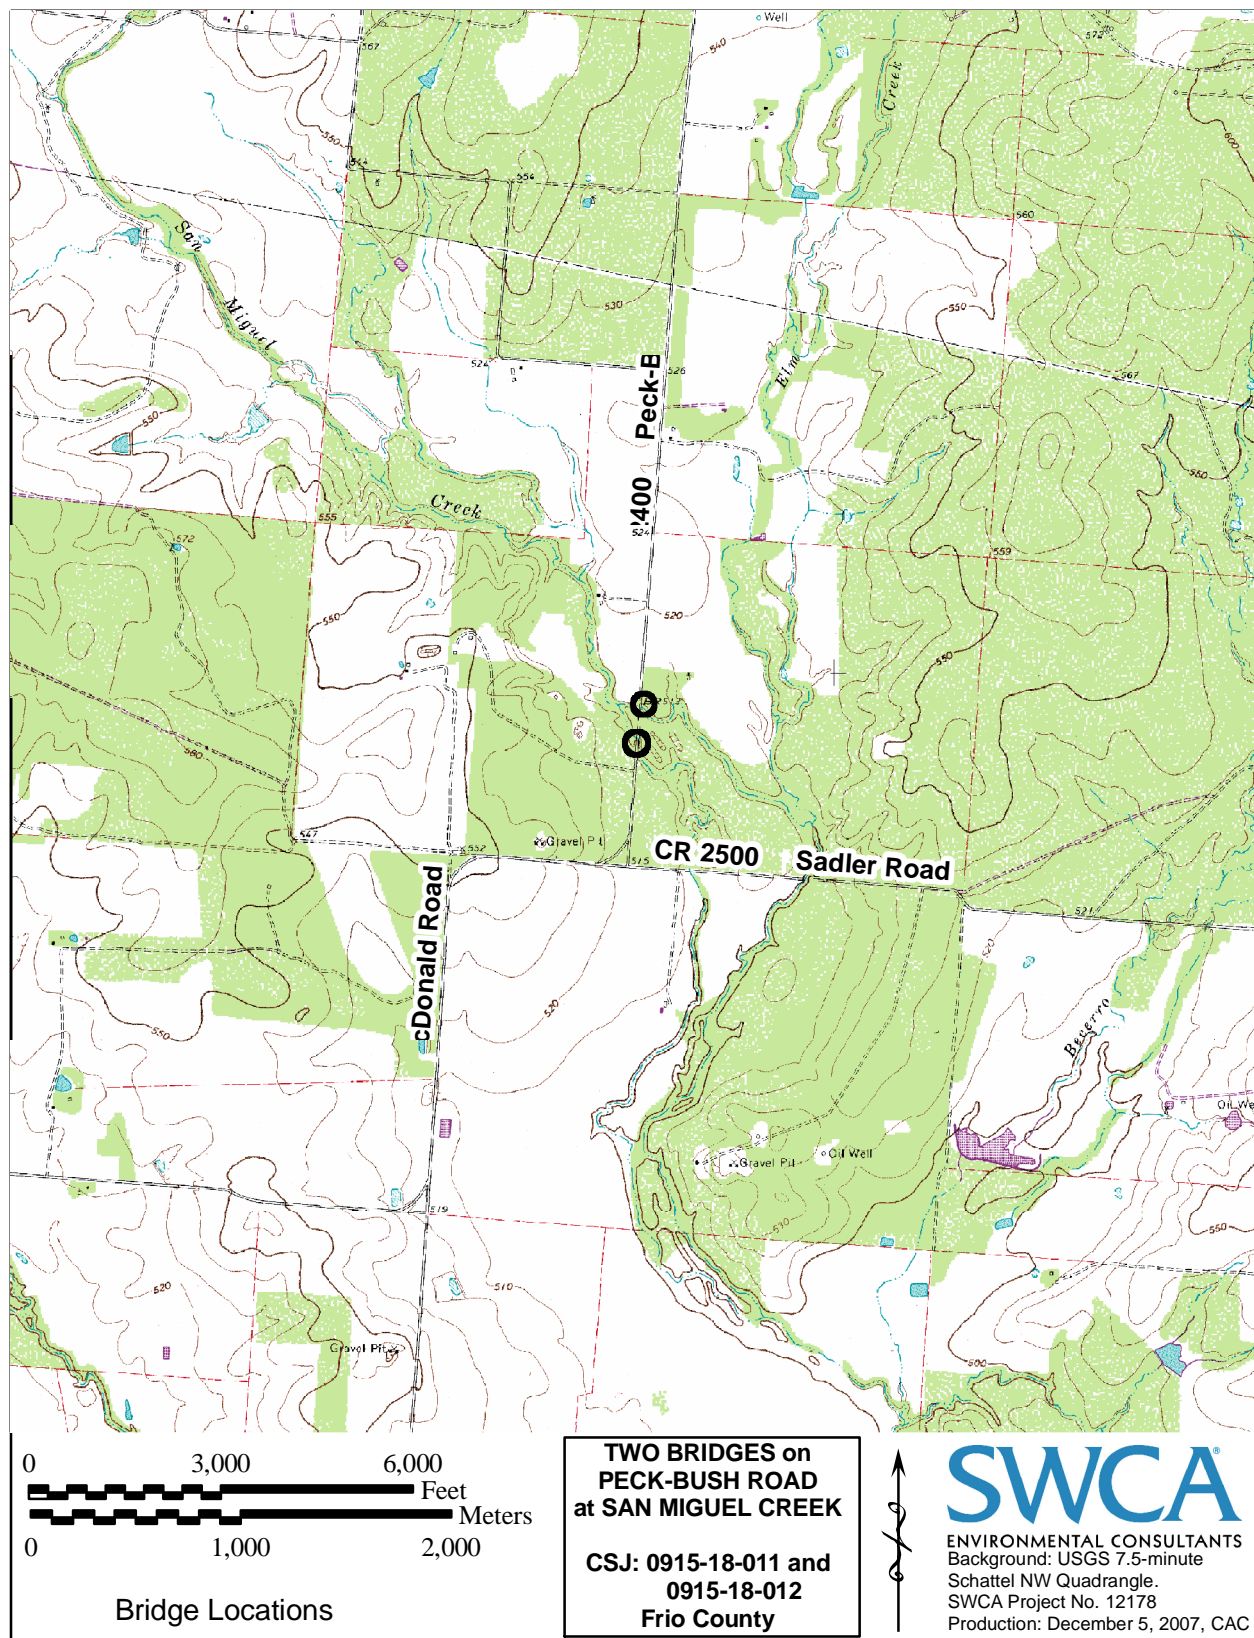
Figure 2. Two bridges at Peck-Bush Road (CR 2400) and Lucas Creek.

The project area encompasses two bridges located along Peck-Bush Road at a divergence of San Miguel Creek. The two crossings are approximately 0.1 mile apart and are located just north of the intersection of Sadler Road (CR 2500) and Peck-Bush Road (see Figure 2). The project area encompasses approximately 2 acres of existing 80 feet wide ROW that includes the road and the two bridges.

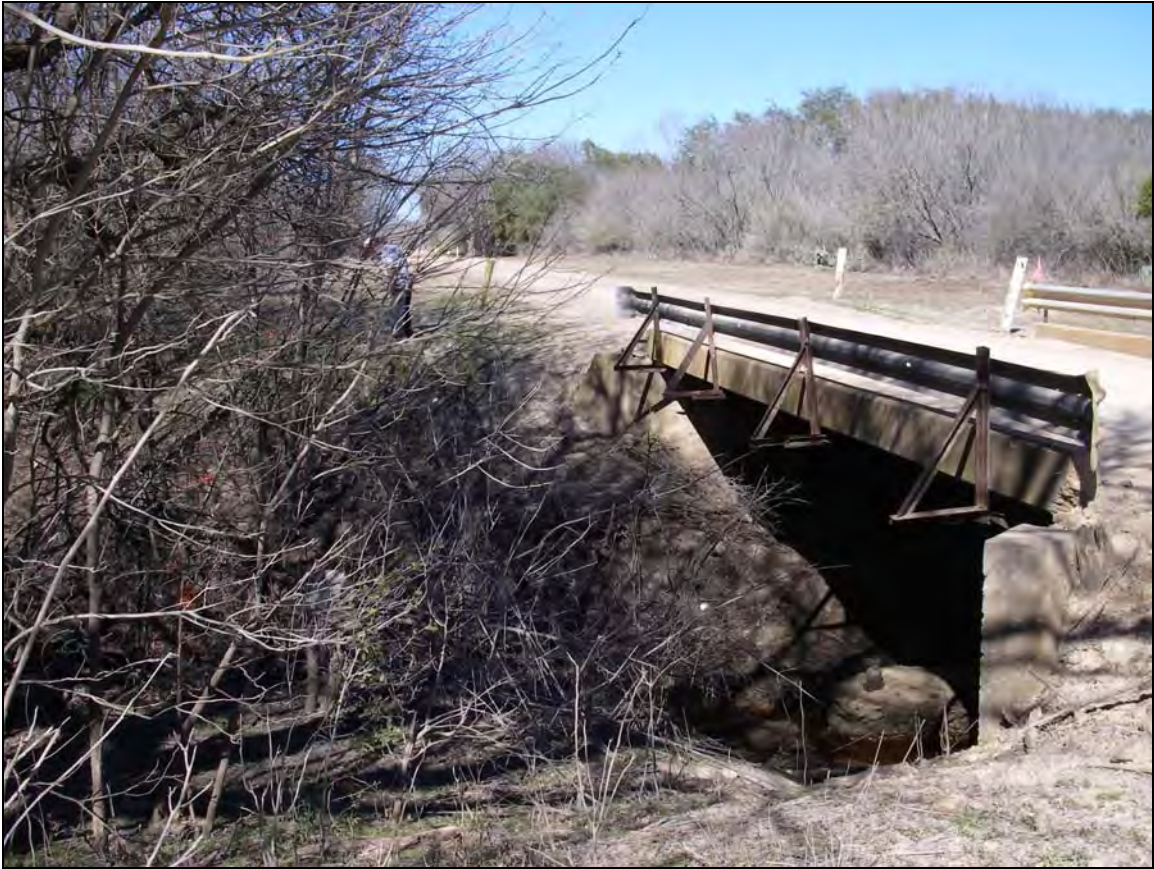
Each of the existing bridges consist of a single span concrete beam approximately 40 feet long and 15 feet wide and supported by concrete abutments at the drainage banks (Figure 5). The Peck-Bush roadway runs north to south and consists of a 20-foot wide graded road with no shoulders. The San Miguel Creek drainages, at these crossings, trends northwest to southeast and exhibits 4-foot high cutbanks. At the time of this evaluation, the drainage contained isolated areas of standing water at low points conducive to intermittent flow.

**Figure 5.** Overview of the bridge over the southern San Miguel Creek divergence at the Peck-Bush Road crossing, facing northeast.

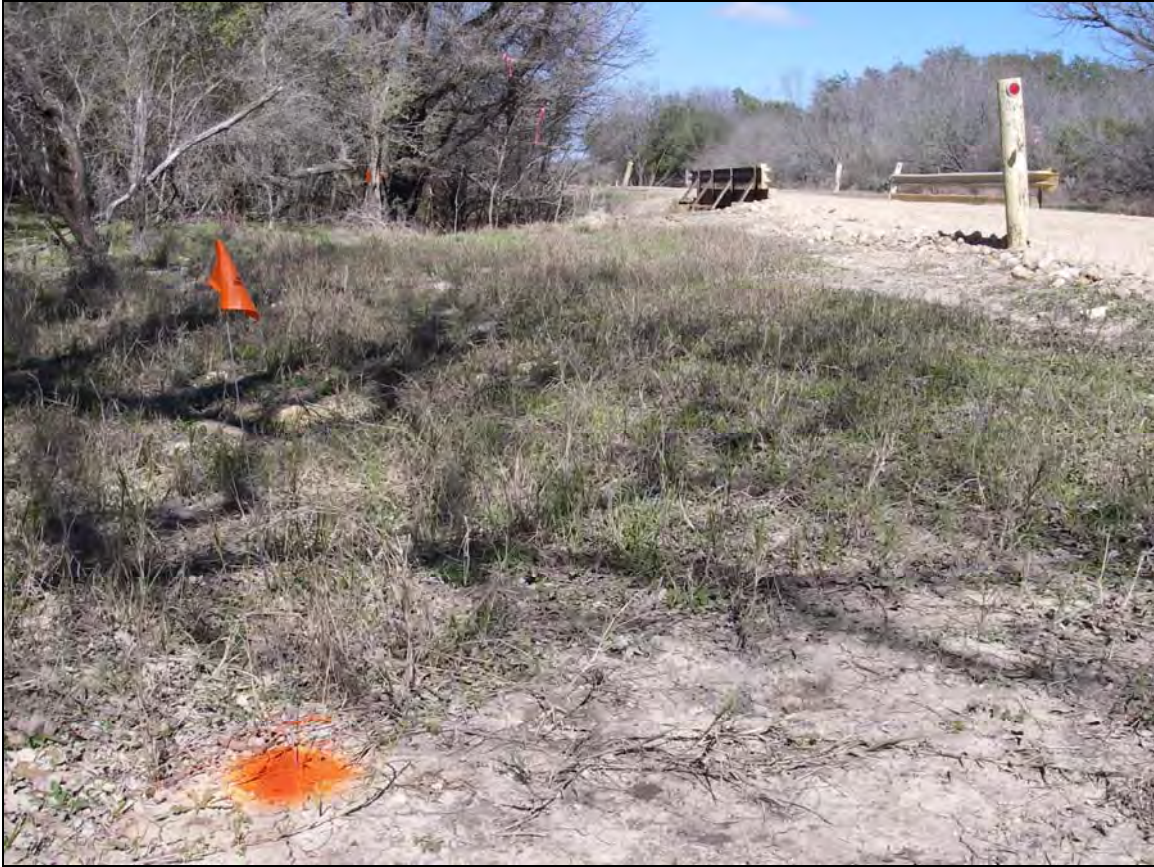
The utilities within the project area include a buried communication line adjacent to the western ROW boundary running parallel with the roadway along the entire project area (Figure 6). An additional buried utility was unmarked and discovered in BHT 3 (Figure 7). The utility is located adjacent to the eastern ROW boundary running parallel to the roadway from the northern extent of the project area to just north of the southern creek crossing. From that point, the line appears to change direction to run perpendicular to the roadway in an unknown direction. The line, however, does not continue along the eastern ROW, south of the southern creek crossing.

**Figure 6.** Marked buried utility along the western ROW boundary near the southern Peck-Bush Road at San Miguel Creek crossing, facing north/northeast.

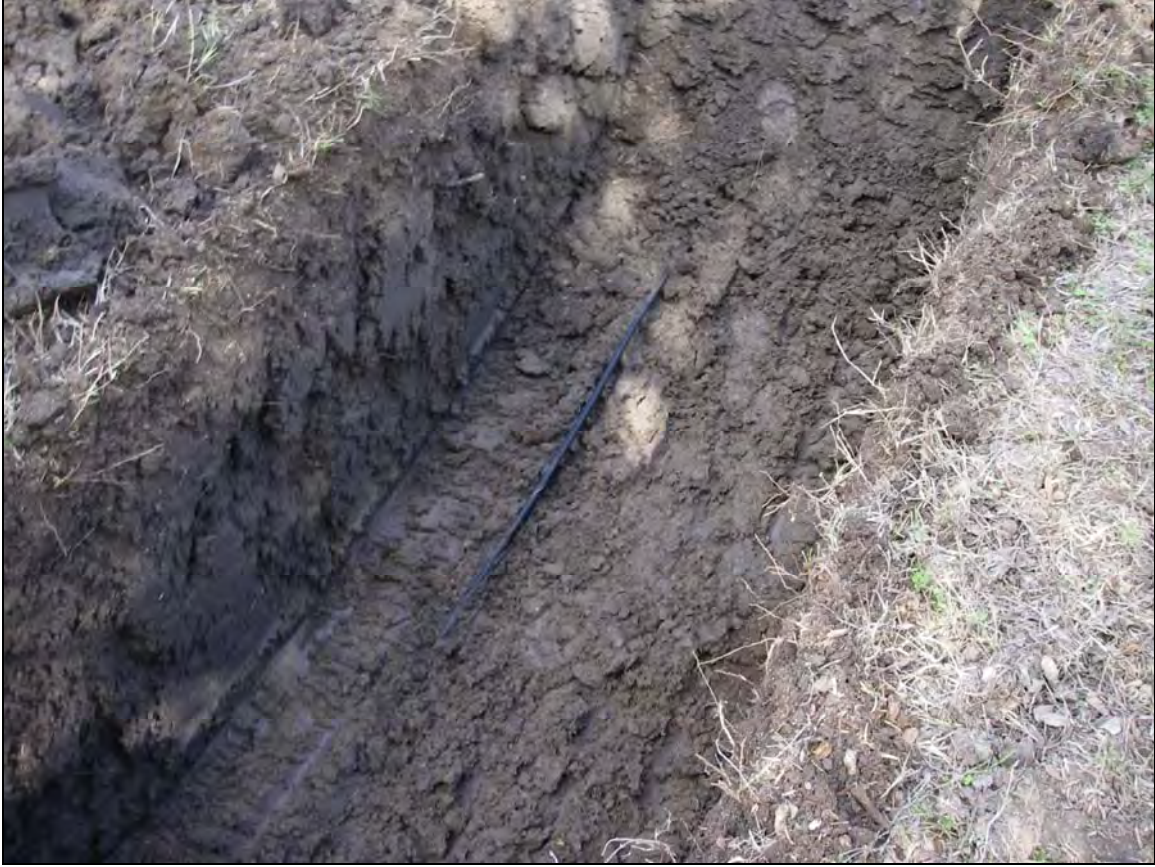
**Figure 7.** Exposed unmarked buried utility in BHT 3 north of the northern Peck-Bush Road at San Miguel Creek crossing.

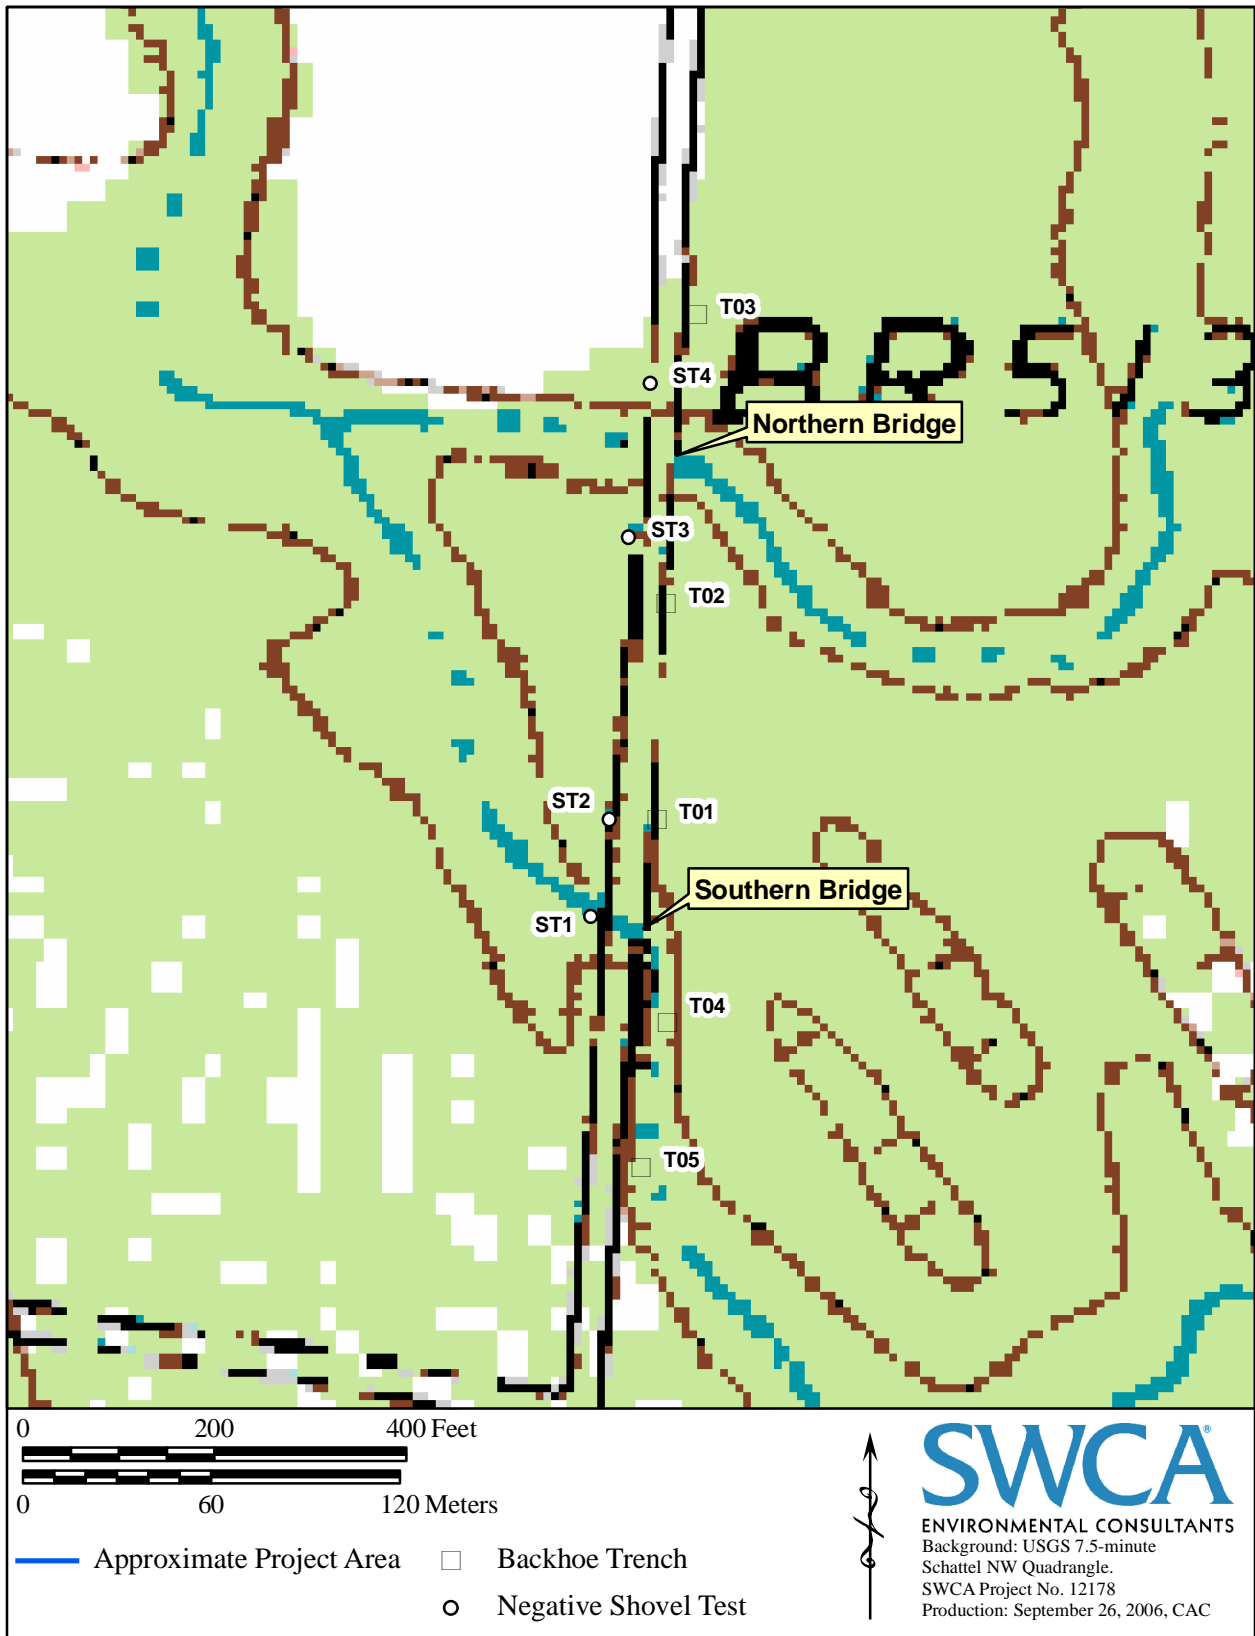
Subsurface investigations within the Peck-Bush Road at San Miguel Creek project area included five backhoe trenches and four shovel tests (Figure 8). The backhoe trenches revealed a disturbed layer extending up to 44 cm below surface. This disturbed layer consists of the previously discussed road gravels and asphalt, as well as modern debris mixed within soils similar to the underlying matrix. The underlying matrix is a very dark brown (10YR 2/2) friable sandy clay loam over a firm brown (10YR

4/3) clay loam. The southern trenches (BHT 1 and 5) had an extremely firm dark yellowish brown (10YR 4/4) clay loam under the darker clay loam. This lower stratum became shallower with increased distance away from the southern San Miguel Creek drainage. The color of this deeper stratum is similar to the surficial soils away from the project area and the soils on the graded road (Figure 9). No cultural material was observed in any of the subsurface investigations. In addition, the entire project area was examined and all available cut bank exposures were inspected with no cultural materials observed.

Figure 8. Backhoe trench and shovel test locations at the Peck-Bush Road bridges.

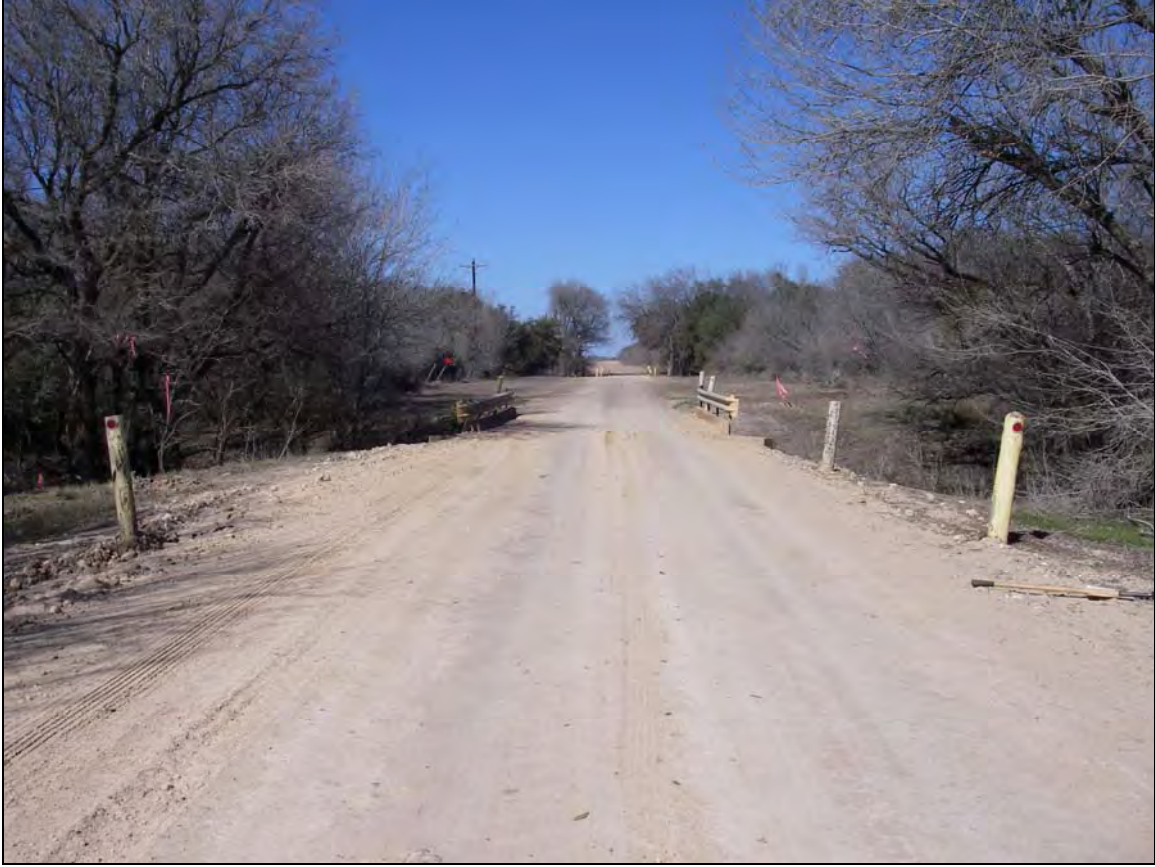
Disturbances to the project area include road grading and buried utilities. The road grading has imported chert and limestone gravels from areas south and north of the project area in more upland environments with exposed bedrock gravels. These areas contain abundant surficial gravels and cobbles not observed near the San Miguel Creek crossings. The lack of gravels within the project area is apparent in the trench and shovel test profiles excavated adjacent to the roadway. These profiles revealed a thin layer of disturbed road overburden consisting of the above mentioned gravels over alternating clay loam soils with minimal inclusions (Table 1).

**Figure 9.** Overview of Peck-Bush Road and graded imported road fill near the southern Peck-Bush Road at San Miguel Creek crossing, facing north.

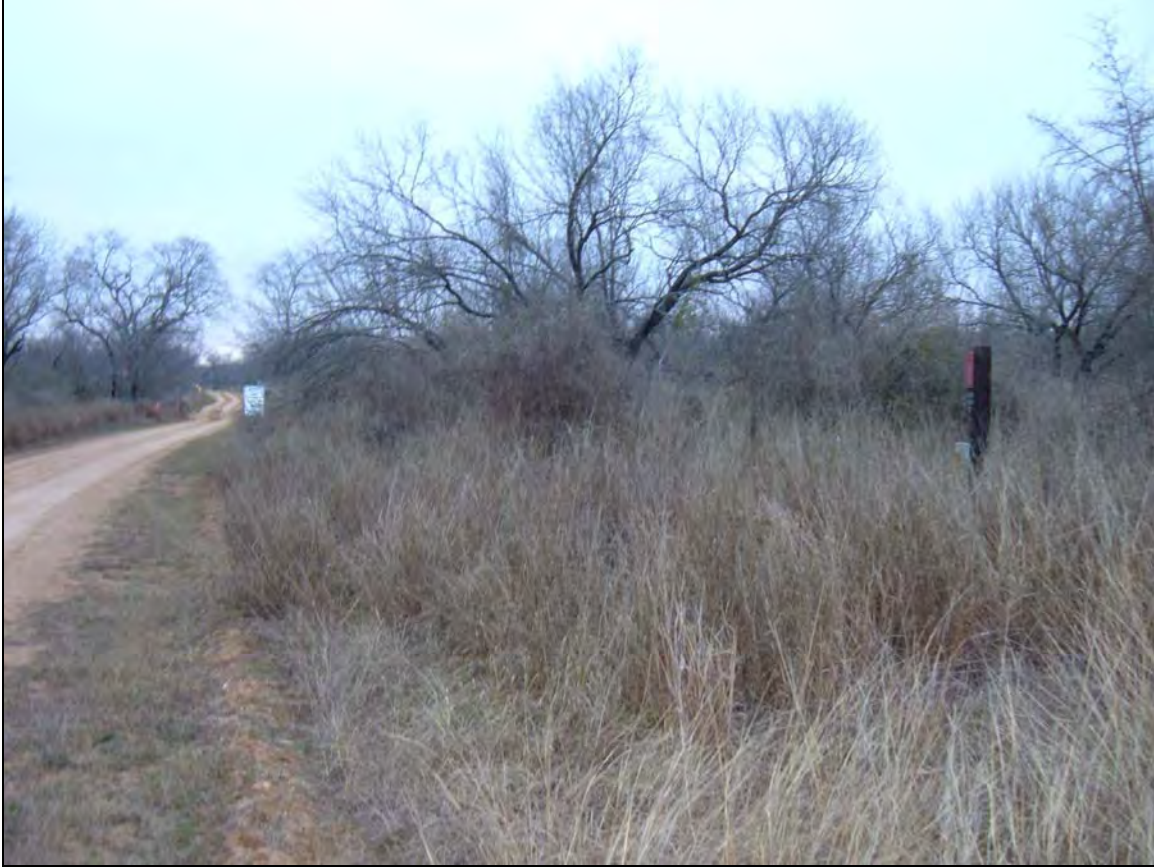
**Figure 10.** Overview of overgrown vegetation within the ROW near the Applewhite Lane at Mustang Creek crossing, facing south/southeast.

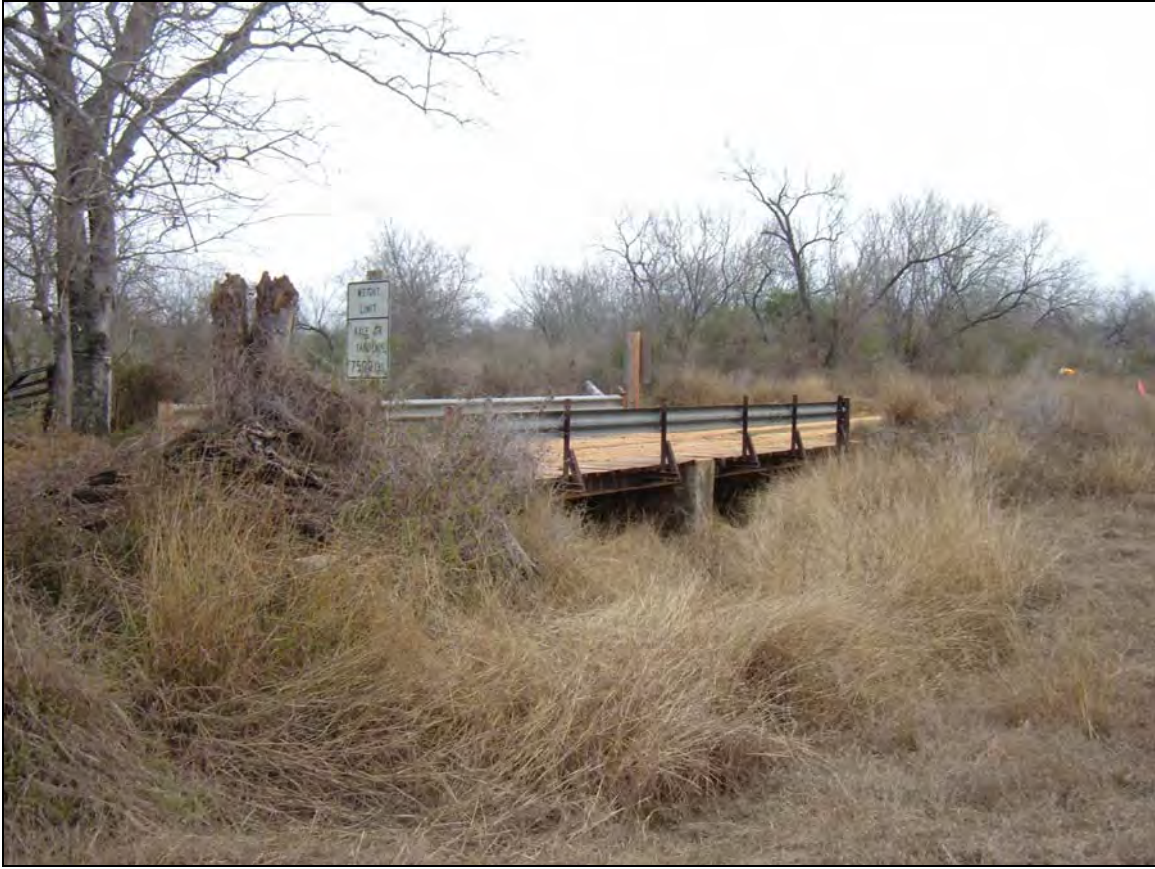
crossing displays 3–4-foot high slightly incised cutbanks. At the time of evaluation, the drainage did not have any water flowing suggesting intermittent flow. The northern bridge approach is cut below grade from 1–3 feet and the southern approach is cut below grade from 1–2 feet, leveling the undulating area. The bridge itself consists of steel girder I-beams with a steel plating deck supported by a concrete beam (Figure 11). The road along the approaches of the bridge is comprised of gravel and dirt that has been intensively bladed.

**Figure 11.** Overview of the Applewhite Lane at Mustang Creek bridge, facing east.

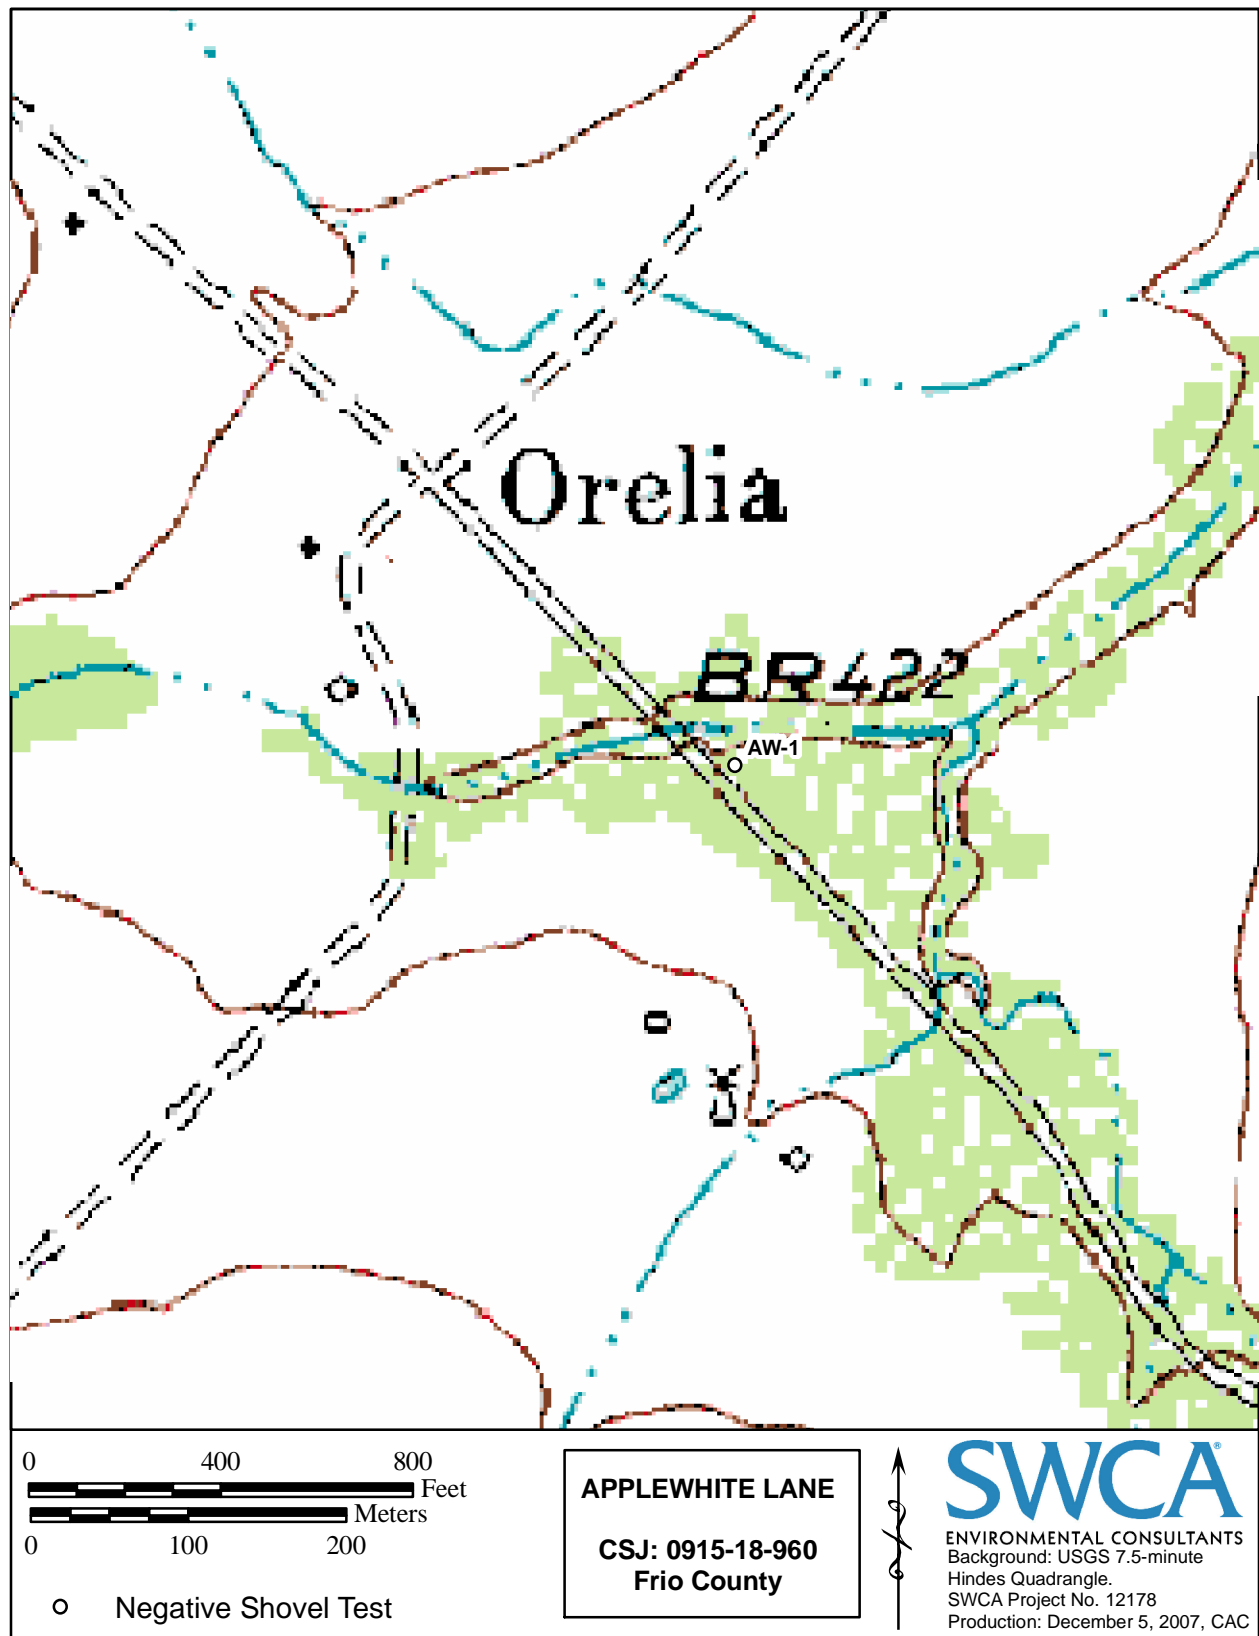
Due to the high amount of disturbances in the narrow APE, only one shovel test was excavated (Figure 12, Table 2). The shovel test (AW-1) revealed a disturbed silty loam layer over a slightly mottled dark brown (7.5YR 3/3) silty loam to 70 cm below surface. These soils sat atop a brown (7.5YR 4/2) basal clay loam. No cultural material was encountered. In addition, the entire project area was examined and all available cut bank exposures were inspected with no cultural materials observed.

Figure 12. Shovel test location at Applewhite Lane bridge.

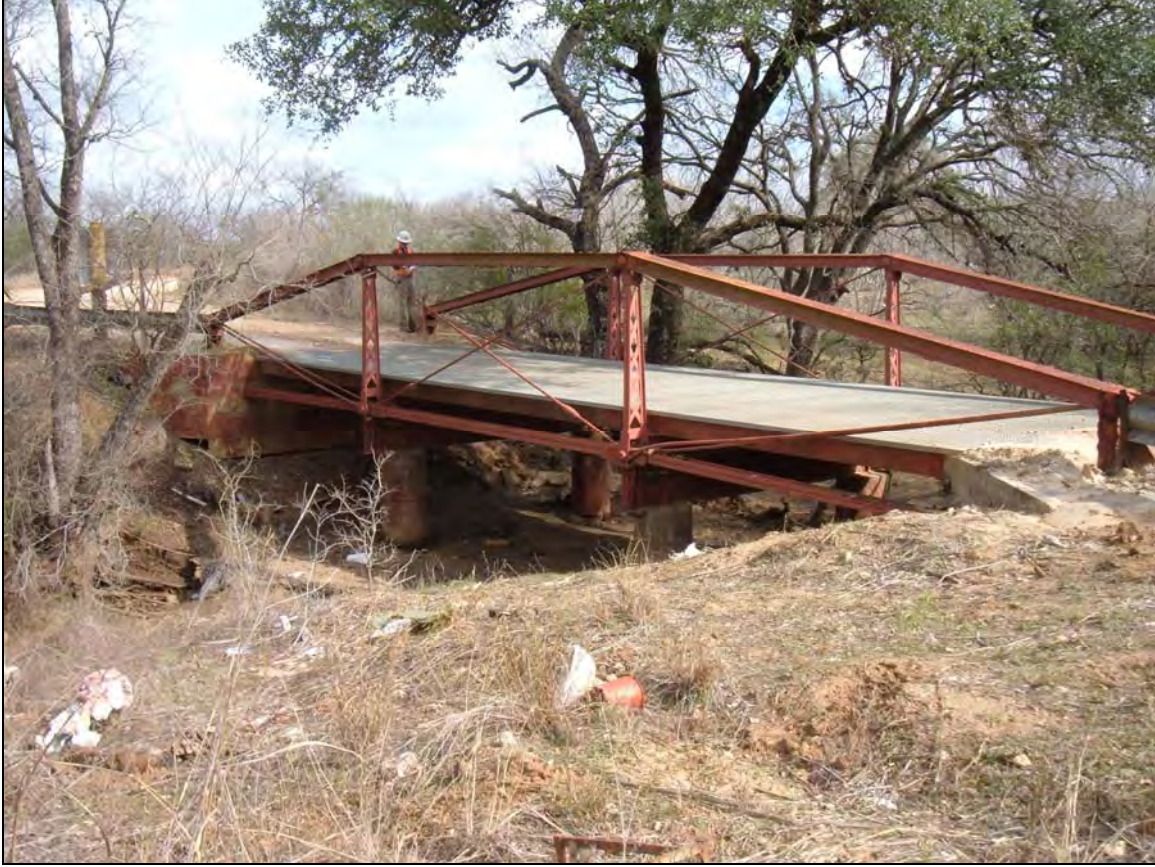
**Figure 13.** Overview of the Andy Sadler Road at Live Oak Creek bridge, facing east/northeast.

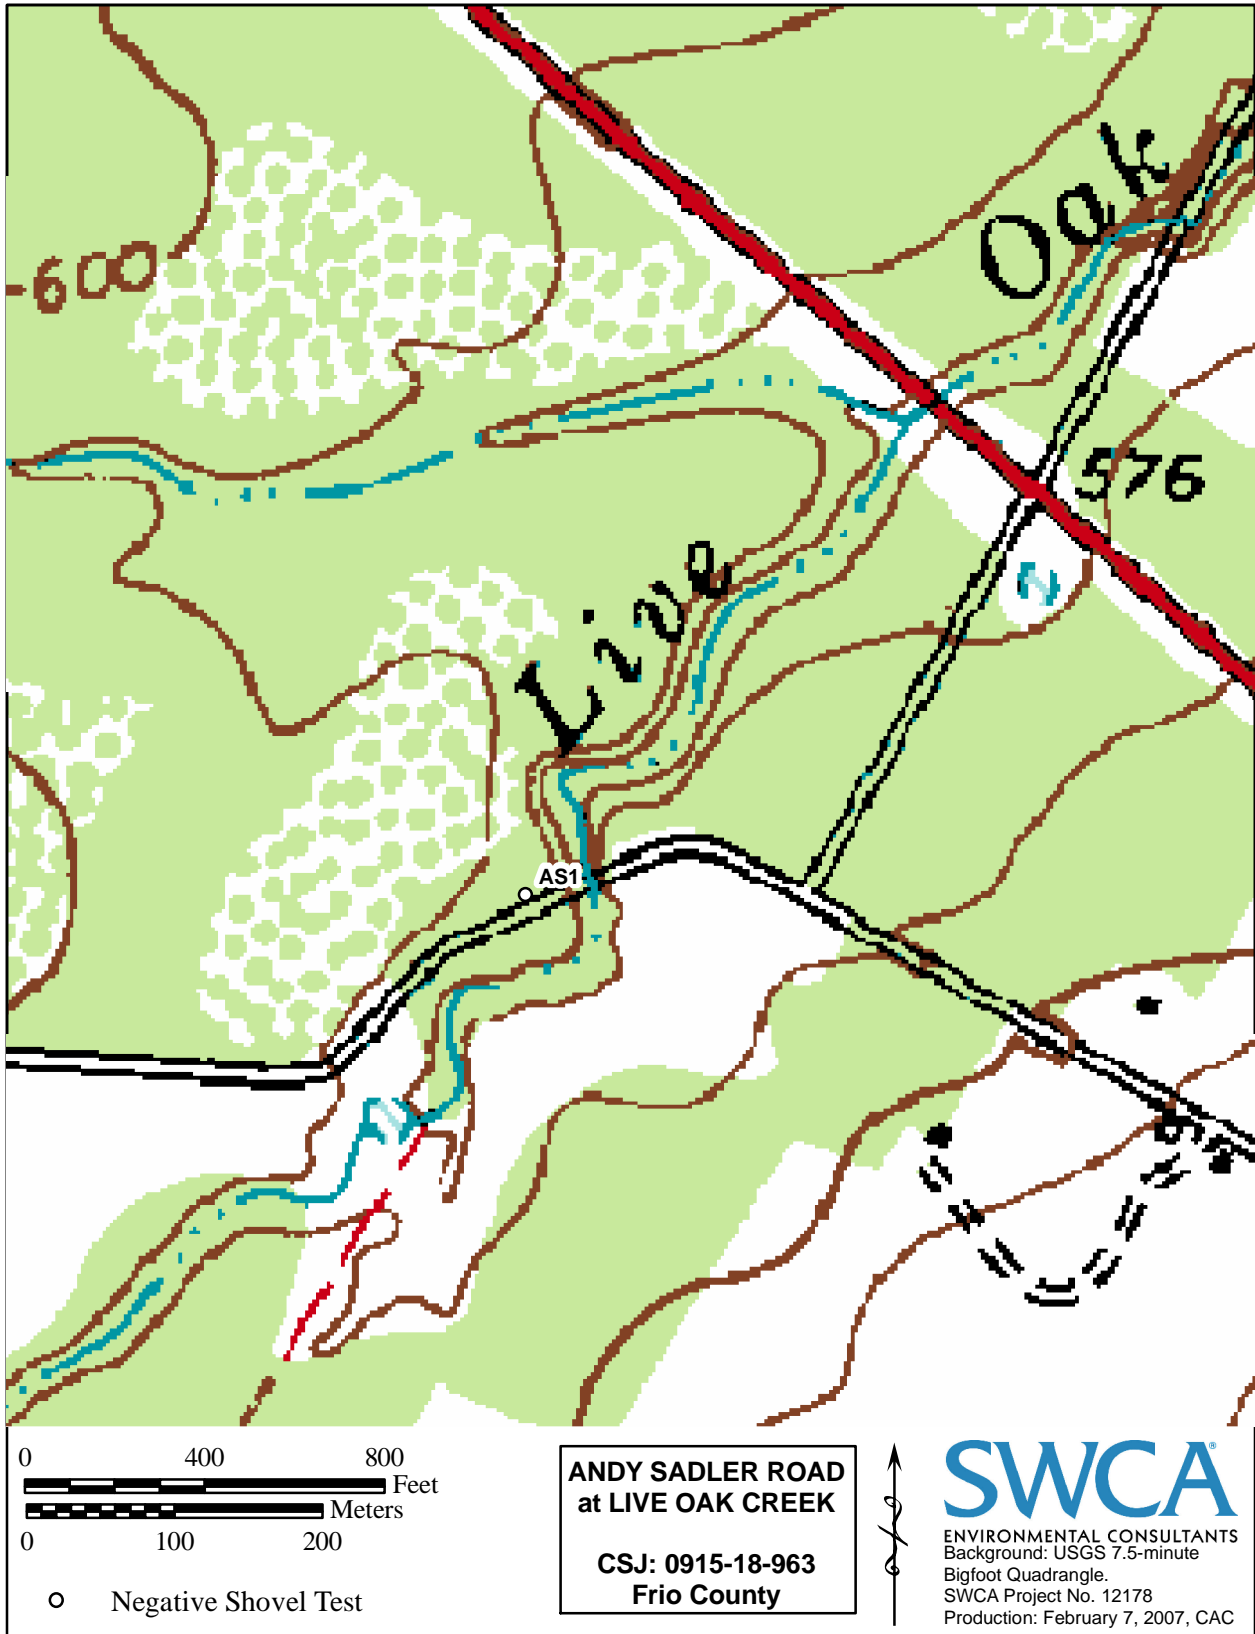
Due to the high amount of disturbances and the narrow APE, only one shovel test was excavated (Figure 14, Table 3). The shovel test (AS-1) revealed a dark brown (7.5YR 3/2) sandy loam layer over a brown (7.5YR 5/4) sandy loam to 70 cm below surface. These soils sat atop a brown (7.5YR 4/2) basal clay loam mottled with yellowish red (5YR 4/6) clays. No cultural material was encountered in the shovel test. In addition, the entire project area was examined and all available cut bank exposures were inspected with no cultural materials observed.

Figure 14. Shovel test location at Andy Sadler Road bridge.
