Cultural Resources Survey of Two Atascosa County Bridges, Atascosa County, Texas

Texas Antiquities Permit 4401

SWCA Cultural Resource Report No. 07-67

January 2015

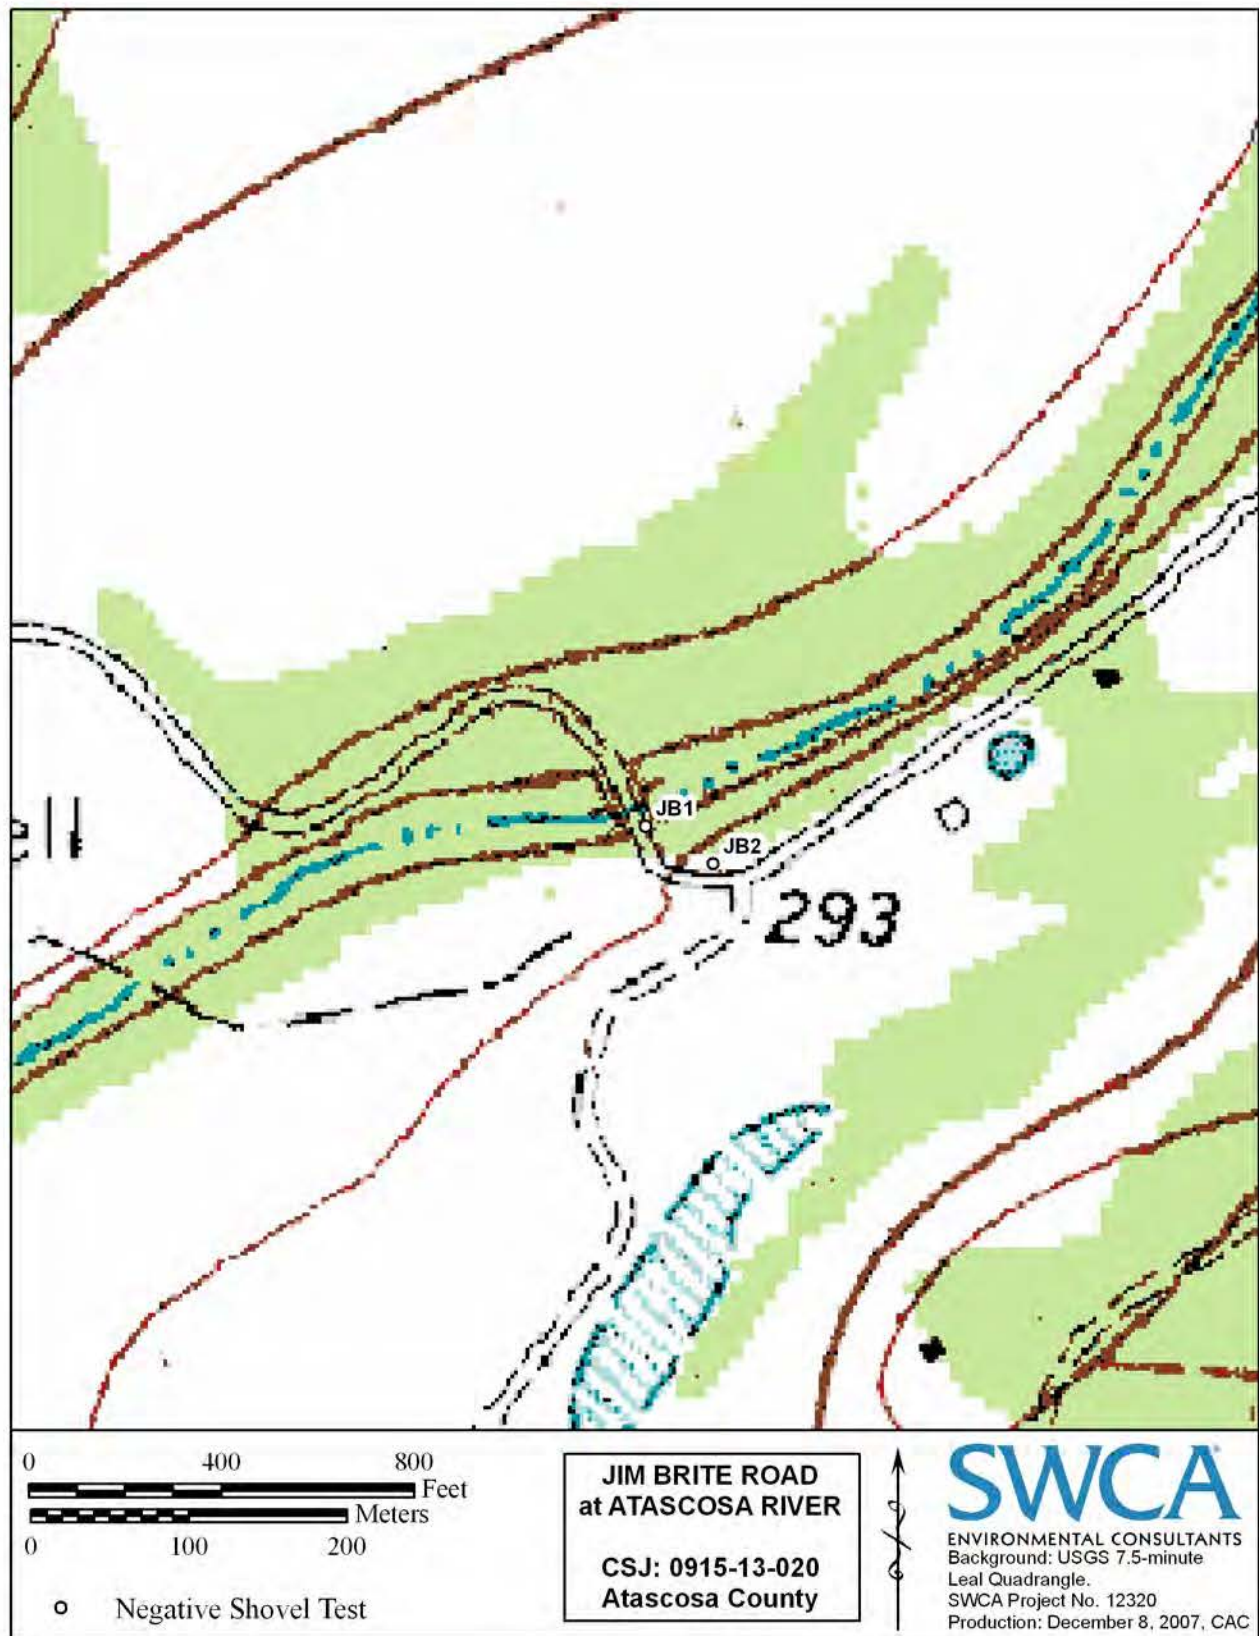
Figure 13. Shovel test locations at Jim Brite Road bridge.

Originally, this crossing was scheduled for subsurface investigations with backhoe trench excavations. However, upon evaluation of the project area it was determined that the ROW is too narrow and disturbed for backhoe trench excavation. A reasonably intact area was observed along the eastern approach that was investigated with two shovel test investigations (ST JB-1 and JB-2). The shovel tests were placed along the edge of the ROW within the narrow (5 feet) strip between the fence line and the cut below grade (Figure 13). One shovel test (JB-1) was placed on the first terrace of the Atascosa River while the second shovel test (JB-2) was placed on the second terrace of the drainage. Shovel test JB-1 was excavated to a depth of 80 cm below surface (bs) before terminating at impassible tree roots. Shovel test JB-1 encountered a 20-cm thick horizon of very dark grayish brown (10YR3/2) silty loam overlying a yellowish brown (10YR5/4) clay loam that graded into fine sand, which extends below 80 cmbs (Table 1). Shovel test JB-2 located on the second terrace encountered deep very dark grayish brown to brown (10YR3/2–4/3) sands that extended below 120 cmbs (Table 1). Of note, some of the examined road cuts in this area exhibited a brown (10YR4/3) clay horizon below the very dark grayish brown to brown sand horizon, which began about 135 cmbs and extends below 140 cmbs. No cultural materials were observed during the shovel test excavations or during the road cut profile examinations (Figure 14).
