Exploring the Utility of Small Unmanned Aerial System (sUAS) Products in Remote Visual Stream Ecological Assessment

2 Exploring the Utility of Small Unmanned Aerial System (sUAS) Products in Remote Visual
3 Stream Ecological Assessment

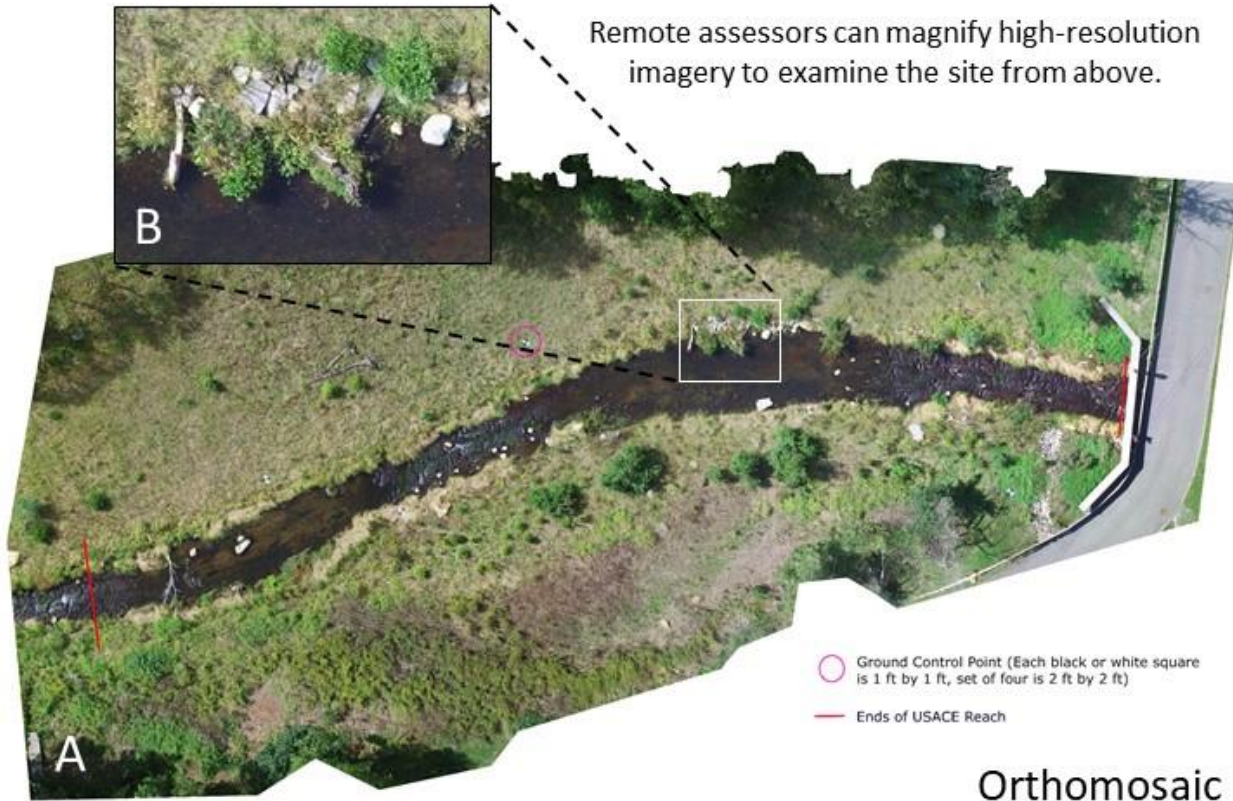
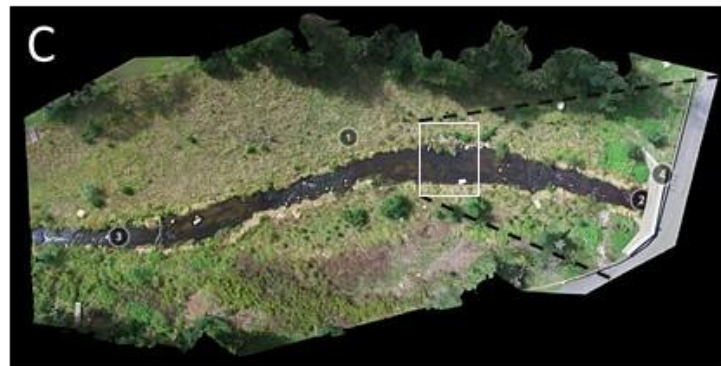
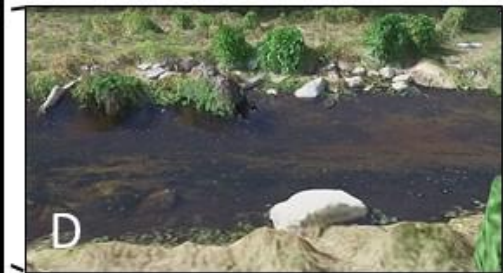
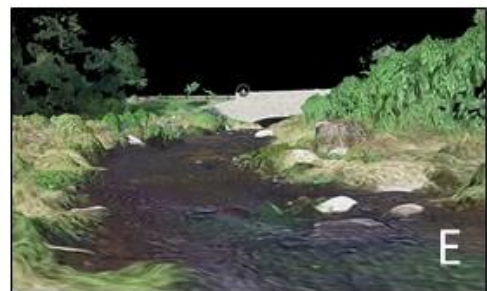
Remote assessors can magnify and rotate detailed models to examine the site from many perspectives.

Remote assessors can click on numbered annotations to learn about the model.

679 Figure 5: Illustration of the differences between the sUAS orthomosaics and 3D models using the
680 MA site as an example. Image A is the annotated orthomosaic provided to the remote assessors.
681 Image B shows a magnified version of some habitat features on the bank using the same
682 orthomosaic. Image C shows the same aerial perspective the orthomosaic provides but using the
683 3D model. Image D shows a magnified oblique perspective of the 3D model highlighting the
684 same habitat features in image B. Image E shows a perspective on the 3D model as if you were
685 standing in the stream. Image F illustrates the numbered annotations on the 3D model that
686 viewers can click on and scroll through to learn more about the model and site characteristics.
687 Screenshots of the 3D model were taken from the viewer on the sketchfab website.

242 The orthomosaics were helpful for all feasible scoring elements, while the 3D models were
243 reported to be especially useful for examining channel condition, entrenchment, bank features,
244 and relative vegetation height (Fig. 5). Most of the participants cited the orthomosaics or 3D
245 models as the most useful products for remote evaluation, and one participant preferred the
246 video. The video gave participants the ability to observe water flow, as well as get a better sense
247 of water clarity and depth. The usefulness of the 3D model was questioned by a couple
248 participants, one who criticized that the models did not give enough sense of slope for it to
249 matter, and another who did not use the 3D models as much due to difficulty navigating them.
250 On the other hand, another participant preferred using the 3D models because of the ability to
251 navigate them and enhance the view of the channel banks. One participant expressed that the
