Test Excavations of a Stone Foundation at
Ayr Mount Historic Site, Hillsborough, North Carolina

Technical Report No. 28

Research Laboratories of Archaeology
University of North Carolina at Chapel Hill

September 2000

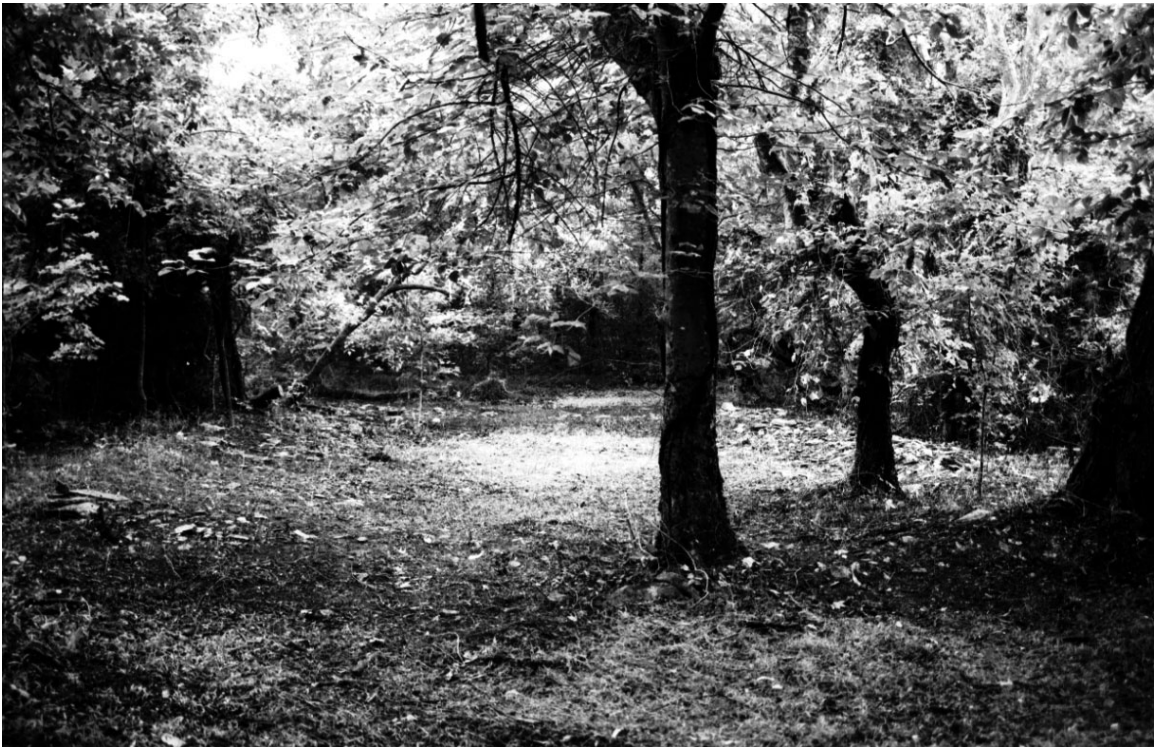
Figure 2. 31Or441 prior to investigation.

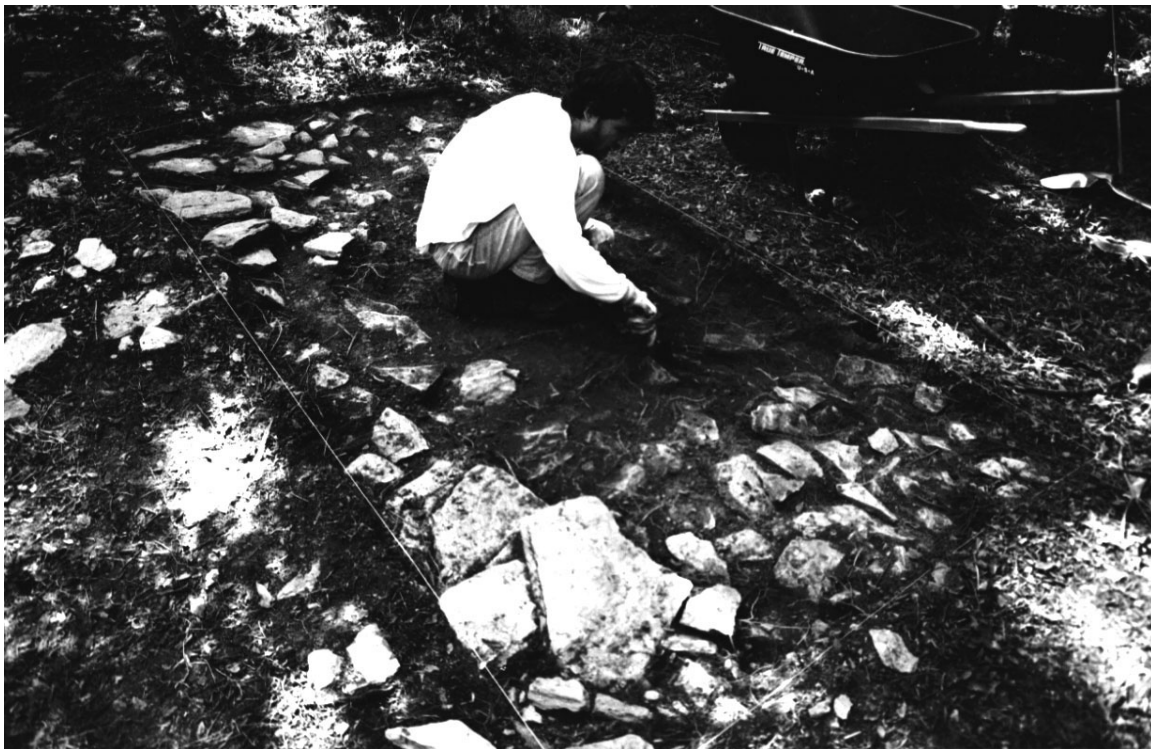
Gaps in the distribution of smaller stones scattered around the southern end of the stone feature provide further support for the idea that an entranceway existed in this area (Figures 4 and 5). These gaps occurred inside and outside of the stone feature adjacent to the smaller stones in the upper course. A lens of yellowish brown clay mixed with gravel, small pieces of stone, and small brick fragments was present within this gap on the southern side of the feature. This lens was about 7 inches thick and rested on subsoil. Due to our limited investigations, it was unclear as to whether this lens extended below the scattered stones. This lens also was present in between the scattered stones on the north side of the feature, but it was not excavated. If an entrance was located in this area,

Figure 5. Chris Rodning excavating clay lens between gap in stones in 110R140.

this lens of yellow clay mixed with rock and brick may represent a more resistant surface that was placed in a high-traffic area.

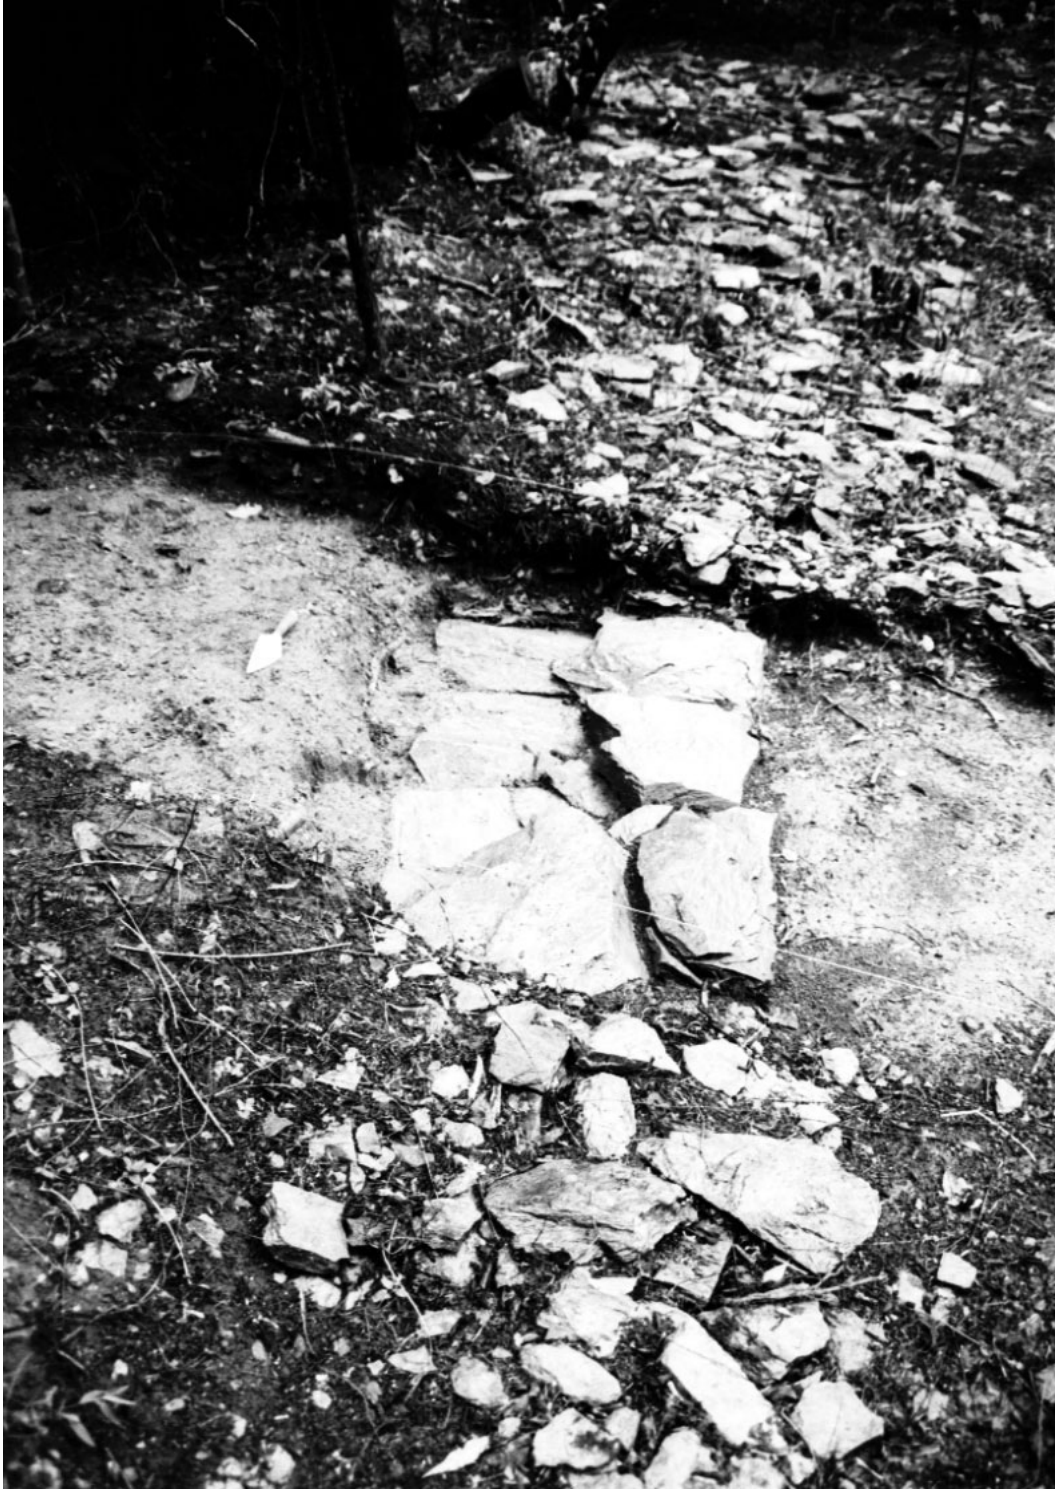
Figure 6. Portion of east foundation wall exposed in 140 Trench.

The second area of excavation at the site consisted of a 5 foot wide (north/south) and 40 foot long (east/west) trench, the southern edge of which extended from 140R110 in the east to 140R150 in the west. This trench intersected the east and west walls of the stone feature, providing us with a complete cross-section of the site. In the western part of the excavation trench, the removal of the smaller stones revealed a roughly north/south oriented builder's trench within which were set two parallel rows of large stones (Figure 6). Portions of two courses were visible, but it is unclear if the lowest course visible to us was actually the lowest course of stones in the trench (Figure 7). On the western side of the foundation, our excavations revealed an empty builder's trench (Figure 8), signs of which are visible on the surface in the form of a linear depression along the western part of the foundation (Figure 9).

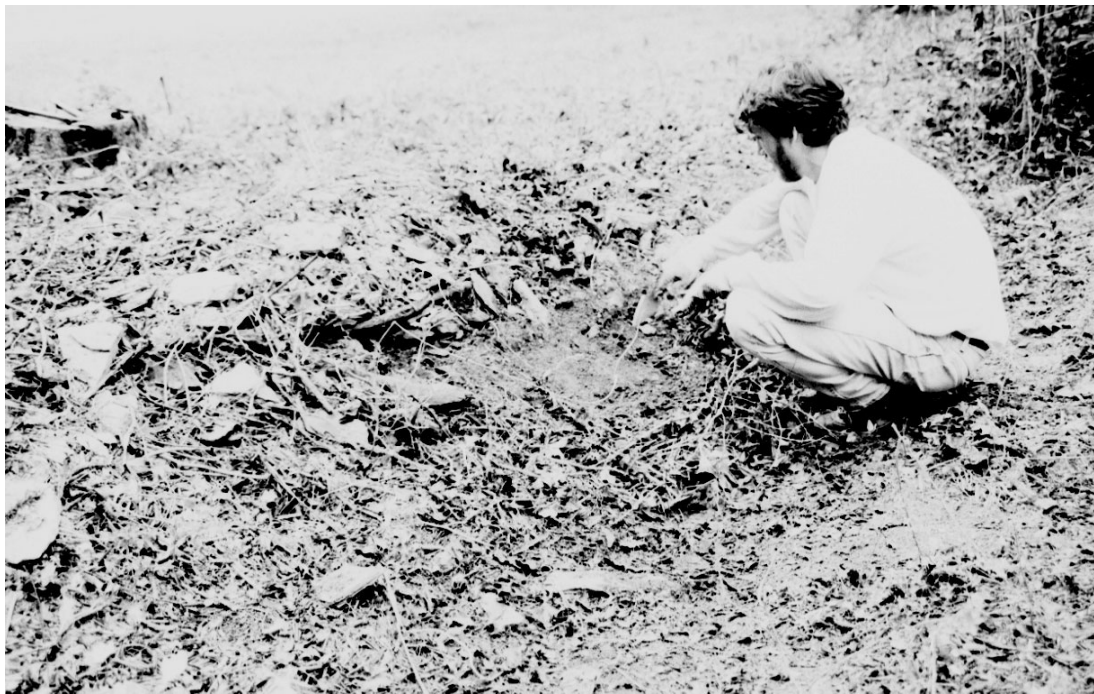
Figure 9. Chris Rodning in depression formed by builder's trench in the western part of the site.
