ARCHAEOLOGICAL EXCAVATIONS
AT THE SITE OF
GUILFORD COURTHOUSE

PREPARED BY THE RESEARCH LABORATORIES OF ANTHROPOLOGY
UNIVERSITY OF NORTH CAROLINA
CHAPEL HILL

Trawick Ward
Field Director

1976

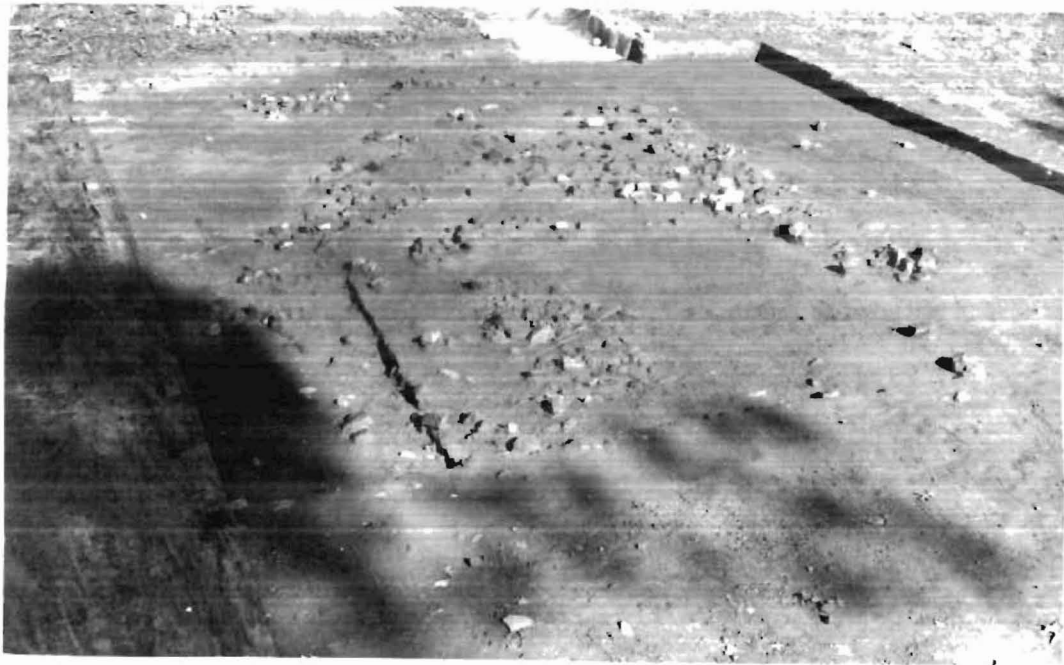
Brick Rubble - 1974 Excavation

The excavation of this area was completed in three steps. Because the broken brick and rock rubble was extremely compact and began to appear just beneath the surface, the entire area was first taken down to an average depth of only .3', and all brick fragments and stone were left in situ. Although no whole brick or articulated patterns were discerned, this initial clearing made possible the definition of the edges of the rubble, which was designated Feature 12. It was then mapped and photographed, and excavation continued to the subsoil surface. All brick, brick fragments, and stones resting on or intruding into the subsoil were again left in place. In addition to the rubble, traces of mortar were found throughout and in three instances, fairly thick homogeneous lens were noted. However, no articulated brick or rubble patterns reflecting definite structural or functional characteristics were in evidence (Figure-3). At this point it was felt that some type of footing was probably set in the subsoil and concealed by the rubble. Again, the feature was mapped and photographed prior to the complete clearing of the subsoil to determine if such a footing was present. This final operation revealed that no articulated structural remains were associated with the rubble mass. It was simply scattered throughout the 40' by 30' area, although it was concentrated in the center of the excavation.

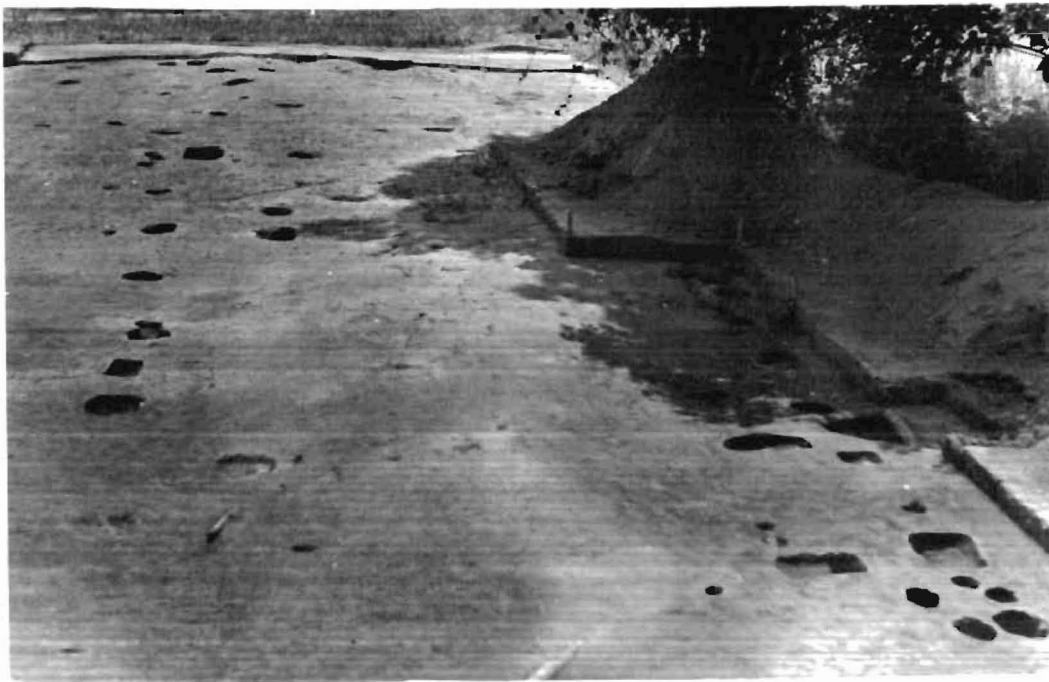
Foundation Postholes - 1975 Excavation

approximately 1' in depth. The size, spacing, and alignment of the postholes suggested they might have been dug to support wooden piers used in the underpinning of a structure. It was expected that parallel lines of similar intrusions would be found along one or both sides of this initial line. The search for supportive evidence led to the eventual excavation of a strip 15' wide on either side of Trench 14. A series of 10' squares was also taken out along the eastern edge of the rubble in hopes of finding additional structural evidence. At the end of the 1975 field season, the evidence for the existence of a structure in the courthouse area was substantial. In addition to the rubble, numerous postholes and features were uncovered indicating a considerable amount of construction activity (Figure 4).

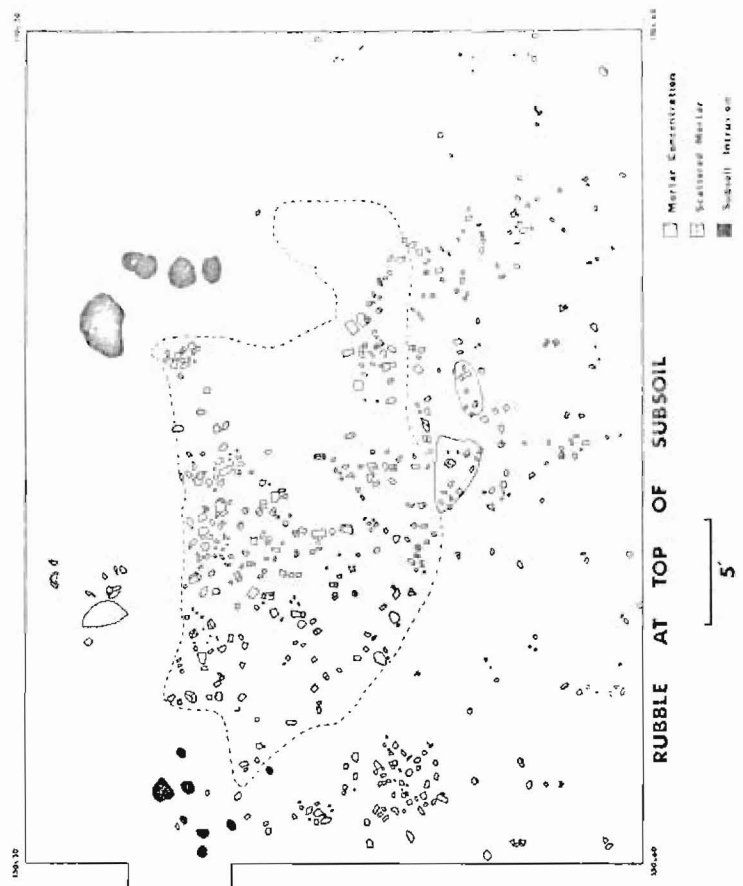
ARCHAEOLOGICAL REMAINS
OF
GUILFORD COURTHOUSE

As was previously mentioned, the western end of Trench 13 revealed a thin, badly disturbed modern deposit. In contrast, the eastern end of the trench contained a large number of small eighteenth century brick fragments in the plow zone and embedded in the upper portion of the subsoil. The discovery of these brick fragments led to the initial excavation of a 40' by 30' area approximately 25' west of the traditional courthouse site (Figure 3).

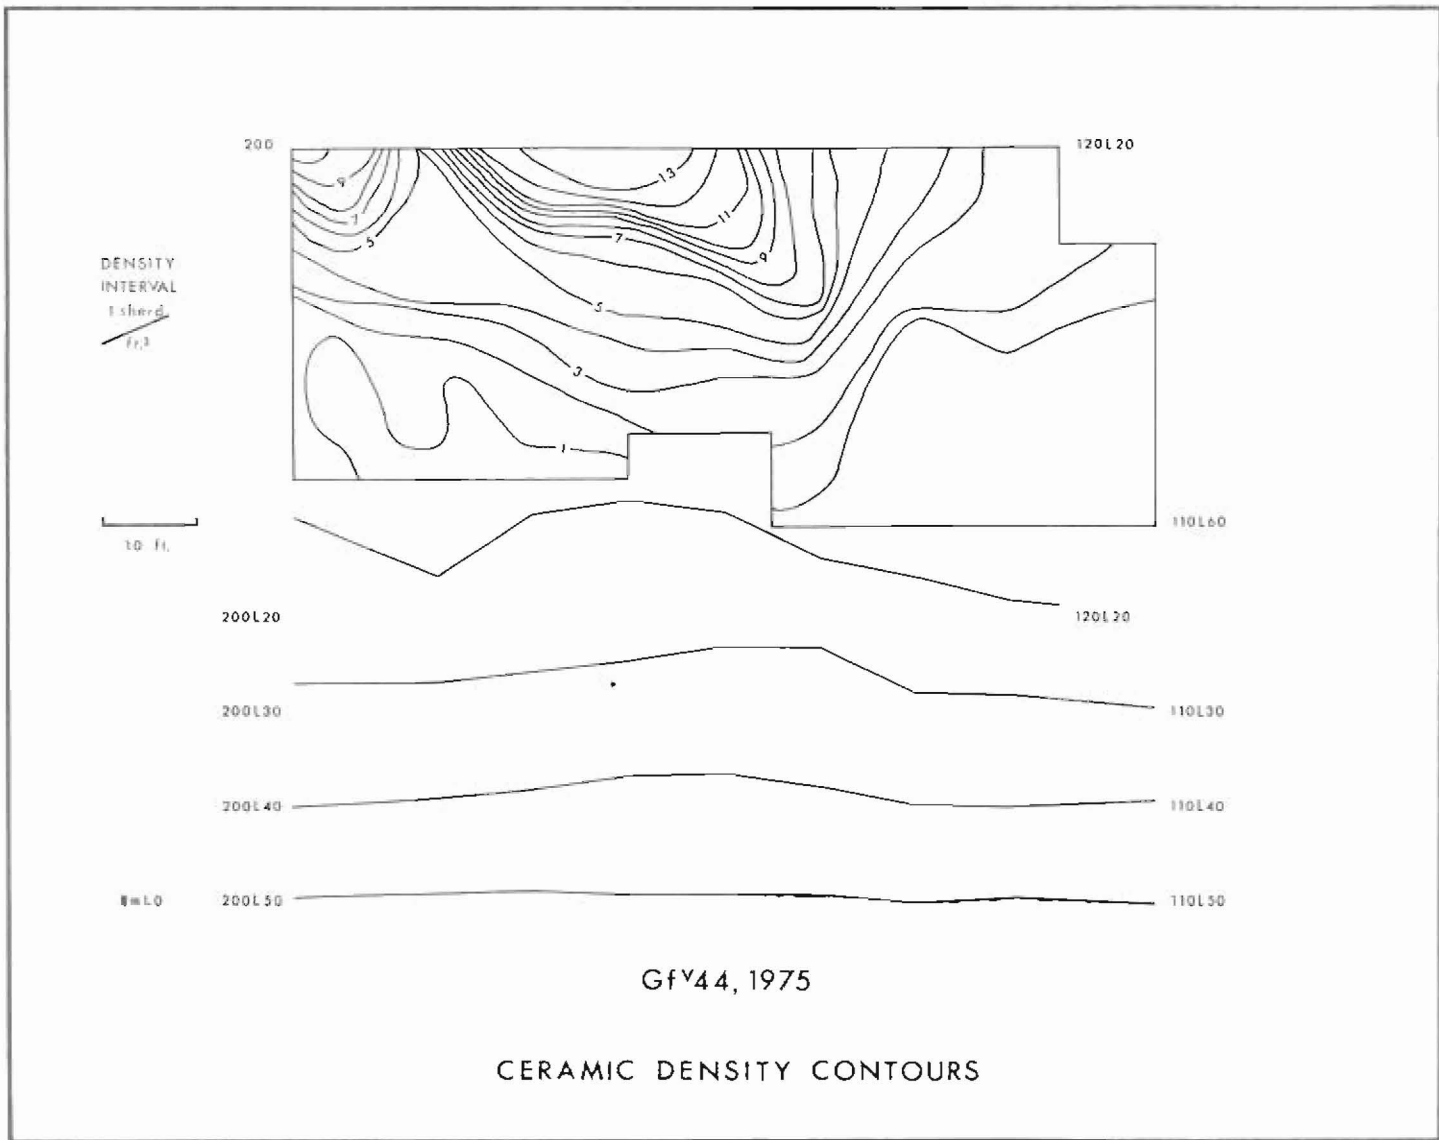
Figure 6

Each artifact class had a different overall distribution, but all were similar in that there were low densities in the area of the postholes. There was also a general tendency for the densities to increase in the east-central area of the excavation from roughly 140-160L30-40. The ceramic density increased fairly evenly from west to east and began peaking along the L30 line. There was also a peak in the northeast

corner next to the old well (Figure 6). Nails were most common between 140-160L30-40 and also had a high occurrence in the southwest section of the excavation adjacent to the western edge of the chimney fall (Figure 7). Flat glass, in most instances window glass, had the lowest densities of the three artifact classes, but in terms of distribution, it was very similar to the ceramics (Figure 8).

Since almost all of the material was recovered from the plow zone, in conjunction with the fact that the site was occupied for such a relatively brief period, vertical, stratigraphic separation was impossible. However, while excavating squares in the courthouse area, it was noticed that some units tended to produce more material and different kinds of material than others. To determine if there were any horizontal patterns to these variations and to see if various artifact classes co-varied, the occurrence density of the most frequently encountered artifact groups (ceramics, nails, and flat glass) were calculated. These calculations were made by dividing the total number of specimens in each class by the total volume of excavated earth from each horizontal grid section. Specimens from postholes and other sub-soil intrusions were excluded because of their extremely low densities and the difficulties involved in calculating the volumes of irregular configurations. This exclusion had minimal impact on the procedure as over 95% of the artifacts were from the plow zone. After density figures were derived for the grid units, they were transformed into contours and frequency profiles (Figures 6, 7, and 8).

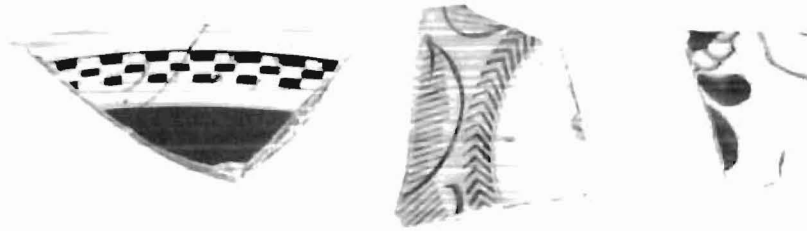
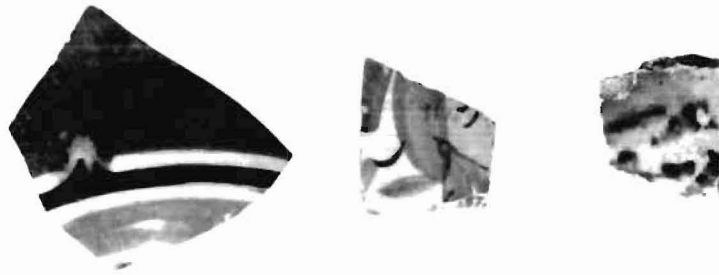
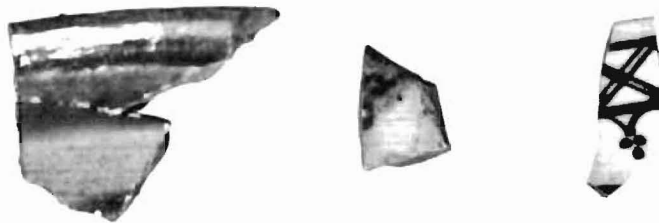
Typical Small Sherds

Left to Right, Row A; "Annular Wares", "Scratch Blue" Salt-Glaze, Delft. Row B; Mocha, Underglaze Polychrome, "Clouded" Ware. Row C; Polychrome Lead-Glazed, Transfer Printed, Underglaze Blue Hand Painted.

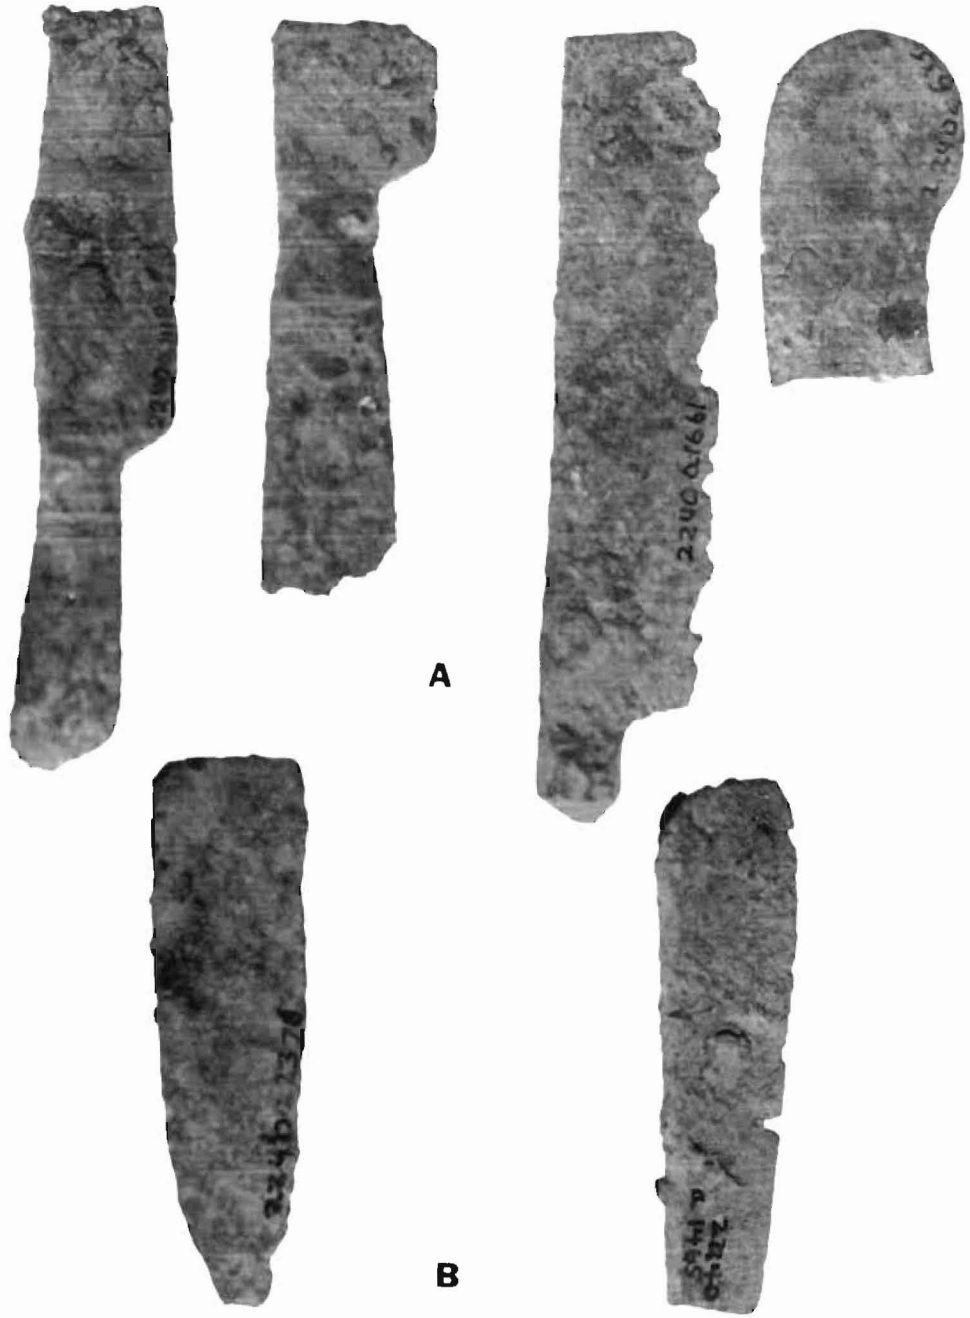
Plate IV
Cutting Tools

Butcher knives were represented by one-blade piece, which was heavily backed and wedge shaped in cross section. The blade width did not vary appreciably from the table knives, but the back of the blade was nearly three times as thick, 3 mm. as opposed to 1 mm. The identification of this fragment as a butcher knife blade was based on its

robustness as evidenced by the back thickness (Plate IV, Row B, far left). The blade of a straight razor was recovered which was also heavily back, but the sides were concave below the back making it considerably thinner than either the butcher knife or the table knife blades (Plate IV, Row B, far right).

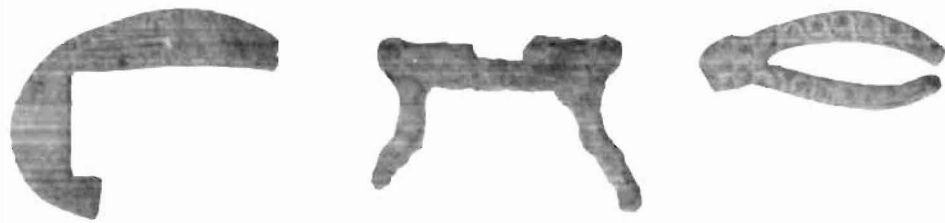
A total of nine shoe buckle parts were found, and all but one were brass frames with various geometric motifs in relief around the periphery (Plate VII, Row A, far left and far right). The exceptional shoe buckle fragment (Plate VII, Row A, center) was part of an ogee sided back piece similar to types found at Colonial Williamsburg (see Abbitt 1973: fig. 18.7, 19.9). The possible belt buckle had a brass frame and an iron tang, but no date could be ascertained (Plate VII, Row B).

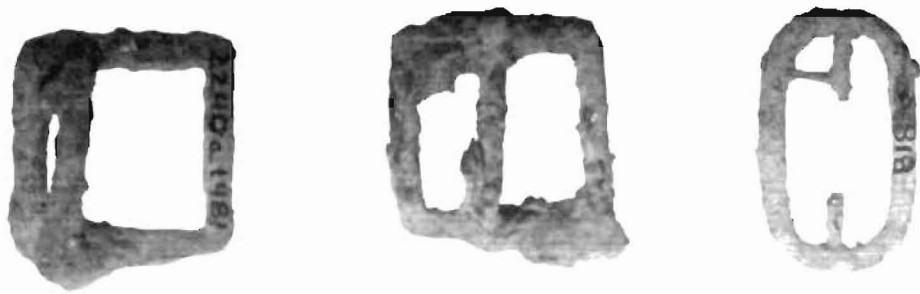
C

Both harness and shoe buckles, as well as one possible belt buckle, were represented. Seven of the eight harness buckles were square, made of iron and had single tangs. One specimen was ovoid in outline and was probably double tanged (Plate VII, Row C). The corroded condition and generalized nature of the buckle prohibited detailed description, and it was not possible to establish temporal limits.

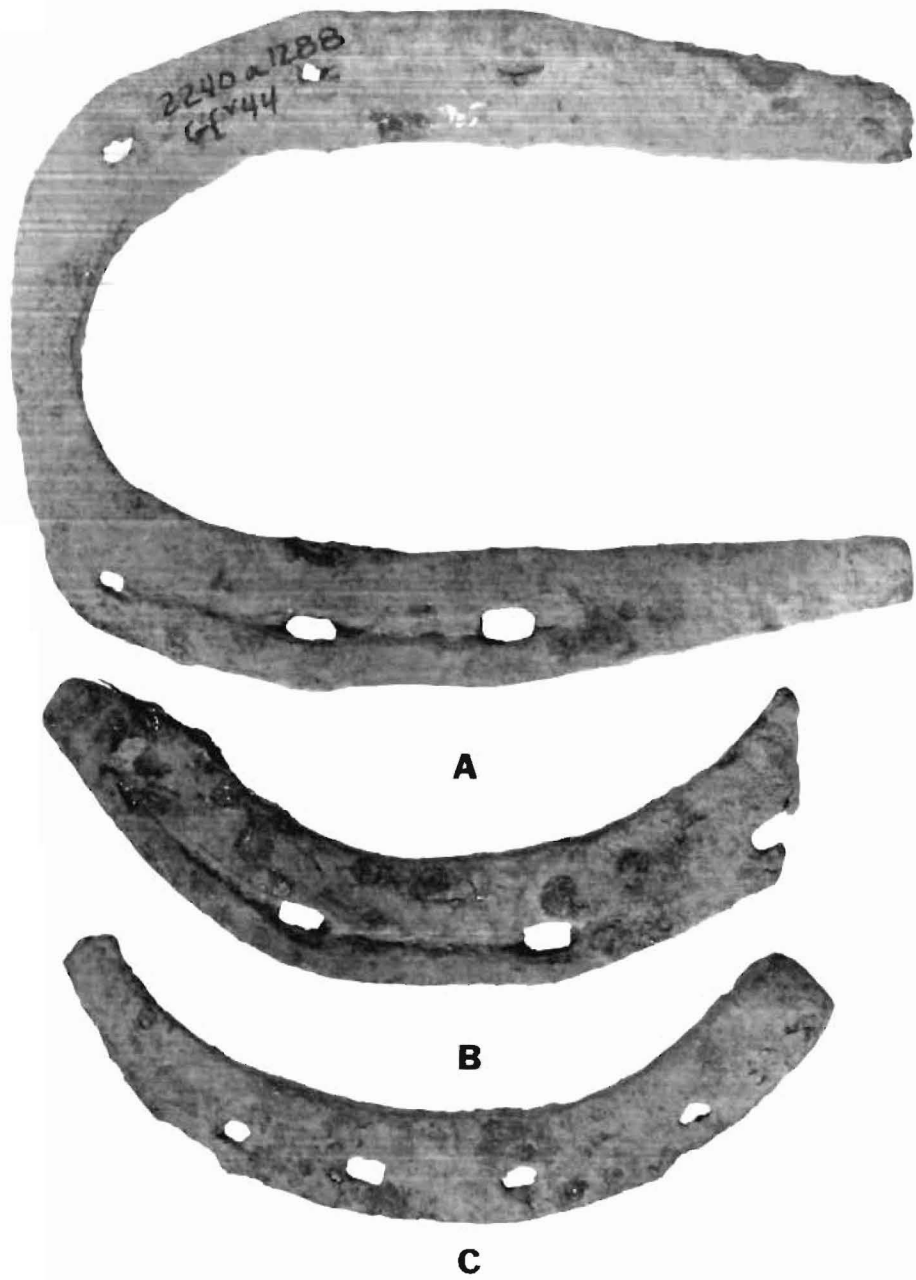
Plate VIII
Horseshoes

Twelve halves and one complete horseshoe were collected during the course of the excavation. At first glance, the horseshoe halves resembled ox shoes, but closer examination revealed that they were branches of badly worn shoes which had broken at the tip of the U-shaped toe. All were handmade and of the keyhole variety (Plate VIII, Row B and C). Three holes per branch were most common although one specimen contained four holes. All calkins were extremely worn and fullering was frequently indeterminate, but when it could be observed, a U or V-shaped cross section indicating hand-wrought shoes was present. Horseshoes with these characteristics were widely used throughout the eighteenth century (Chappell 1973:103). The one complete shoe was also handmade, but the branches were thicker and more U shaped resembling those commonly used during the nineteenth century.

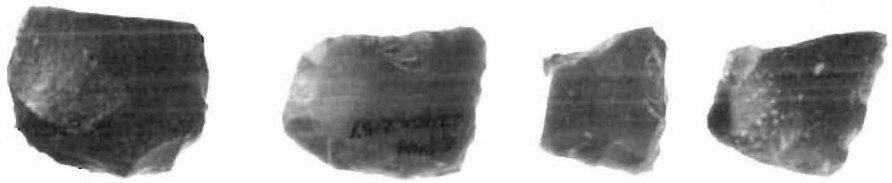
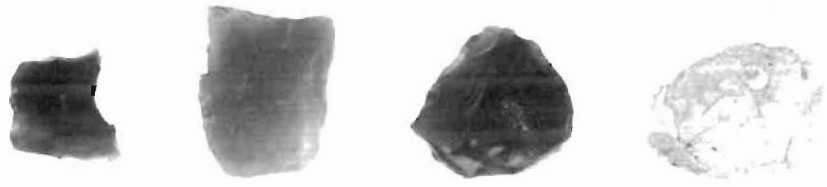
Plate X
Gunflints and Gun Spalls

Gun spalls were more common than the blade flints as 13 were found. Eight were manufactured from British and French flints (Plate X, Row C, second and third from the left), and four were chipped from a fine grained grey-black chert that was very similar to material found in the Tennessee area (Plate X, Row B). The type of material used to make the remaining spall could not be ascertained because of distortions produced by exposure to considerable heat (Plate X, Row C, far right). All of the gunflints and spalls, with one exception, were used in rifles or muskets. The exception was a small, blade type British flint which might possibly have been used in a pistol (Plate X, Row C, first on the left).

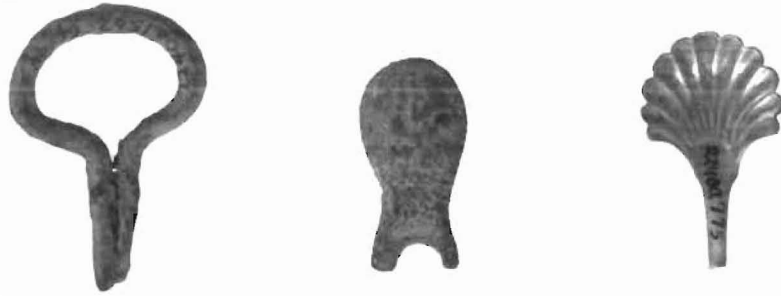
B

Although literally hundreds of bits and pieces of metal artifacts were recovered, the overwhelming majority were too fragmentary or corroded to permit even the most general classification and description. The few exceptions which could be identified but did not occur with sufficient frequency to warrant individual treatment in separate sections of the report included an iron Jews Harp (Plate XI, Row B, first on the left), part of a brass side plate from a firearm (Plate XI, Row B, second from the left), and silver plated and plain escutcheon plates
