Performance Evaluation Test of the Peco Tracked Brush Blazer

January 2008

Prepared by
Institute for Defense Analyses
4850 Mark Center Drive
Alexandria, VA 22311-1882

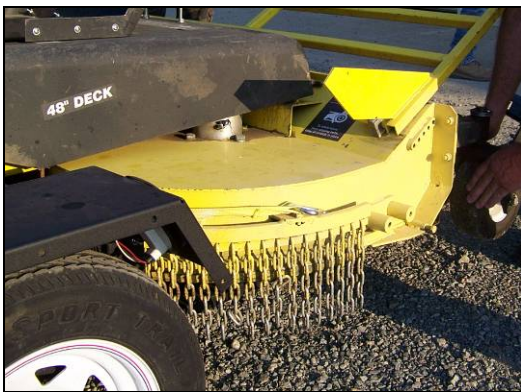
Figure 2: Chain-guarded Cutting Deck

The Peco Tracked Brush Blazer TBB-2001, referred to as the Peco Cutter, shown in Figure 1, is a heavy-duty brush cutter advertised as capable of cutting heavy undergrowth and trees up to 10 cm in diameter. It is equipped with a hydraulic track drive that gives the operator the ability to maneuver in all types of terrain, as well as perform 180-degree turns within its own length of 2.4 meters. Safety features of the Peco Cutter include a chain-guarded deck (Figure 2) and a front safety bar (Figure 3) to push over vegetation to be cut.

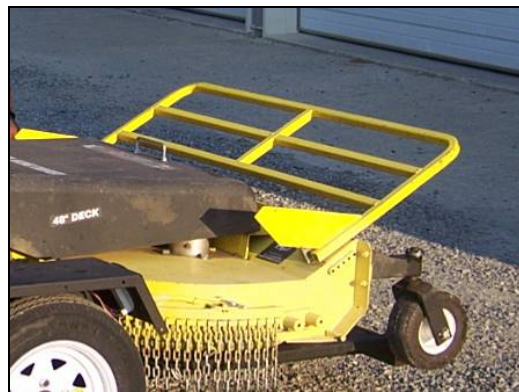
Figure 3: Front Safety Bar

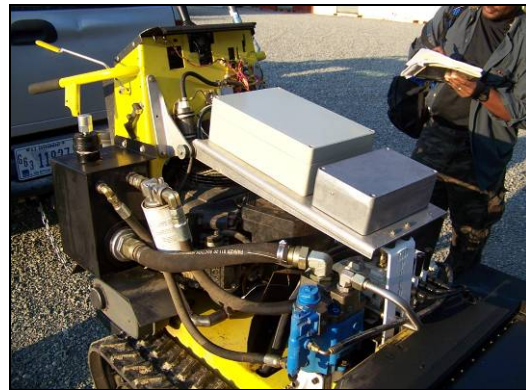
Figure 5: Peco Cutter Engine After Modifications (Top Cover Removed in Photo)

Modifications to allow for push-button manual operations as well as remote operations were made by the Humanitarian Demining Program Office's vehicle fabrication shop at Ft. Belvoir. The Peco Cutter remote-control system enables operators to start and shut off the Peco Cutter engine remotely, enable and disable the cutter remotely, and continue line-of-sight operations for distances up to about 400 meters. Photos of the modifications can be found in Figures 4 through 10. Table 1 lists specifications for the Peco Cutter.

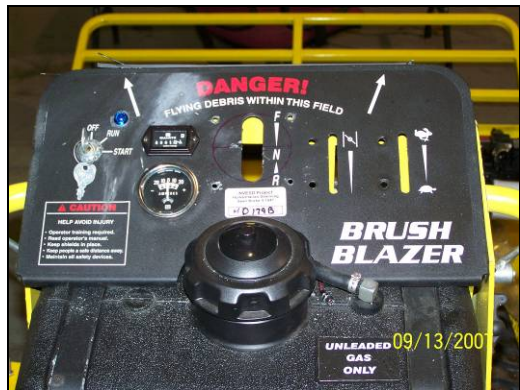
Figure 6: Instrument Panel Before Modifications (Note: Panel Levers Are Removed)

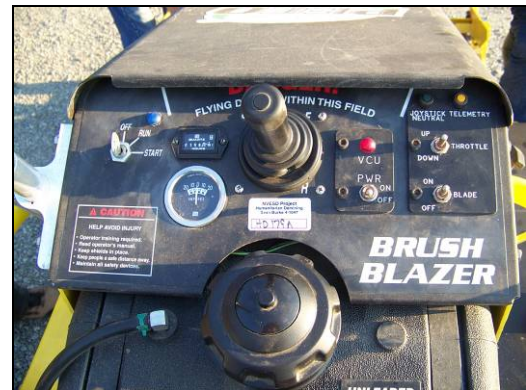
Figure 7: Instrument Panel After Modifications

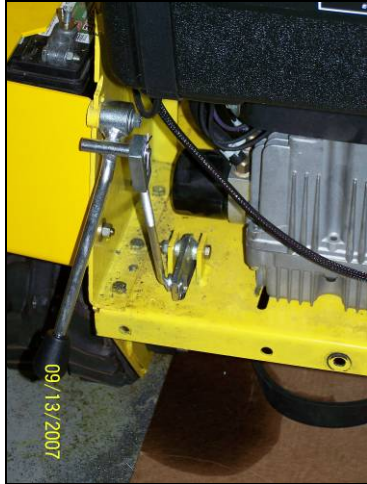
Figure 8: Manual Cutter Engaging Lever Before Modifications

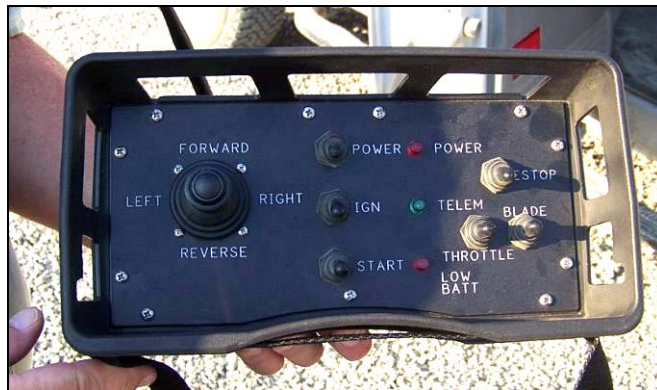
Figure 10: Hand-held Remote Control Device

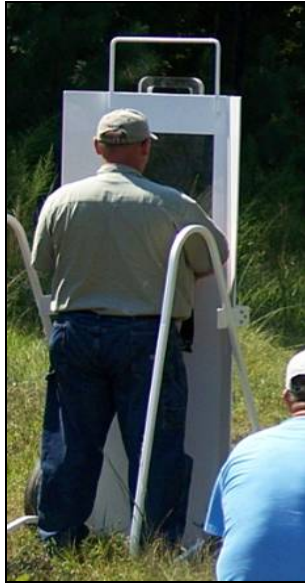
Figure 24: Operator Working Close to Shield

The remote antennas were initially mounted on the Peco Cutter and on the operator's remote-control device. As the operator stood behind and close to the shield, as shown in Figure 24, radio transmissions were blocked. The Peco Cutter's remote system was designed to shut down the vehicle if the communicating signal was lost. Thus, there were several instances when the Peco Cutter shut down due to interference from the shield. To remedy this problem, the remote control unit's antenna was removed and mounted on the top of the mobile shield (see Figure 25), and a connecting cable was run between the antenna and the remote-control unit as shown in Figure 26. Also, a hook was mounted to the inside of the shield, so the operator could continue operations without having to hold the remote device. With this configuration, remote operations were

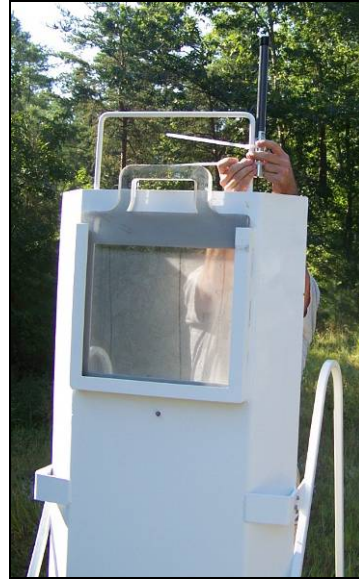
Figure 25: Mounting Remote Antenna to Operator Shield

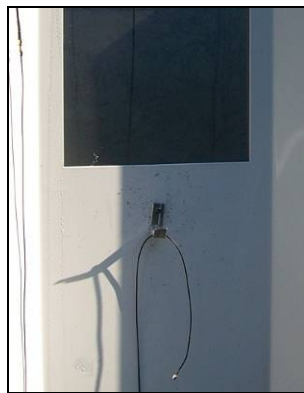
Figure 26: Remote Device Hook and Antenna Cable

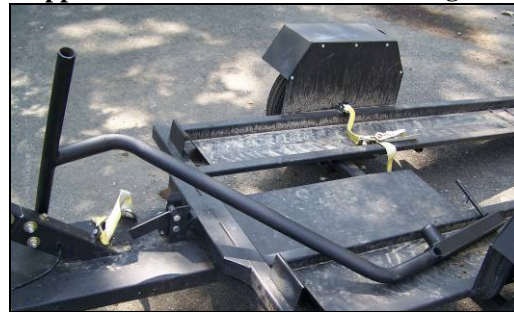
Figure 32: Trailer with Removable Handle (Handle is Lying on Trailer, Not Connected)

The Peco Cutter, its on-road traveling trailer, the operator's shield, and all mechanical and electronic spare parts are stowed in a 10 ft (3 m) shipping container. The Peco Cutter is shipped strapped to its trailer (Figure 30), and metal ramps are used for loading and off-loading the duo (Figure 31) into the container. A removable handle (Figure 32) is used to assist personnel in maneuvering the trailer into and out of the shipping container.

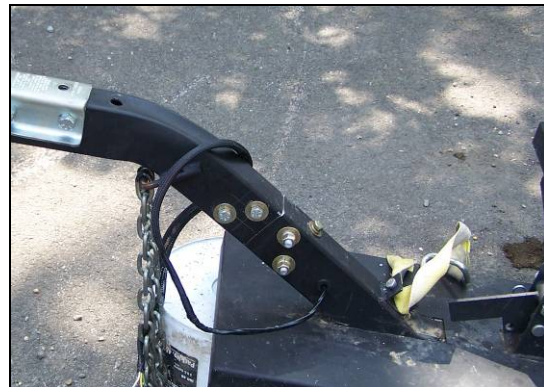
Figure 34: Trailer Connecting End, After Modifications

To ensure that the trailer would fit into the container, a modification was made to the trailer's connecting end (as shown in Figures 33 and 34), making it removable. Table 3 shows specifications for the trailer.
