Operational Evaluation Test of Mine Clearing Cultivator and Mine Clearing Sifter

January 2005

Institute for Defense Analyses
4850 Mark Center Drive
Alexandria, VA 22311-1882

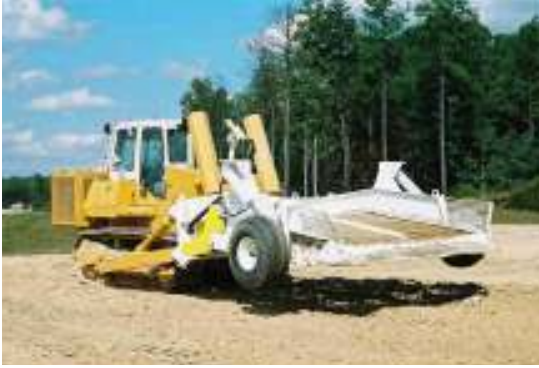
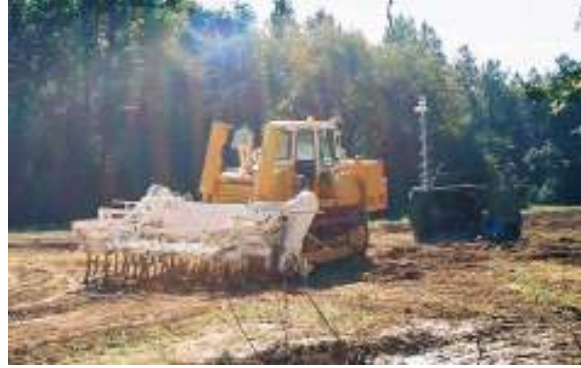
Figure 1: MCC/MCS and Control Vehicle

The Mine Clearing Cultivator/Mine Clearing Sifter (MCC/MCS) consists of the following: the prime mover, the cultivator, the sifter, the Standardized Remote Control System (SRCS) and a hydraulic power unit (HPU). The prime mover for both the cultivator and the sifter is a Liebherr Crawler Tractor, Model No. PR742B, with a rear-mounted HPU. The HPU supplies power to both the cultivator and the sifter. The Mine Clearing Cultivator was designed and built by the Modeling and Mechanical Fabrication Shop of NVESD at Ft. Belvoir, Virginia, as was the Standardized Remote Control System for remote operation of the prime mover, cultivator and sifter. Support equipment includes a separate vehicle to house the remote operators' control station and a portable generator unit. The Reliance Corporation built the sifter.

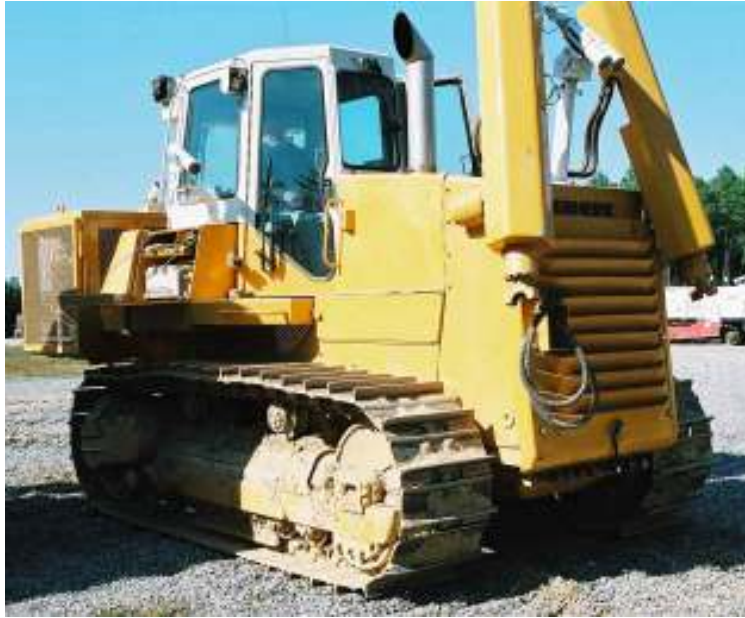
Figure 2: Liebherr Tractor with Modifications

The prime mover for the MCC/MCS is a Liebherr Crawler Tractor, Model PR742B Litronic, manufactured by Liebherr-Werk-Telfs GmbH, Telft, Austria. The Liebherr has a hydrostatic transmission system, which allows continuous and total control of the power to the tracks. This feature gives the operator the ability to adjust the power setting necessary to maintain a set speed for the prime mover as resistance to forward movement varies, a desired capability when operating the MCC/MCS.

allow driving of the tractor and operation of the MCC and MCS from a remote command vehicle.

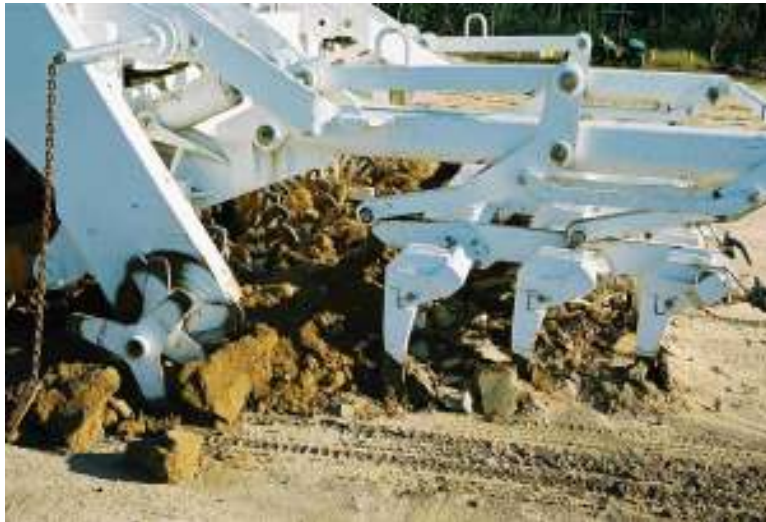
Figure 4: Mine Clearing Cultivator

The MCC was designed and built by the Modeling and Mechanical Fabrication Shop of the Night Vision and Electronic Sensors Directorate (NVESD), Ft. Belvoir, Virginia. The cultivator tines are designed to break up the soil and bring dislodged mines to the surface. The spacing of the cultivator tines allows a mine to move through the cultivator to a horizontal auger whose purpose is to move the mines out of the cultivator and deposit the mines in a berm to either the left or right of the cultivator and tractor.

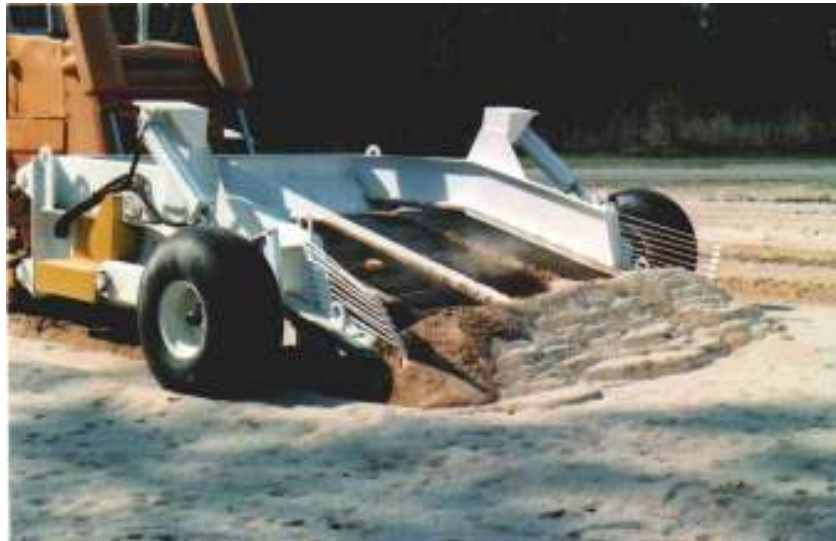
Figure 8: Mine Clearing Sifter

The Mine Clearing Sifter (MCS), manufactured by the Reliance Corporation, is identical to the Heartlands Sifter tested by NVESD in 2002. (The report on the 2002 test of the Sifter is presented in Appendix A). The sifter, an off-the-shelf agricultural machine, is used to remove land mines from the soil by the sifting action of two steel-bar conveyor belts and a discharge conveyor belt that deposits the mines in windrows off to the side of the sifter and prime mover. The discharge belt drive mechanism allows selecting the side of discharge.

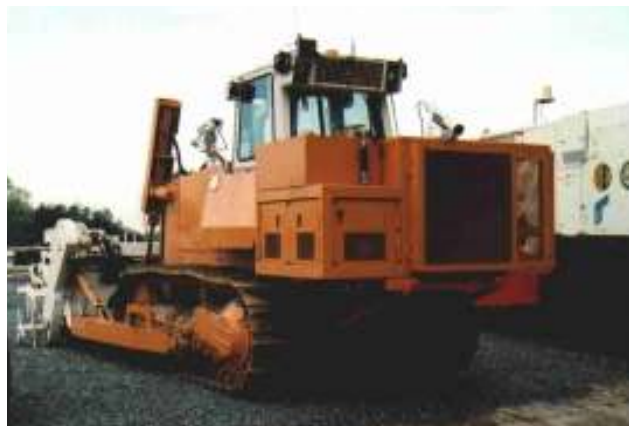
Figure 11: Hydraulic Power Unit (HPU)

Due to the hydraulic power requirements of the cultivator and sifter, an auxiliary, diesel-driven HPU was mounted just aft of the cab on the Liebherr crawler tractor. The HPU, powered by a 177 HP, Deutz diesel engine, is capable of providing 80 gpm of hydraulic fluid at a pressure of 3000 psi.

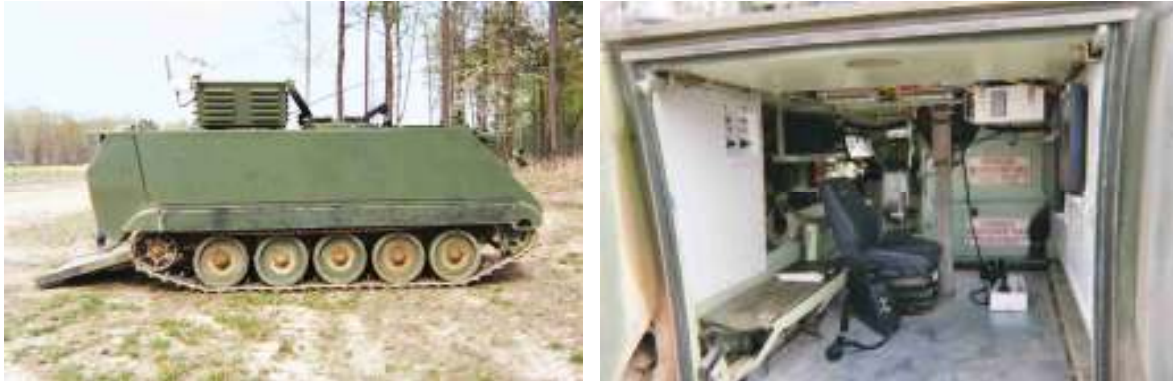
Figure 12: Remote Command Vehicle (exterior and interior)

The SRCS is a stand-alone system that can be mounted in any van-like vehicle (or large SUV) or a small portable room. The volume needed must accommodate the vehicle and mast-mounted camera operators and have wall space for five flat-panel displays measuring 18×24 inches each. For this test, an M113 armored personnel carrier was used as the Remote Command Vehicle (RCV). In other tests using the SRCS, SUV-like vehicles have been used as the RCV. The portable generator for the SRCS and a commercial air conditioner were mounted on the roof of the M113.

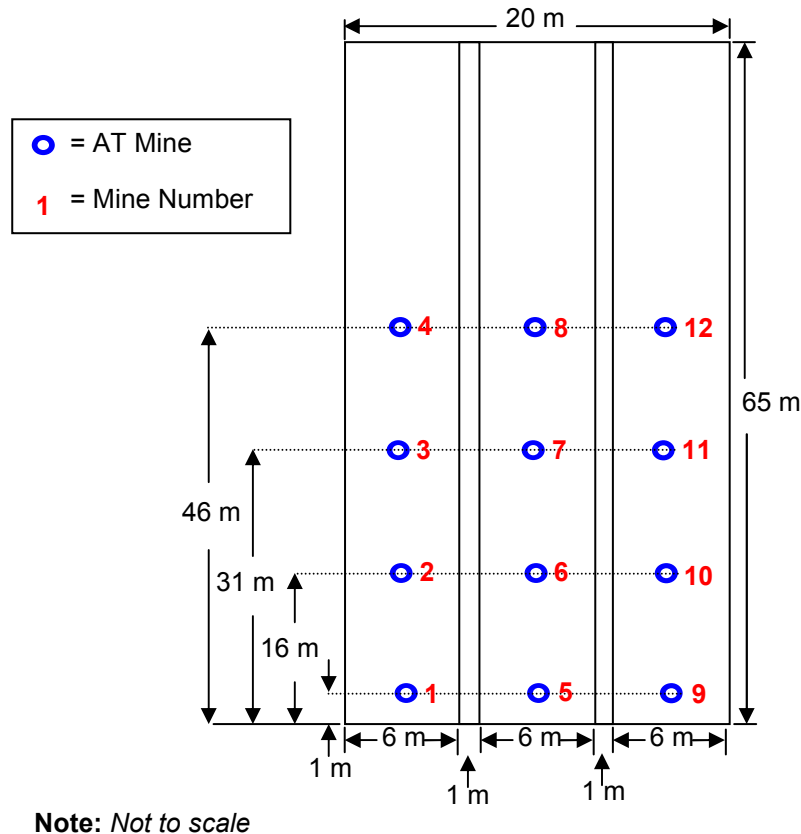
Figure 18: Standardized Test Layout

For Sites 1 and 2, the standardized test was conducted in an area that was 20 meters wide (three 6-meter-wide lanes with one-meter separation between the lanes) and 65 meters in length. Four AT mines with smoke fuses were buried in the center of each lane, with a 15-meter separation between each mine, starting at one meter (see Figure 18). Each mine was buried at a depth of 4 inches (10 cm) measured to the top of the mine. The purpose of having the cultivator engage the mines close to the cultivator's centerline was to maximize the distance a mine would have to travel inside of the cultivator until it was discharged by the auger.

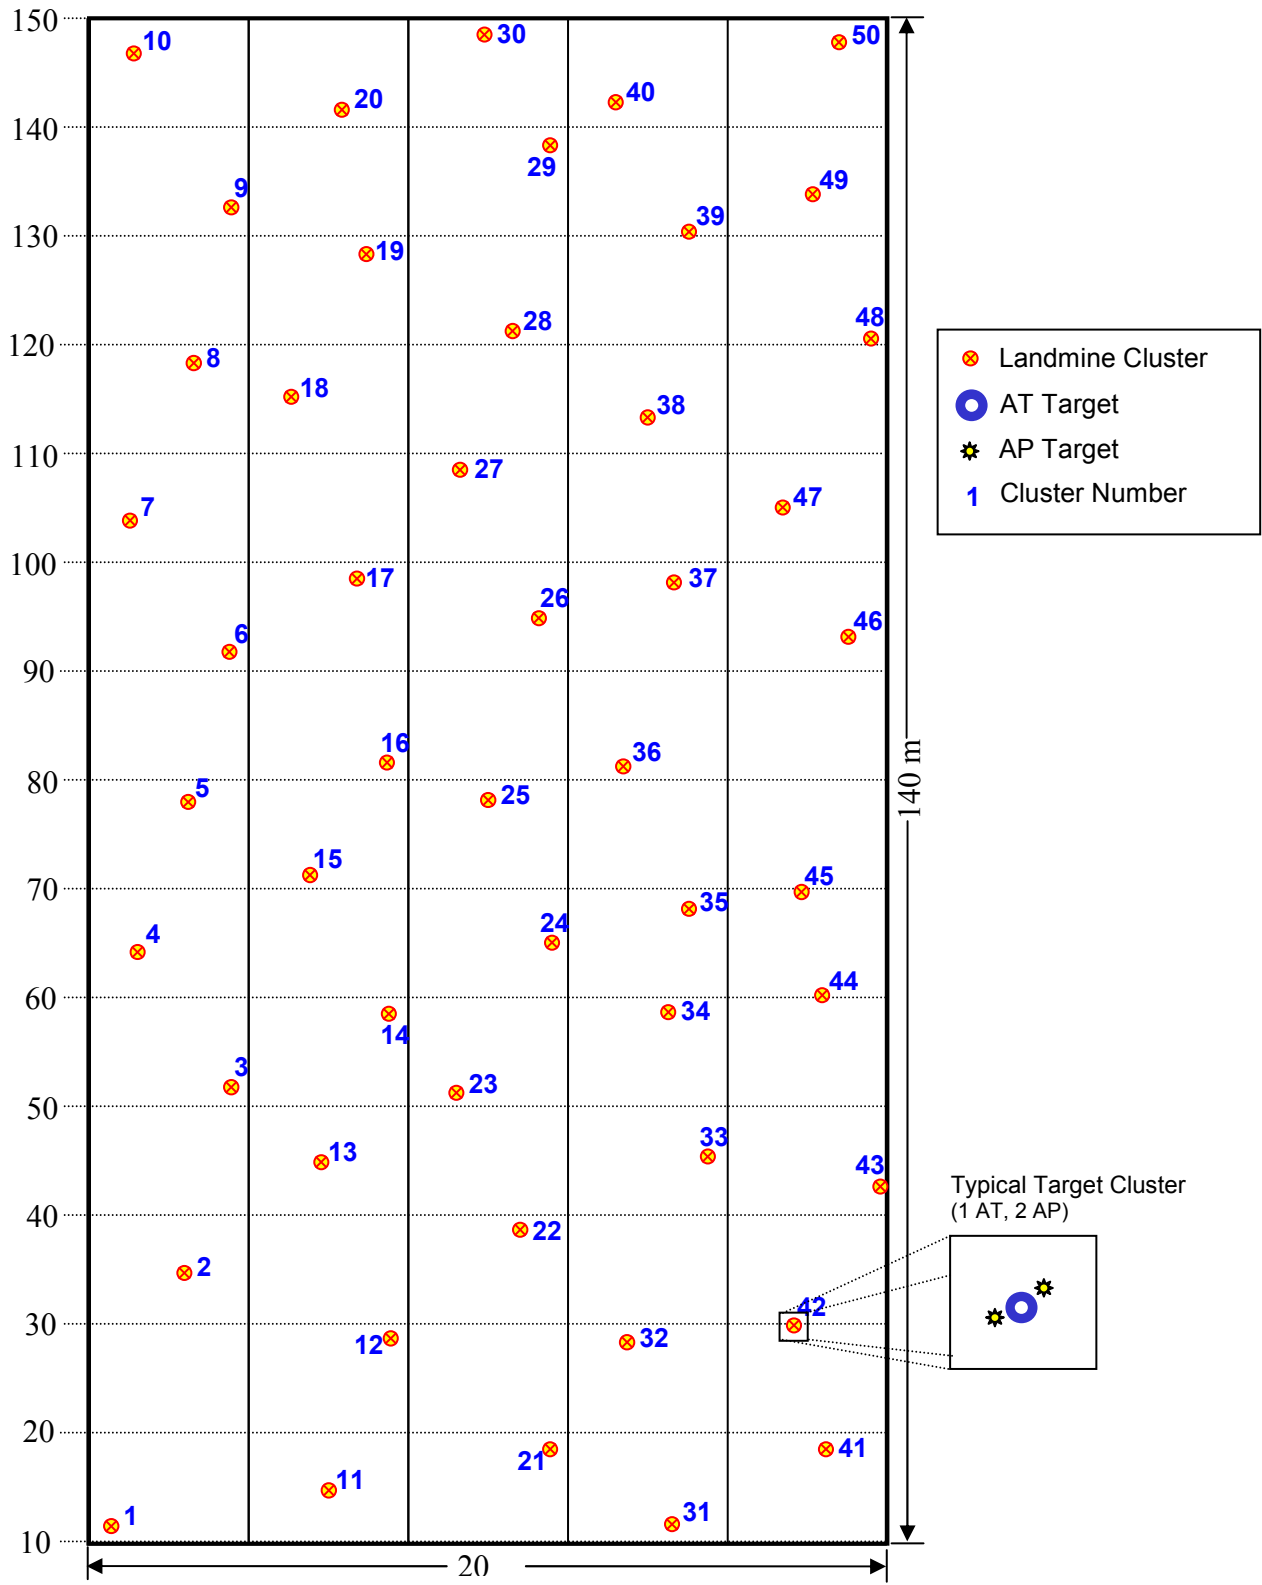
Figure 20: Minefield Layout at Test Sites 1 and 2

The round, metal AT mines at all three test sites were buried with smoke fuses installed to simulate the detonation of an AT mine.

After the removal of the mines, the cultivator was used to remove the sod ground cover. The mines were then reburied as shown in Figure 20. The cultivator worked reasonably well in the soil with the sod removed. However, the cultivator still experienced some soil build-up due to the root system that remained in the soil, and the moisture content after the sod had been cleared. This root system/soil build-up was not significant enough to stop the equipment from completely clearing the minefield.

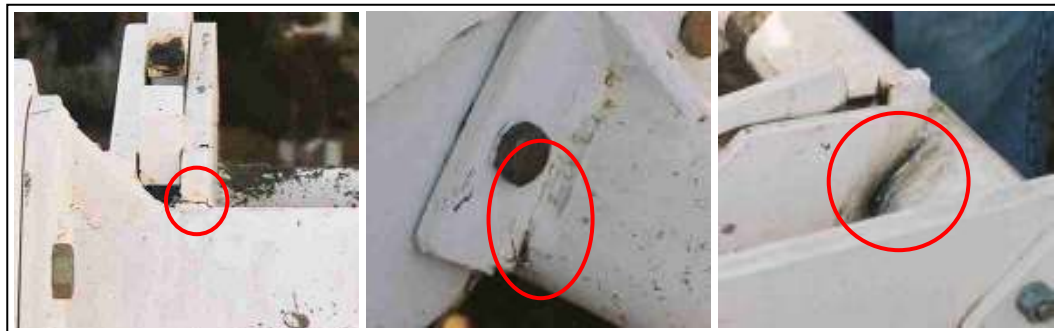
Figure 23: Cracks Found on the MCC

1. During a routine inspection of the tines of the MCC after the trials at Test Site 1, cracks were found along the welds between the connecting bar and the tines (see Figure 23). A welding unit was brought in and the cracks were fixed within an hour. The remainder of the test was completed with no new cracks developing.

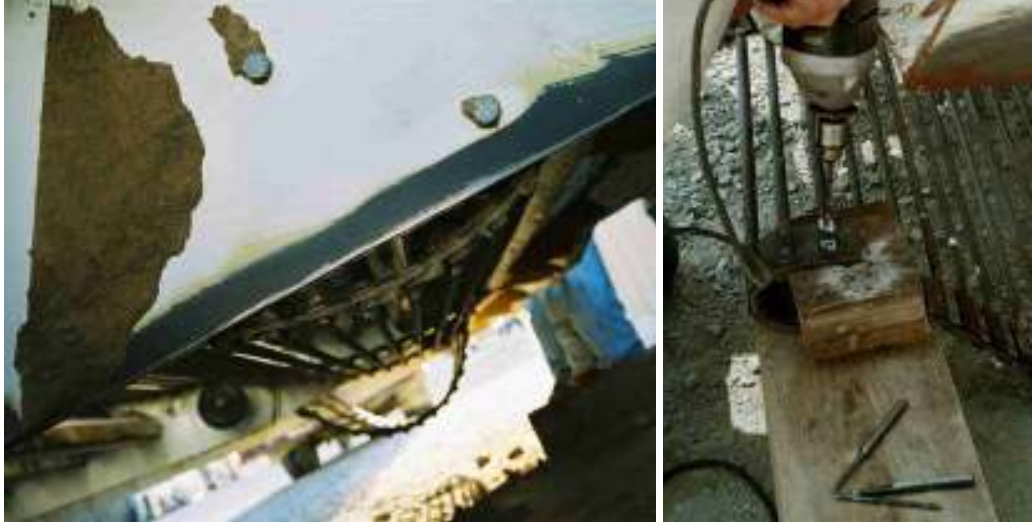
Figure 24: Loose MCS Belt Repair

2. A major concern was the main conveyor belts on the MCS. In previous tests, it was found that operating the sifter with heavy loads (very moist or rocky soil) could cause the main sifting belt to stretch, causing it to override the drive sprockets. While care was taken to prevent this from happening during this test, a belt was found to have stretched excessively from the limited work done at Test Site 1 (in soil with 25% to 30% moisture levels at 8 inches depth). The main sifting belt was opened at the closing (master) link, unfastened from the MCS and tightened by shortening the belt by removing one bar and its webbing.

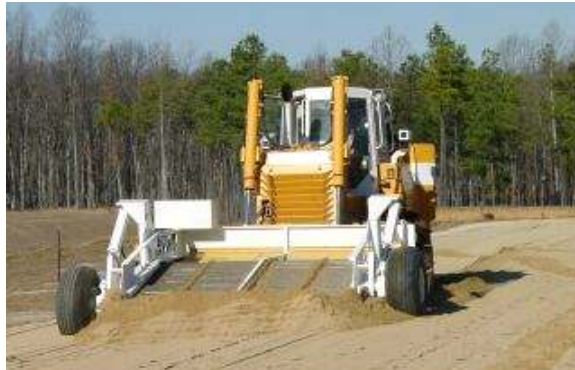
Figure A-1: Heartlands Sifter

operations. Using customized mounting hardware, the HLS can be mated to various construction vehicles which function as the prime mover. The prime mover selected for this test was the Liebherr 742 crawler tractor with a four-point, C-frame hook-up. The Modeling and Mechanical Fabrication Shop of the U.S. Army Communications Command, Night Vision and Electronic Sensors Directorate (NVESD) Fort Belvoir, Virginia, integrated the HLS with the Liebherr tractor.

The COTS HLS consists of everything forward of the Liebherr tractor (i.e., the sifting web, cross sifting web, and the tires) (see Figure A-1). An auxiliary hydraulic unit driven by a 175 HP diesel engine, mounted on the rear of the tractor, drives the sifter. The dimensions of the sifter are provided below in Table A-1 and depicted in Figure A-2.

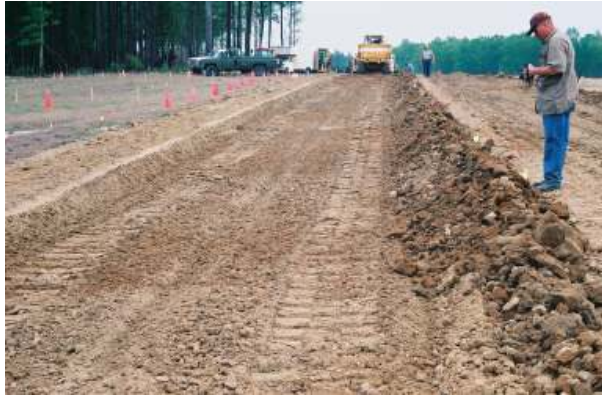
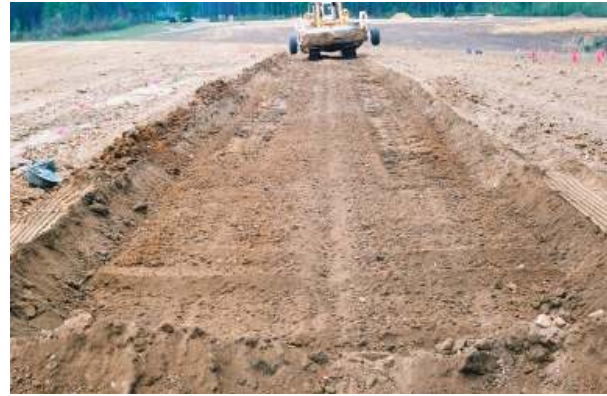
The HLS was evaluated over four runs in the cultivated and sifted heavy clay and covered 900 m² of area in 32.5 minutes (1660 m²/hr). The average soil moisture content was 11.9%. The soil was prepared using the FMB and the HLS. The evaluation was conducted as the HLS processed the soil for the second time. The only significant difference in processing between the cultivated heavy clay and the cultivated and sifted heavy clay was the amount of time the HLS took to process the soils. The HLS processed the sifted soil 11.2 minutes faster than the unsifted heavy clay soil. The HLS dug as deep as 30 cm, lifting uncultivated and unsifted soil as well as sifted soil from the previous run, which resulted in large berms of dirt clumps and debris along the windrow.

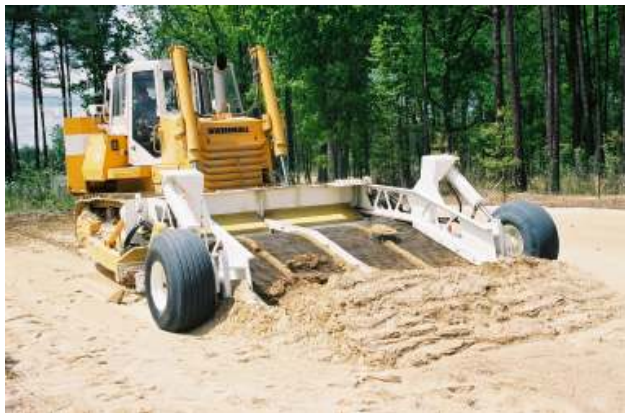
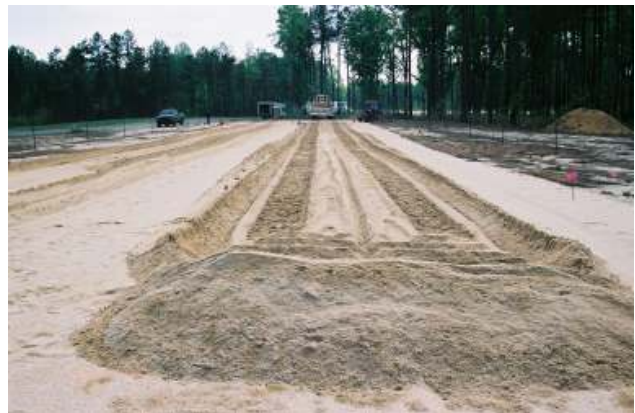
The HLS was evaluated during six runs in the sandy soil, covering 1350 m² of ground in 64 minutes (1265 m²/hr). The sandy soil was loose and damp with an average soil moisture content of 17.2%. The HLS was able to dig as deep as 40 cm. This depth is 10 cm more than the manufacturer's recommended maximum depth for the system. Soil preparation was not needed for the HLS to operate effectively in the sand. However, after each run, the rake mounted on the back of the tractor was used to level out the end-berm left by the HLS.

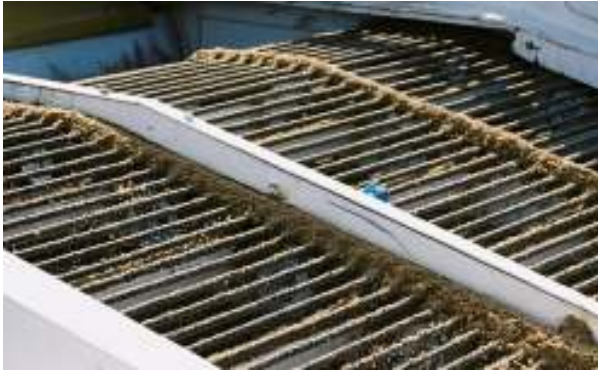
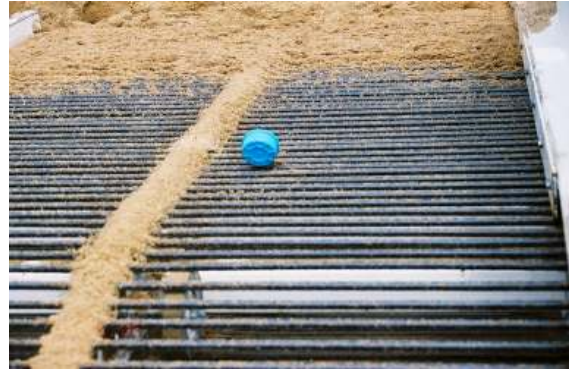
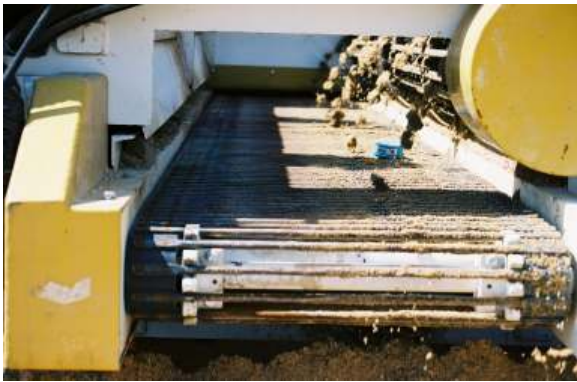
In four instances, the smaller targets (one PMN, two MK2, and one Type 72) slipped between the main sifting web and the cross conveyor. These targets were either caught underneath the main web or fell back onto the sifted ground underneath the HLS. If these were live mines, additional problems could have occurred. First, the sifted soil could have contained live mines. Second, the probability of some mines detonating could be increased due to the mines being battered as they continued to bounce in the sifting web instead of clearing the sifter.

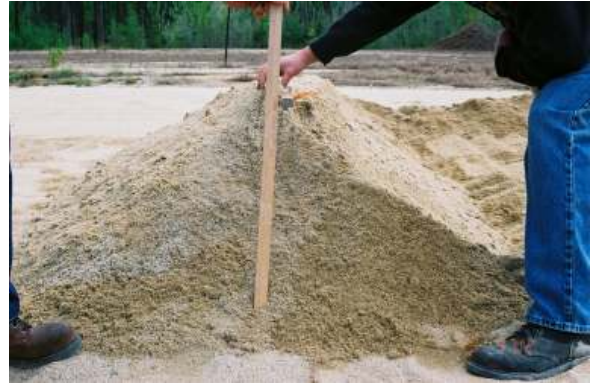
In both heavy and light clay soils, the HLS left large windrows, where the targets were either partially or totally reburied under the clumps of soil. For actual demining operations, another mechanical system or deminers with metal detectors will have to follow the HLS to find and remove these reburied targets from the berms. In all soil conditions, a soil bow wave formed on the front scoop during operations through which mines entering the sifter had to pass. When the dirt bow wave was removed from the sifter at the end of each lane, an end-berm was formed. Since the end berm could also contain mines, it also must be treated mechanically or by deminers with metal detectors to removes any remaining mines.

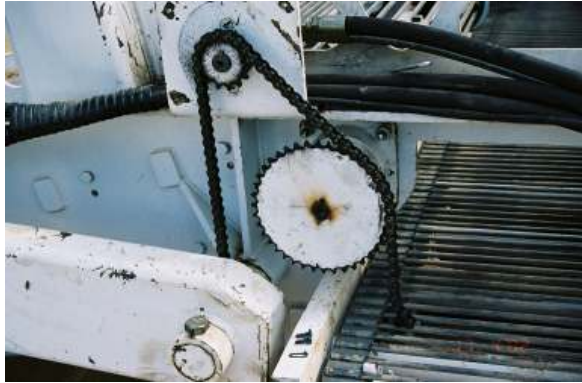
The only damage to the HLS that required major repair occurred at the beginning of the test period, during the start of the second run. The left sprocket chain and the right main sifting web broke. The repair took about half a day once the parts arrived. The HLS performed well for the rest of the testing period.
