Source: *Studies in Conservation*, Vol. 37, No. 3 (Aug., 1992), pp. 193-200

# DECAY AND TREATMENT OF MACAEL WHITE MARBLE

**Abstract**—This paper reports the process of deterioration of the white marble used in the Alhambra of Granada, and its consequences. Variations in mineralogical composition, microscopic topology, hardness, compressive strength, propagation of ultrasonic waves, absorption and diffusion of water and properties related to the pore structure were studied. The relationships between these factors, the visible deterioration and possible mechanisms are discussed. A preliminary evaluation of some protective treatments was carried out. The results can also be applied to white Macael marble used in other monuments in an environment with wide fluctuations in temperature and relative humidity.

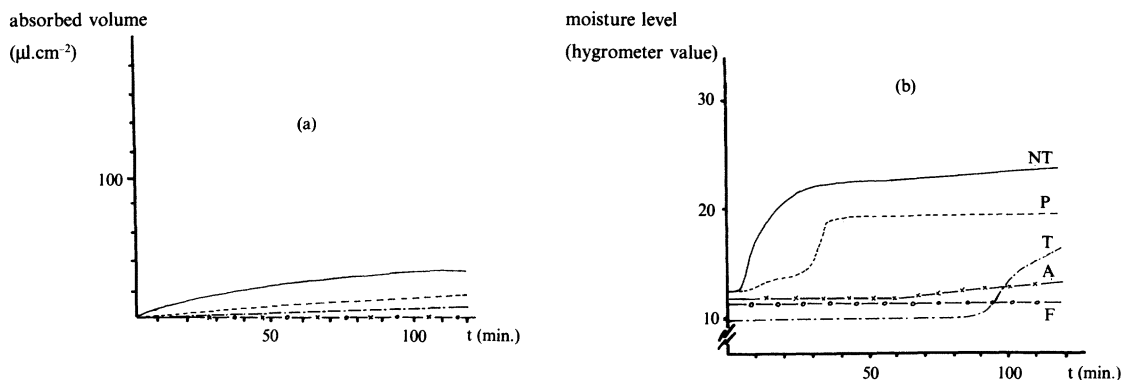
The extent of water-proofing achieved was measured by the test for water absorption at constant hydrostatic pressure described previously. The results obtained are shown in Figure 8 where water absorption and diffusion curves have been plotted against time. As can be seen, all the products give a decrease in water absorption and diffusion; the best results for water absorption were obtained with Fomblin and ARD 55.050, and for diffusion of water with Fomblin.

Figure 8 Water absorption (a) and diffusion (b) curves at constant hydrostatic pressure for Macael marble: untreated (NT), treated with Fomblin (F), ARD 55.050 (A), Tegosivin (T) and Paraloid B-72 (P).

Preliminary evaluation of the water-proofing effect of some protective products has shown that the acrylic product is not suitable for this purpose. The other products tested gave good results in general, but it will be necessary to submit the samples of treated marble to accelerated weathering to evaluate their behaviour under different conditions.
