Sand Retaining Structure to Increase Longevity of Beach Nourishment – A Case Study in the USA

Haiqing Liu Kaczkowski, Steven Traynum & Drew Giles
Coastal Science & Engineering, Inc., Columbia, South Carolina, USA

Abstract: Beach nourishment is the primary soft solution for coastal erosion and has been widely used in the USA. However, where a site's erosion rates are high, or the duration of construction has to be short, nourishment alone may not provide a sustainable solution. In such cases, sand-retaining structures can be incorporated into the nourishment design to increase project longevity. The authors have successfully implemented this combined design at several project sites. Folly Beach County Park, South Carolina was nourished at least 13 times between 1979 and 2005. After the 2005 nourishment, the restored beach eroded at an accelerated rate and was no longer providing storm damage reduction along the park. A combination of a terminal groin and nourishment was determined as the optimal means of restoring and maintaining the beach and protecting park infrastructure. The project was completed on 19 June 2013 and has been monitored since then. The results show that the once

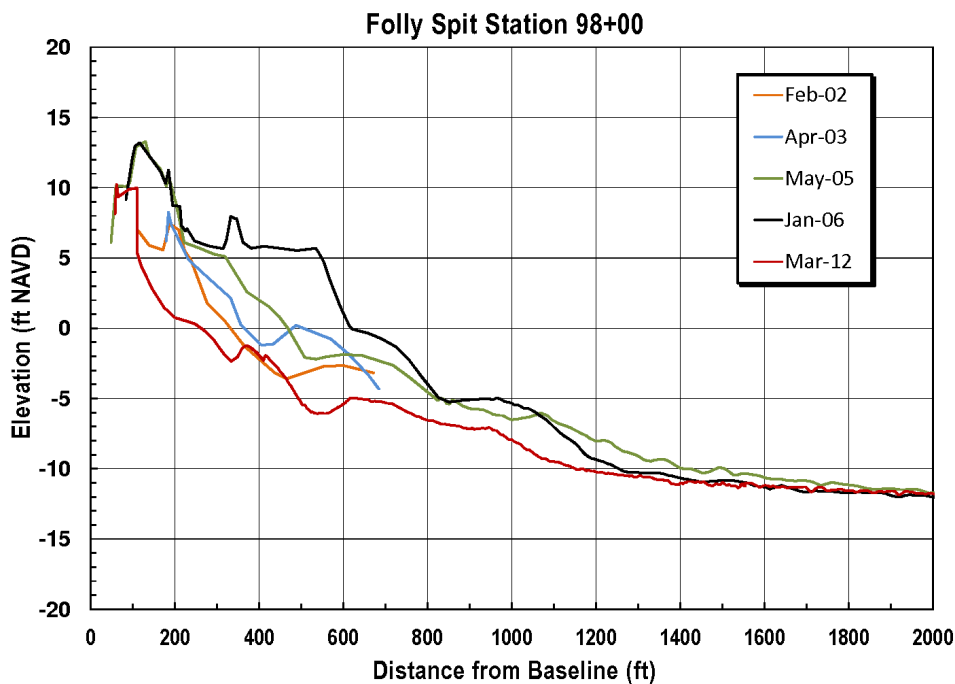
Fig. 3. Representative profiles (February 2002 to March 2012) for station 98+00 located near the proposed terminal groin.

The visible beach is situated at distances of 30–180 m (100 – 600 ft: Fig. 3) from the survey baseline. Review of the profiles in Fig. 3 shows a major advance of the visible beach between 2005 and 2006. This period coincides with the federal renourishment of Folly Beach (using an offshore borrow source

off the eastern end of the island). Between 2006 and 2012, the visible beach eroded nearly 135 m (measured at the +1.5 m contour). The net change compared with February 2005 is a recession of 38 m (125 ft). In other words, the beach at station 98+00 advanced seaward from 2005 to 2006 (due to nourishment) before retreating over the next six years. Net sand volume loss within the park upcoast of the 2002 proposed terminal groin was 275,200 m³ between January 2006 (post-nourishment condition) and March 2012. In August 2011, FBCP suffered heavy erosion after Hurricane Irene passed off the South Carolina coast. The storm rendered certain facilities inaccessible, forcing closure of the property and eliminating public access and parking on the west end of Folly Island.

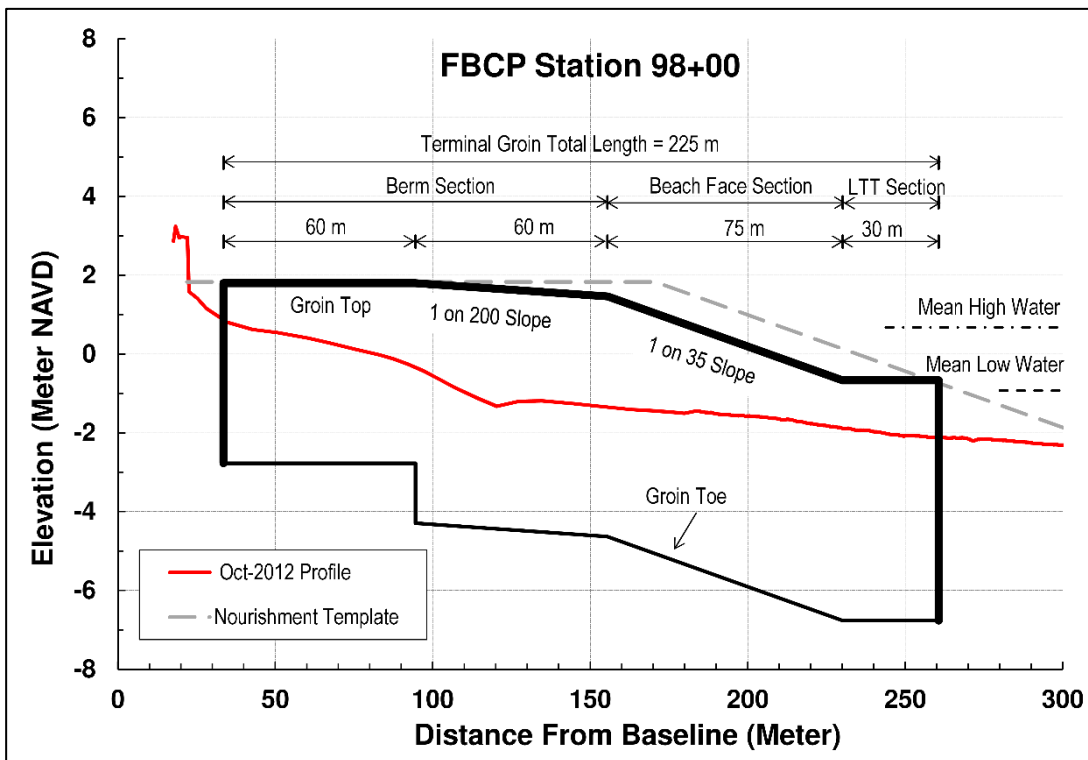
The proposed groin at FBCP was designed to follow the local beach profile to the extent practicable. The average slope of the natural beach served as a basis for establishing the sloping section of the groin. The proposed groin at FBCP was designed to be located at station 98+00, and composed of three sections: berm section, beach-face section, and low-tide terrace section (Fig. 6).

The final profile of the groin included a 60 m (200 ft) backshore section at +1.8 m (+6 ft) NAVD, a 60 m (200 ft) berm portion sloping from +1.8 m to +1.5 m (+6 to +5 ft) NAVD, a 75 m (245 ft) beach-face section sloping 1:35 from +1.5 m to -0.6 m (+5 ft to -2 ft) NAVD, and a 30 m (100 ft) low-tide-terrace section at -0.6 m (-2 ft) NAVD. Elevations are to the top of the steel sheet piles—the concrete cap increased the elevation of the final groin by 25 cm (10 inches). Granite armor stone (SC DOT Class F – 36-inch [91 cm] maximum diameter), bedding stone, and a filter cloth layer were to be placed at the seaward end for toe protection.

Fig. 6. Generalized cross-section profile of the design groin, calling for slopes to match the natural profile of the beach (1:35) along the beach face section. Sheet pile lengths were 4.5 m along the back berm section and 6 m along the front berm, beach face, and low tide sections.

To estimate groin-trapping capacity, the groin profile was superimposed on the beach section of nearby station 98+00. Beach fill was placed over the profile, then assumed to adjust to an equilibrium shape matching the natural profile. The berm section width (of the groin) was used to establish the point at which the adjusted profile closely matched the groin cross-sectional area. Some allowance was made to round values for simplification of the design and in consideration of the fact that a natural profile will not exactly match the groin profile because it is continually being modified by waves and tides.

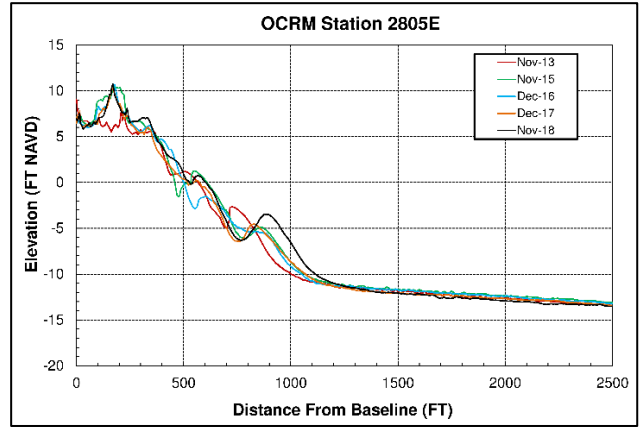
Fig. 8. Post-project survey profiles along station 2805E (~500 feet updrift of the groin.).

The authors have also been surveying the project area using a set of stations established by the State of South Carolina, as illustrated in Fig. 7. Profiles of a representative station are plotted in Fig. 8. The overall results are consistent with GEL's annual survey results and show that the once eroding beach has become an accreting beach (Fig. 9). Downtide stations (2801E and 2803E) have gained an average of 15 m³/m/yr (6 cy/ft/yr) of sand between November 2013 and November 2018, indicating that the groin reached the maximum sand-trapping capacity and excess sand has bypassed the structure and migrated downtide. Updrift stations (2805E and 2810) have also gained sand at a rate of 17 m³/m/yr (6.8 cy/ft/yr) over the past five years. Adverse downtide impacts of the structure have been negligible primarily due to a continued updrift sand supply and efficient bypassing around the low profile structure.

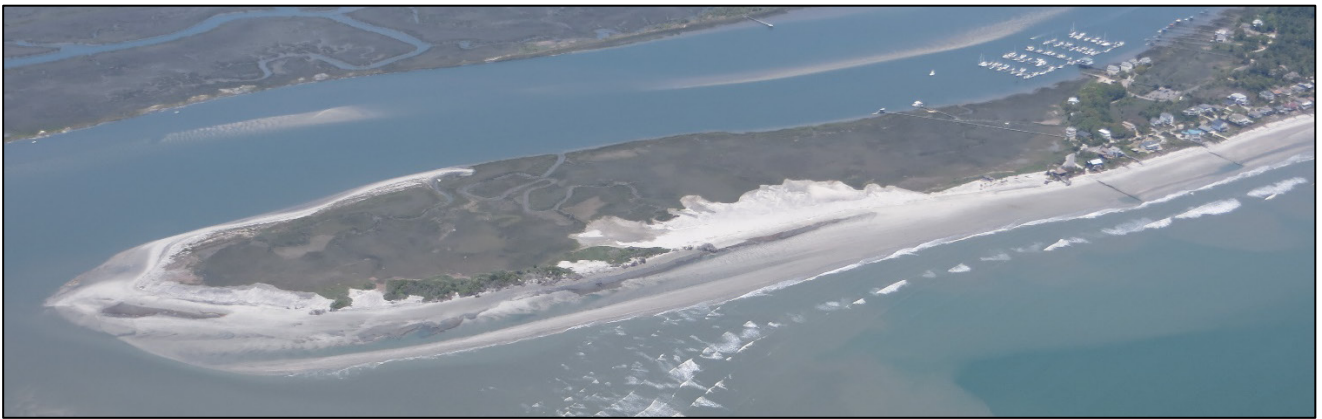
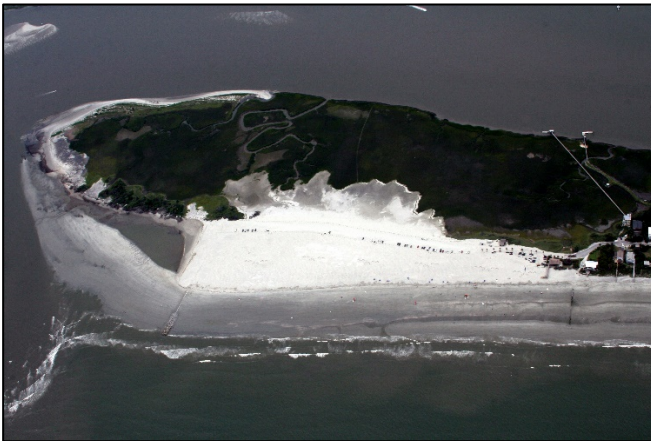
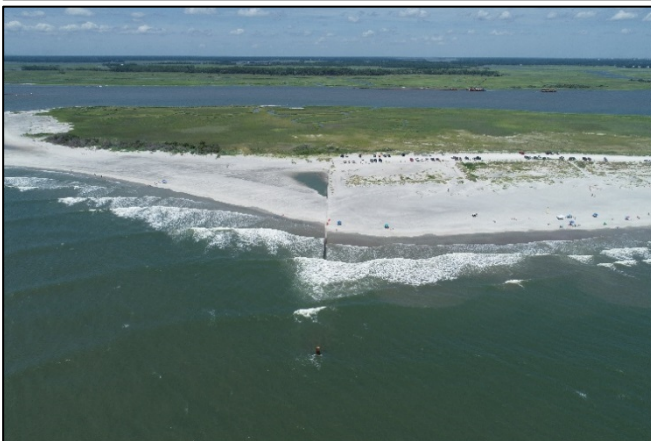
Fig. 9. Aerial photos of FBCP before and after the 2013 project.

[UPPER] Photo taken on 24 March 2013 before the project.

[MIDDLE] Photo taken on 24 July 2013 after project completion.

[LOWER] Photo taken on 17 August 2018 five years after project completion.
