## CONSIDERATIONS ON THE JOINT RECOVERY OF THE MONUMENT AND ITS ENVIRONMENT: THE TOWN WALLS OF ALBARRACÍN (SPAIN)

The city walls of Albarracín (Teruel) show an exemplary trajectory of restoration and conservation works, thanks to a fifty year-long trajectory of interventions carried out by different architects. The last of these projects, promoted by the City Council and driven by *Fundación Santa María de Albarracín*, was drafted in 2019 and involved the restoration of the southern end of the wall. For the first time, this project has addressed the recovery of the monument and its surroundings in a joint effort that bets on a global vision for the city's public space system. The keys to this binomial are based on the following premises: a well-coordinated monument-environment relationship, the emphasis on a conservative approach to the restoration works, the promotion of public use and the dignification of the space in a coherent way with its context. The joint treatment of the building and its environment goes far beyond an aesthetic or functional issue – which may have been achieved through independent projects – and verifies the criteria adopted for both dimensions of the proj

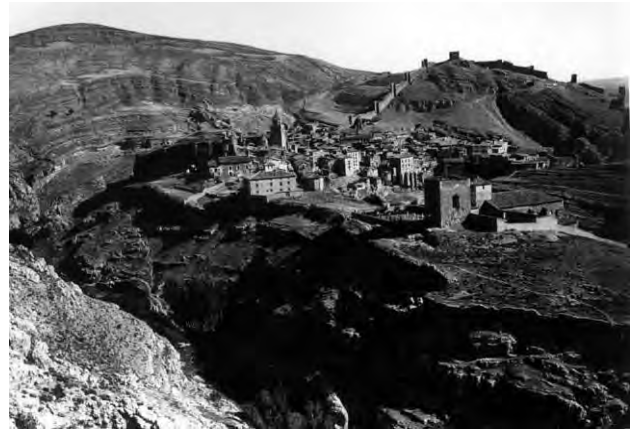
Figure 3. The city of Albarracín from the North (Instituto de Estudios Turolense, Archivo López Segura, 147, 25/6/1952).

The restoration of the city walls has been carried out, stretch by stretch, over fifty years and nowadays only a minor section remains incomplete (Figure 3). As a result, the progressive evolution of preservation theories over this period can be easily observed in the comparison of the different interventions, ranging from strong restitutions to purely conservative works.

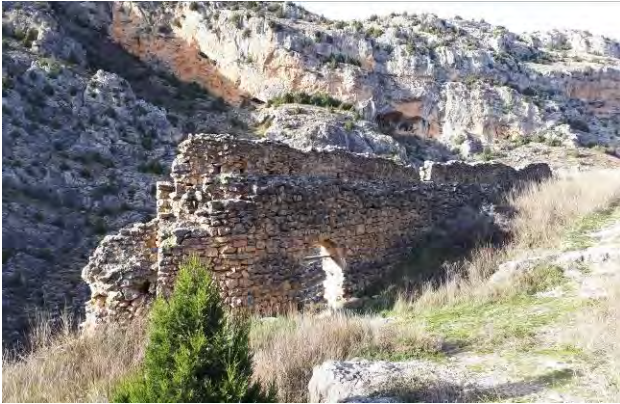
Figure 4. View of the wicket gate from the interior of the fortified precinct (J. Díaz).

Some water drains conserved in the exterior of the wall show the original height of the ground in its inner face, which is now silted up to its crowning with debris. It has a wicket-gate opened in the path that descends towards the river (Figure 4) and the remaining of a structure that, according to Almagro (1987), may have been the watchtower that controlled this area until the construction of the tower of *Doña Blanca*.

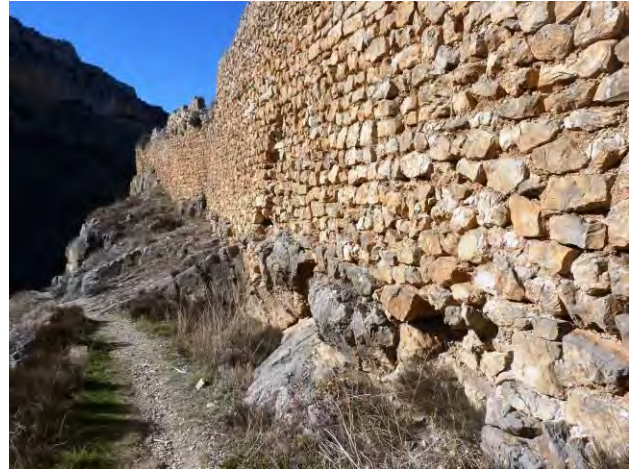
Figure 5. City wall of Albarracín, outer face of the *Torre Blanca* section (F. J. Gómez-Patrocínio).

All the stretches of the wall are formed by two external masonry layers, affixed using lime mortar, that confine a nucleus filled with lime concrete (Figure 5). Thick joints are due to the irregularity of the rough limestones, coming from the quarry known as *Barranco de Rusia*, that were used in the masonry walls. Only the protruding corner that starts the stretch with the wicket gate includes some coarsely carved ashlar.

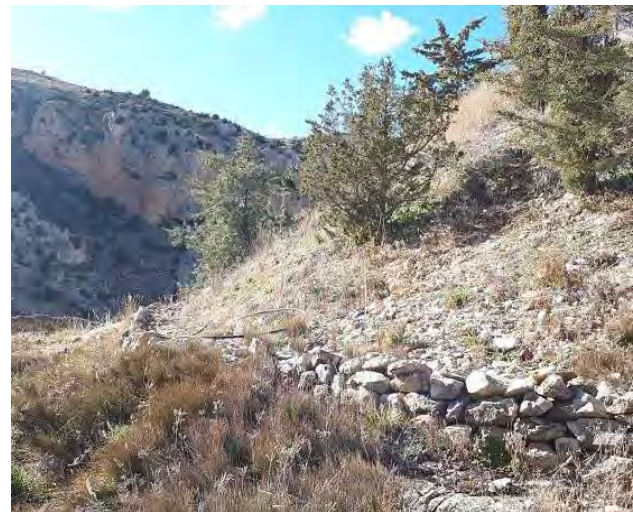
Figure 7. Historical debris dumped in the surroundings of the southern end of the city wall (J. Díaz).

The vast volume of debris accumulated in this area, which was the local landfill for over a century, made it impossible to address the recovery of the original ground level to the interior of the wall (Figure 7). Consequently, the project plans the substitution of the materials silting in the inner face of the wall by a draining filler relieved by the original gutters. However, the height of this filler will be lowered about a meter from its current level, which is even with the crowning of the wall.

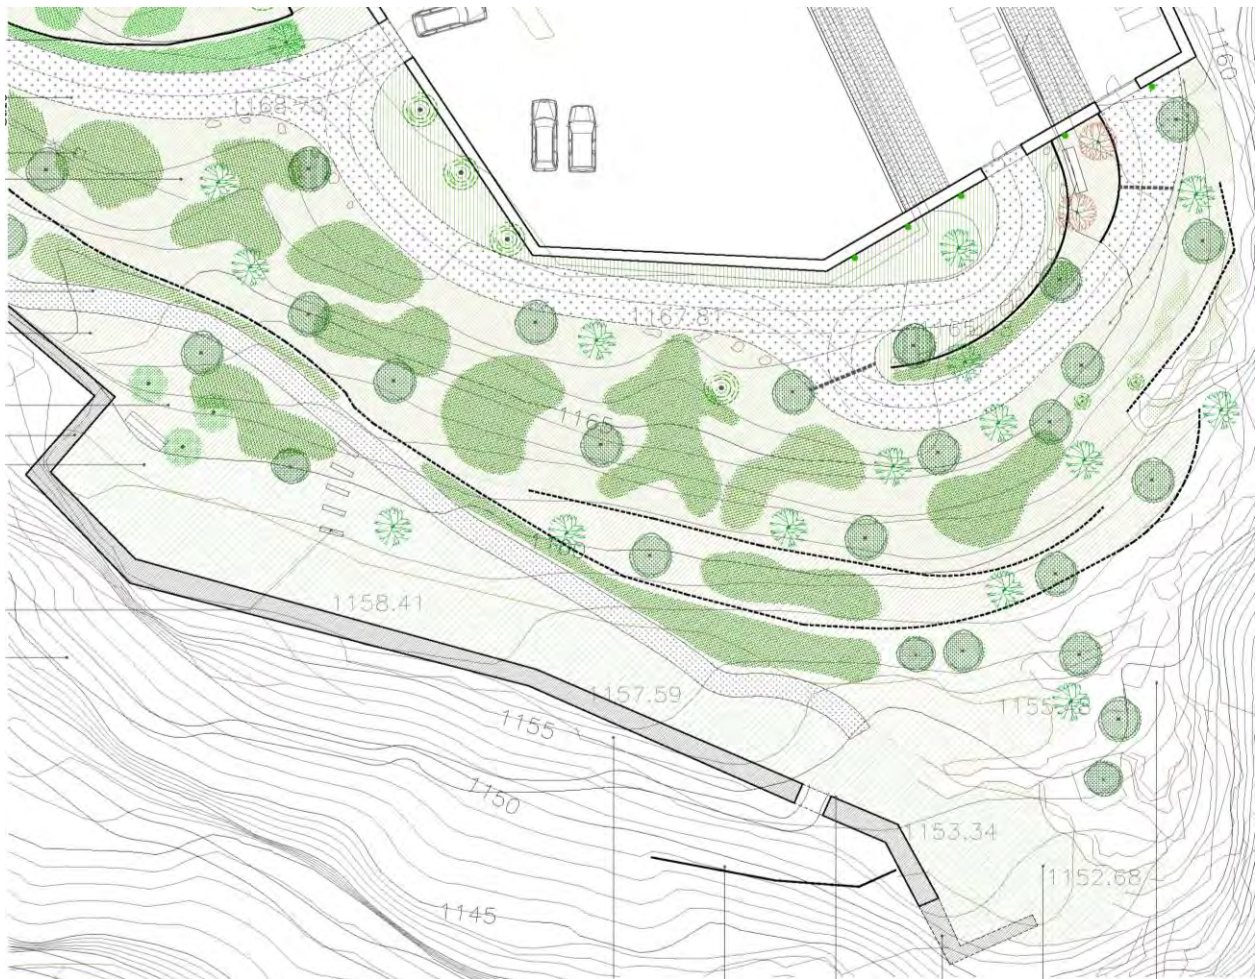
Figure 9. Plan of the projected landscape intervention (Díaz and Baró, 2019).

The joint vision of the open space system and the patrimonial dimension of Albarraçin has provided the key elements of the planned intervention. The project proposes the re-naturalisation of the area by removing imported, distorting elements and substituting them with autochthonous species. It aims to revert the effects of some inappropriate interventions (relief alterations, species planted with inaccurate criteria, uncontrolled dumps, obsolete conductions, etc.) to dignify the environment of the monument and unify it with the lowly anthropized slopes that surround the city (Figure 9).

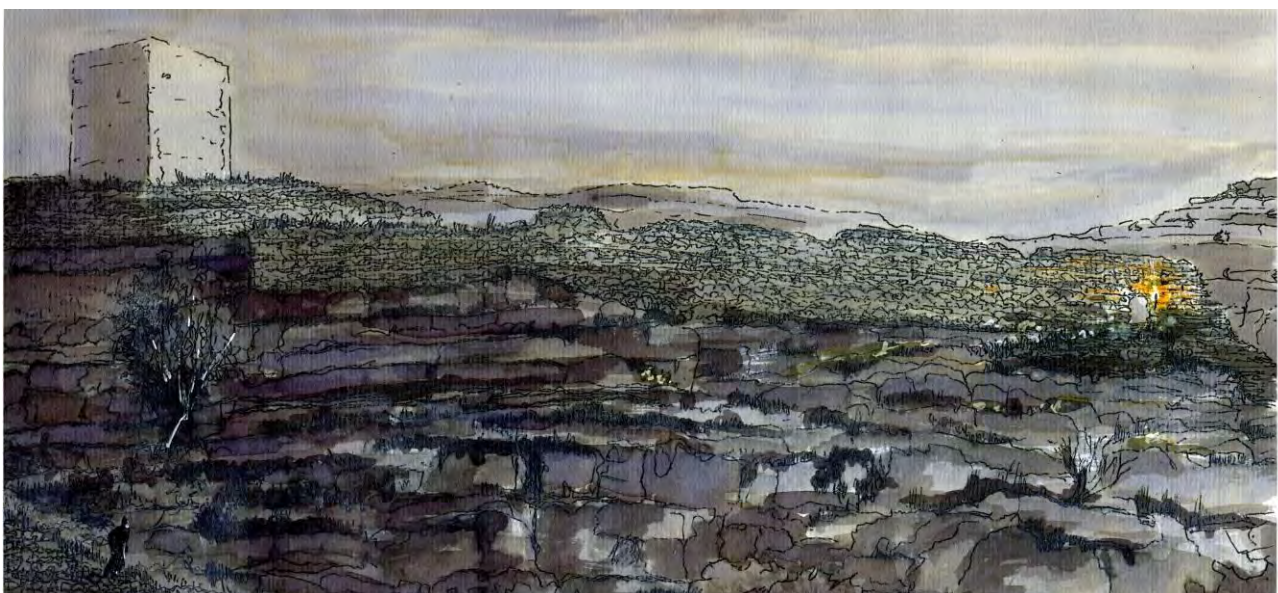
Figure 10. Sketch of the wall and its surroundings (J. Díaz).

The first element benefitted from these synergies is the historical path that descends towards the river from the terrace next to the graveyard. Its itinerary runs next to the wall at this area and, thanks to a coordinated design, will include small haven-viewpoint spaces that will improve the perception of the monument. Some metres further, the path crosses the wall through the wicket gate and leaves the fortified precinct. A lonely, tenuous uplift has been installed at this point, underlining its singularity as an inflexion point and turning it into a milestone in the landscape: from here on, the path abandons the city and plunges into nature (Figure 10).
