# Vibration monitoring on a PC girder bridge during a bridge collapse test

**ABSTRACT:** Using the information gathered from structural health monitoring (SHM) has been proved successful when identifying damage on specific type of bridges. However to know the extent of the localized damage into the structural performance or even the degree of its vulnerability by means of the SHM is still under discussion. This study aims to examine how changes in load resistance capacity of an actual PC girder bridge influence on their dynamic properties. In this study a real PC girder bridge under static loadings, a bridge collapse-test, is discussed. In the static loading test, the PC Bridge was put under several loading and unloading levels until failure. Besides, forced vibration tests from both impact hammer test and moving-vehicle test were carried out along the static loading test, in order to assess the changes in the dynamic properties of the PC Bridge with different health conditions. The study investigates the influence of different phenomena, such as creep and cracks propagation, on the variation of modal parameters. Observations showed that changes in the frequency of the second bend

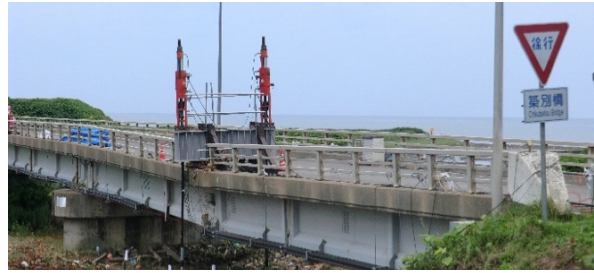
(a) General view of PC-girder bridge

(b) Loading jack for static loading test  
Figure 1: Target bridge.

The target bridge consists of four PC girders and five spans. The length of each span is 34.3 meters and width of 7.2 meters. One span of them is the target of the experiment. Figure 1 shows the target bridge with the static loading device installed. The bridge had been operated more than 50 years since its construction. The bridge suffered salt damage to the main girder, and cracks in the main girder and peelings of the concrete caused by corrosion of internal steel material were observed by visual inspection. Figure 2 shows the appearance of the lower part of the girder, in which cracks in the longitudinal direction, exposed reinforcing steel and peeling of repair/reinforcing material can be observed.

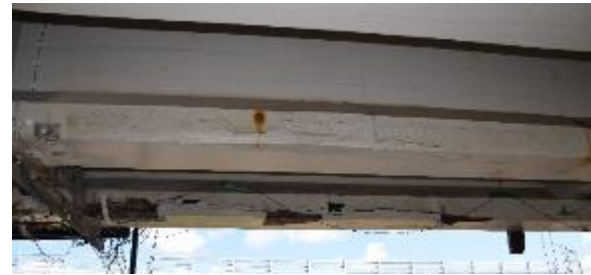
Figure 2: Damage on girders.

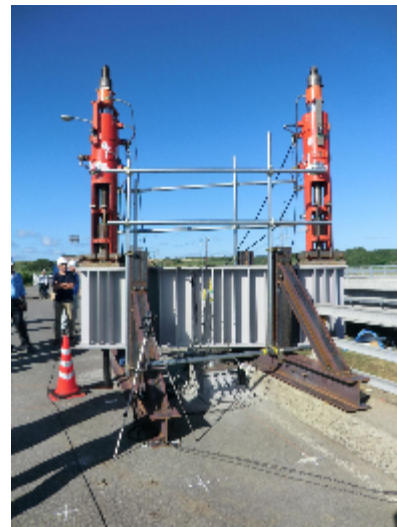
Figure 3: Loading test device.

The static loading test was carried out by means of a single point load from two jacks which have a capacity of 2500kN per each. Figure 3 shows the loading test device. The load point is set at the span center of the outer girder (G1 girder in Figure 4), and static load was monotonically increased. Twenty displacement sensors were distributed uniformly under the girders, five in each girder as shown in Figure 4. From these twenty sensors, nine displacement sensors were laser type (mostly allocated under girder G1 and G2) and the other eleven were displacement transducers of tape measure type.

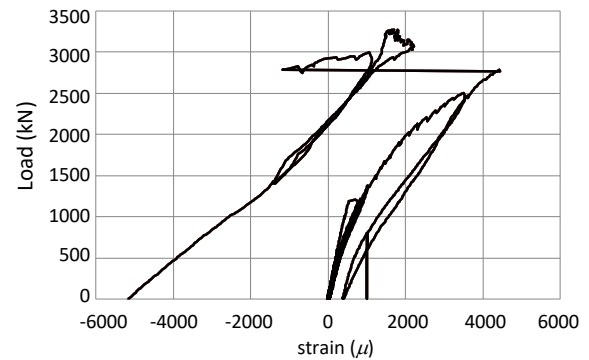
Figure 8: Load vs. strain curve.

Figure 8 shows the load-strain curve observed at near the span center of the G1 girder (see Figure 4). From the Figure 8, it is clear that the rupture of the PC tendon occurs when around 2700kN load is given.

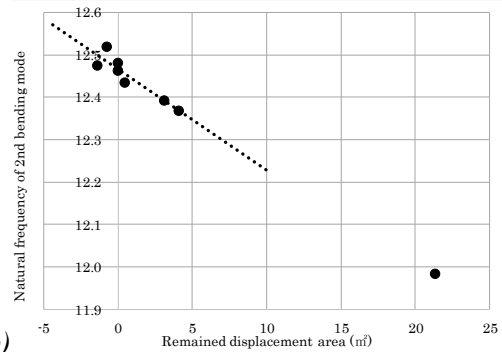
Figure 17: Remained displacement area vs. frequency: (a) 1st bending mode; (b) 2nd bending mode.

Figure 17 shows the comparison of changes in residual displacement and changes in natural frequency. The dotted line in the figure shows a

linear regression between them from stage 1 to stage 8. From the linear regression, 2nd bending modal frequency has a correlation with residual displacement, and this correlation is stronger than that between energy capacity and natural frequency.
