Emergency Responder's Guide to Protecting the Edwards Aquifer: Instructional Enhancements

Rudolph A. Rosen Texas A&M University-San Antonio

Marcus Gary Edwards Aquifer Authority

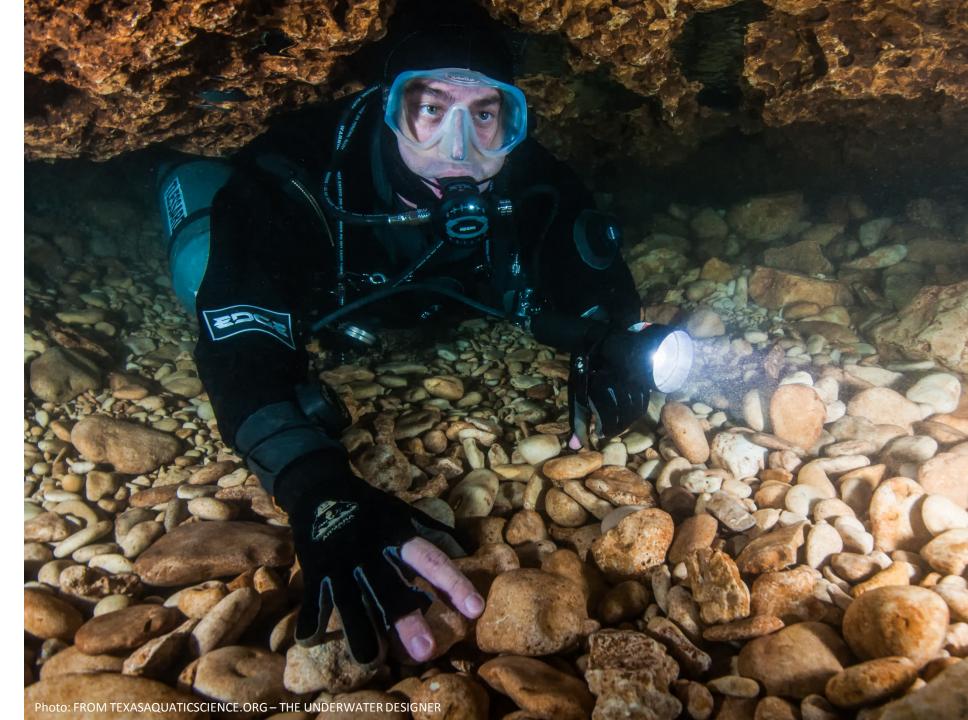
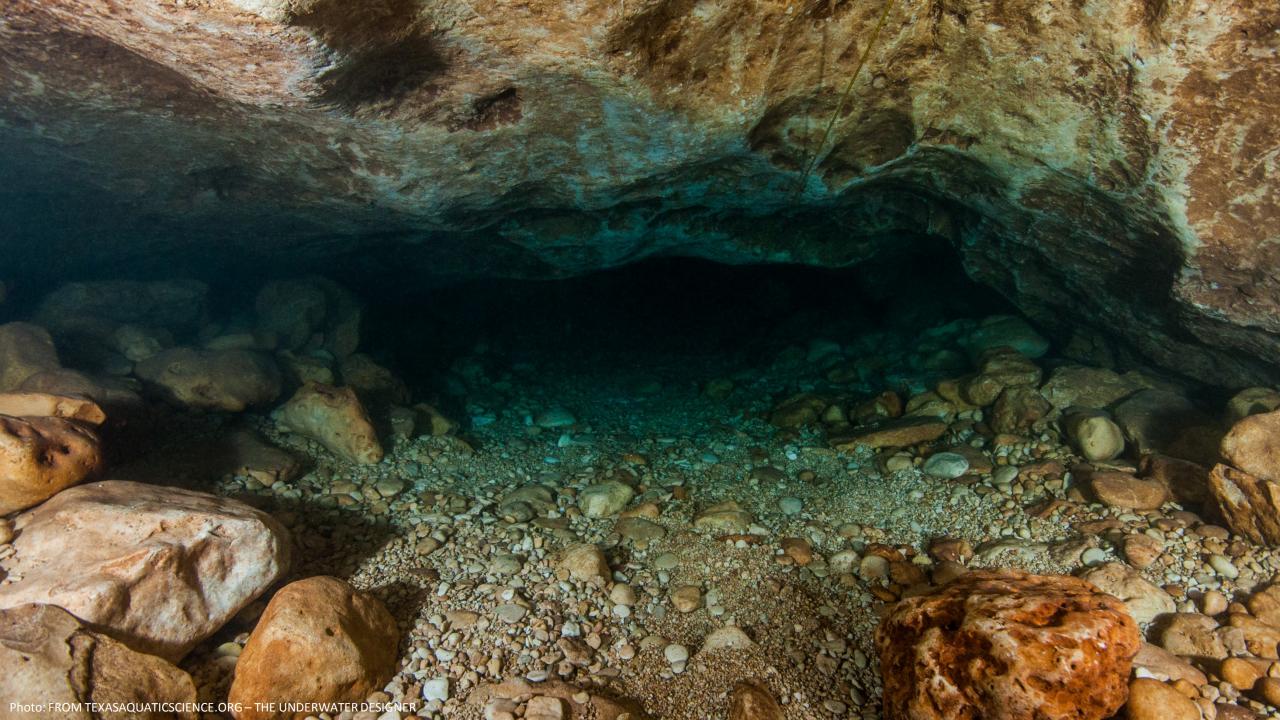
Here's what the Edwards Aquifer looks like deep underground.

It's a place of wide open tunnels, underground rivers, and caves all connected to the surface by thousands of cracks and openings.

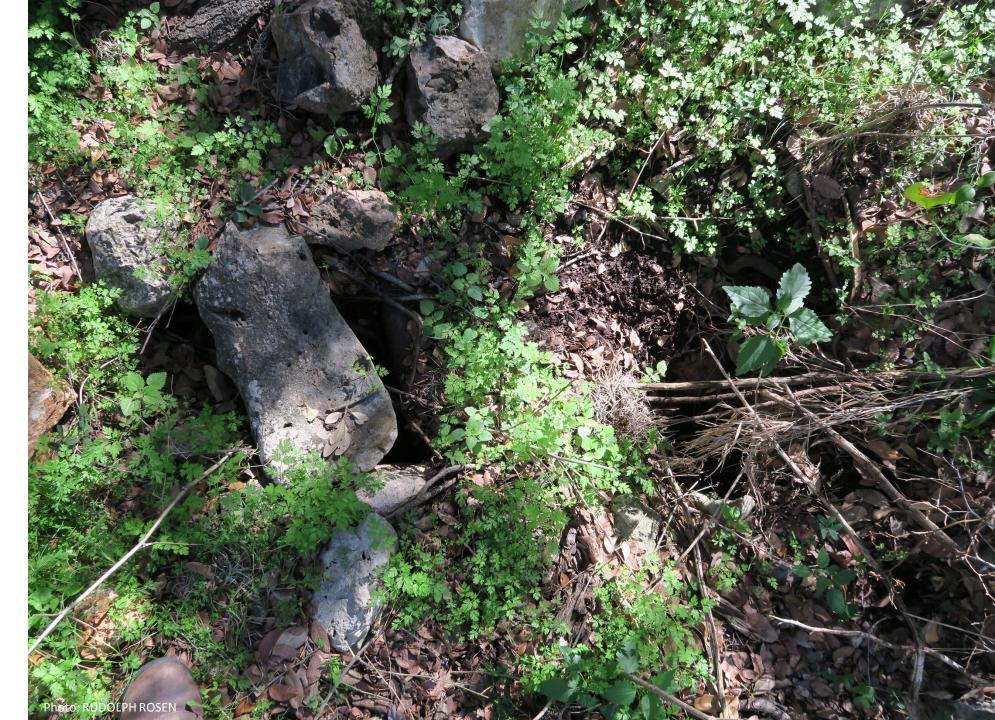
Sink holes and depressions in the land surface are typical signs of openings to the aquifer at or just below the surface.

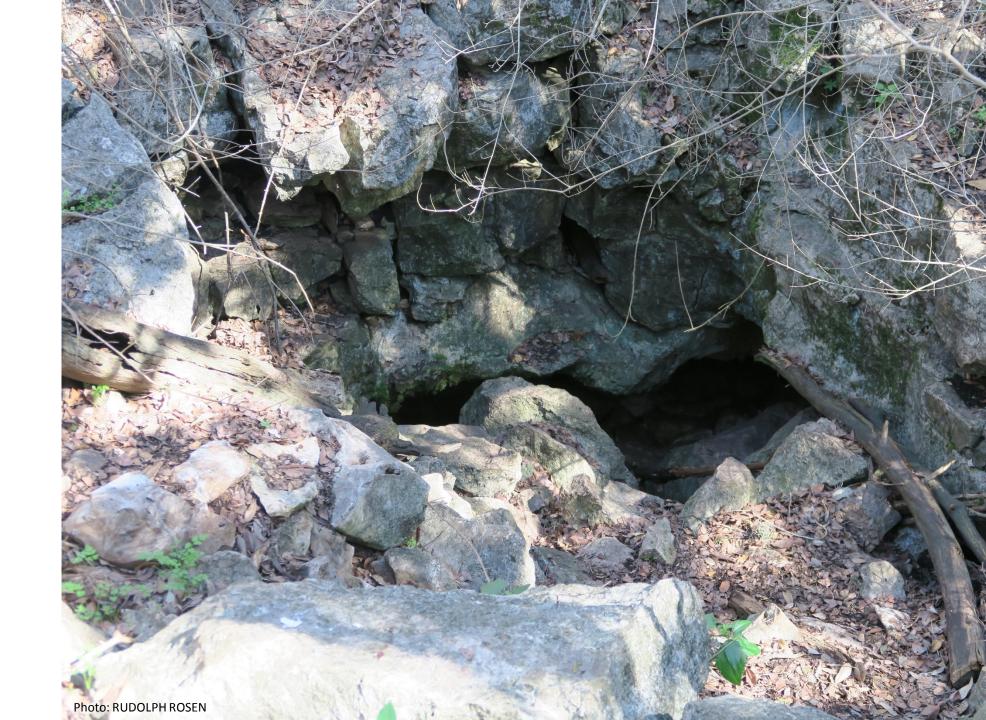
Sink holes and depressions in the land surface are typical signs of openings to the aquifer at or just below the surface.

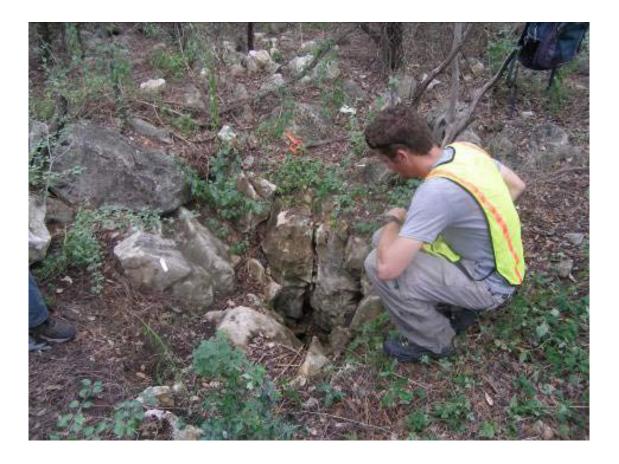
This sinkhole measures 9 ft in diameter and 12 ft in depth. It receives flow from approximately 10 square meters off a hilltop.

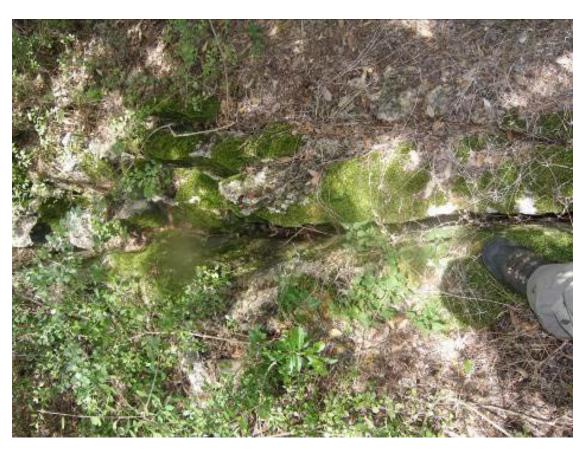
This cavity is an enlarged fracture measuring 12 ft long by 3 ft wide by 1.6 ft deep. It receives flow off approximately 20 square meters of hillside.

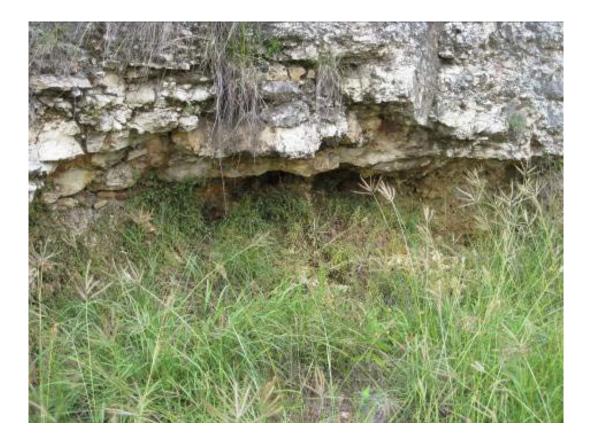
This cavity is an enlarged bedding plane measuring 5 x 1.5 ft and 1 ft deep. This feature has breakdown, silt, exposed bedrock, and vegetation present within. This feature is set high enough in the that it would not receive runoff from a roadway or ditch.

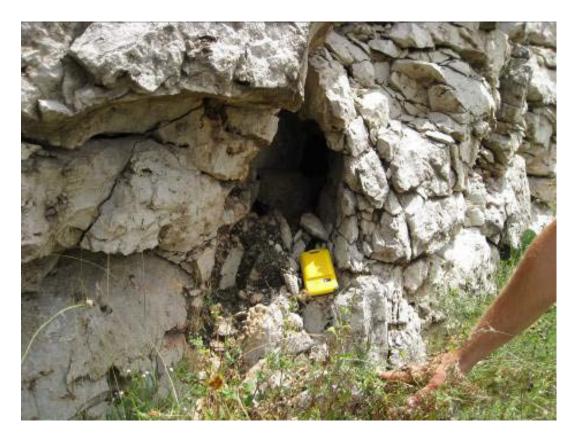
This enlarged fracture measures 1 x 4 ft and is 2 ft high. The feature contains exposed bedrock and broken rock fragments. It is located in a roadcut of Loop 1604.

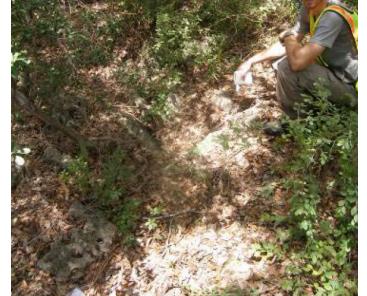
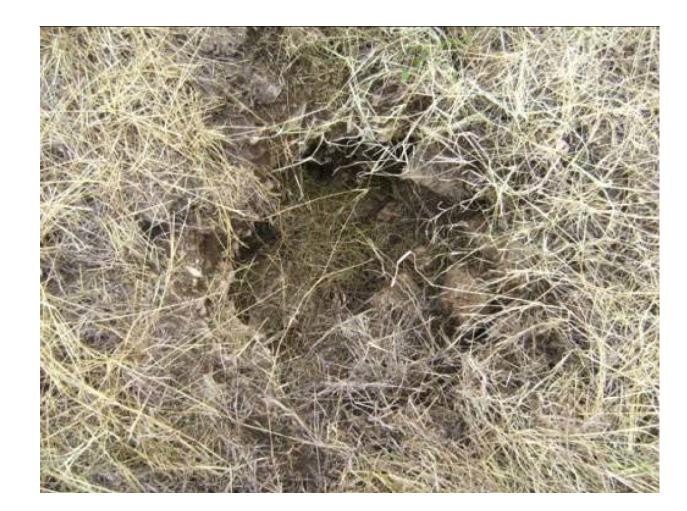
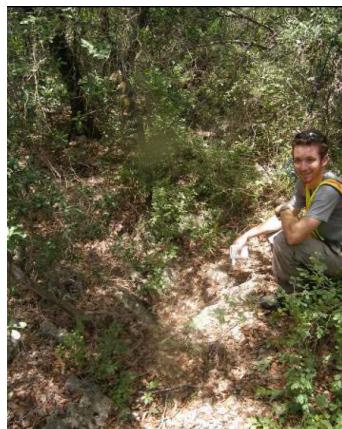
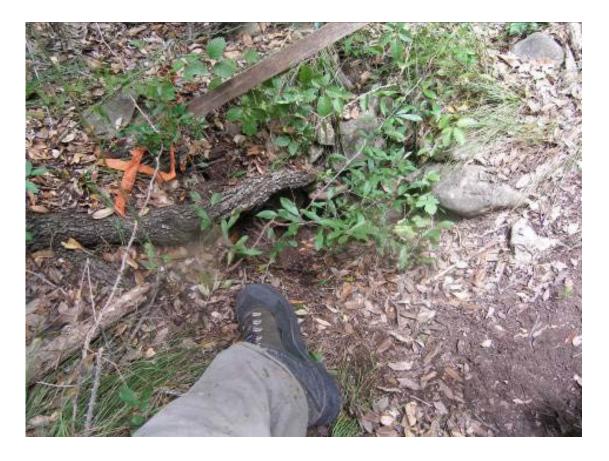
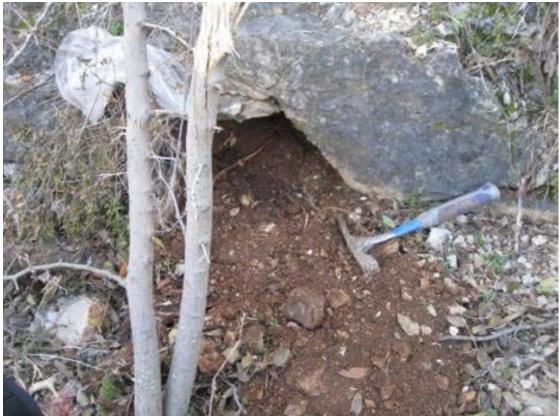
This sinkhole measures 4.6 ft in diameter and 3 ft in depth. It appears to have a drain continuing further underground out of sight and out of reach

This cavity measures 1.5 x 1.5 ft and is 0.3 ft high The feature contains breakdown rocks, soil, and reddish brown clay.

This sinkhole measures approximately 98 ft in diameter and 7 ft in depth. It receives drainage from the east, and the deepest part of the depression abuts a paved parking lot and a concrete drainage structure.

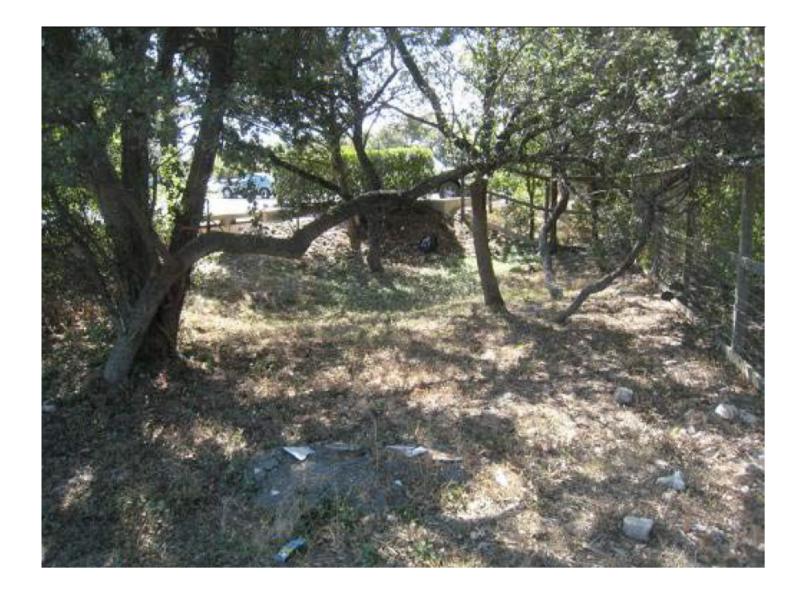
This cavity measures 2.6 ft wide, 8.2 ft long, and 2.6 ft in vertical extent. It contains dry flowstone and exposed bedrock.

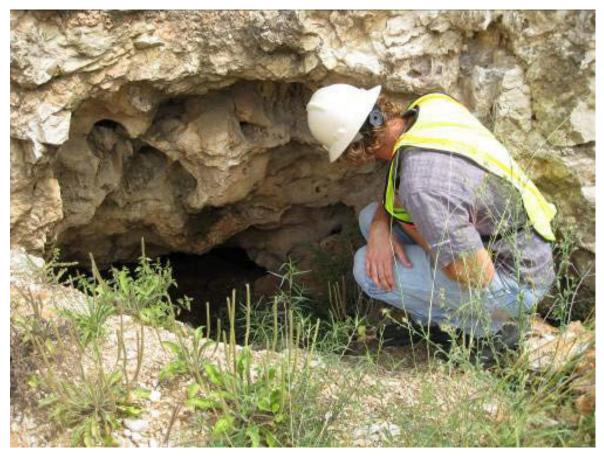
This cavity measures 4.5 x 3 ft and is 7 ft high. The feature contains silty clay, small breakdown, and exposed bedrock. This feature is formed at the base of a road cut, and slopes downward to a rubble fill.
