Article

# Managed Aquifer Recharge at a Farm Level: Evaluating the Performance of Direct Well Recharge Structures

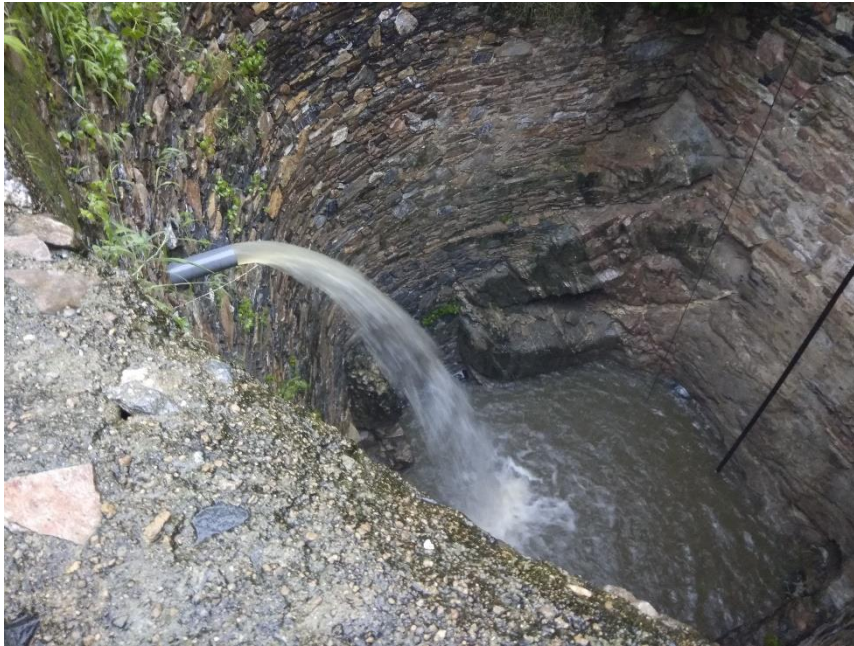
**Figure 3.** Runoff discharge into well after it was collected in the pit and had passed through the filter.

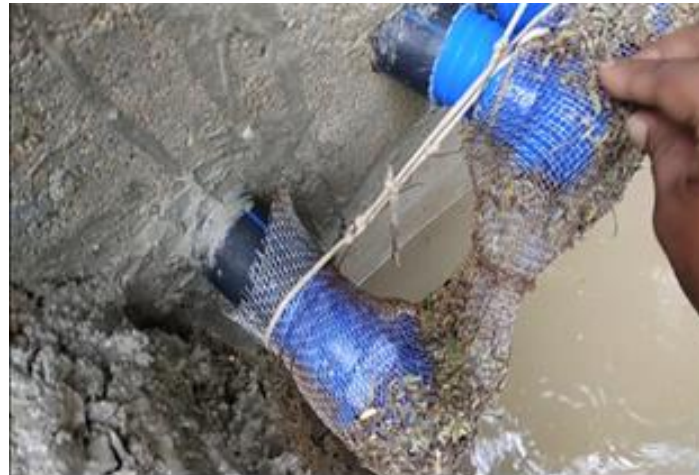
Figure 9. Recharge pit with filters. and clogging of the flow meter inlet.

The runoff water was filtered before redirecting it into the recharge well to retain suspended sediments and thereby reduce the blockages of fractures (see Figure 9) and improve the groundwater quality. During the first two to three rainfall events in the study, we observed that the surface water carried with it considerable amounts of suspended fine silt particles and organic plant materials, including rotten leaves and plant debris. The filter bed made up of coarse sand and gravels retained much of the suspended silt. It was also observed that timely manual cleaning of the pit, namely, the removal of the silt and plant debris, was an important activity to reduce any blockage of the discharge pipe inlets. During the monitoring, on some occasions, the water meters were observed as being clogged by plant debris, and thus to overcome this problem, we installed a wire mesh at each flow meter inlet.

For the long-term success of DWRS structures, removal of any suspended material through filtering is important before runoff water is discharged into wells to avoid potential clogging of aquifer fractures. Clogging has been observed a significant issue in Australia when stormwater runoff and treated municipal waste-water effluent are injected into aquifers to produce water for irrigation (NRMCC, EPHC, NHMRC 2009) [19]. Baveye et al. (1998) [20] reported that the main problem in infiltration systems for enhancing recharge of groundwater is clogging of the infiltrating surface (basin bottoms, walls of trenches and vadose-zone wells, and well-aquifer interface in recharge wells), resulting in reduced infiltration rates. Silt removal is done mechanically with scrapers, front-end loaders, and graders, or manually with shovels and rakes.
