“A review of the application performances of concentrated solar power systems”

-Applied Energy-

December 2019

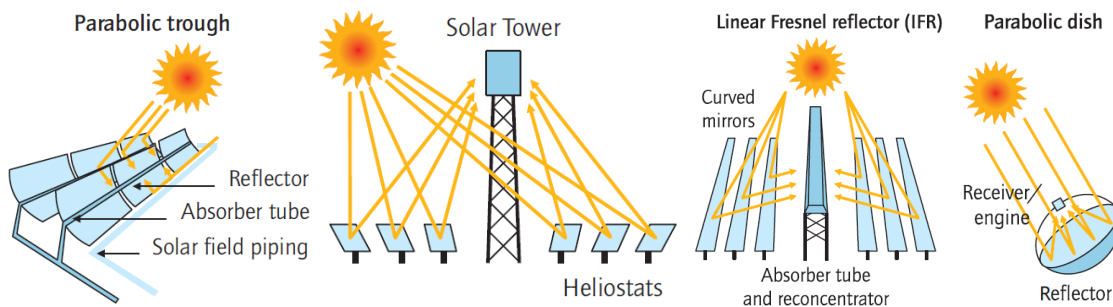
Figure 1. Current CSP configurations [7].

- *Photovoltaic (PV)* where energy is generated by the photovoltaic effect. This effect is produced when sunlight incises on solar cells, that generates electricity in certain semiconductors. This electricity can be stored or sent to the electricity grid [4, 5].
- *Concentrated Solar Power (CSP)* where the energy is generated from heating a fluid using concentrators and mirrors. In this field, Spain and the USA are the greatest producers of CSP with more than 4 GW [6]. Figure 1 shows the main CSP configurations.

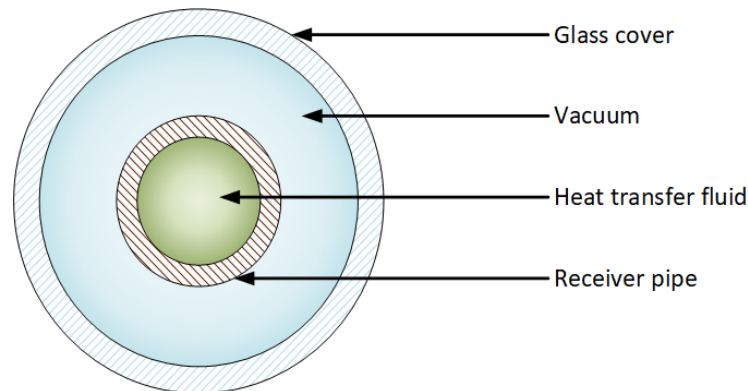
Figure 2. Absorber tube scheme.

improve the absorptance of their external surface [33, 34]. Figure 2 shows the basic scheme of an absorber tube (AT).

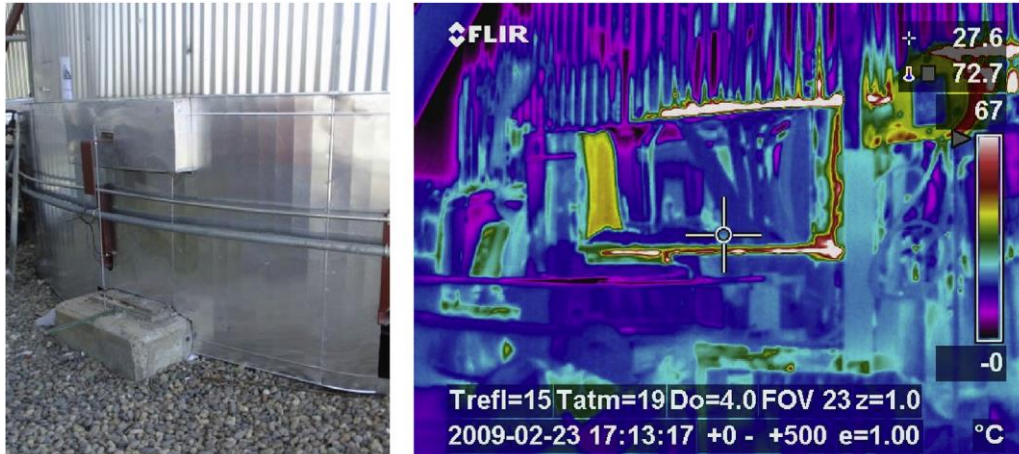
Figure 3. Thermal losses in the hot tank foundation [66].

Analysing storage tanks involves measuring and mitigating thermal losses by modelling the behaviour of the system. Heat losses were observed and mitigated by Prieto et al. [66] in a pilot plant in Seville, see Figure 3. They analysed and modelled the losses and proposed the addition of a cold mesh in order to reduce them. Similar work was carried out by Prieto et al. [67], who measured the temperature distribution and the thermal losses in a pilot plant in Lleida.

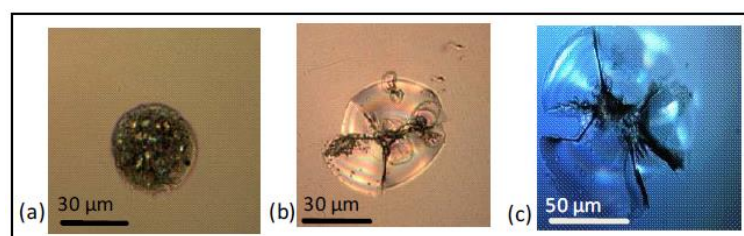
Figure 4. Damaged surfaces: (a) desert site; (b) oceanic site; (c) laboratory [84].

The study carried out by Karim et al. [84] focused on the effects of sandstorms on mirror surfaces. Figure 4 shows some effects. Two different locations, the ocean and the desert, were considered. Samples of real sand were simulated under laboratory conditions, considering speeds and impact angles. Two impact shapes were discovered, i.e. a ring and normal cracks, depending on wind velocity.

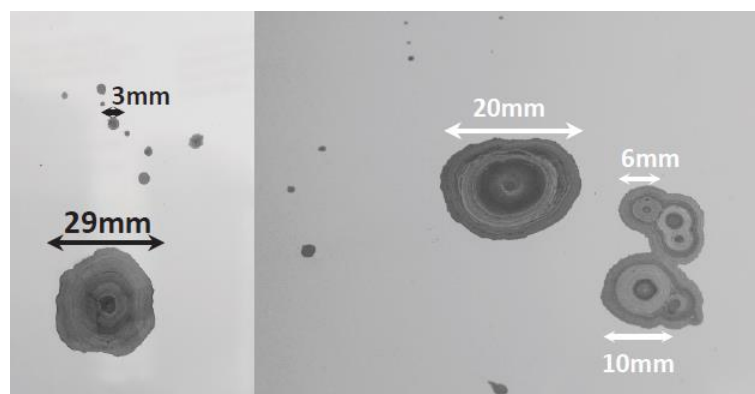
Figure 5. Pitting corrosion spots after 3 years of use [94].

Fernández-García et al. [94] analysed the efficacy of accelerated laboratory experiments using three commercial mirrors to test the surface and edge corrosion related to ageing and use. This study compared the degradation of real mirrors after two years with accelerated ageing cycles of up to 3000h. They concluded that some types of tests cannot be used to make life estimations, and that accelerated ageing experiments could only be used to replicate short exposure periods. Figure 5 shows the effects of corrosion and erosion in a desert environment after 3 years of exposure.

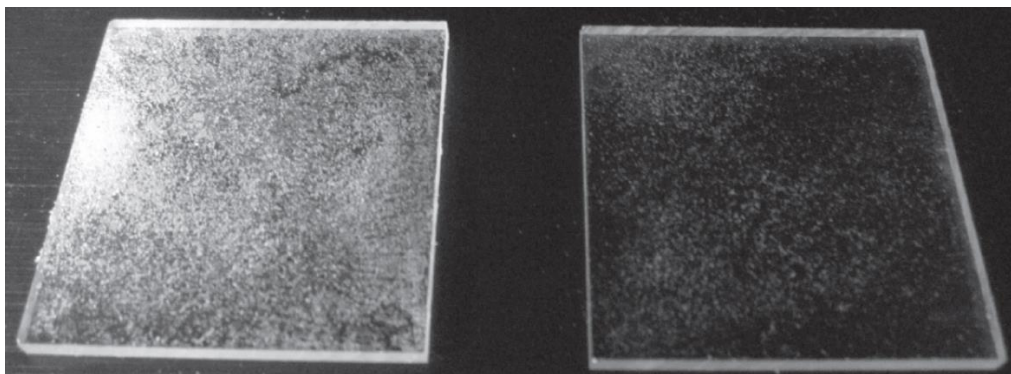
Figure 6. Samples without (Left) and with (Right) coating after experiments [133].

Regarding mirror coatings, Hunter et al. [132] proposed a hydrophobic coating based on nano-silica and polymer materials. These materials allow durability to be increased up to 2 years in a working environment, but they cause a reduction in reflectivity. Sueto et al. [133] studied the effectivity of multi-layer coating on Fresnel lenses. In each experiment, 1g of sand was discharged. Then, the electrostatic voltage and deposited sand in the samples were measured. A significant difference between both samples was obtained, see Figure 6. The stability of this coating was also tested under high humidity, thermal cycling and freezing conditions without observing any additional degradation.

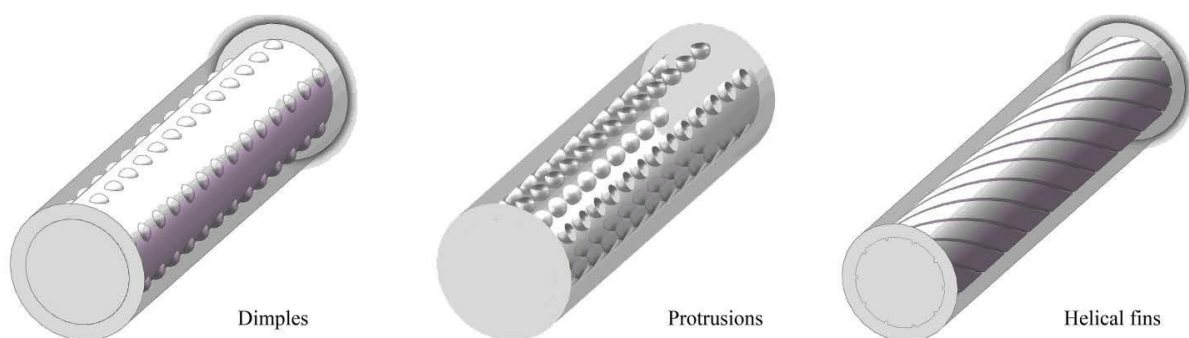
Figure 7. Proposed irregularities in the inner surface of the pipe [141].

Heat transfer improvement can be also made using some techniques such as the addition of pins in the inner surface [140] of the pipe, or other irregularities such as dimples, protrusions or helical fins (see Figure 7) [141], or the use of a corrugated tube [142]. These methods use FEM and fluid dynamics equations to model the turbulence and heat transfer capacity of these irregularities.

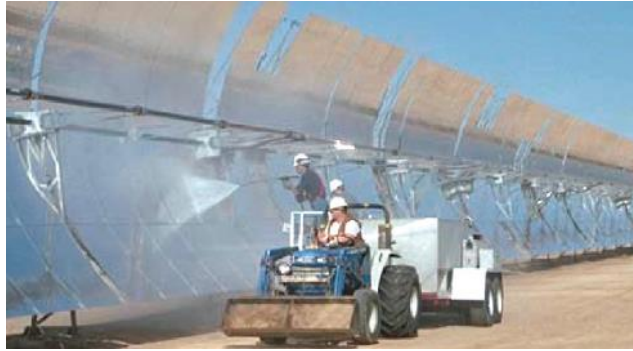
Figure 8. Manual cleaning of CSP mirrors using high-pressure spray [152].

There are several methods that can be used to attenuate the consequences of soiling. Sayyah et al [152] differentiated between three techniques: natural cleaning, manual cleaning (Figure 8) and surface coating. However Sarvver et al. [153] considered two methods: restoration (washing and using mechanical methods) and prevention (surface modifications and active prevention).
